Alloy 152/52-LAS Dilution Zone and Interface/Fusion Line PWSCC Testing

***Mychailo Toloczko, Matt Olszta,
Nicole Overman, and Steve Bruemmer***
Pacific Northwest National Laboratory

EPRI 690/ 152/ 52 PWSCC Research Collaboration Meeting
Nov 29 to Dec 1 • Tampa, FL

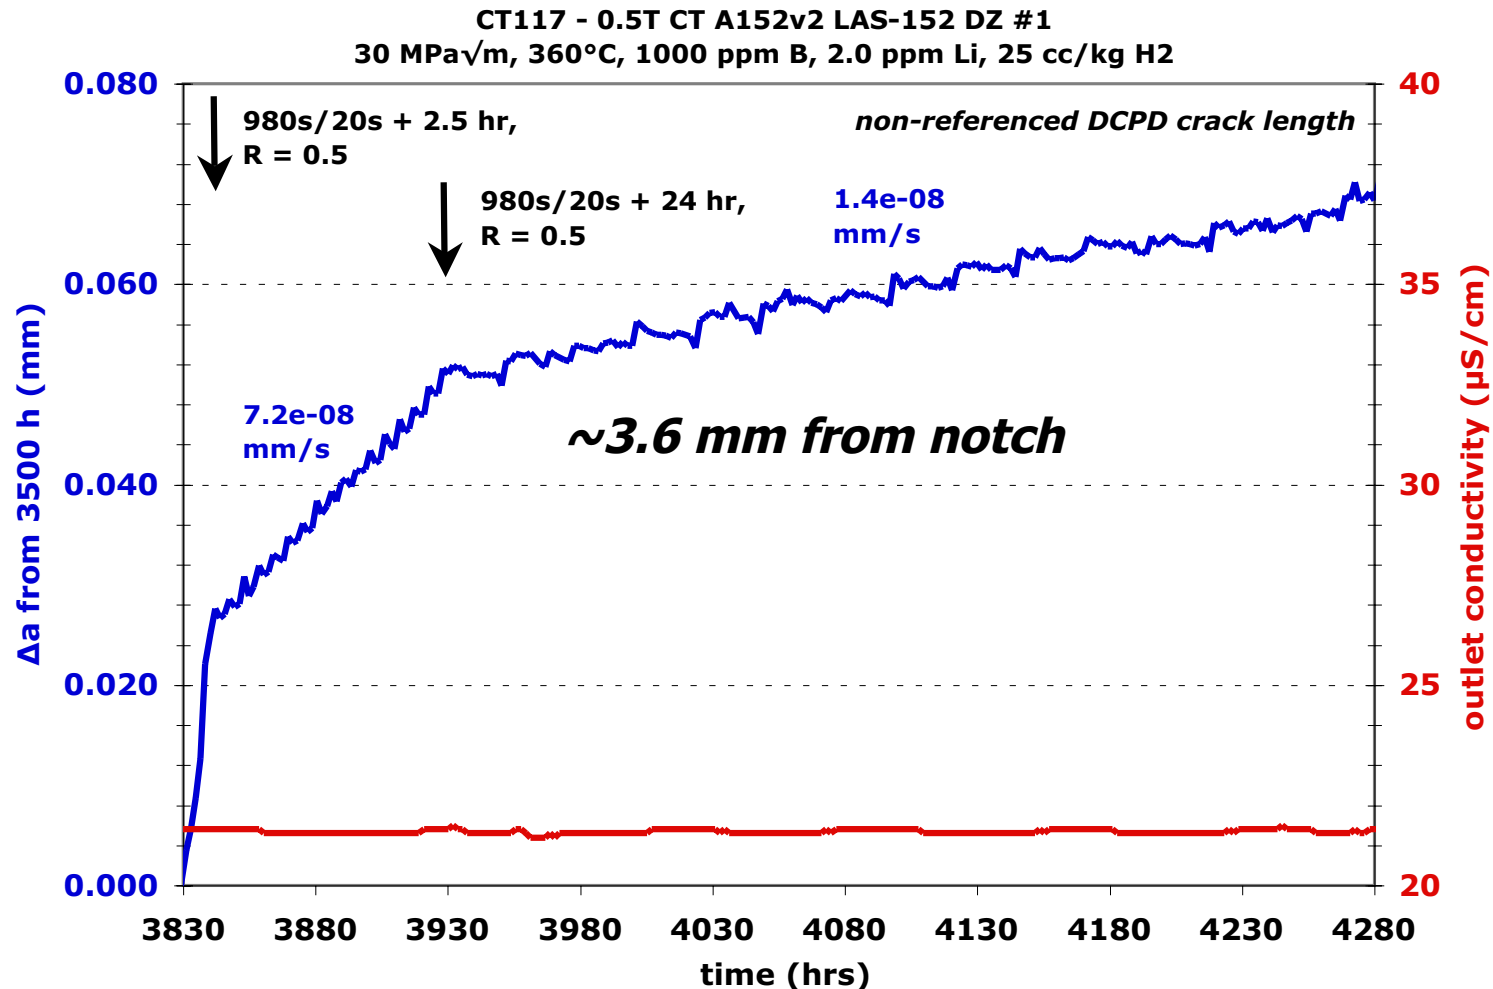
24 Hour Hold Response

- ▶ 1.4×10^{-8} mm/s measured in this observation.
- ▶ $2-7 \times 10^{-9}$ mm/s CGRs typical for non-engaged alloy 152/52.
- ▶ Serrated response suggests ligament breakage.

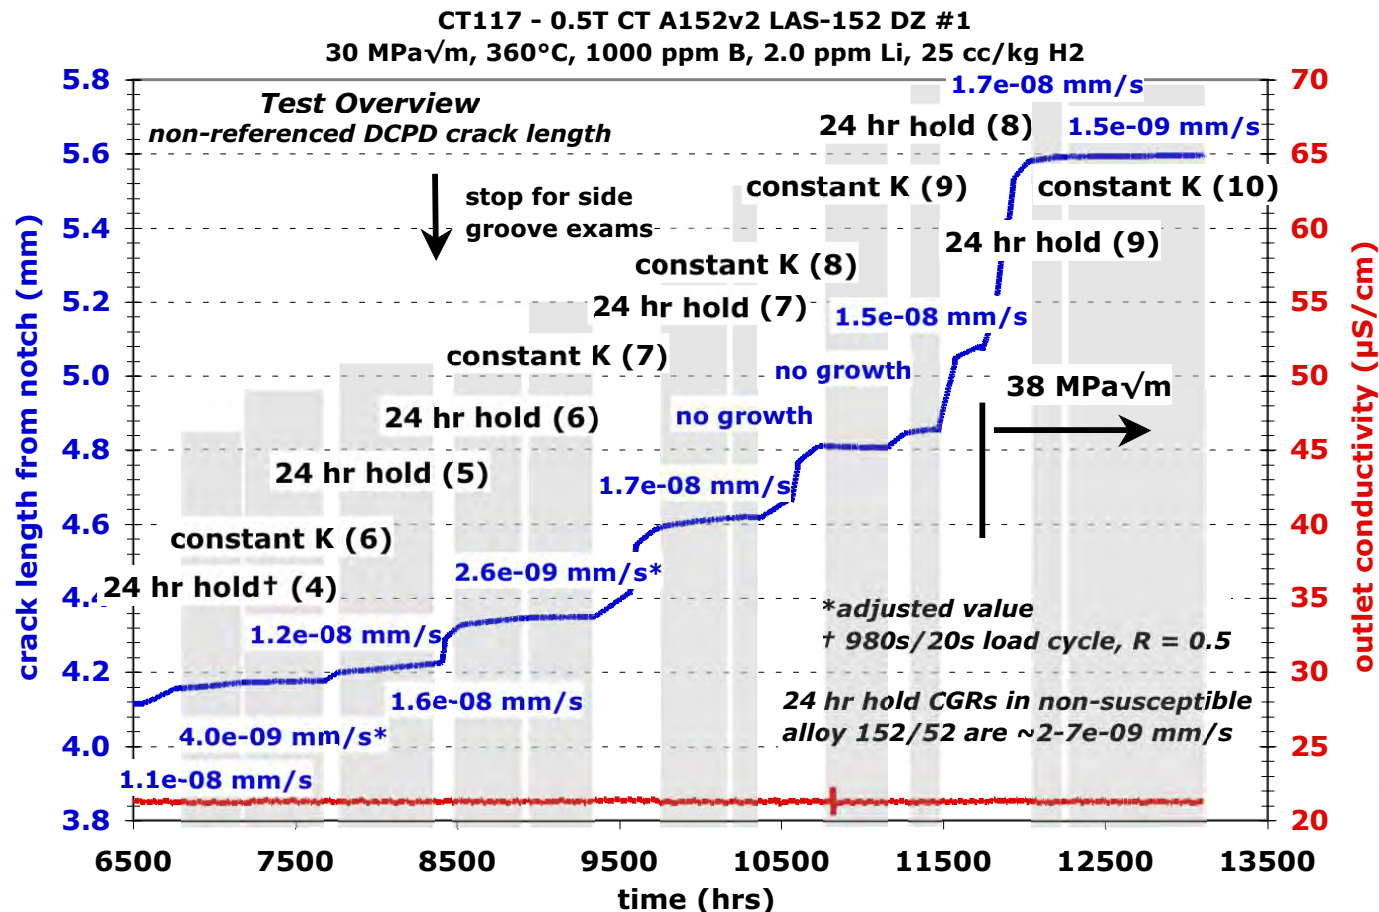
Test Overview – Part 2

- ▶ Increased in susceptibility between ~4.2 – 4.7 mm.
- ▶ Constant K values remain low, but 24 hr hold observations have increasingly higher values.

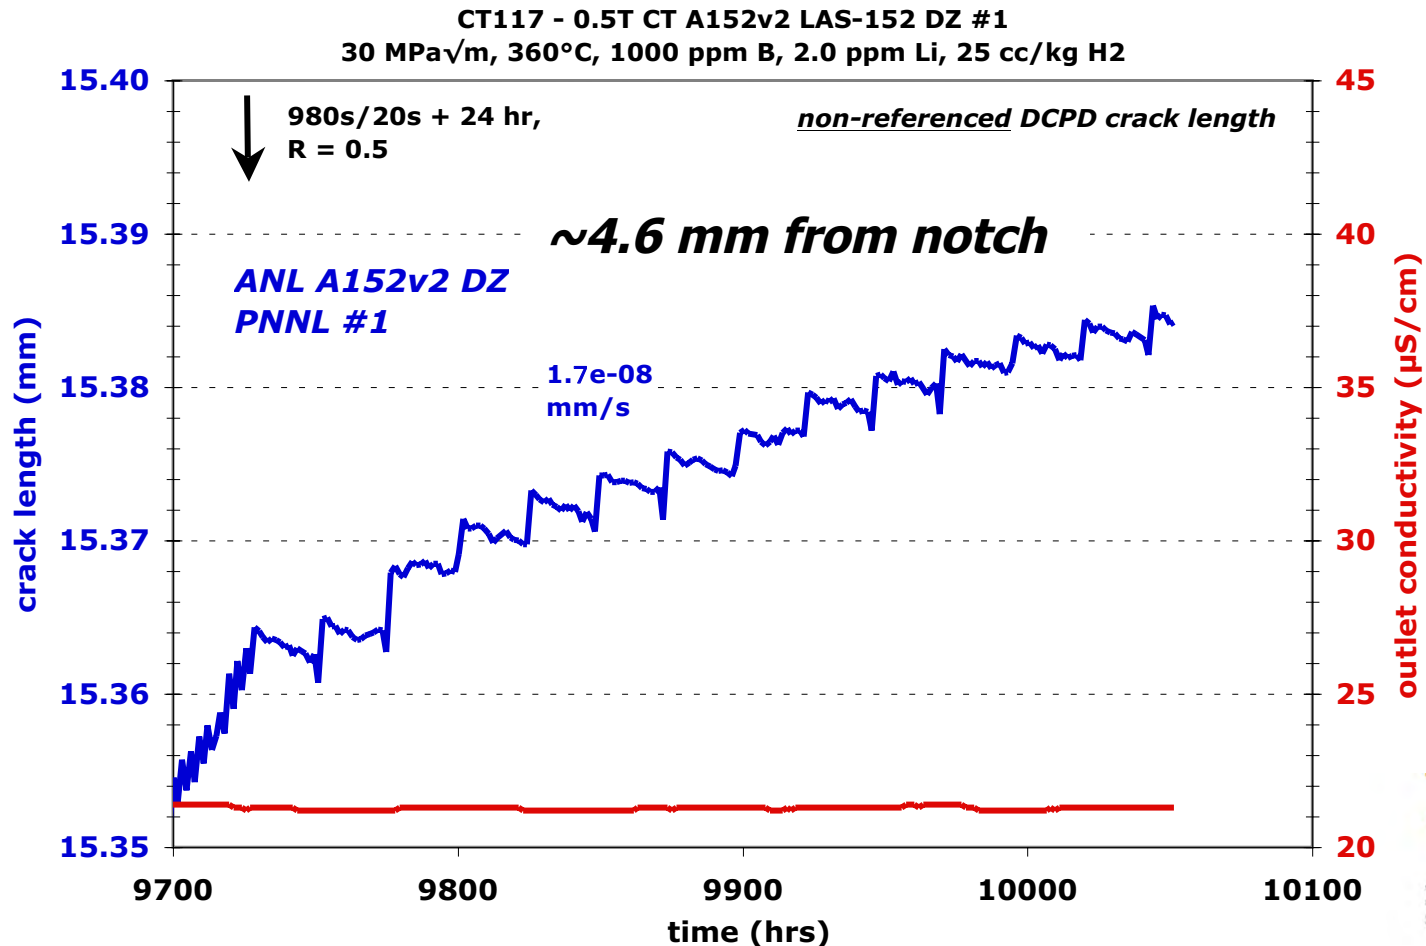
Test Overview – Part 2

- ▶ This is the highest 24 hr hold rate observed for this specimen.
- ▶ Strongly serrated behavior suggestive of ligament or contact issues.

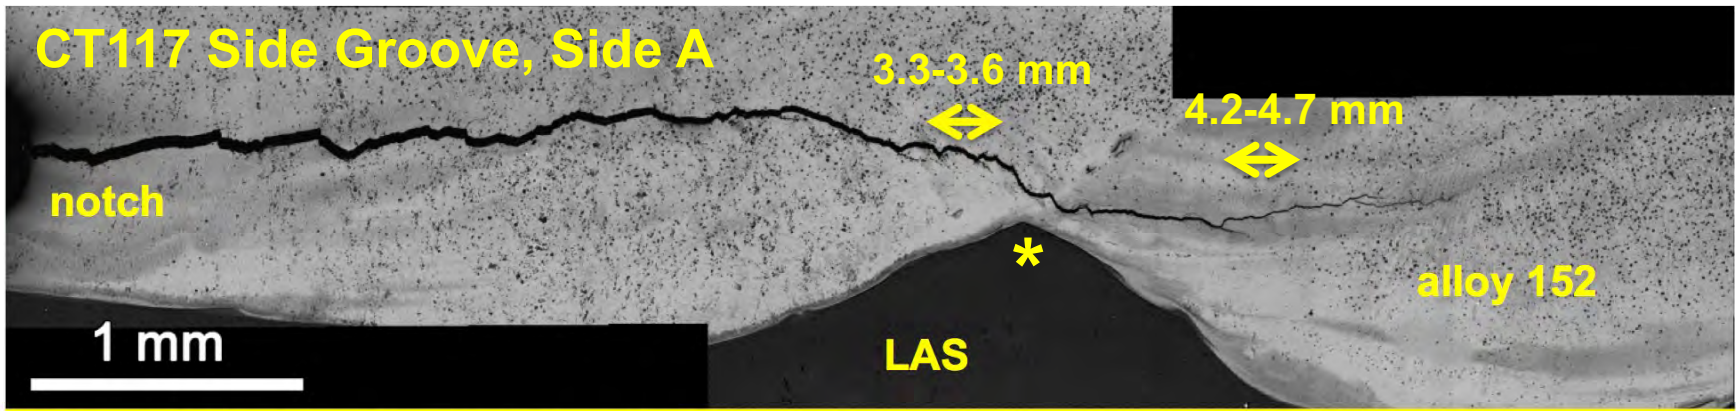
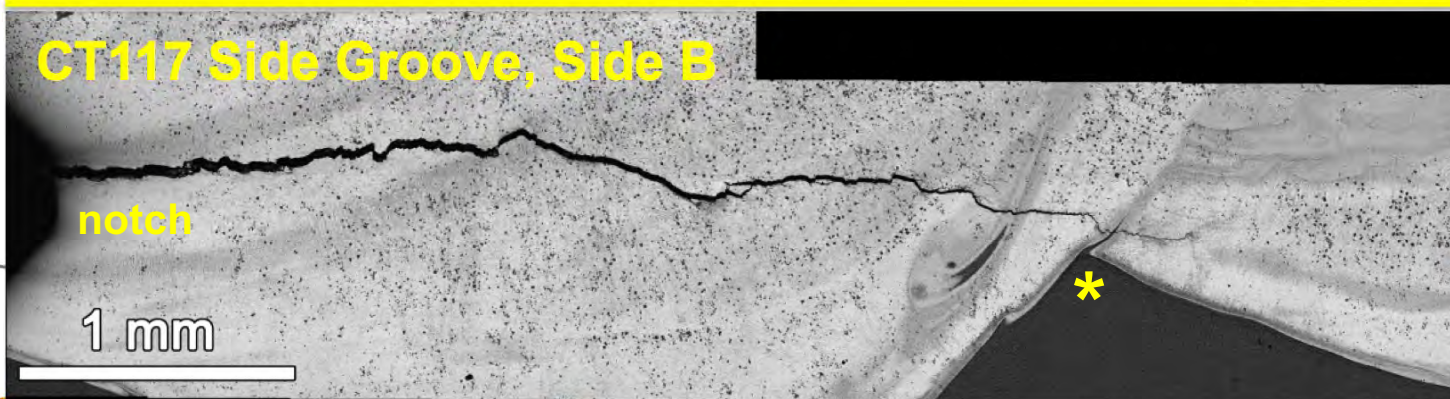
Post-Test **Side Groove** Images

- ▶ *Post-test SEM images of side grooves.*
- ▶ *As with other dilution zone tests, crack eventually moves towards the fusion line.*
- ▶ *Crack length on Side A = ~5.2 mm, Side B = ~4.1 mm.*
- ▶ *Where are regions of enhanced SCC susceptibility?*

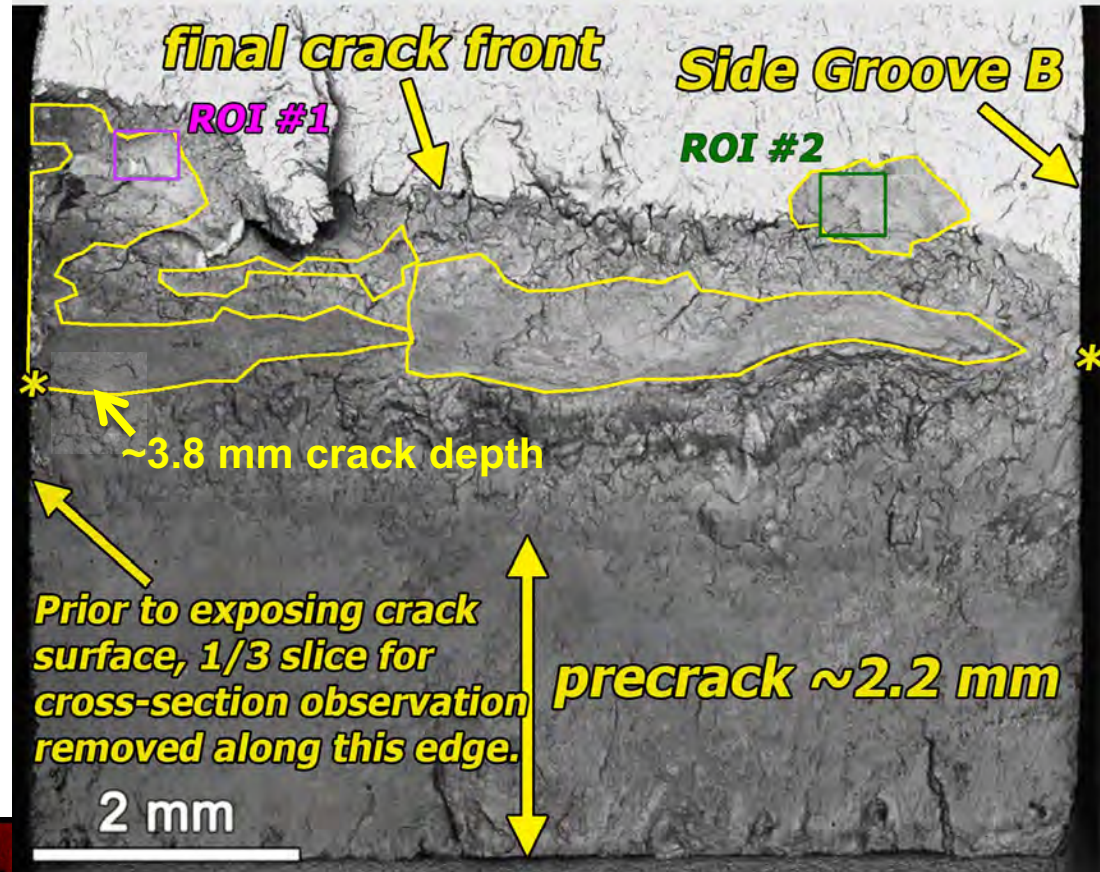
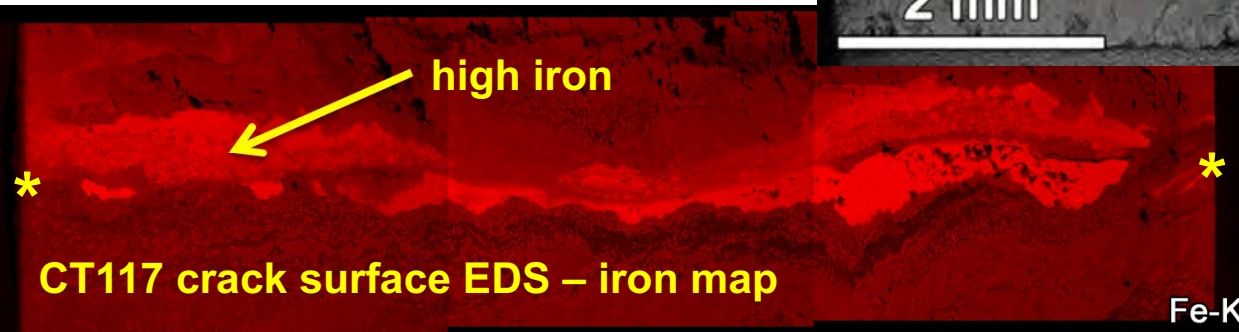
CT117 - ANL 152v2-LAS DZ PNNL #1
2/3 of thickness of specimen

- ▶ Many patches of IG cracking identified in second weld pass.
- ▶ Surface texture has appearance of the end of a dendritic packet.
- ▶ Some IG patches more than 1 mm in size.
- ▶ Distance from notch approximately corresponds to portions of test where higher susceptibility was observed.

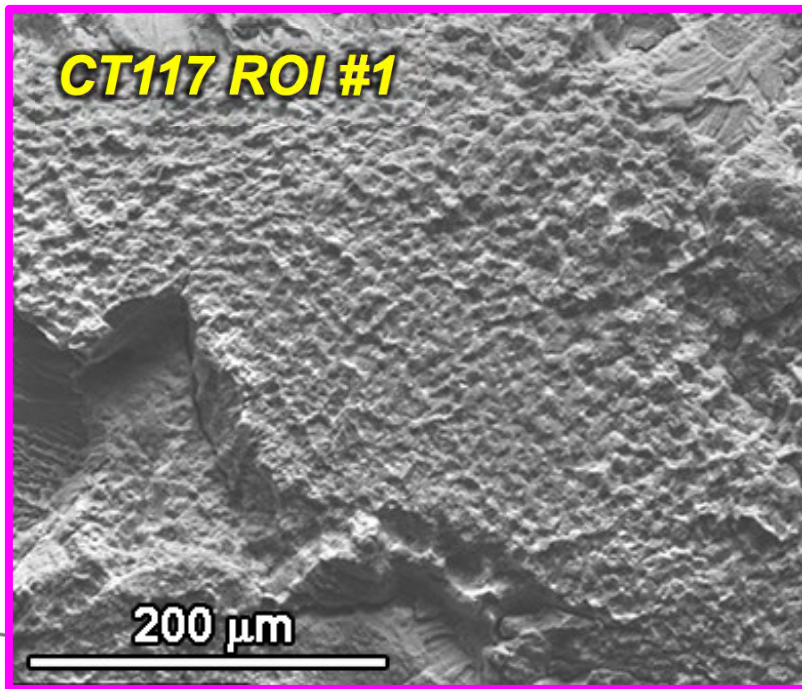
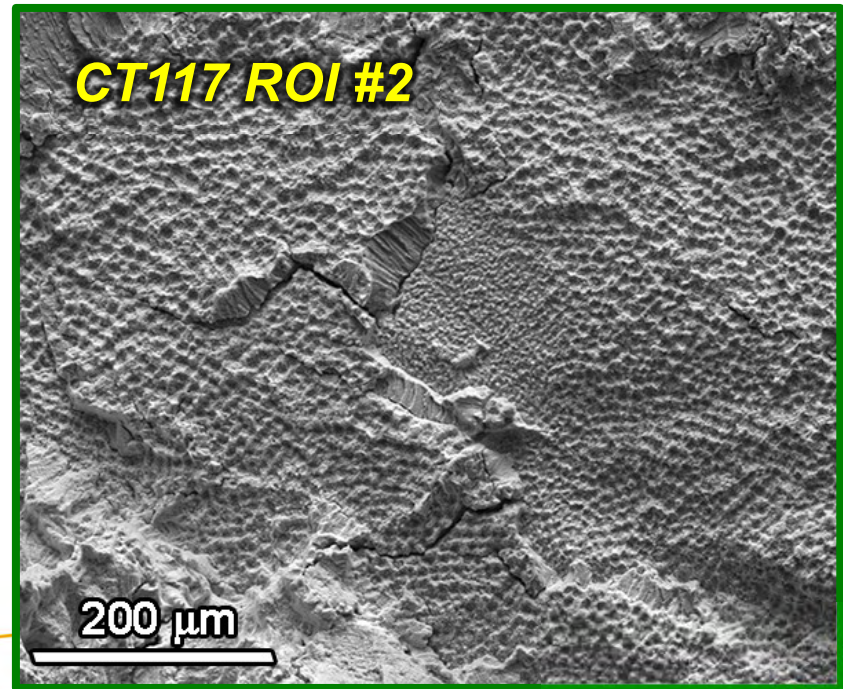
Crack Surface

- ▶ *Regions of IG cracking along aligned high angle boundary.*
- ▶ *Texture has appearance of the termination of a forest of dendrites. Represents the ends of dendrite packets*

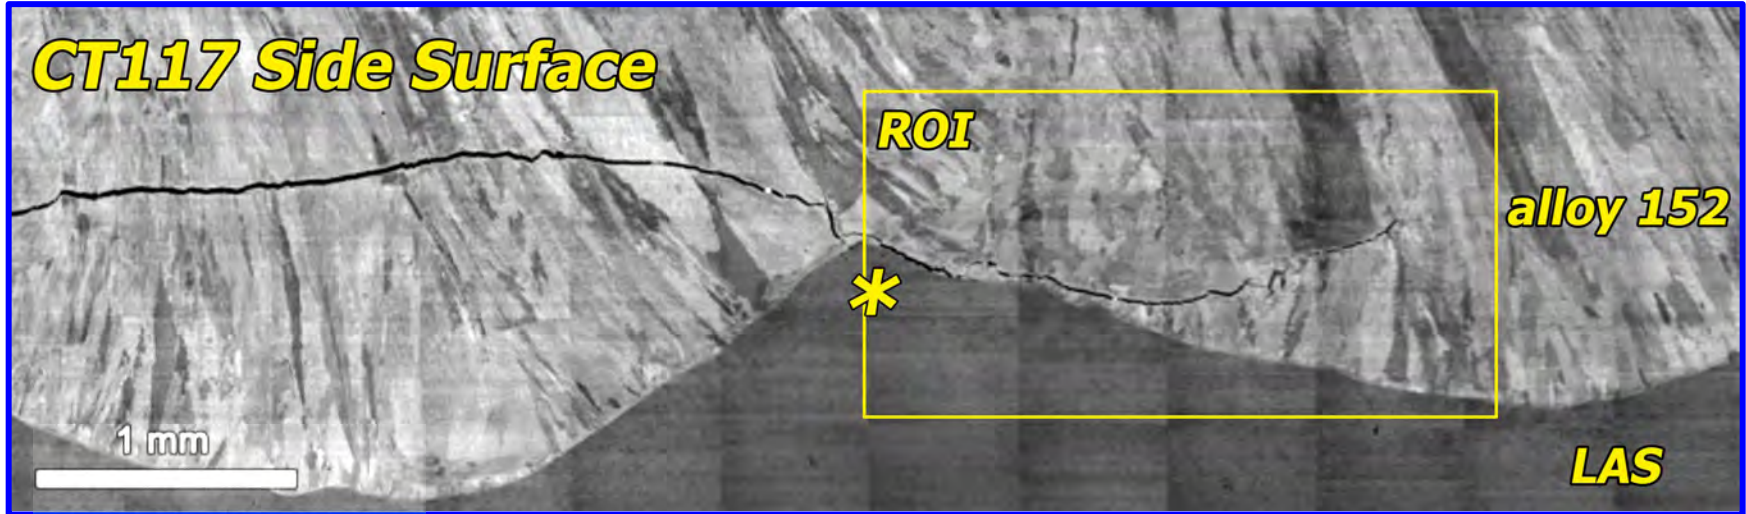
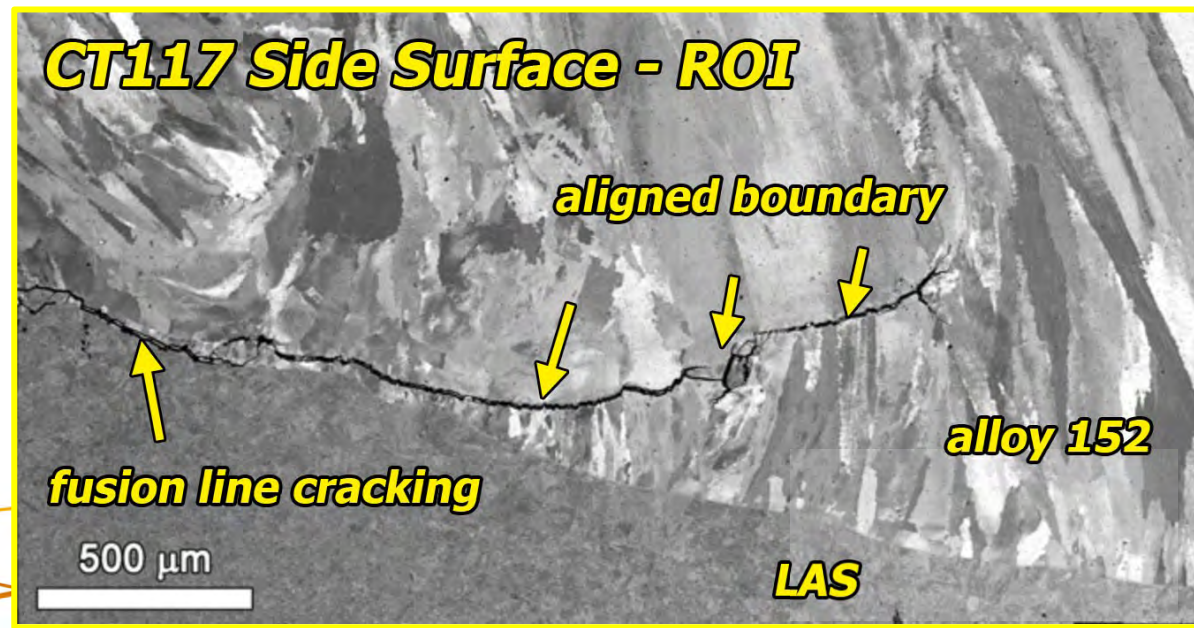
Crack Cross-Section

- ▶ In the second weld pass, cracking on fusion line and on an aligned boundary

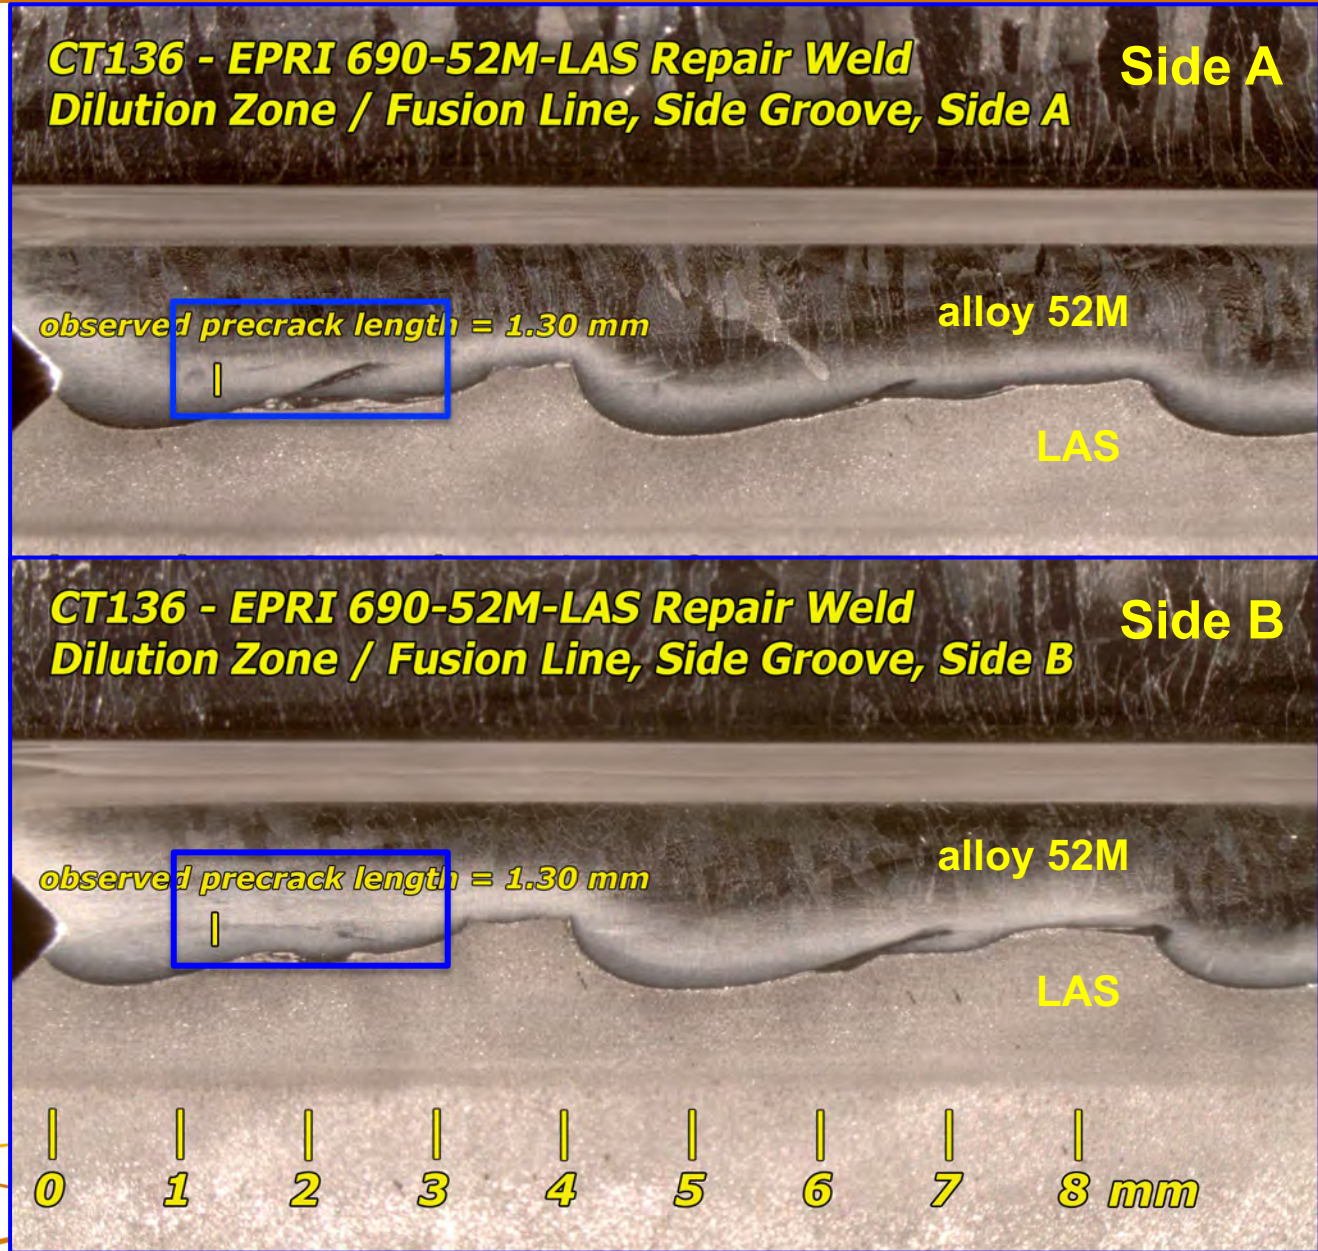
Side Groove Images of DZ Specimen

- ▶ Side groove images after air precracking but before SCC testing.
- ▶ Precrack location aligned to assess dilution region and fusion line response.
- ▶ Blue box indicates detail region shown on next slide.

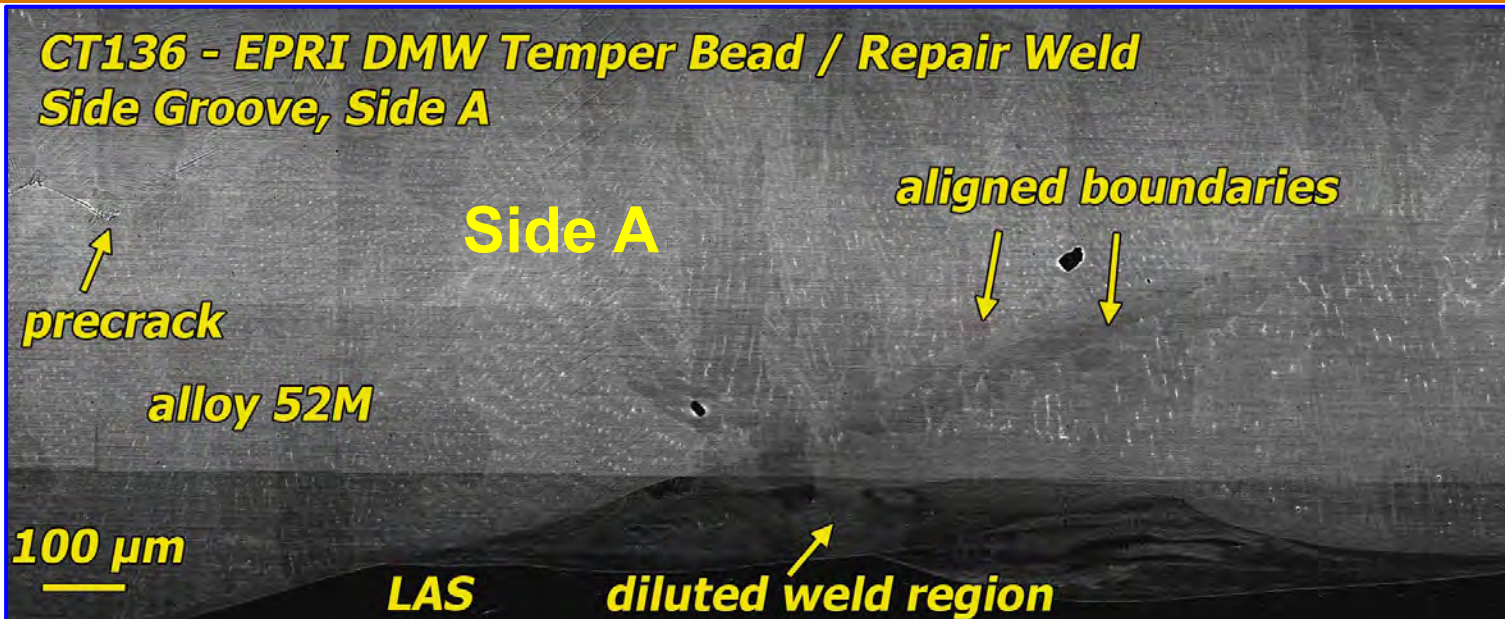
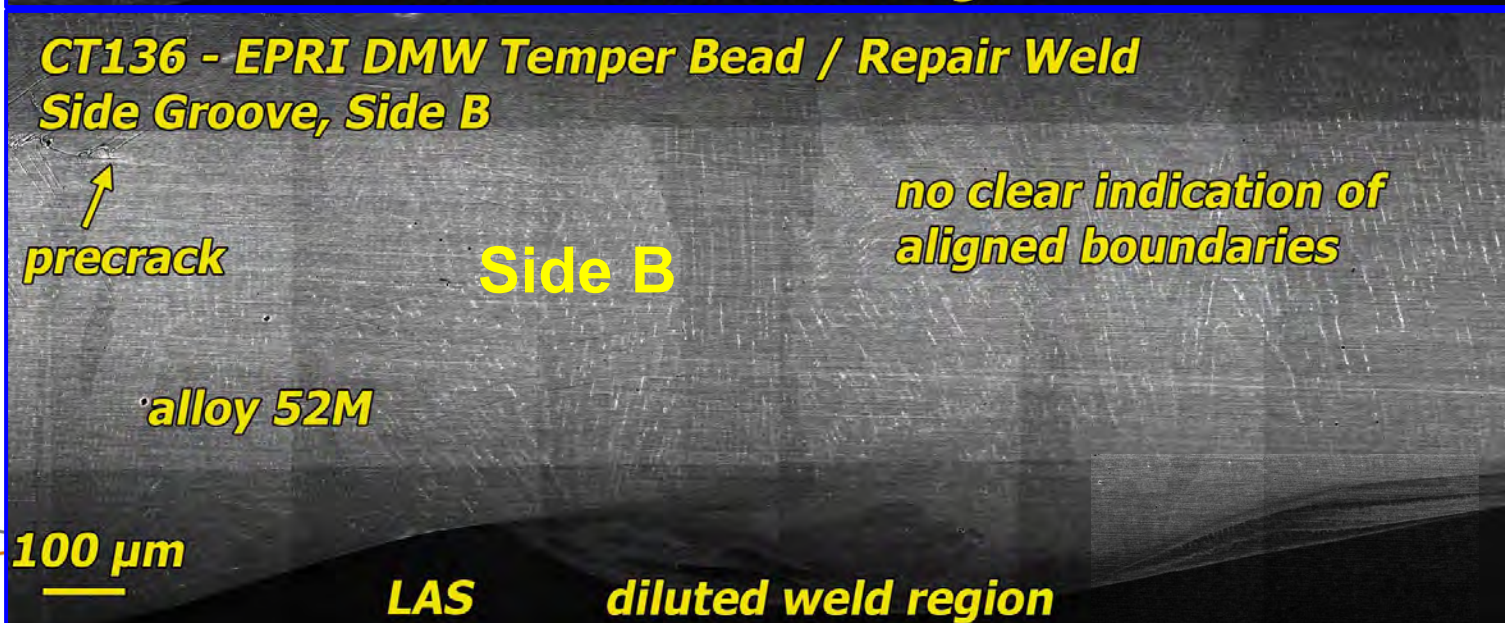
- ▶ SEM detail of side grooves.
- ▶ Aligned boundaries observed on Side A at ~2-3 mm from the notch.

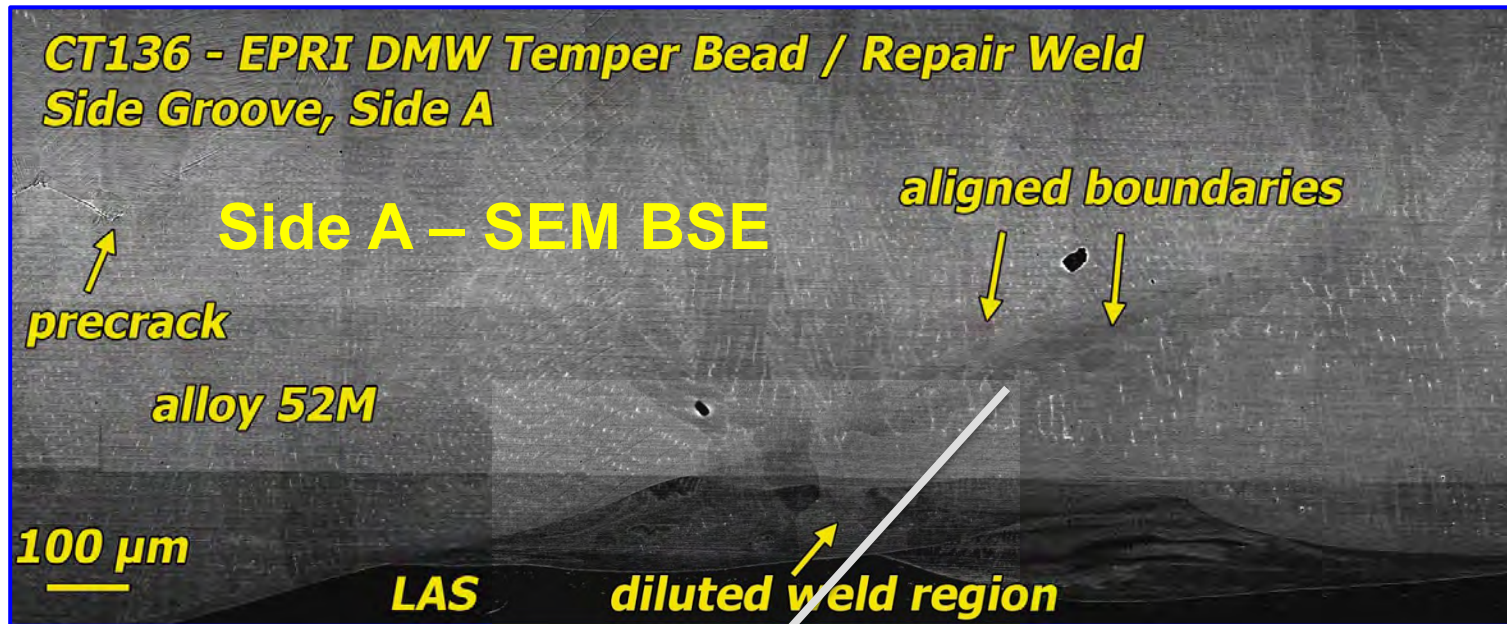
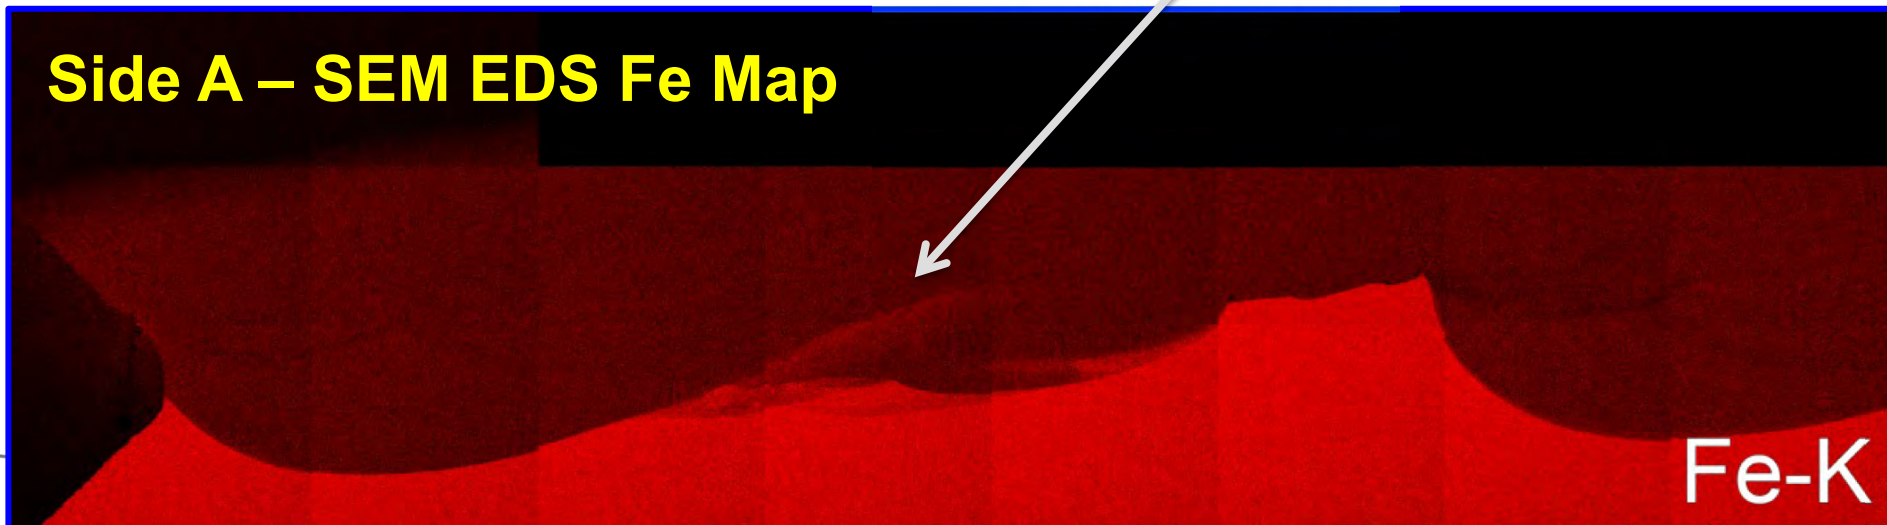
Side A – SEM EDS Fe Map

- Fe enrichment associated with aligned boundaries on Side A.

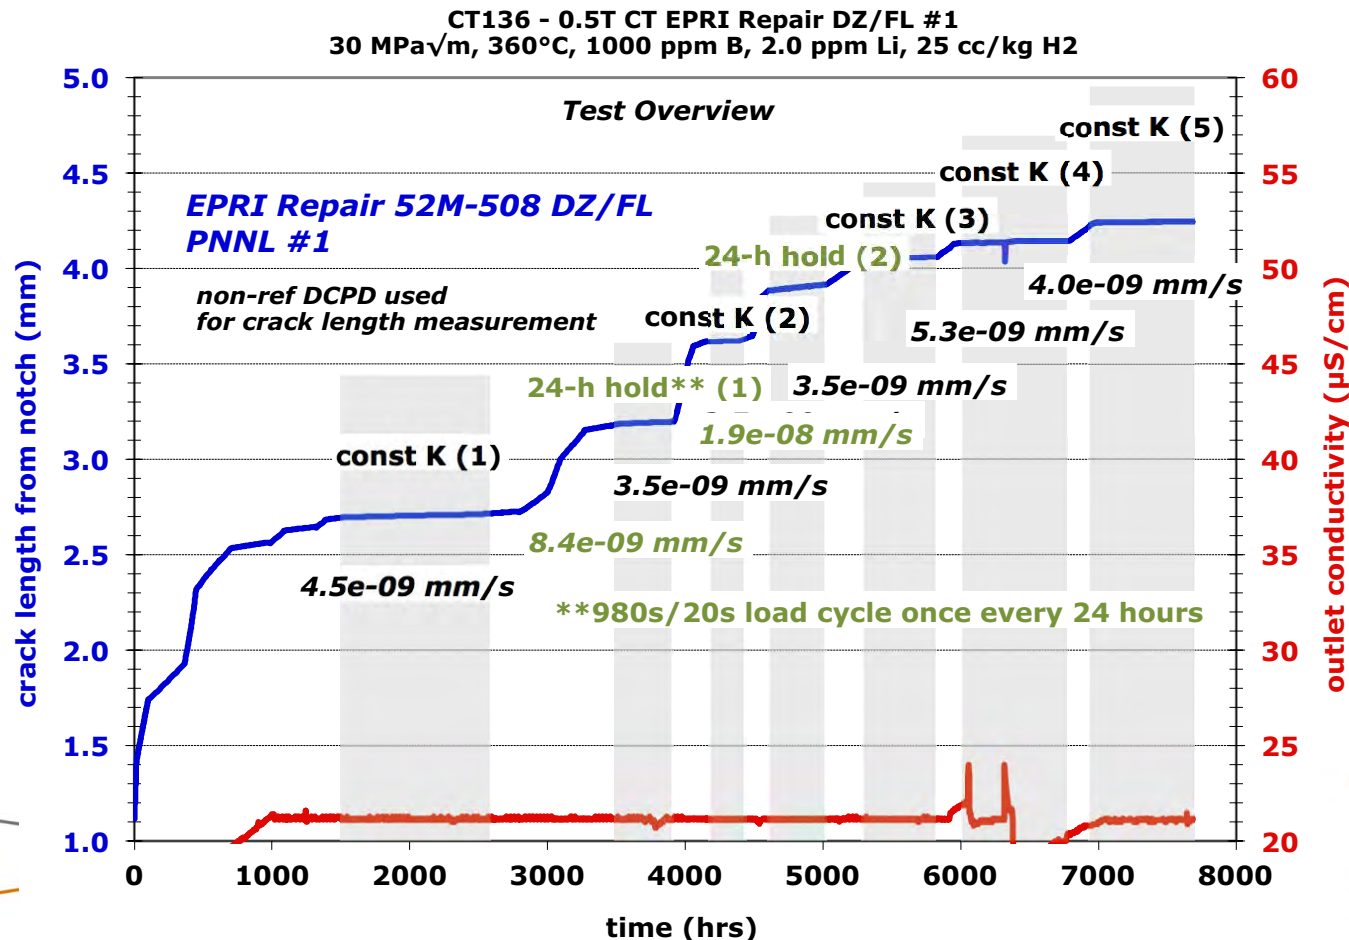
- ▶ Many assessments of SCC susceptibility throughout the test.
- ▶ Aligned boundary roughly at 2-3 mm from the notch.
- ▶ Non-referenced DCPD measurement slightly inflates low CGRs.
- ▶ Possible small indication of SCC susceptibility.

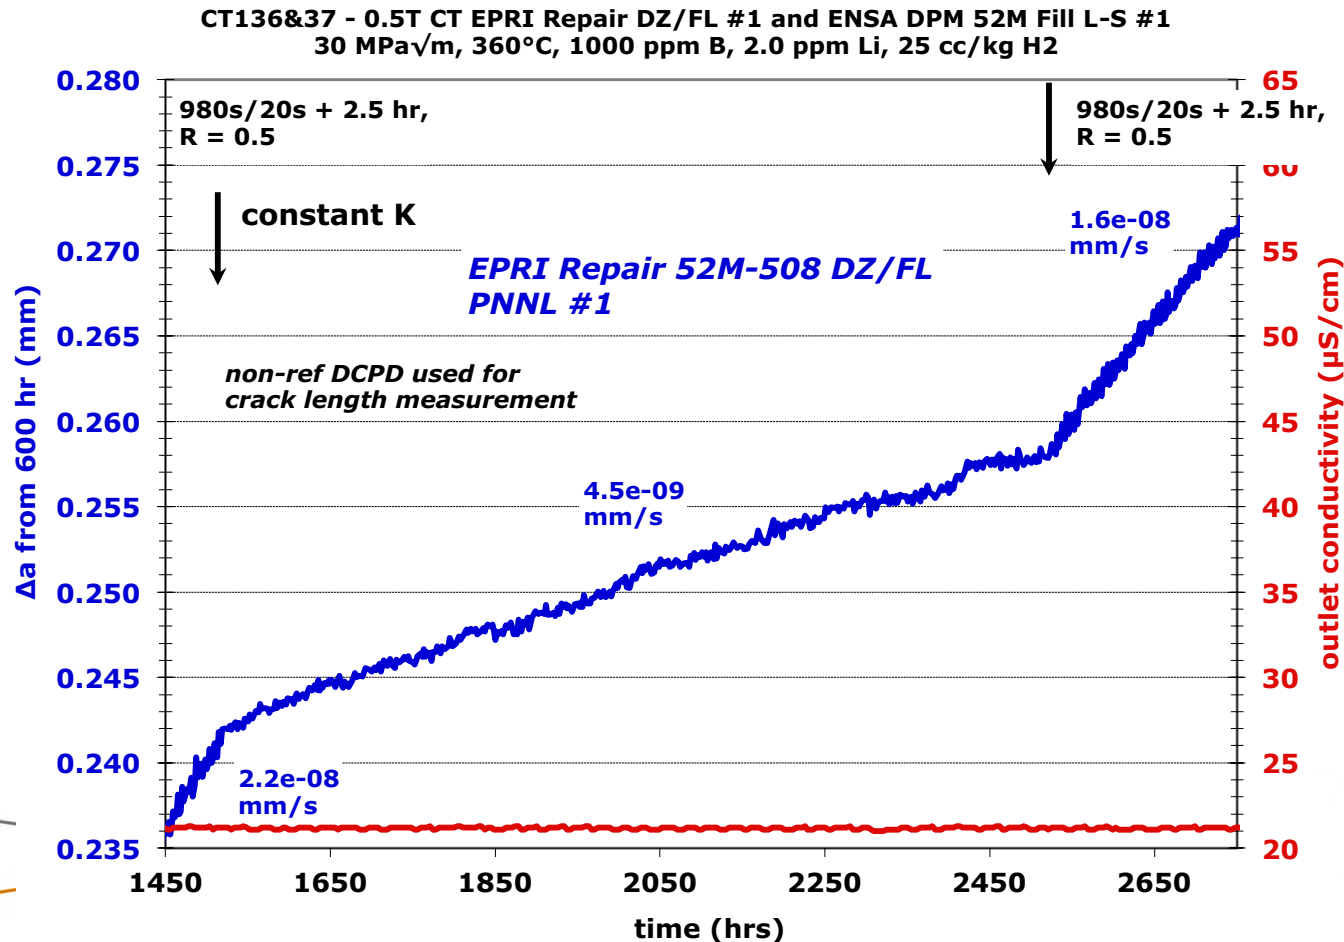
- ▶ Example of steady SCC response at depth corresponding to aligned boundary.
- ▶ Small indication of enhances susceptibility, but no different than remainder of the test.

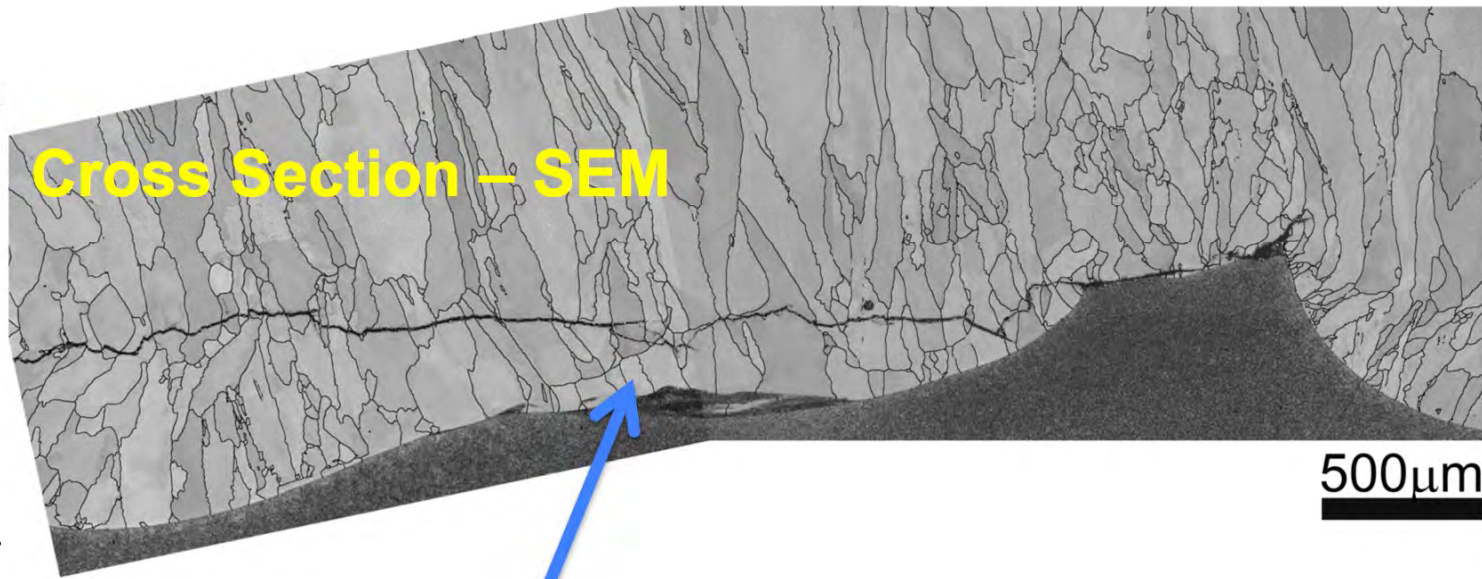
Post-test Cross-section Observation

- ▶ Post-test cross-section image.
- ▶ Opportunity for cracking on aligned boundary, but did not clearly occur.

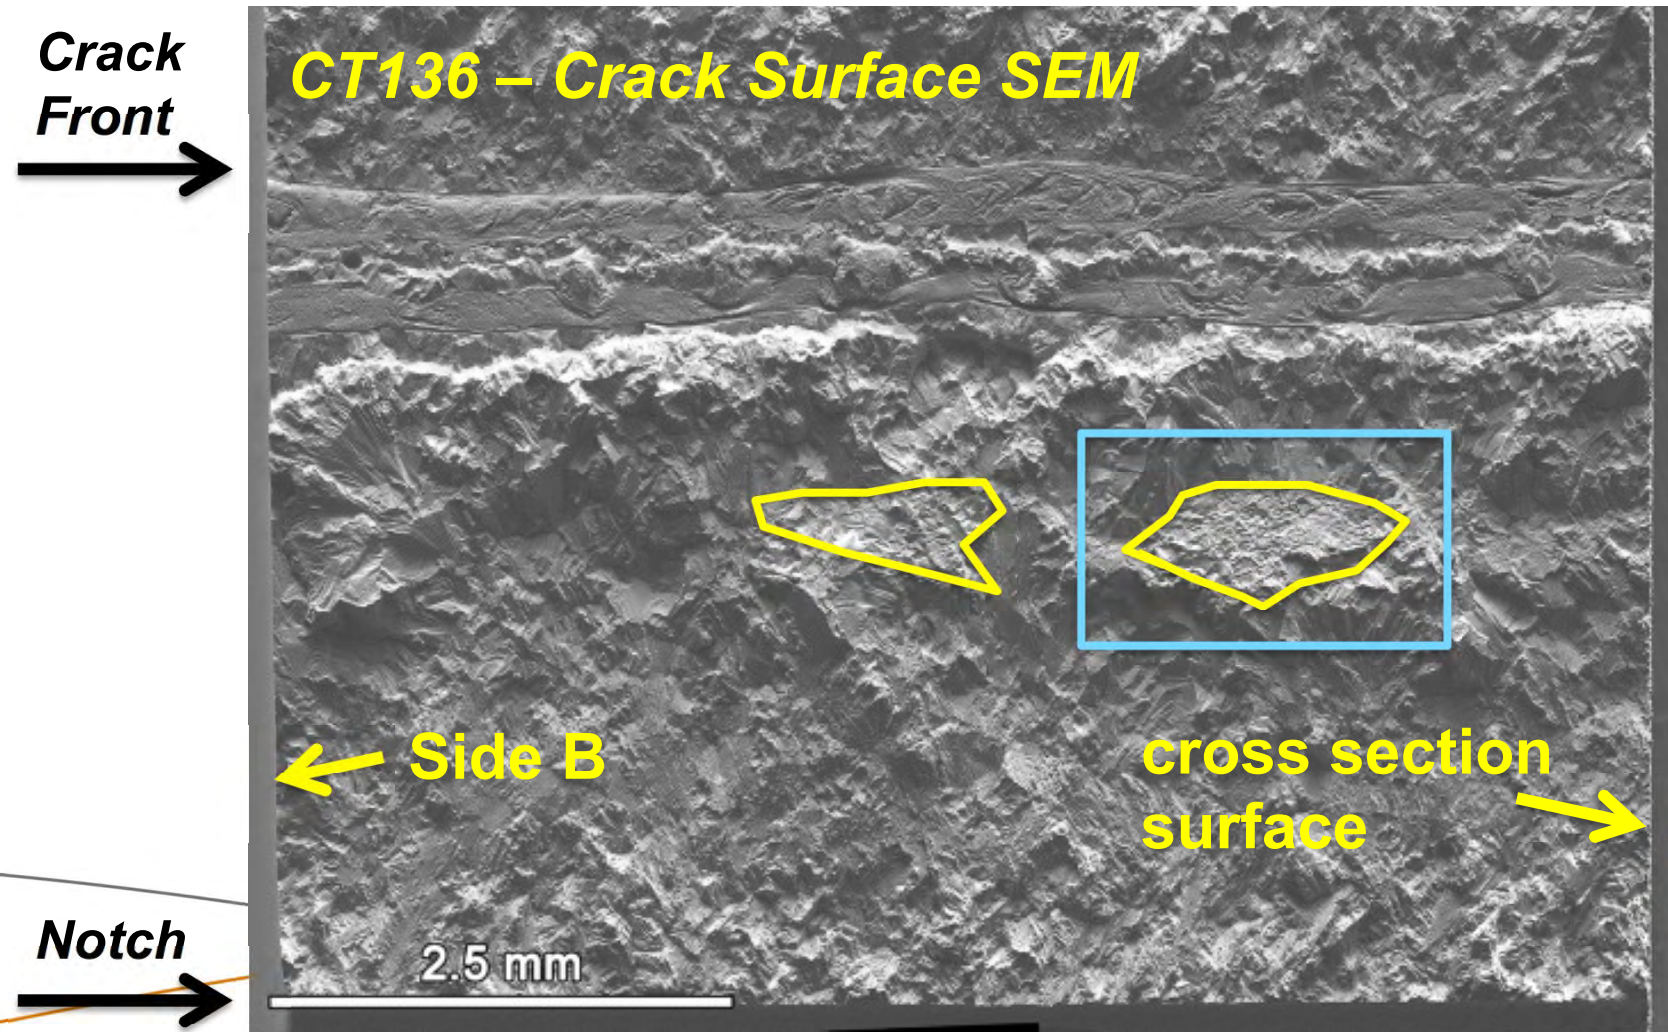
- ▶ Indications of cracking on aligned boundaries on crack surface.
- ▶ Location of boundaries are consistent with location on side grooves and side surface.

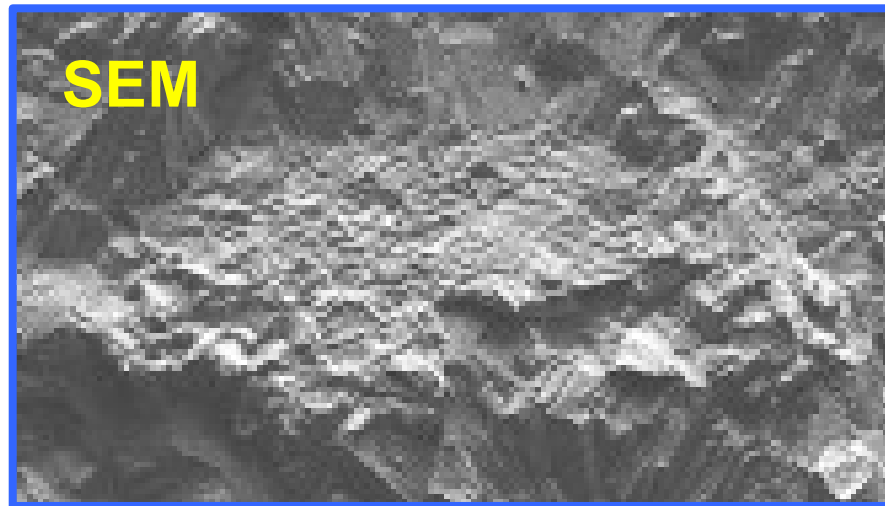
- ▶ *Low resolution image is further suggestive of an IG aligned boundary surface.*
- ▶ *High resolution image not yet available.*

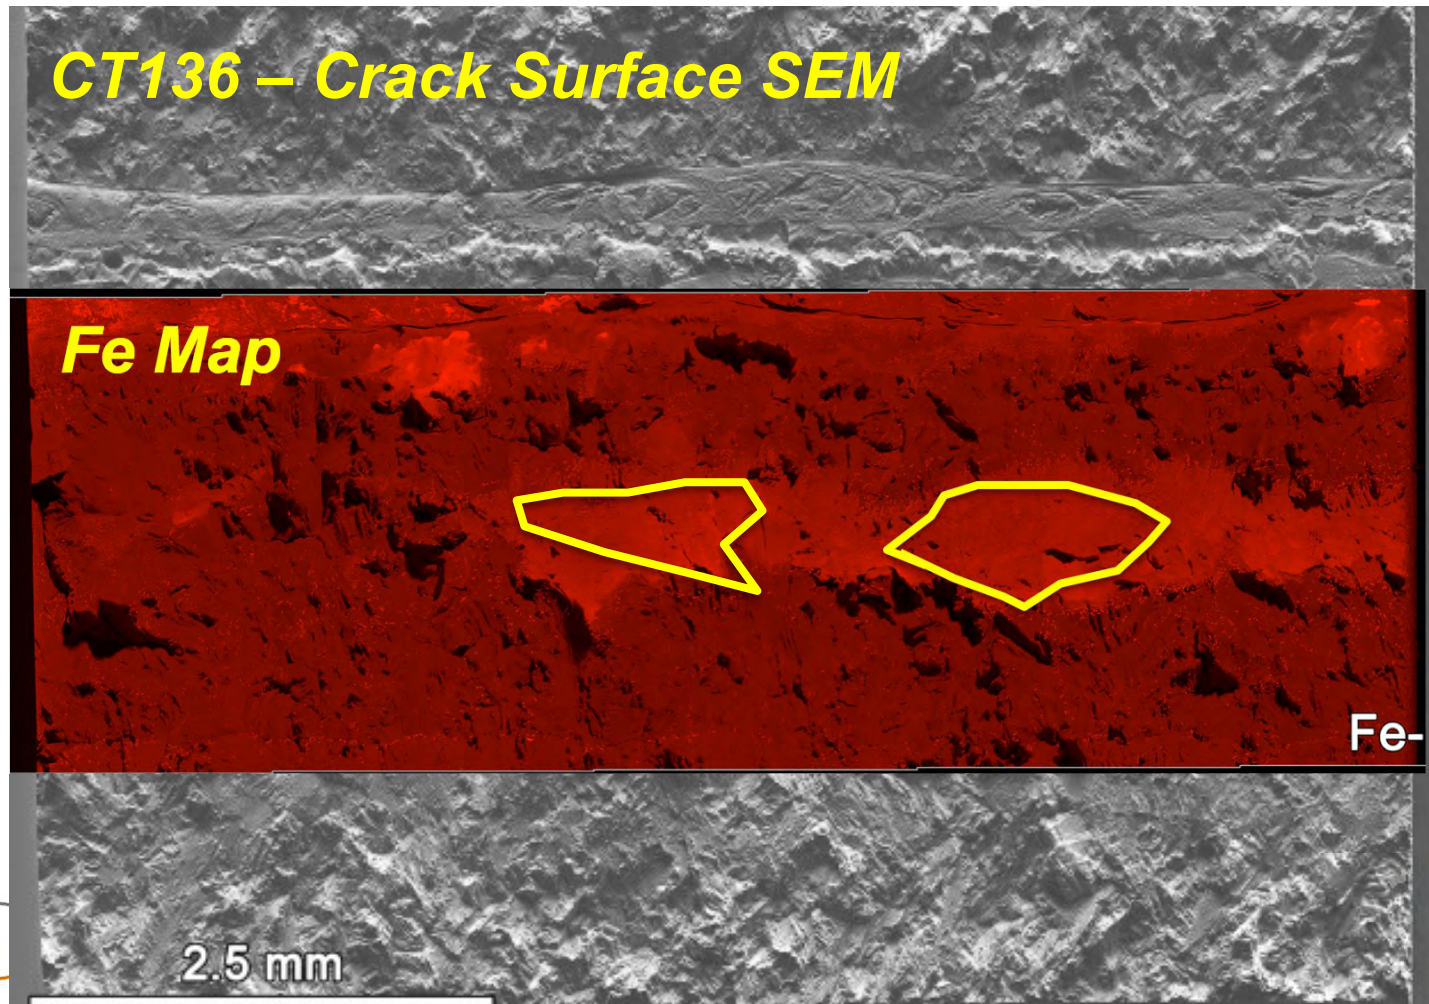
- ▶ SEM-EDS Fe map indicates that regions of possible aligned boundaries enriched in Fe.
