Alloy 152/52-LAS Dilution Zone and Interface/Fusion Line PWSCC Testing

***Mychailo Toloczko, Matt Olszta,
Nicole Overman, and Steve Bruemmer***
Pacific Northwest National Laboratory

EPRI 690/ 152/ 52 PWSCC Research Collaboration Meeting
Nov 29 to Dec 1 • Tampa, FL

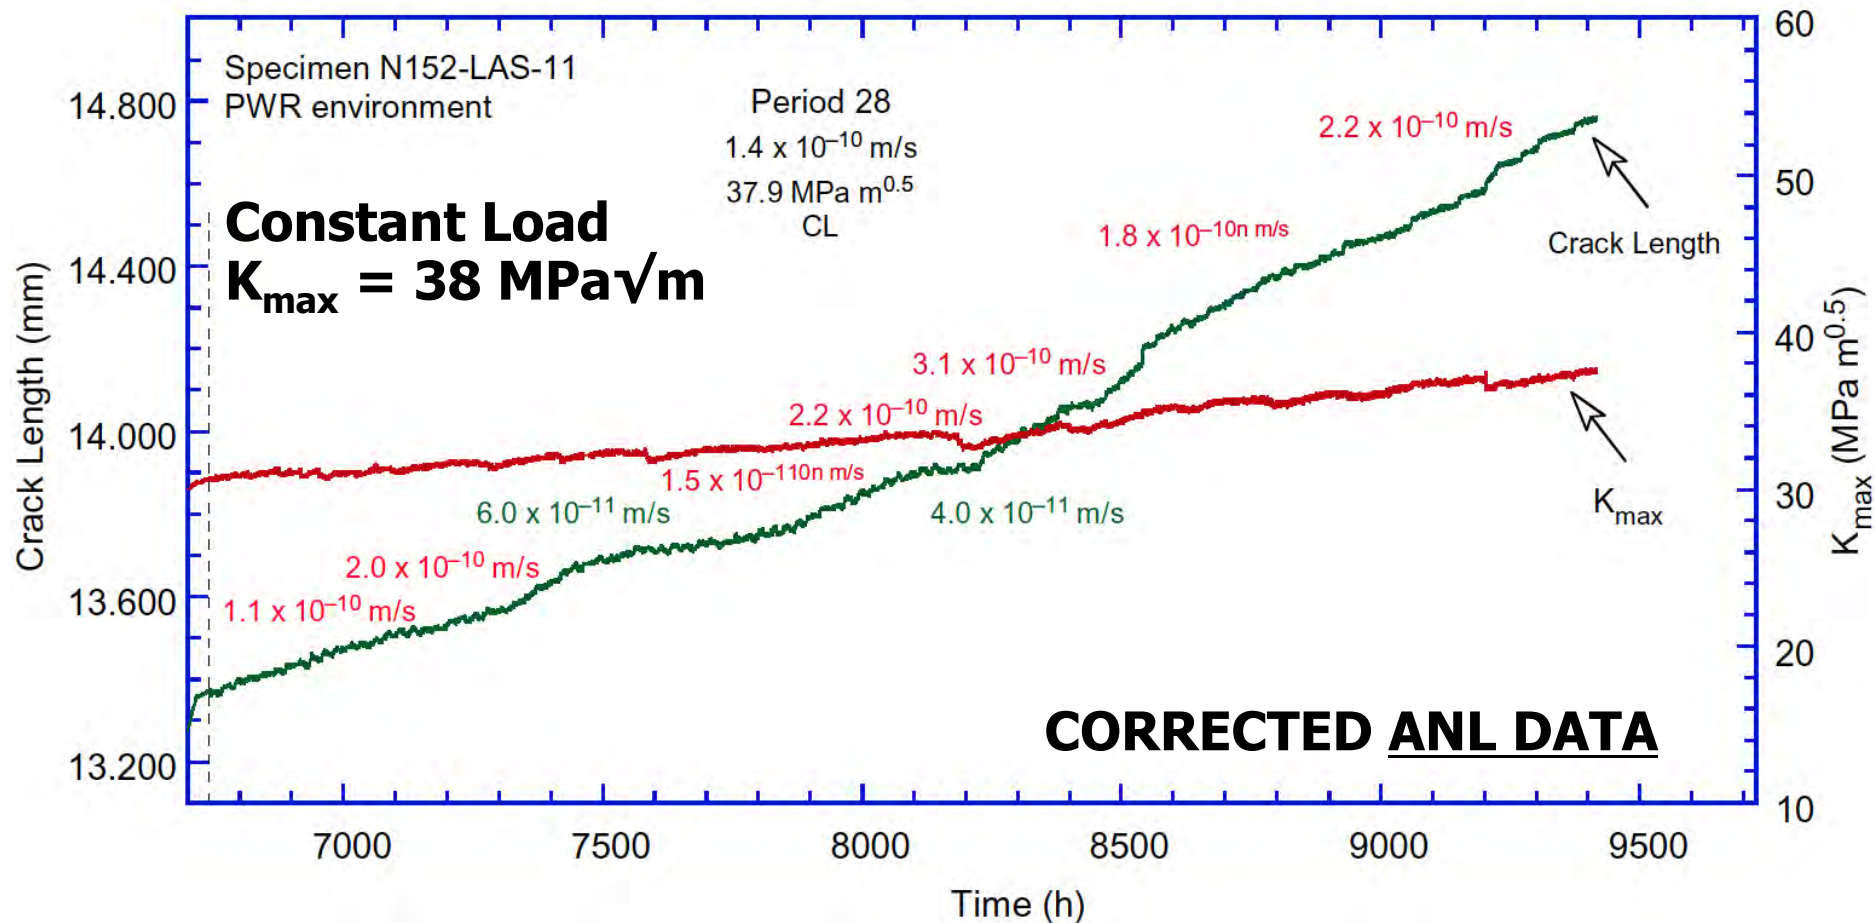
ANL Constant Load Response for N152-LAS-11 Specimen

Post-test corrected average constant load CGRs is $>1 \times 10^{-7} \text{ mm/s}$.

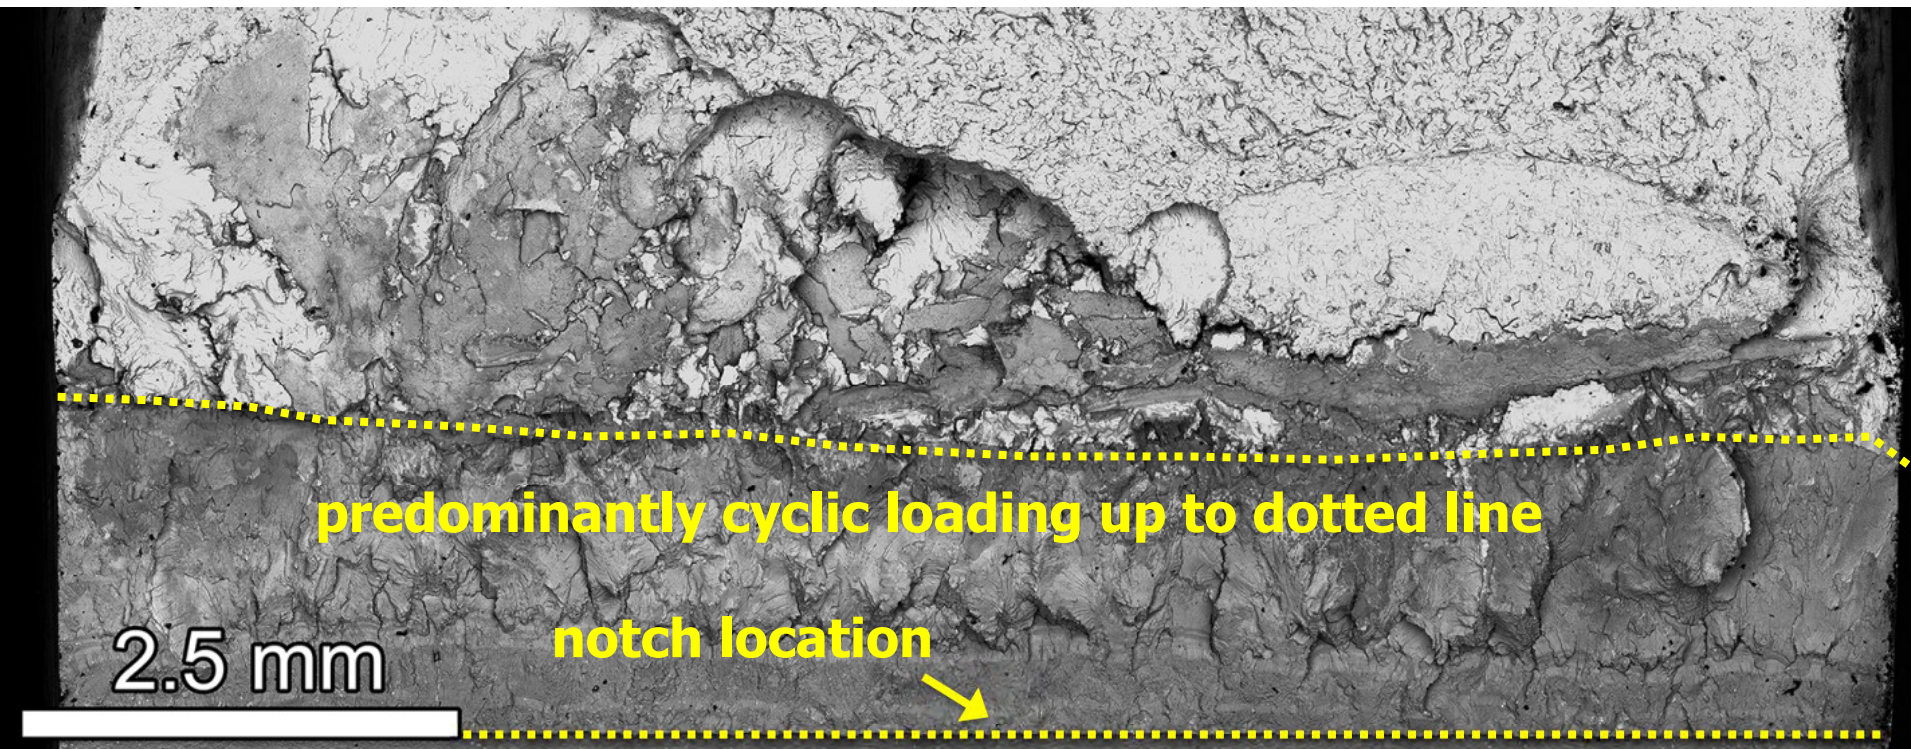
- *Predominantly cyclic loading prior to constant load SCC response that was shown in the previous slide.*

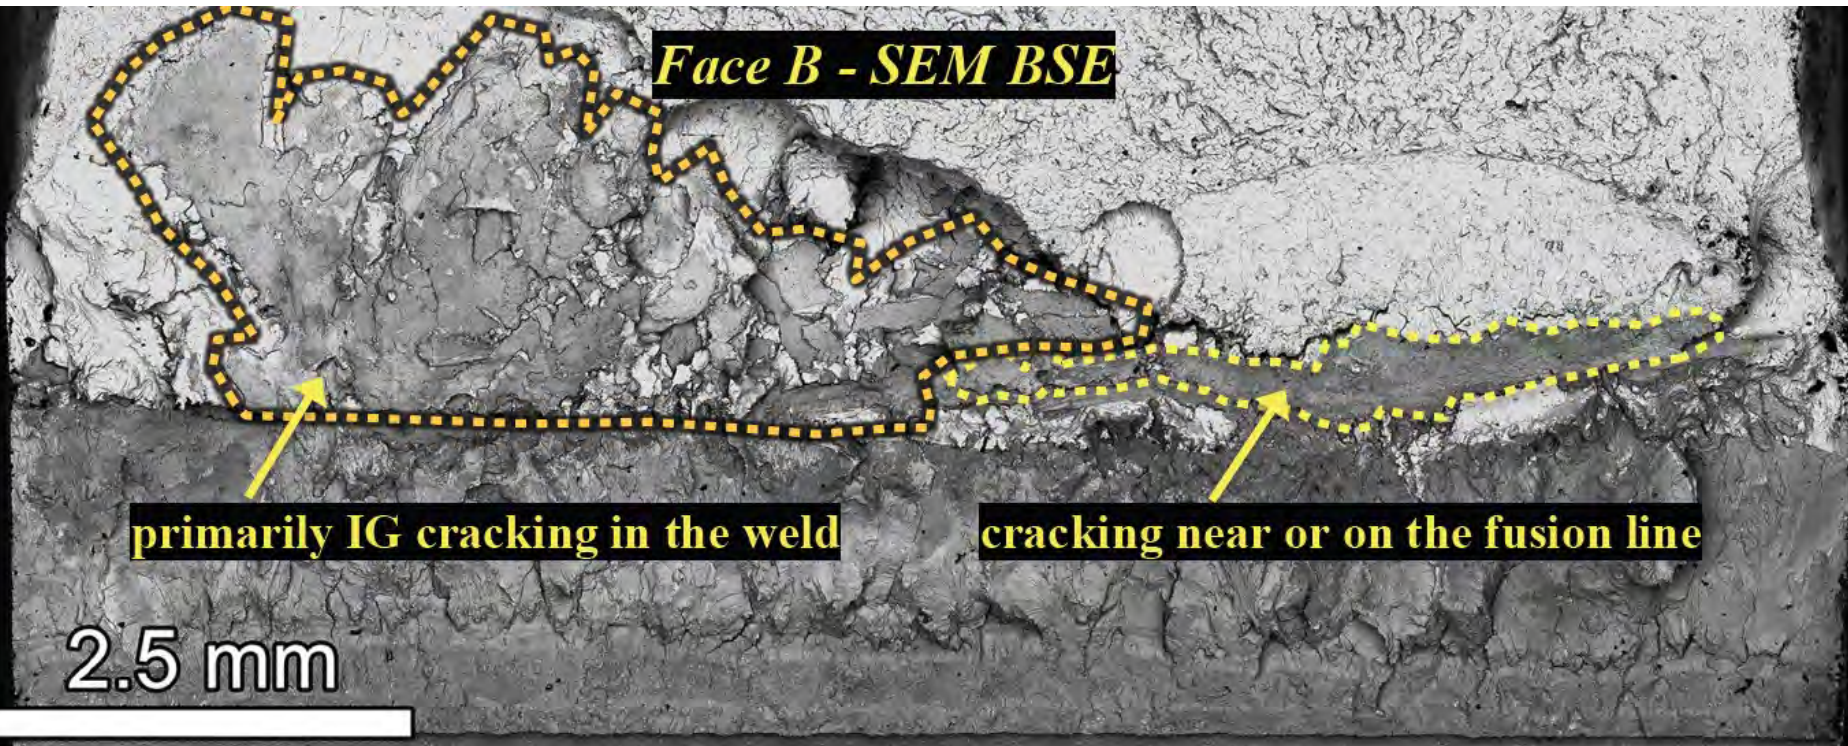
- ▶ Region on left is main area of interest. Cracking is in the weld and appears to be responsible for high SCC CGRs.
- ▶ Region on the right is cracking on or near the fusion line.

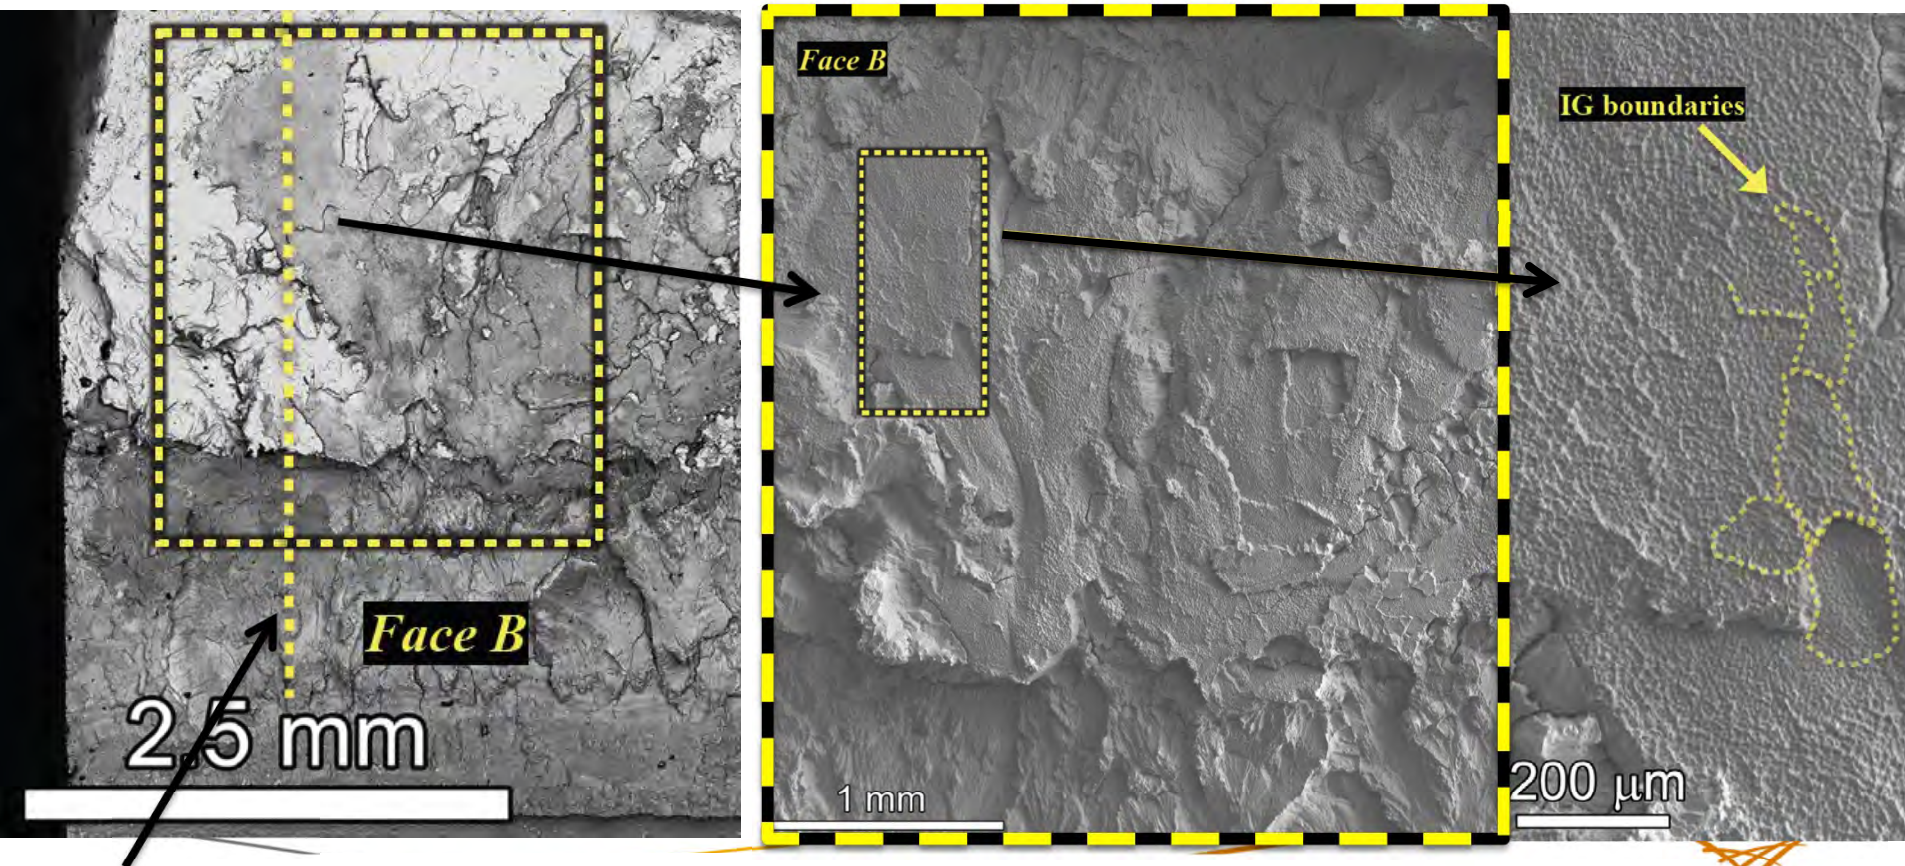
- Crack surface in the weld does not appear transgranular. Has an unusual intergranular appearance. Very flat surface.

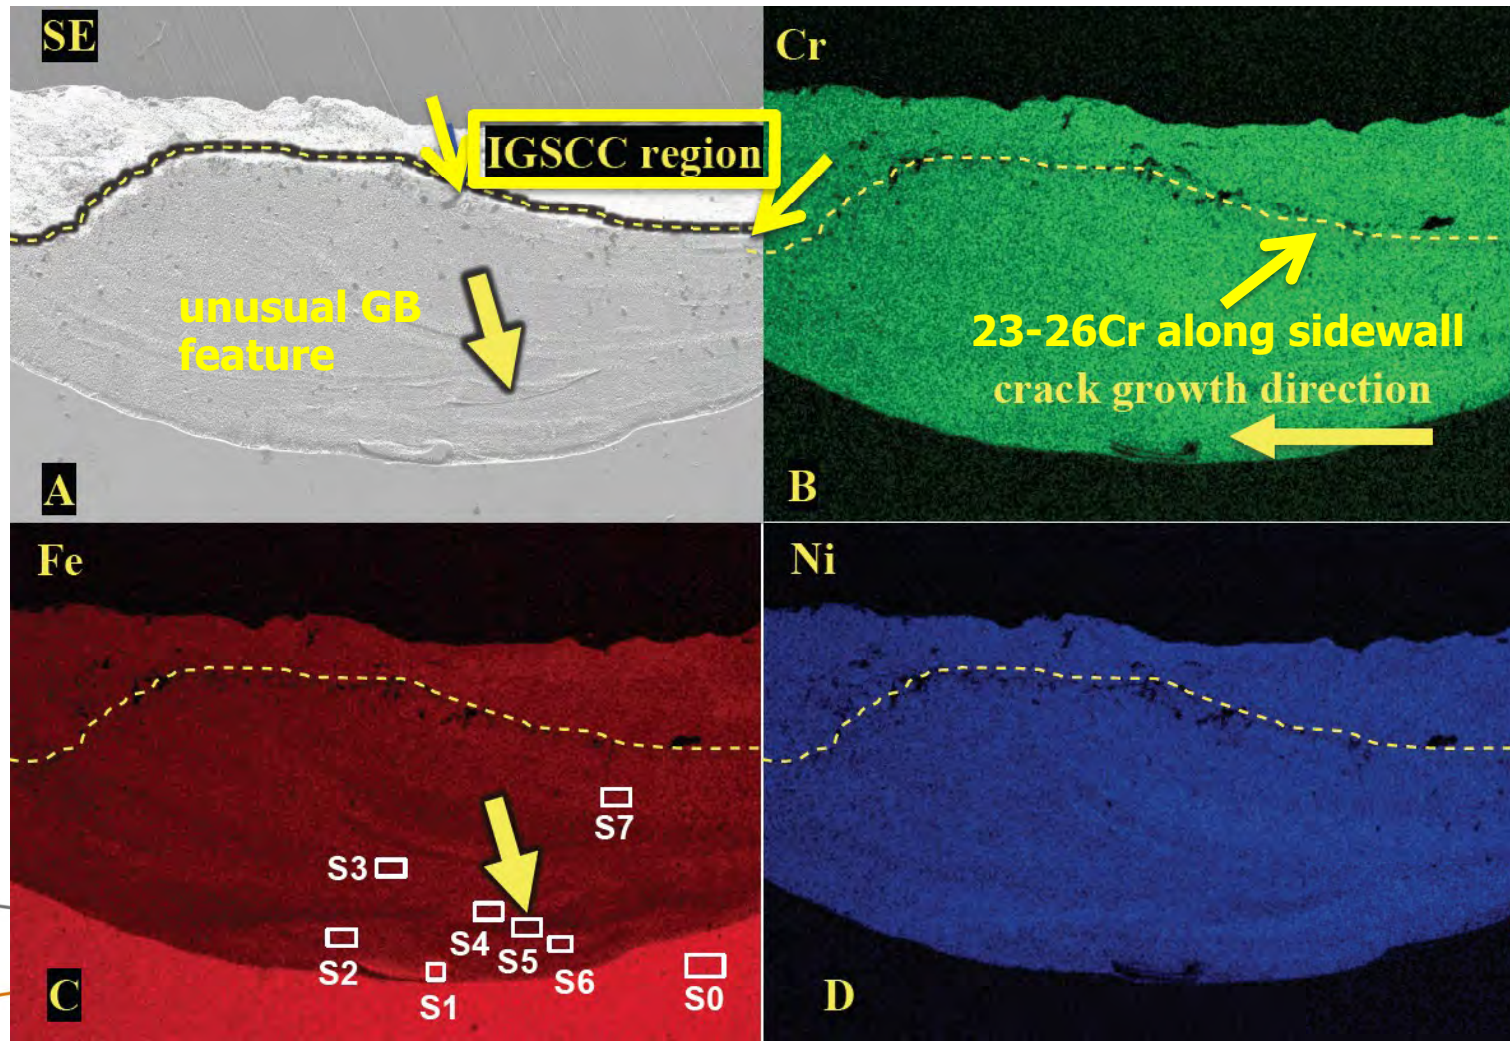
ANL N152-LAS-11 Specimen Cross-Section Observations EDS Region 2

- ▶ SEM-EDS exams indicate that Cr levels near SCC region are 23-26% on this side of the crack.

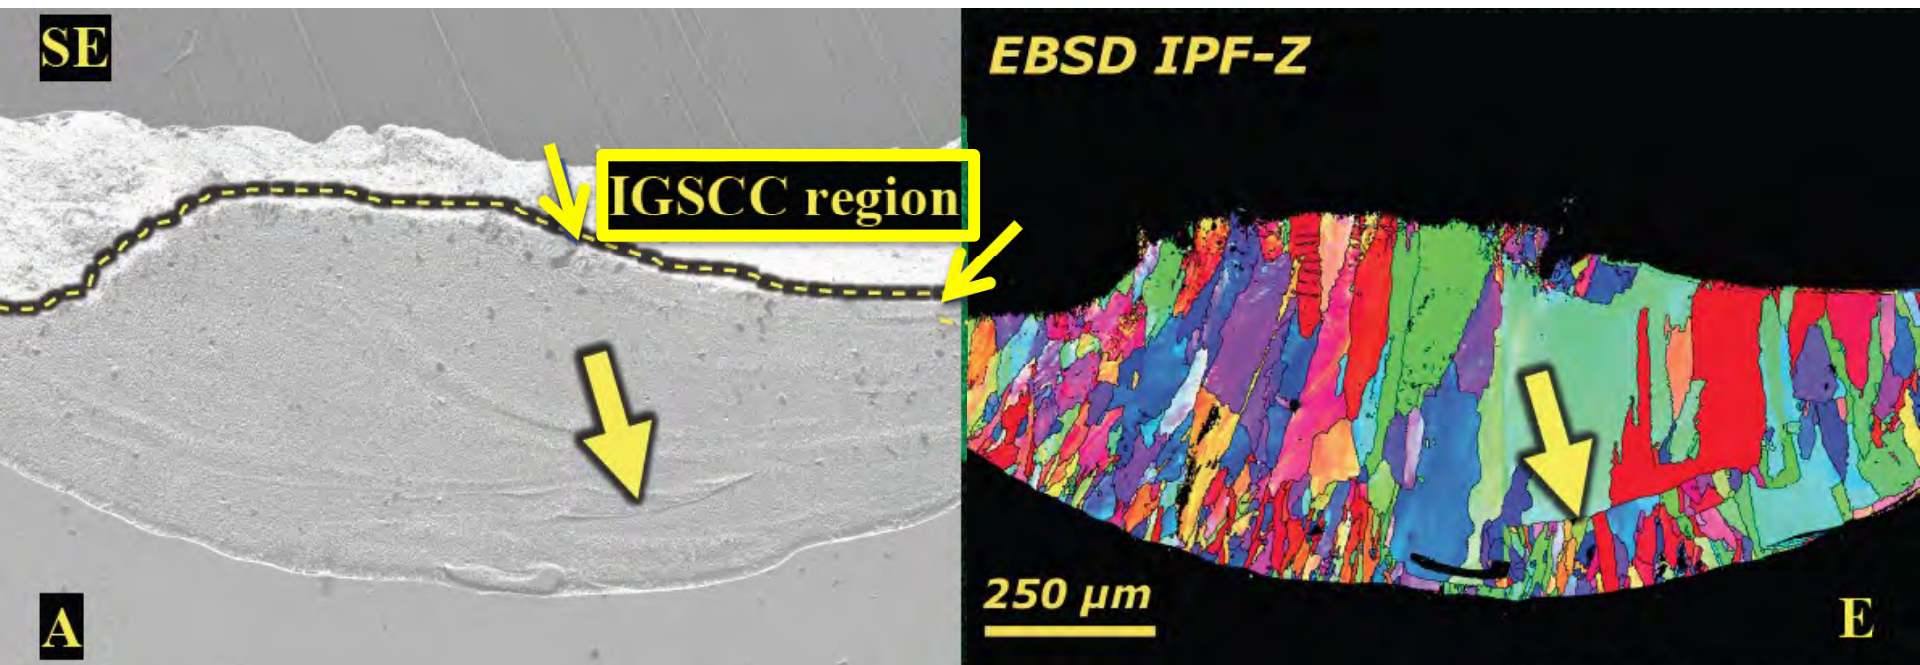
- ▶ *SEM-EBSD exam shows the crack plane to be perpendicular to the long axis of the grain boundaries.*
- ▶ *Did it crack on a weld interpass boundary?*
- ▶ *An unexpected interface was seen that is aligned similar to that of the SCC crack path.*
- ▶ *Could this be the source of the crack path?*

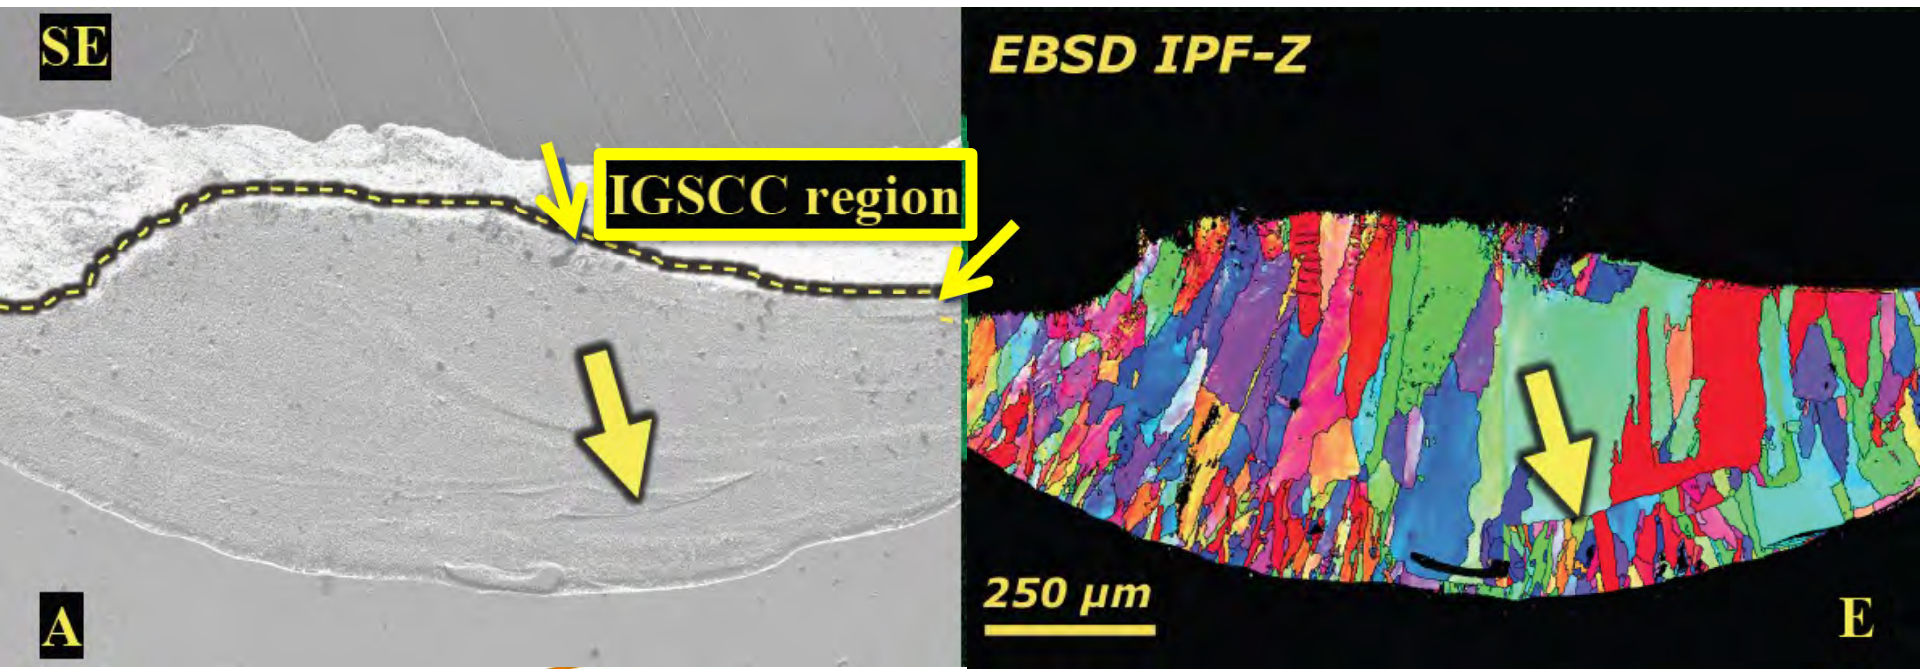
ANL N152-LAS-11 Specimen Summary

- ▶ SCC tested at ANL. Additional exams performed at PNNL.
- ▶ High constant load crack growth rates were observed.
- ▶ 23-26Cr near SCC region in cross-section.
- ▶ Not well aligned to grain boundaries, but IG appearance.
- ▶ Origin of crack path possibly an interpass boundary or this "unexpected" boundary.
- ▶ Additional exams needed to better understand this.
