DESCRIPTION:
Ltr re our 3-20-74, furnishing addl info concerning control rod drive conversion programs at Nine Mile Point #1

PLANT NAME: Nine Mile Point Unit #1

Re: Provisional Operating License: DPR-17
Docket No: 50-220

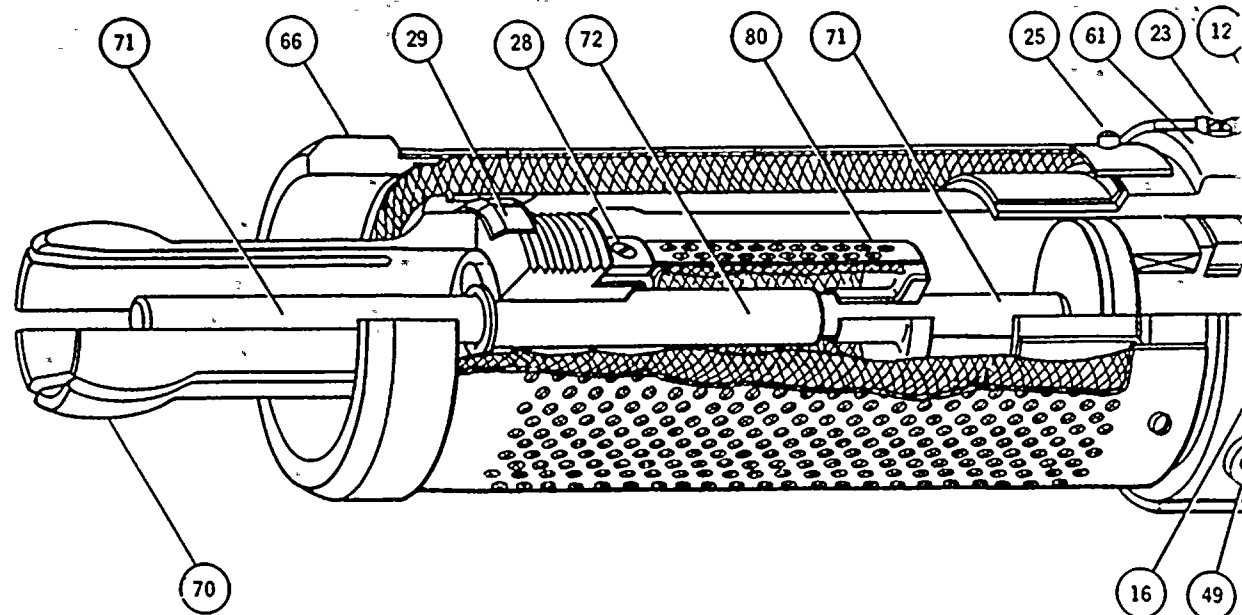
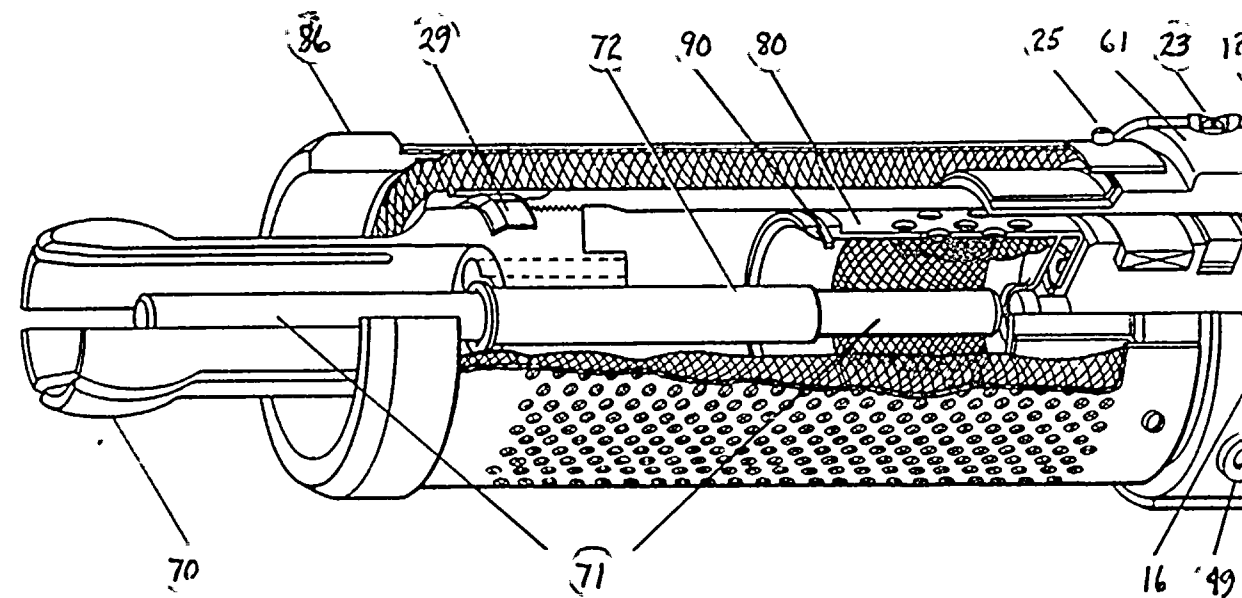
FIG 1

1. The proposed conversion program consists of the repositioning of a filter to place this filter in the flow path for reactor water to the stop piston seals and not in the scram path. (Figure 1) The fine mesh filter was originally mounted on the traveling portion of the drive and early in plant life, prior to changing the mesh size, was responsible for deteriorating scram times. However, with the repositioning, the filter is mounted on top of the stop piston and is provided to filter reactor water flowing to the stop piston seals, removing foreign particles or abrasives matter that could result in internal damage to the seals. This modification has been recommended by General Electric Company, the nuclear steam supplier, and is the design incorporated on later plants¹. Based upon testing results of all control rod drives, criteria has been established in determining the scheduled modification of all control rod drives. A withdrawal stall leakage flow test was performed on all control rod drives.

1. Modify all drives that have clear indication of stop piston seal deterioration, (those that stopped at position 02 on a scram).
2. Modify all drives with withdrawal stall leakage flows equal to or greater than 4 gpm.
3. Modify the remaining drives in decreasing stall leakage flow order time permitting.
