SUBJECT: Forwards comments on VRC review of operating experience  
 "Non-DBE Reductions in Coolant Inventory (Leaks)" suggested  
 as more appropriate categorization of steam generator tube  
 leaks.

Subject: Review of Operating Experience  
R. E. Ginna Nuclear Power Plant  
Docket No. 50-244

Investigation of DB50 Breaker Failures

SUBJECT: Results of Analyses and Testing Performed to  
Determine Cause of Failure of Certain W "DB-50"  
Circuit Breakers at Ginna Station (EWR 3073)

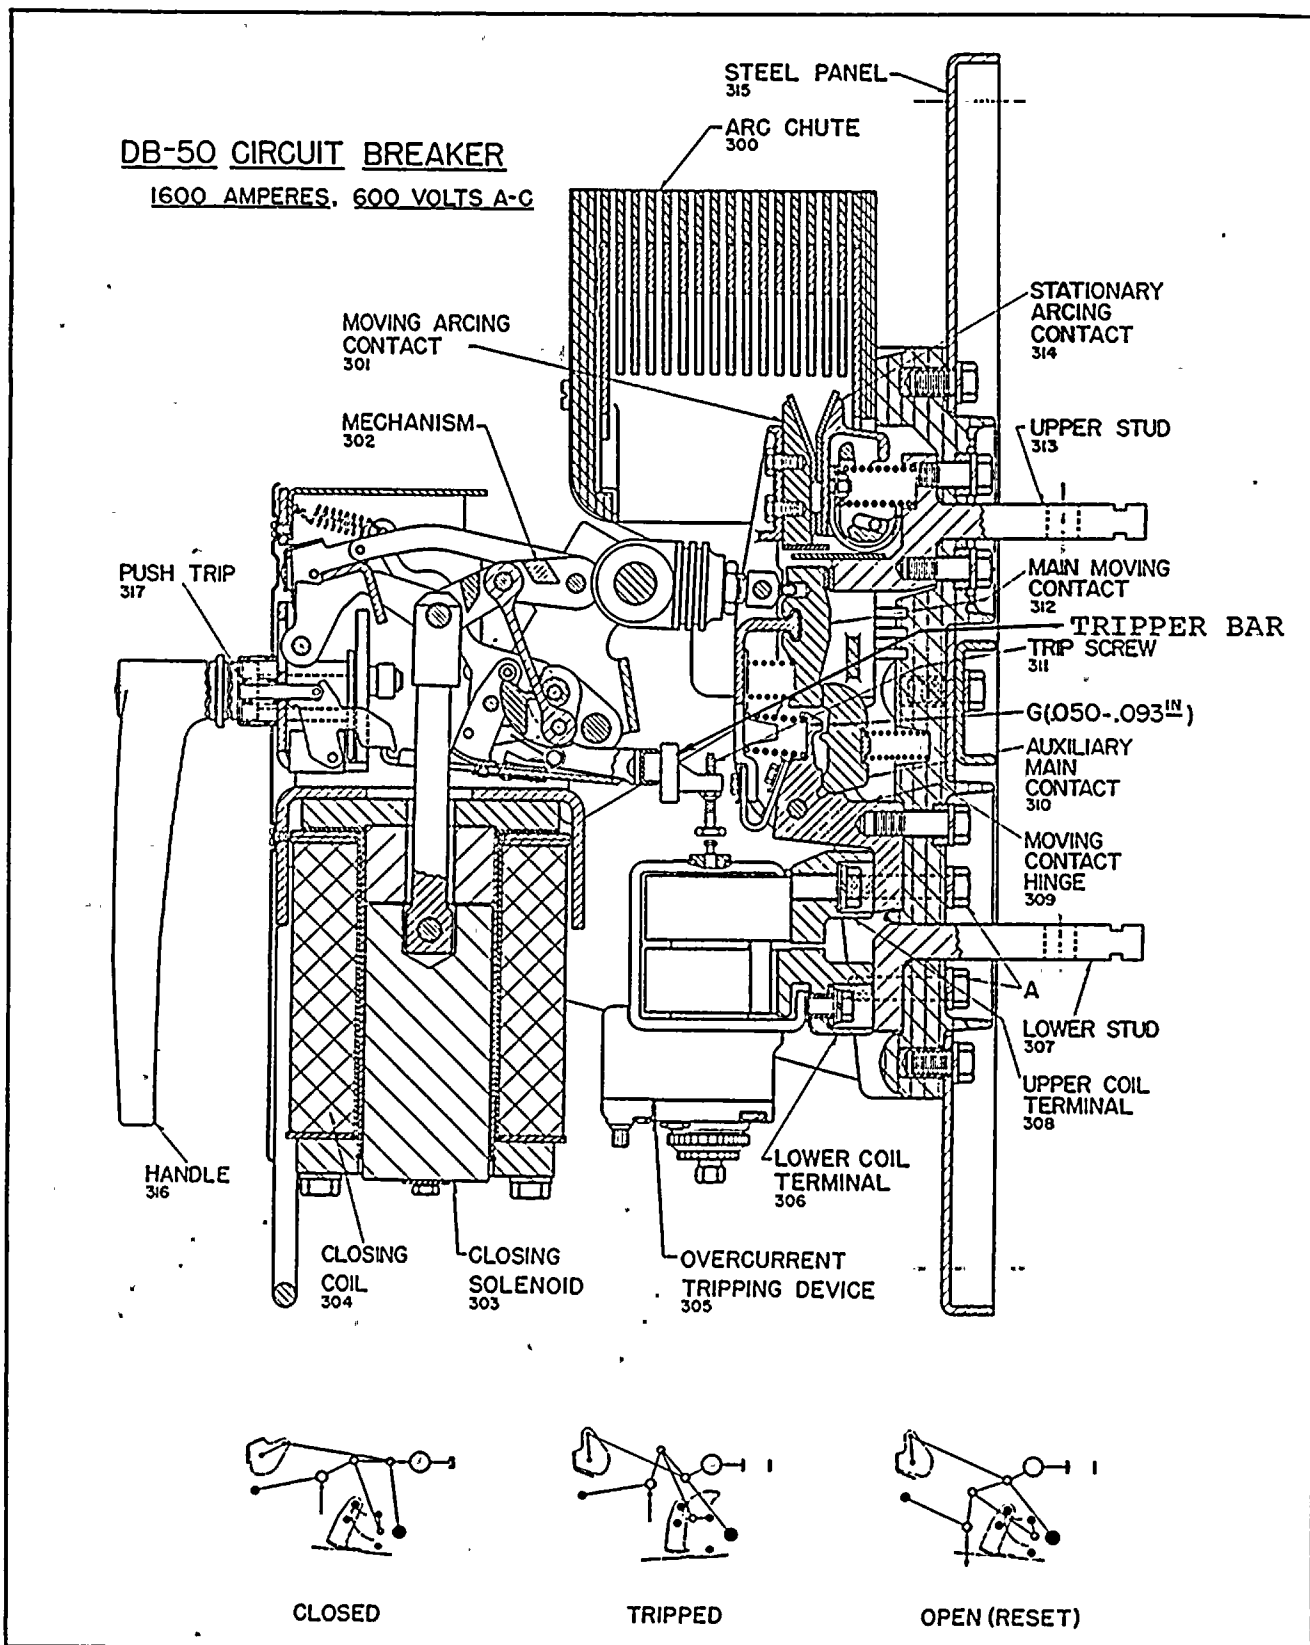
**Fig. 1 - Cross-Sectional View of Type DB-50 Circuit Breaker**

The failure of Circuit Breaker SIP1C1 to close upon receipt of a close signal was determined to be due to inadequate clearance between the lockout assembly and the "tripper bar" which prevented the tripper bar from locking into the closed position, and therefore simulated an overcurrent condition in the breaker. It should be noted that the principal function of the tripper bar is to open the breaker when the overcurrent coil internal to the DB-50 breaker actuates (See figure 1). Existing instruction books for the "DB" breakers with the lockout attachment state there are no adjustments for this clearance, however, Westinghouse has since developed an adjustment method. By loosening the locknut, the elastic stop nut can be turned to adjust the clearance between the lockout assembly and the tripper bar. The clearance should be 1/32"-1/16" with the lockout coil in the energized position (See figure 2).

It is recommended that plant maintenance procedures be modified to check, and adjust if needed, clearance of the lockout assembly on "DB" breakers that have this lockout feature in accordance with the W procedure. This is in addition to any existing maintenance procedures that may apply. When maintenance procedures have been modified, reliability and availability of the breakers will be acceptable.

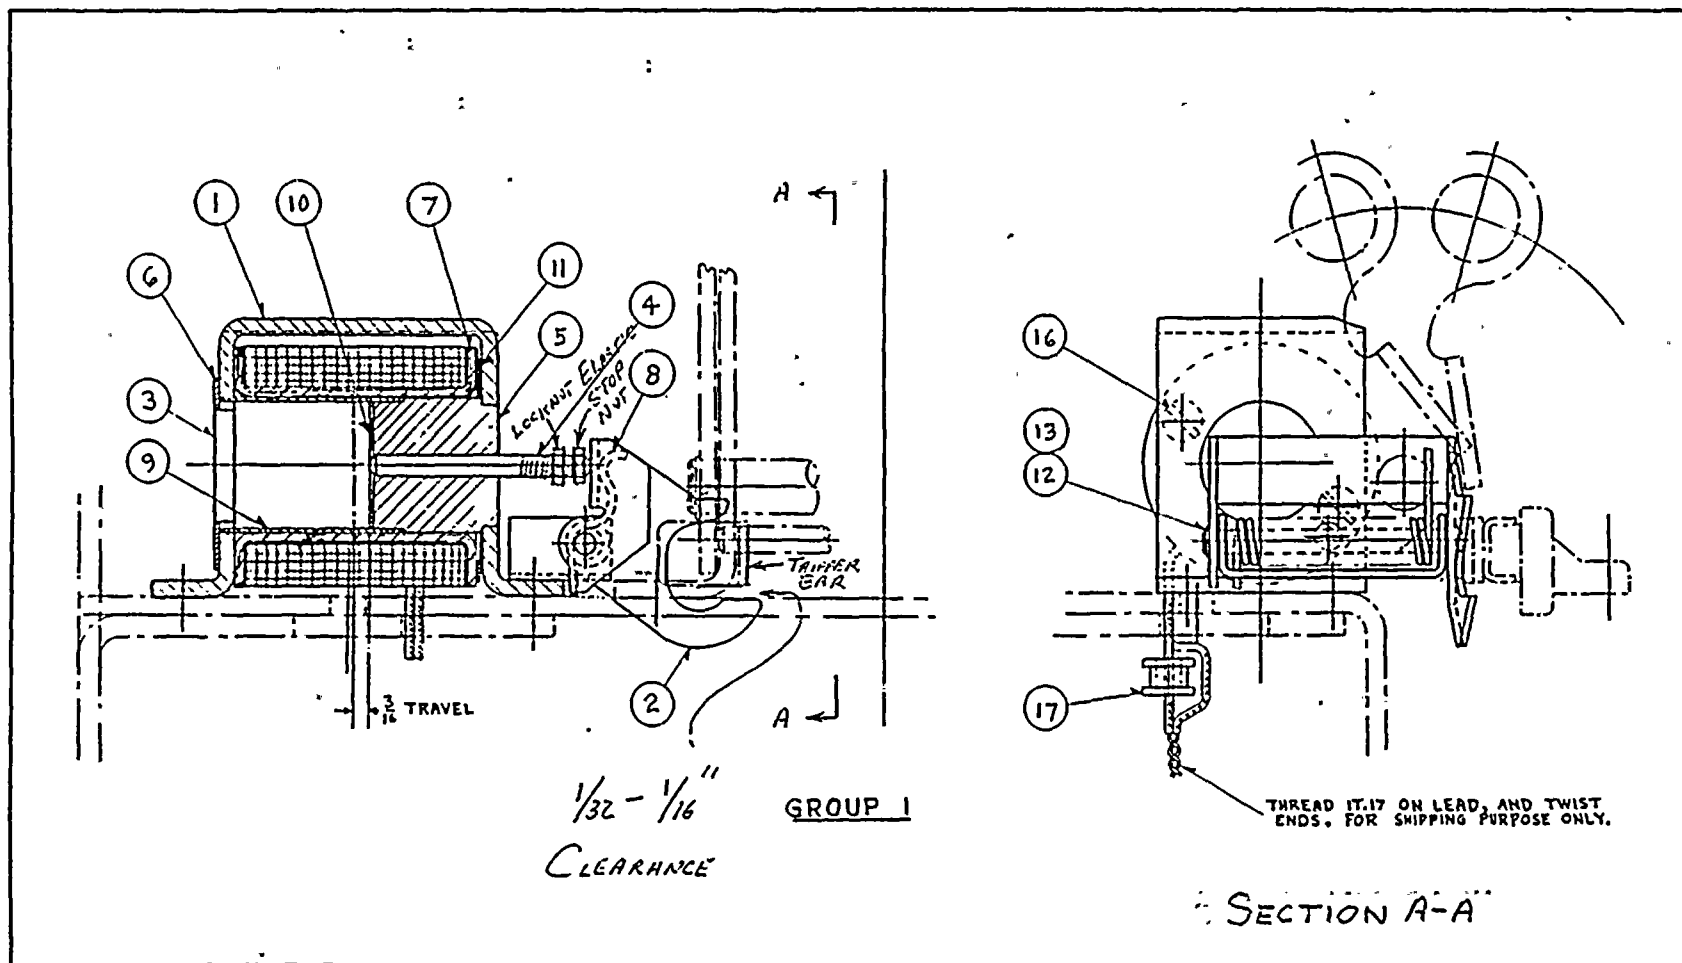
Fig. 2 - Electric Lockout Attachment - Construction Details

This letter is to summarize our findings at East Pittsburgh on April 22, 1981. We found that when the electrical lockout was energized there was no clearance between the electric lockout arm and the trip bar. This caused the breaker to fail to close reliably. There is a screw and locknut adjustment that should be set for 1/32-1/16" clearance between the electric lockout arm and the trip bar when the lockout is energized. We corrected this adjustment and the breaker subsequently closed reliably. This is a breaker manufacturing assembly adjustment that is not normally adjusted in the field.

The results of the testing performed by Westinghouse on the DB-50 breakers were described in reference 1. The specific cause of the SIP1C1 breaker failures was determined to be the mechanical alignment of the lockout coil assembly and the tripper bar. This problem was localized within the breaker mechanism itself and not related to external control wiring or equipment. Corrective action was proposed and adjustments were made on all DB-50 breakers containing lockout coils.
