Investigation of Surface Buring Characteristics
Of a Solid Silicone Sheet Material, NS-1

INVESTIGATION OF SURFACE BURNING CHARACTERISTICS OF:

A SOLID SILICONE SHEET
MATERIAL, NS-1

PROJECT NO. 03-5849-285
FINAL REPORT

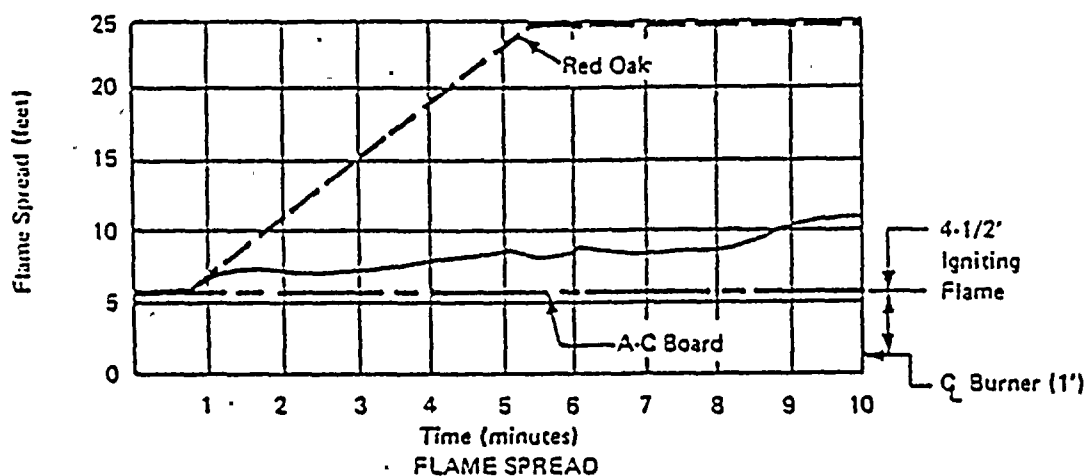
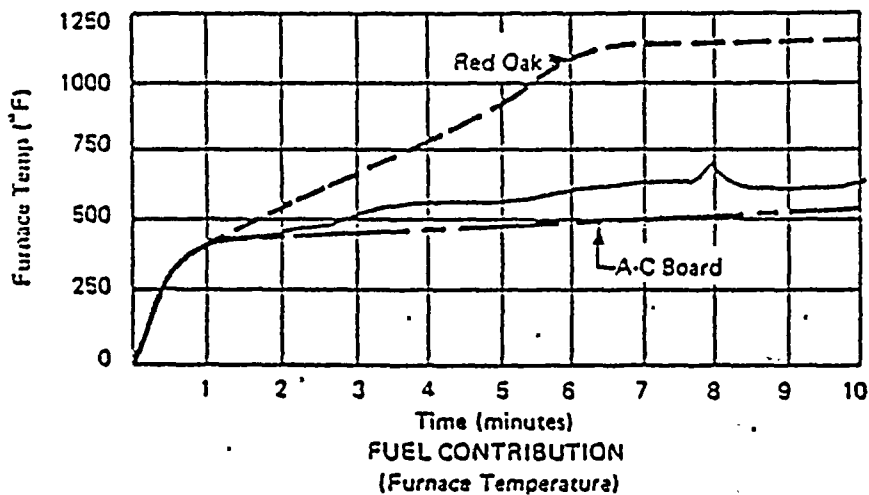
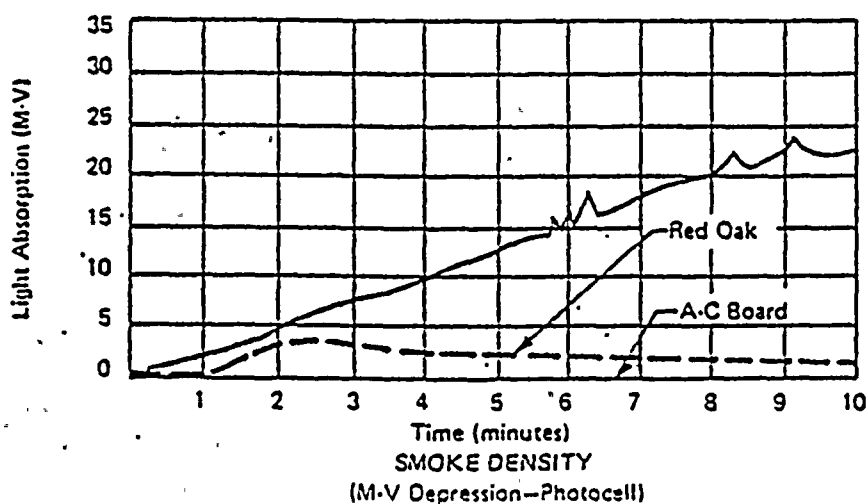
SURFACE BURNING CHARACTERISTICS OF A
SOLID SILICONE SHEET MATERIAL, NS-1

Recorded data for flame spread, fuel contribution, and smoke density of the specimen are shown in the figures at the end of this report as a solid line on each graph.

Test Specimen	Flame Spread	Fuel	Smoke
	Rate E84-79a	Contribution	Density
Asbestos-Cement Board	0	0	0
Red Oak Flooring	100	100	100
Solid Silicone Sheet Material, NS-1	10	5	530
