SUBJECT: Revised application for amend to License DPR-74, providing
 addl info on frequency for torque testing ice condenser
 inlet doors & capability to isolate containment svc air. Rept
 on test dates & drawing of isolation valves encl.

Donald C. Cook Nuclear Plant Unit 2
Docket No. 50-316
License No. DPR-74
AMENDMENT TO TECHNICAL SPECIFICATION CHANGE REQUEST

SUBJECT: STP.207 Report

STP.207 I/C Lower Inlet Door Test Dates and the Dates Condition Reports Were Written

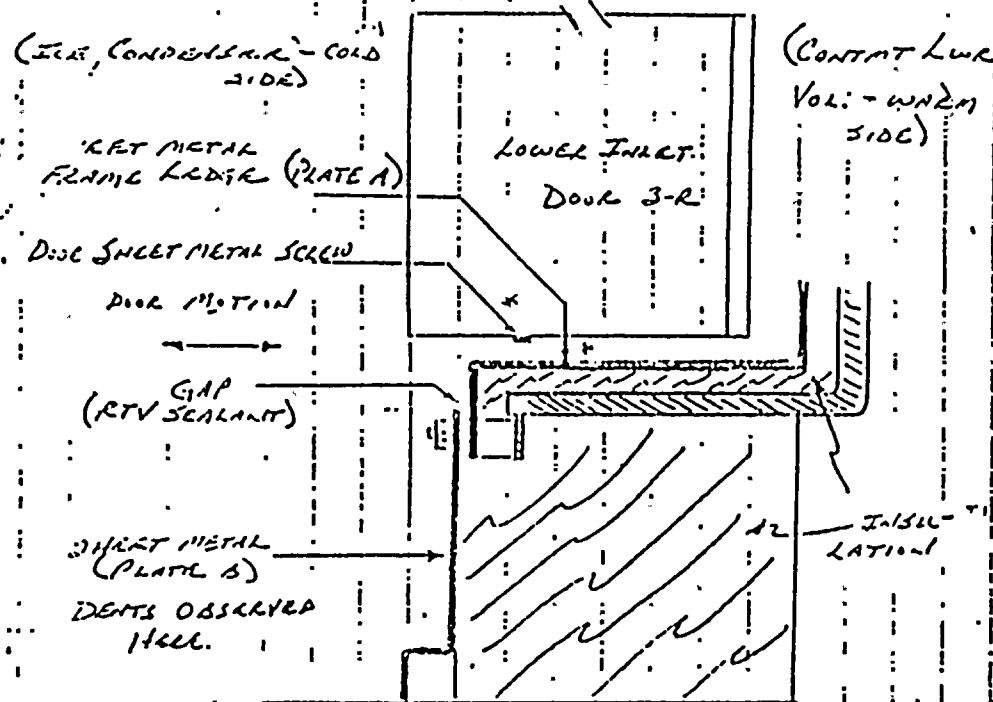
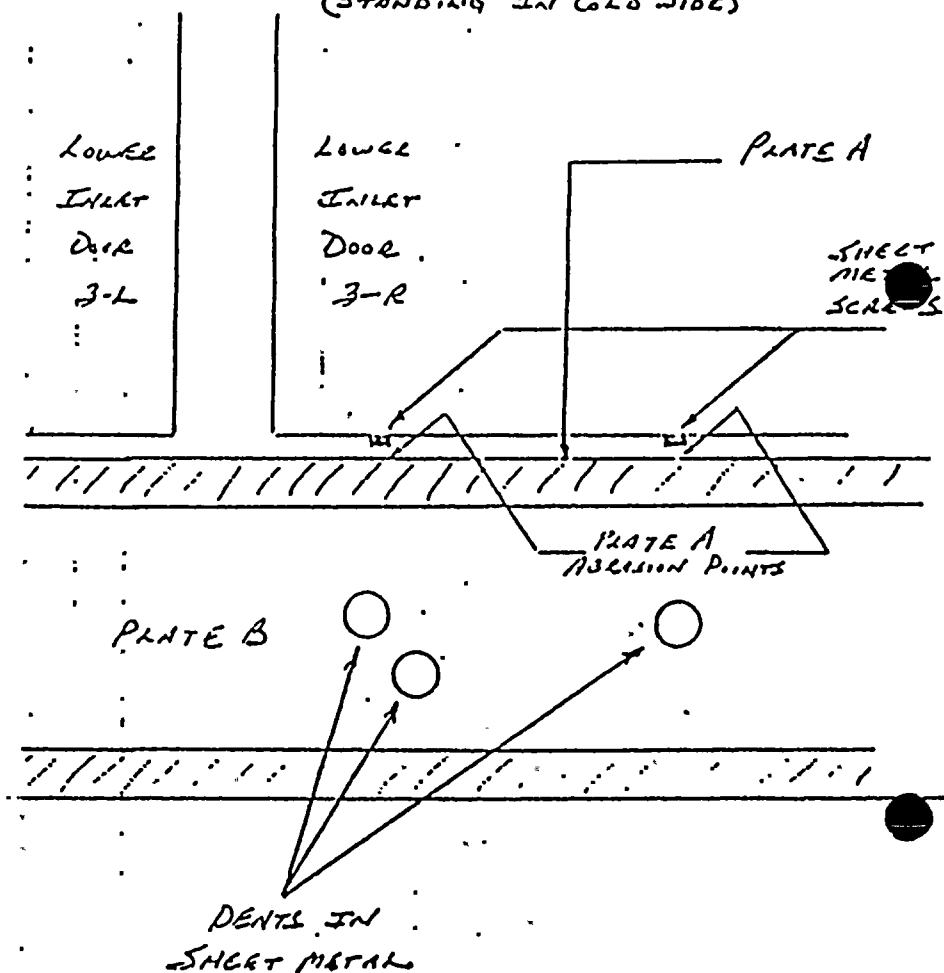
UNIT #1. LOWER ICE CONDENSER
 Door 3-R 4/10/79
 KAT.

The torque required to open lower inlet door 3-R beyond 6 inches of travel was measured to be 902 in.- lbs. The applicable Technical Specification limit is 675 in.- lbs. Upon inspecting the door, it was found that sheet metal screws along the bottom of the door were rubbing against the surface of the bottom edge of the door frame.

As a result of the problem described in the subject Condition Report, two inspections were conducted on April 13, 1979. The first inspection consisted of observations made in bay 3 only. The second inspection consisted of observations conducted throughout the remaining bays based on the results of the first inspection conducted in bay 3.

During the first inspection, the following observations were made (refer to Attachment #1):

- 1) abrasion marks appeared on the door frame bottom ledge where two of the door's sheet metal screws were making contact as the door was opened,
- 2) large dents in plate B were observed directly below the abrasion points thereby suggesting that a mechanical force, imparted on plate B, may have resulted in forcing plate A upwards and also increasing the size of the gap between plates A & B,
- 3) the RTV sealant, previously installed in the gap between plates A & B, was found missing thereby allowing the possibility of condensation to run from atop plate A down into the insulation to freeze and push plate A upwards and
- 4) mineral residue, indicating condensation flow across plate A (from warm side to cold side) and down toward the gap between plates A & B, was observed.

Based on the observations made during these inspections, it is apparent that door 3-R plate A was forced upwards (and in contact with the door's sheet metal screws) as a result of a combination of mechanical impact transmitted from plate B and insulation expansion as a result of freezing condensation. During the insulation, it became obvious that not only did the blows to plate B force plate A upwards but also resulted in widening the gap between plates A & B which resulted in a high probability of increasing condensation flow into the insulation.

* CONTACT BETWEEN THESE TWO POINTS
 INDICATED BY ABRASION MARKS
 ON FRAMING LEDGE (PLATE A)

Depressed lower inlet door 3-R frame bottom edge surface to allow door to be opened beyond 6 inches utilizing an opening torque of 328 in lbs.

- Upon completing the inspections described in the attached investigation report, Dayco Sheet Metal Inc. replaced all of the frozen insulation along the bay 3 door frame bottom ledge and plates A & B were reinstalled in both bay 3 and bay 14. In addition, RTV sealant was installed along the entire length of the gap between plates A & B in both bays. The RTV sealant is considered a permanent fix in prohibiting condensation flow down through the gap and into the insulation.

To completely eliminate the possibility of this problem in the future, a RFC has been written to replace the horizontal plate A with a plate that would slope down in the direction as shown in Attachment #2. The sloping feature of the this plate would provide a significantly greater clearance between the plate and the door's sheet metal screws. The greater clearance will allow plate B to absorb impact without causing plate A to interfere with the door's opening travel. It is planned to install the RFC in each unit during each unit's upcoming refueling outage. (This has been completed)
