SUBJECT: Forwards response to NRC RAI to support technical review of
util 920225 proposed license amends re OL expiration date.

Re: Turkey Point Units 3 and 4
Docket Nos. 50-250 and 50-251
Request for Additional Information (RAI) -
Proposed License Amendments
Operating License Expiration Date

TURKEY POINT UNITS 3 AND 4

PROPOSED LICENSE AMENDMENTS:
OPERATING LICENSE EXPIRATION DATE

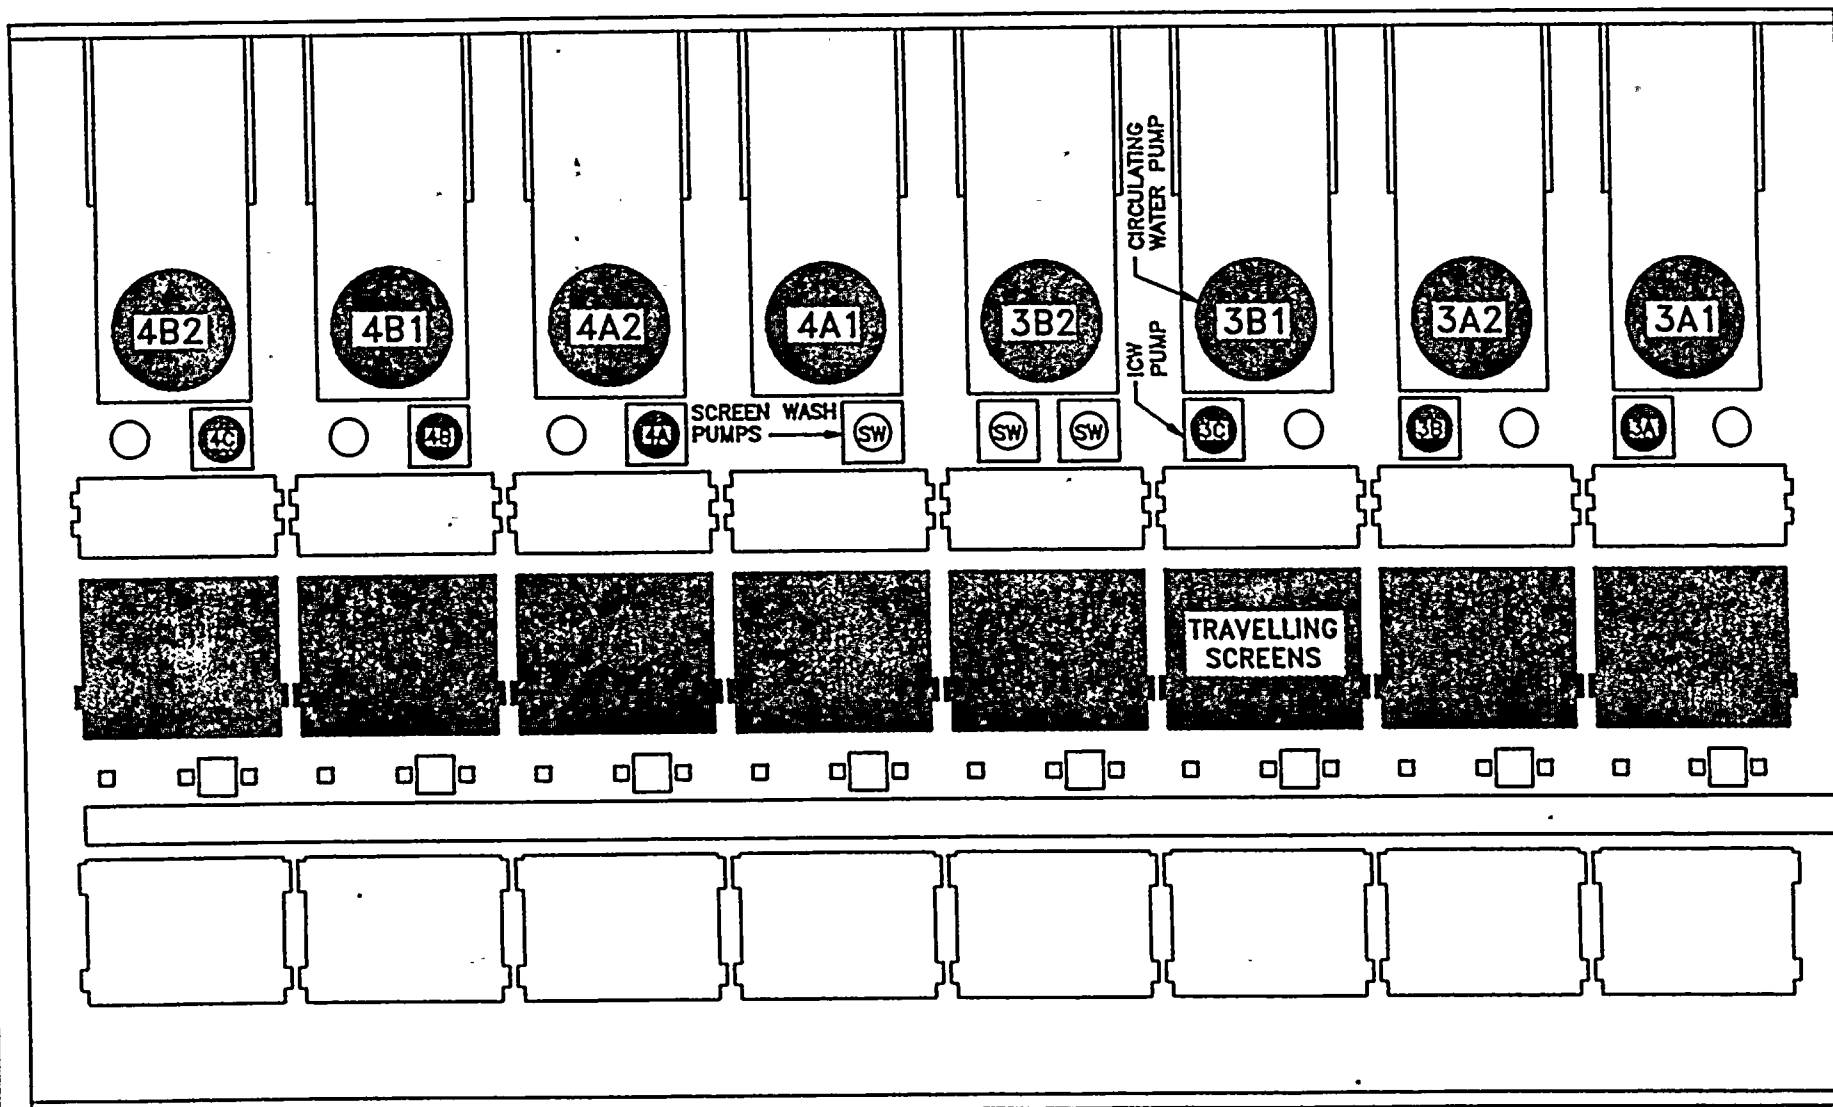
GENERAL ARRANGEMENT
INTAKE STRUCTURE
(PLAN VIEW @ EL 16'-0")

The main structural components of the intake structure, which are composed of reinforced concrete, are depicted in Attachment 1. They consist of the foundation, bay walls, horizontal struts including Circulating Water (CW) pump thrust beams, and deck support beams for the Intake Cooling Water (ICW) pumps, CW pumps, and travelling screen equipment.

In 1985/1986, inspections of the structure by FPL identified erosion/corrosion of the CW pump thrust beams, horizontal struts at the 1'-9" elevation, and the deck support beams for the ICW pumps. The most significant degradation was present on the CW pump thrust beams. Due to the degree of damage, the beams were replaced. Repairs were also made to the strut beams at elevation 1' - 9" and to the ICW pump support beams. These members reside in the wet/dry zone which is heavily oxygenated, are exposed directly to intake canal water which has a high chloride ion concentration, and have 3 inches of concrete cover over the reinforcement (as required by the American Concrete Institute (ACI) code of record at the time of construction). Other

elements of the structure, including the bay walls, which have 6 inches of cover, and the struts which are normally submerged, did not exhibit any significant degradation.

Based on the physical findings and test reports, FPL initiated an inspection and repair program to assure long term performance of the intake structure. The program was founded on the significance of the individual structural members with regard to the overall integrity of the ICW system and the level of degradation that was observed at the time. Repairs were made to the ICW pump deck support beams to restore the protection for the concrete reinforcement, modifications to assure long term performance of the structure were developed, and inspections have continued on the thrust beams, strut beams and bay walls.

In order to develop a plan for the controlled implementation of the modifications, additional testing was performed and all historical data was reviewed by an independent consultant in 1990 (APTECH Engineering Services). Based on this study, FPL issued Specification CN 2.28 in December 1990 to provide a six year plan to direct permanent repairs and modifications. The plan includes the installation of reinforcing beams under the ICW pump support beams, various modifications to features above the deck that will significantly reduce the rate of intrusion of chloride ions into the ICW pump support beams, and performance of regular inspections of the bays, including visual inspection of the bay walls. To date, all modifications to reduce chloride ion intrusion have been completed, 2 out of 4 bays in each unit have received the deck beam reinforcement with the remaining 2 bays to be completed in the upcoming refueling outages, and inspections of the bays have continued with no significant degradation found.
