LTR-NRC-17-77

Subject: Response to Revised November 21, 2016, U. S. Nuclear Regulatory Commission Request for Additional Information for Westinghouse Electric Company Topical Report WCAP-17794-P, Revision 0, and WCAP-17794-NP, Revision 0, "10x10 SVEA Fuel Critical Power Experiments and New CPR Correlation: D5 for SVEA-96 OPTIMA3" (Proprietary/Non-Proprietary)

## 2 ROOT CAUSES AND FAILURE SCENARIO

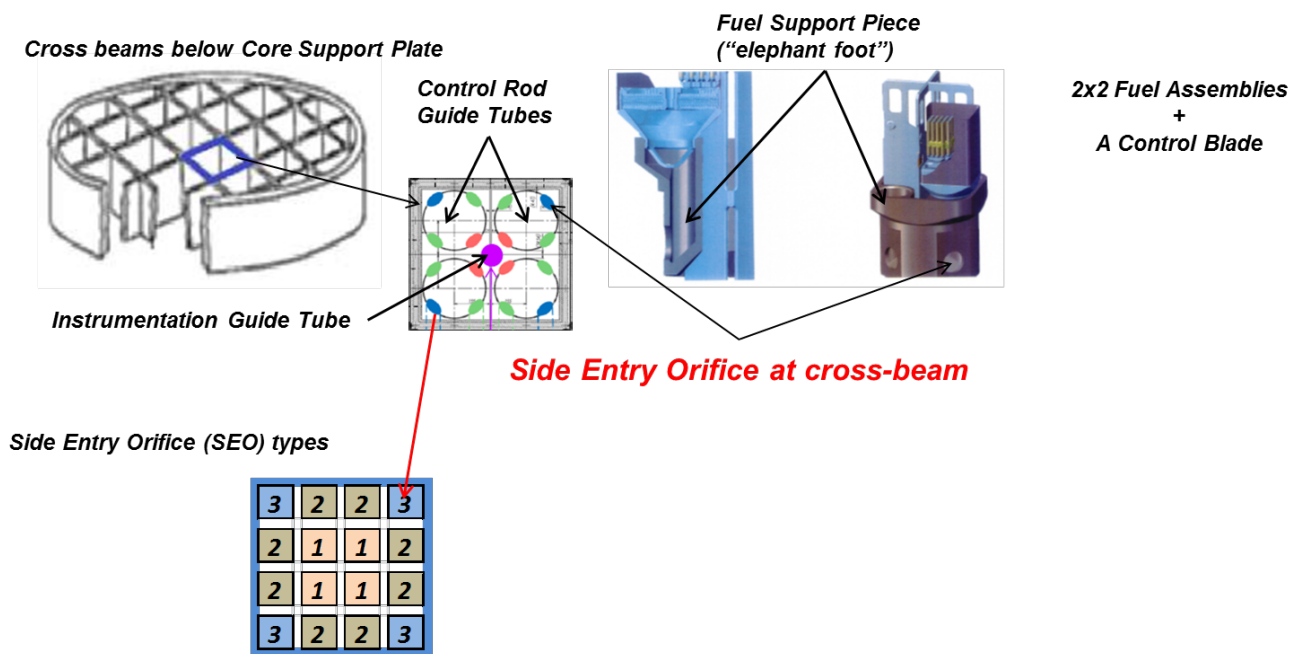
Figure 3-1 - BWR/6 design: Cross beams structure and Fuel Support Pieces

As shown in Figure 3-1, the cross beams structure defines a mesh where 16 (4x4) fuel assemblies are loaded. Four of them (at SEO 1) will not face the support beams, eight of them (at SEO 2) will face a single support beam, and the remaining four assemblies (at SEO 3) will

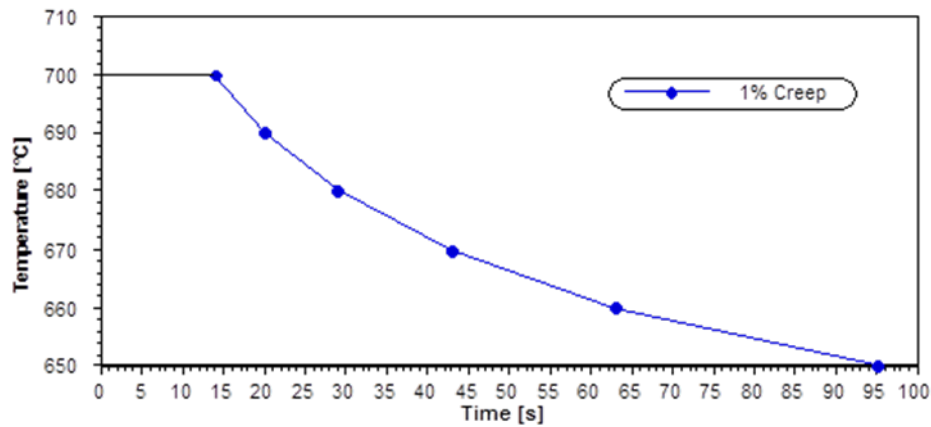
*Figure A1-1 Combinations of times and temperatures that result in 1% circumferential creep strain, assuming a hoop stress of 47 MPa*

It should be emphasized that the temperature-time curve in Figure A-1 describes the space within which the fuel rod can be regarded as unaffected by the temperature excursion. Exceeding the curve does not lead automatically to a prompt fuel rod failure.

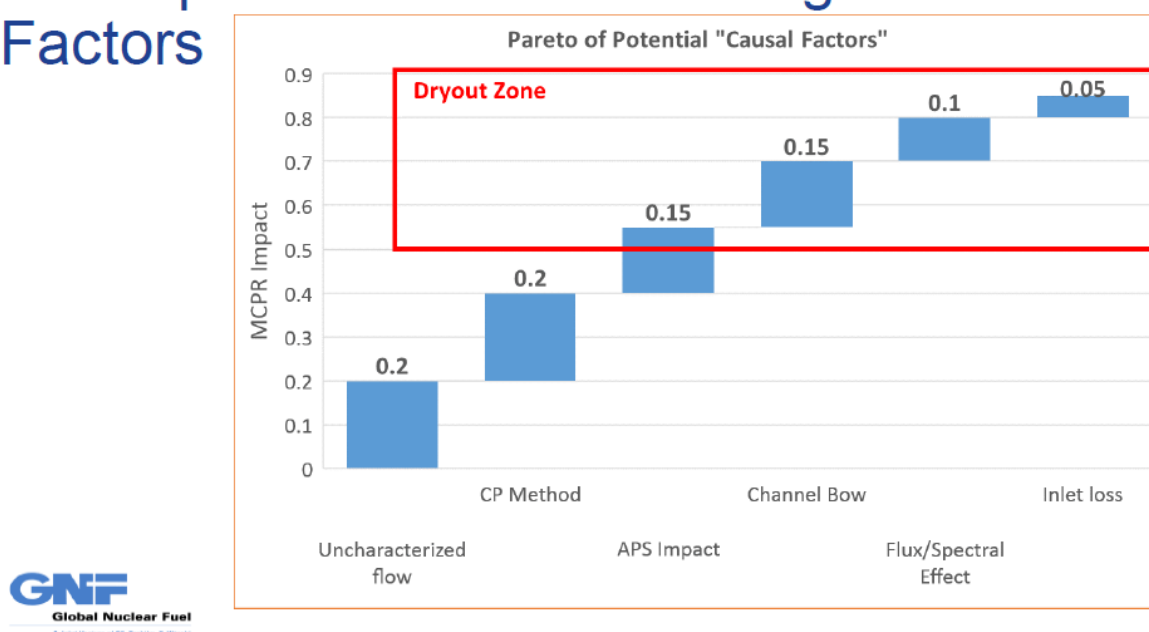
Figure A3-1: GNF’s Conceptual Pareto of Ordering of Contributing Factors (extracted from ADAMS ML1721SA338)

All of the contributions presented in Figure A3-1 have been previously evaluated by Westinghouse using all of the information available about the specific conditions at [ ]<sup>a,c</sup>. While Westinghouse agrees that these are all obvious factors to be considered based on past industry experiences, it has been demonstrated that they have no significant relevance to localized dryout observations, even when conservatively taken in combination. The relevance and potential magnitude of contribution of each factor are discussed below.

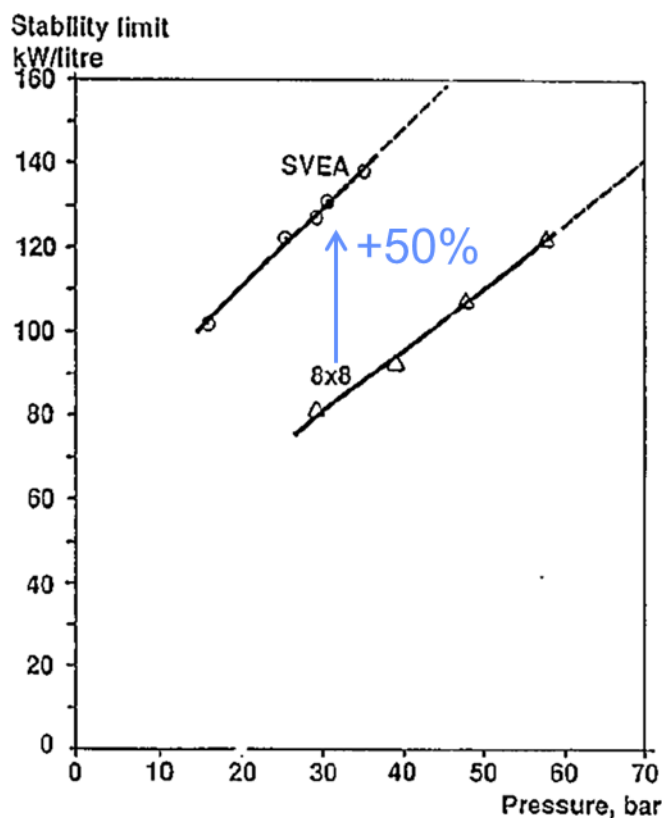
Figure A4-1 summarizes the flow stability experience obtained from FRIGG loop testing of SVEA and 8x8 designs. The comparison indicates that the SVEA design has improved thermal-hydraulic stability compared to the open lattice 8x8 design.

Figure A4-1 Stability limits at natural circulation for SVEA and 8x8 fuel.

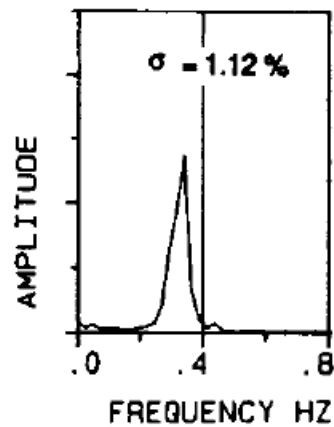
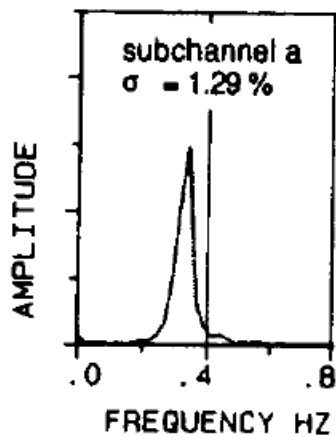
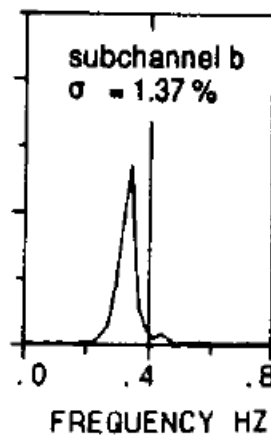
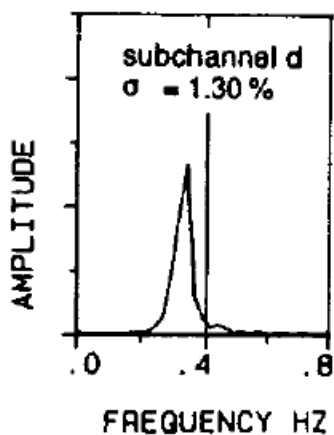
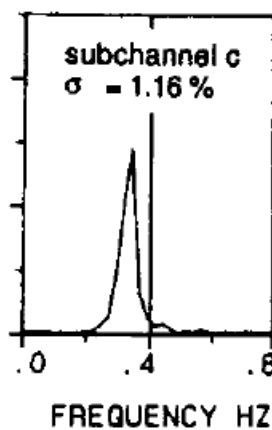
Figure A4-2: Noise auto-spectrum assembly inlet flow (top) and inlet flows to the four sub-channels (a – d)

The figure shows that the inlet flows to the four sub-channels fluctuate at the same characteristic frequency as the assembly inlet flow and have the same damping properties (decay ratios). This follows from the fact that the peaks appear at the same characteristic frequency and have the same spectral shapes (peak width ratios) as the assembly inlet flow.

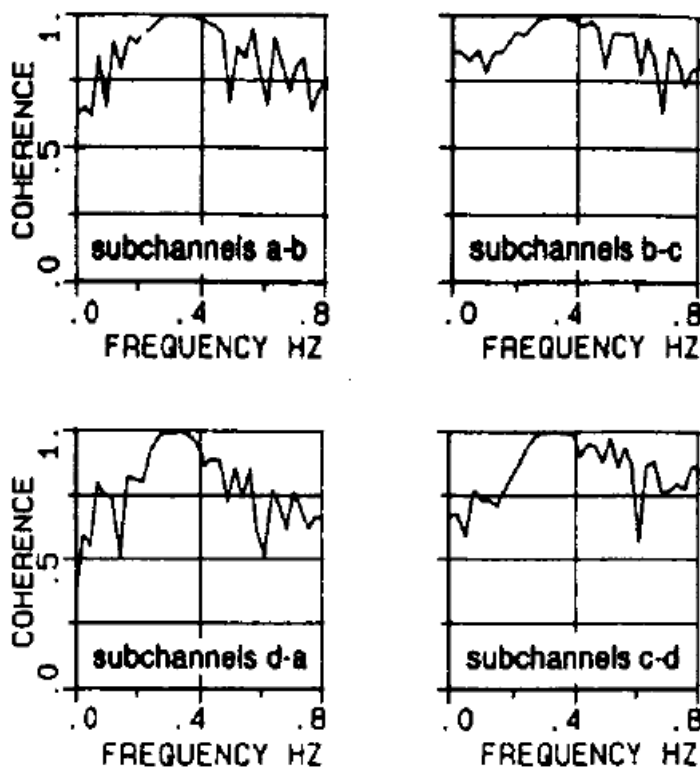
These five flow signals have been cross analyzed in order to investigate the process couplings between adjacent sub-channels. Figure A4-3 presents the coherence results for the signals that refer to inlet flows to the pairs of sub-channels (a-b), (b-c), (c-d), and (d-a). Good signal coherence is present everywhere and in particular at the peak frequency observed in Figure A4-2.

*Figure A4-3: Coherence between inlet flows to adjacent sub-channels in SVEA-64 test*

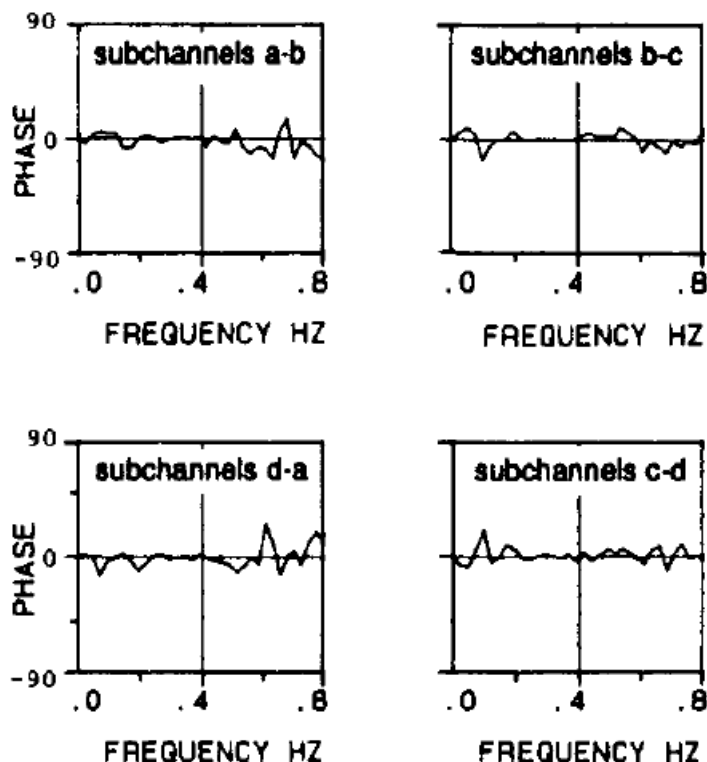
Figure A4-4 below, which presents the corresponding phase relations, shows that there are no significant phase differences between the signals. Together, Figures A4-2 and A4-3 demonstrate that the fluctuations occurring in the inlet flows to the four individual sub-channels are all strongly coupled to each other and are all in phase.

Figure A4-4 Phase relations between inlet flows to the adjoining sub-channels in SVEA-64

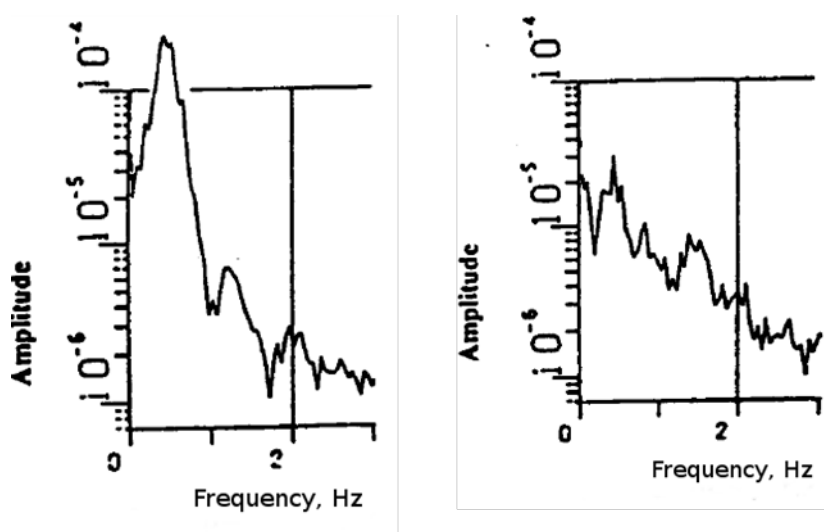
A significant improvement in the thermal-hydraulic stability of SVEA fuel, as compared to 8x8 fuel, can be seen by comparing noise auto spectra for channel inlet flows to one high-power rated 8x8 lattice assembly and to an even more highly power rated SVEA-100 assembly, see Figure A4-6. Both recordings were made at 65% power and at relatively low core flow (close to the instability region in the power-flow map).

Figure A4-6 Noise auto-spectrum for channel inlet flow in 8x8 fuel (left) and SVEA-100 fuel (right) at 65% reactor power and relative assembly power 1.26 for the 8x8 fuel and 1.36 for SVEA-100.
