NINE MILE POINT I
PIPE CRACK TASK FORCE REPORT

CONTRIBUTORS TO NINE MILE POINT I

PIPE CRACK TASK FORCE REPORT

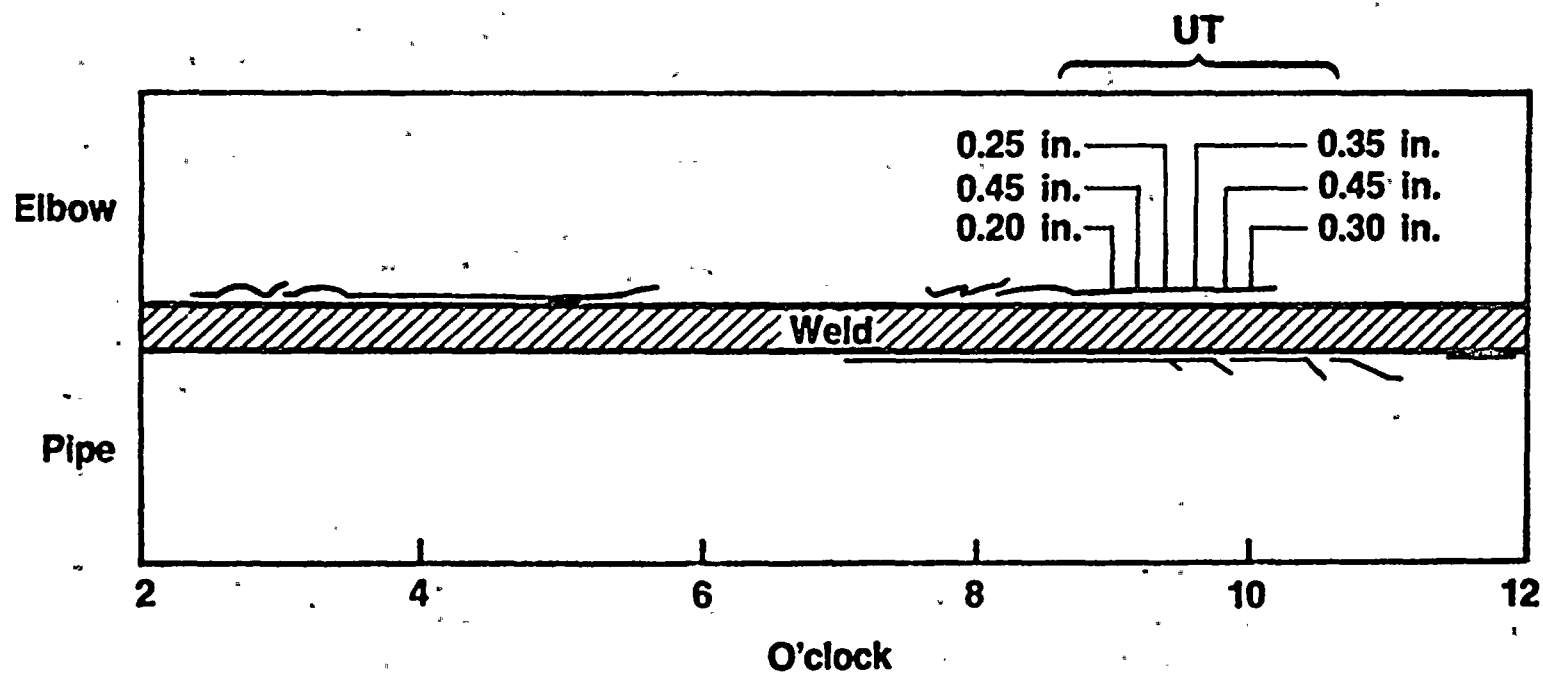
Figure S-2. Sketch of PT Indications in Loop 13 Suction Elbow/Pipe Weld

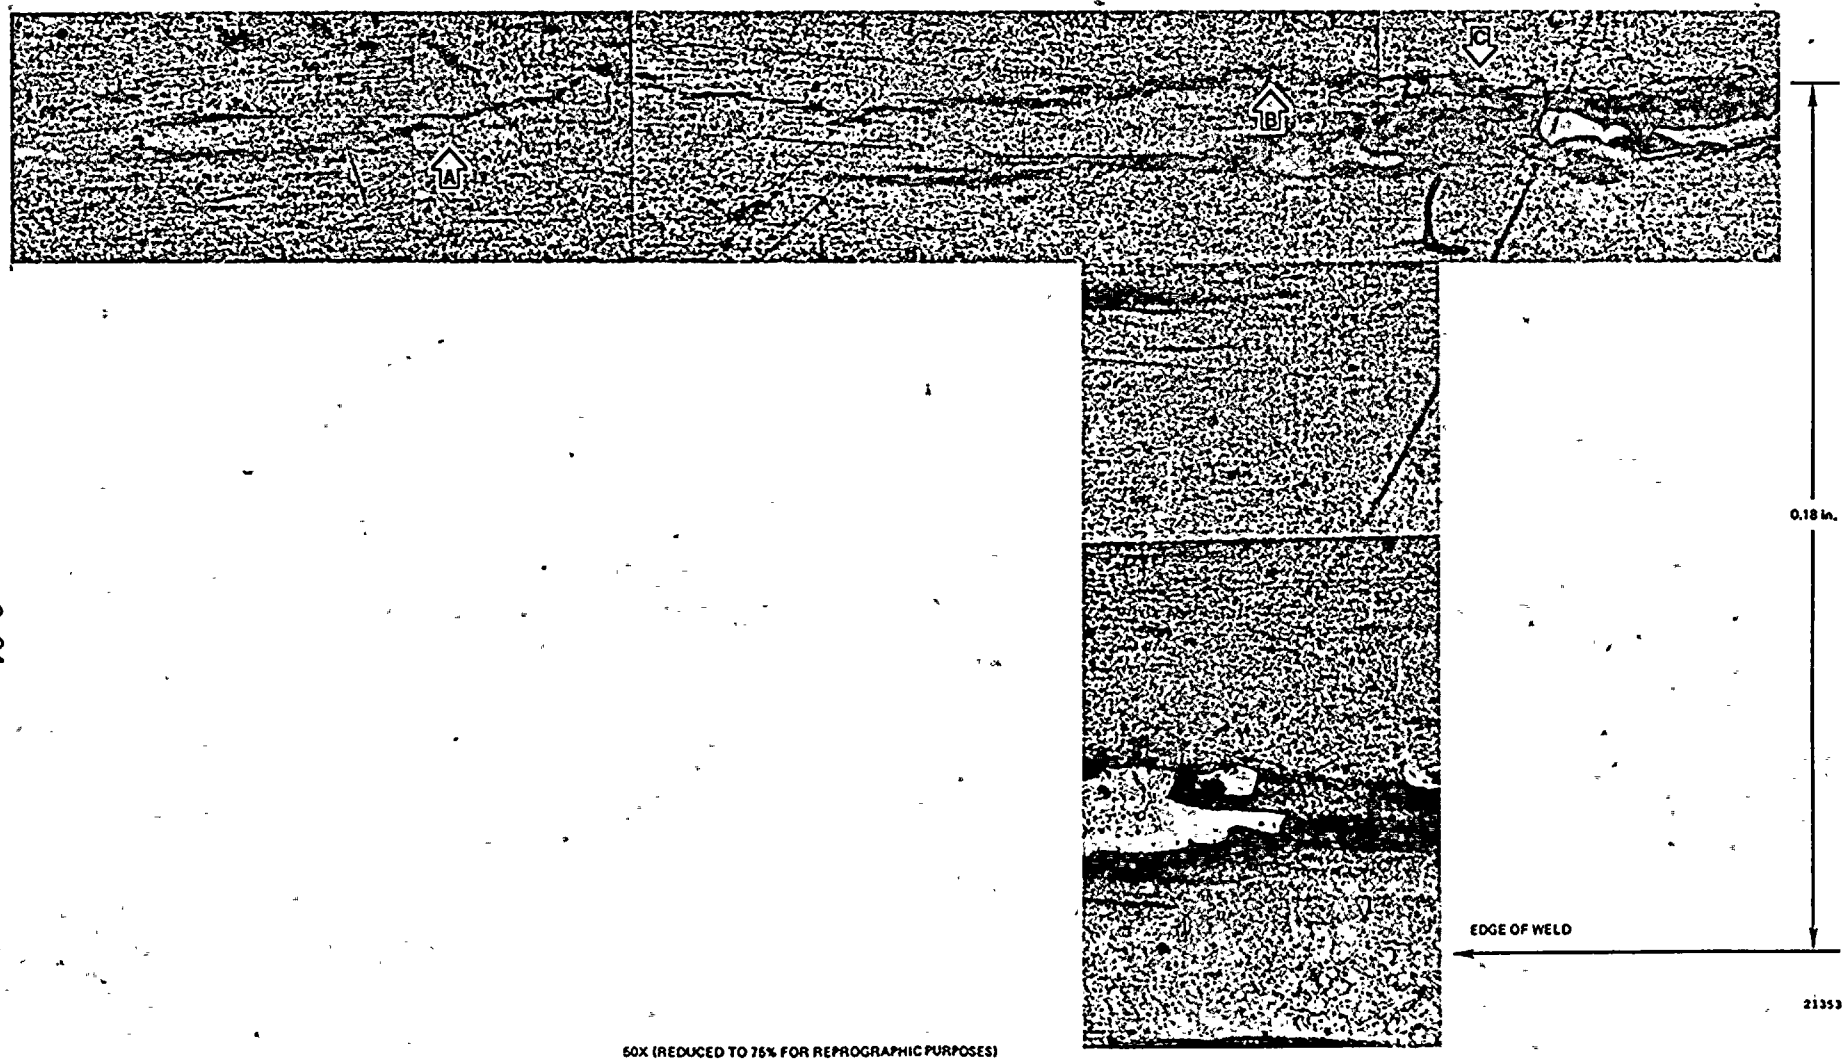
Figure 2. Composite Photograph of Intergranular Crack in Weld Heat Affected Zone (HAZ) at 9:00 Azimuth.

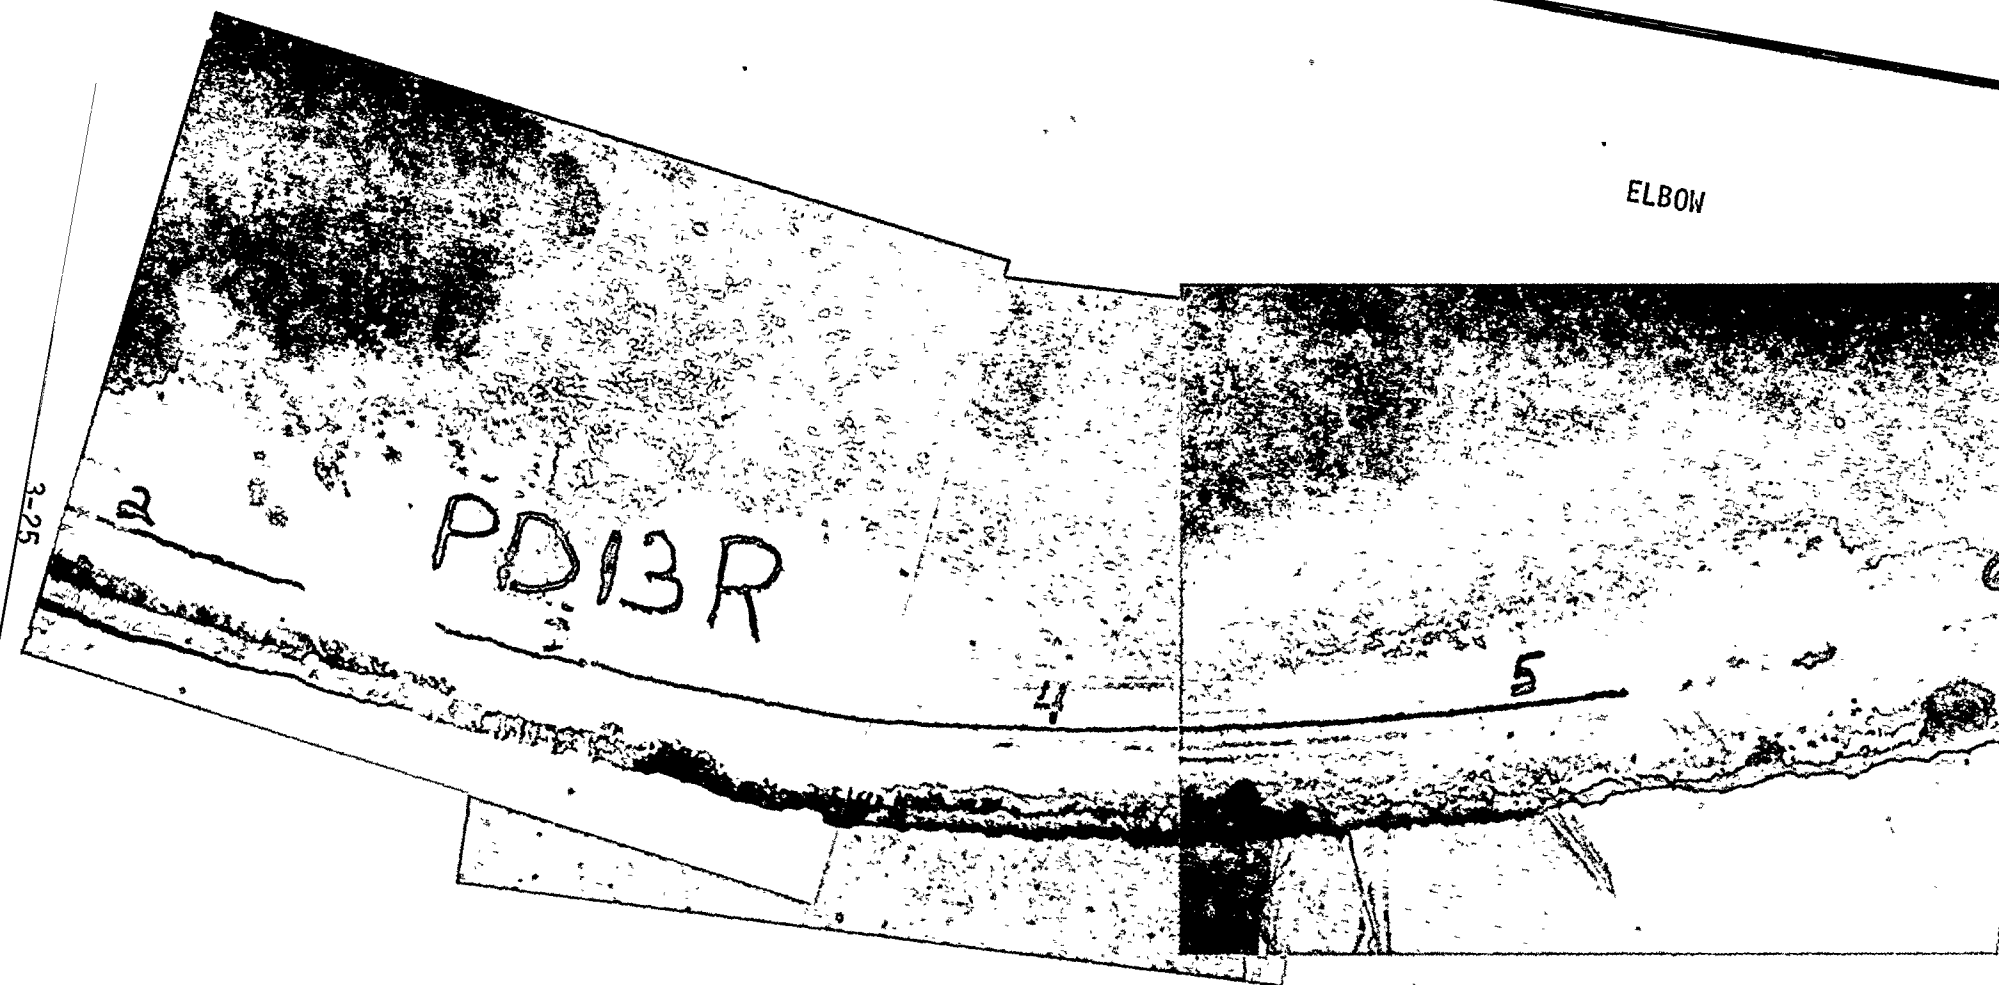
Figure 3. Loop 13 Pump Discharge Weld No. P32-SW-21-W.
Note all indications are on elbow side of weld.

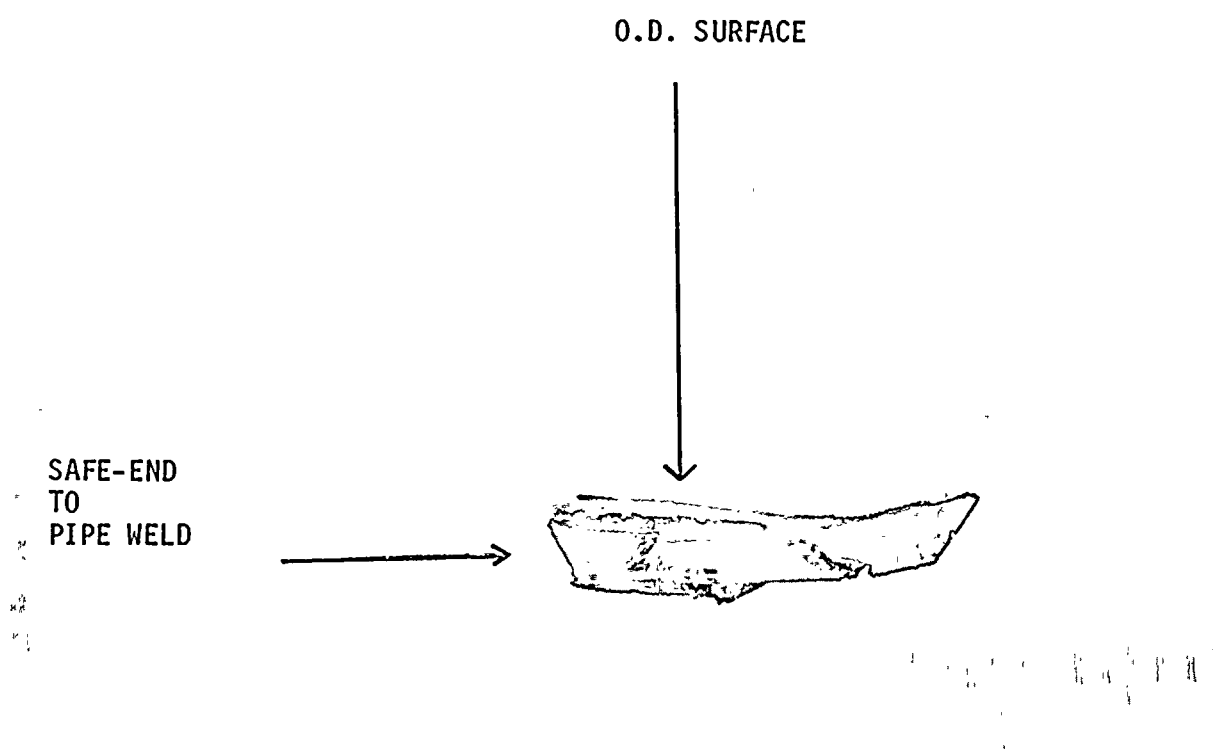
Figure 13. Photograph of Boat Sample showing partially opened crack, 3.5%.

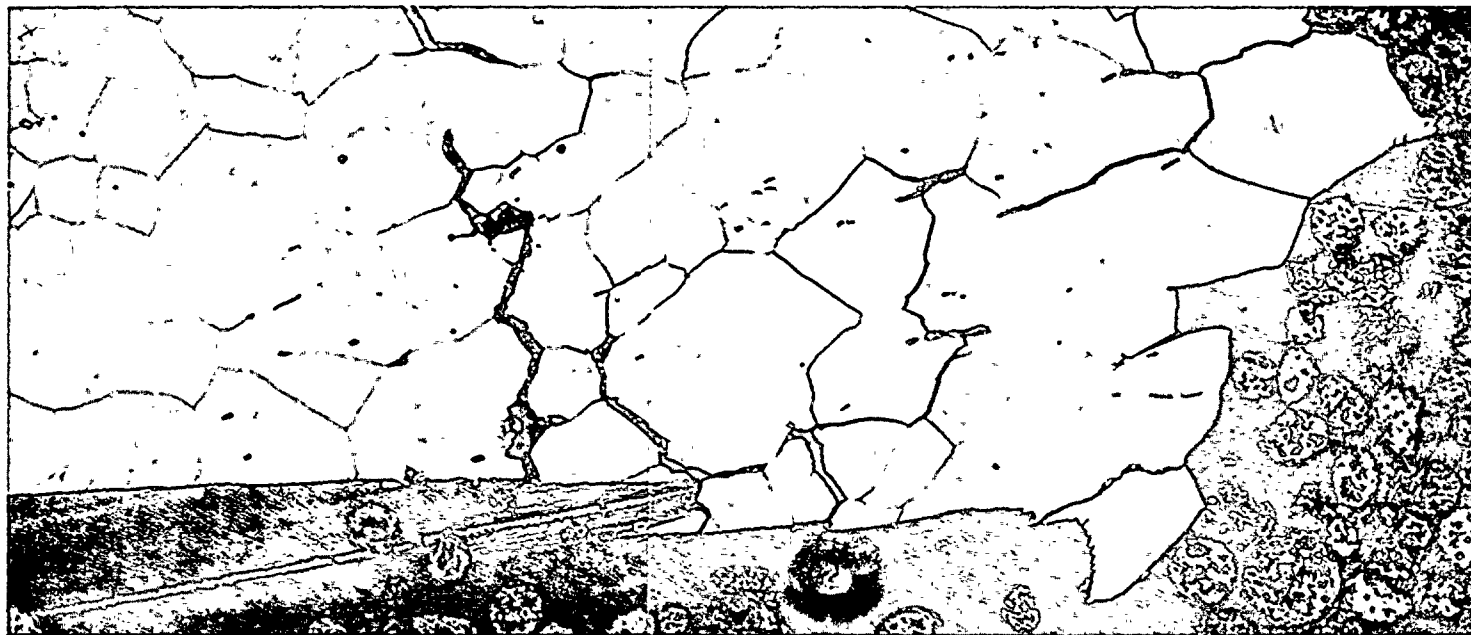
Figure 16. Lower left region of Fig. 15, showing intergranular cracking.
Oxalic Acid Etch, 125X.

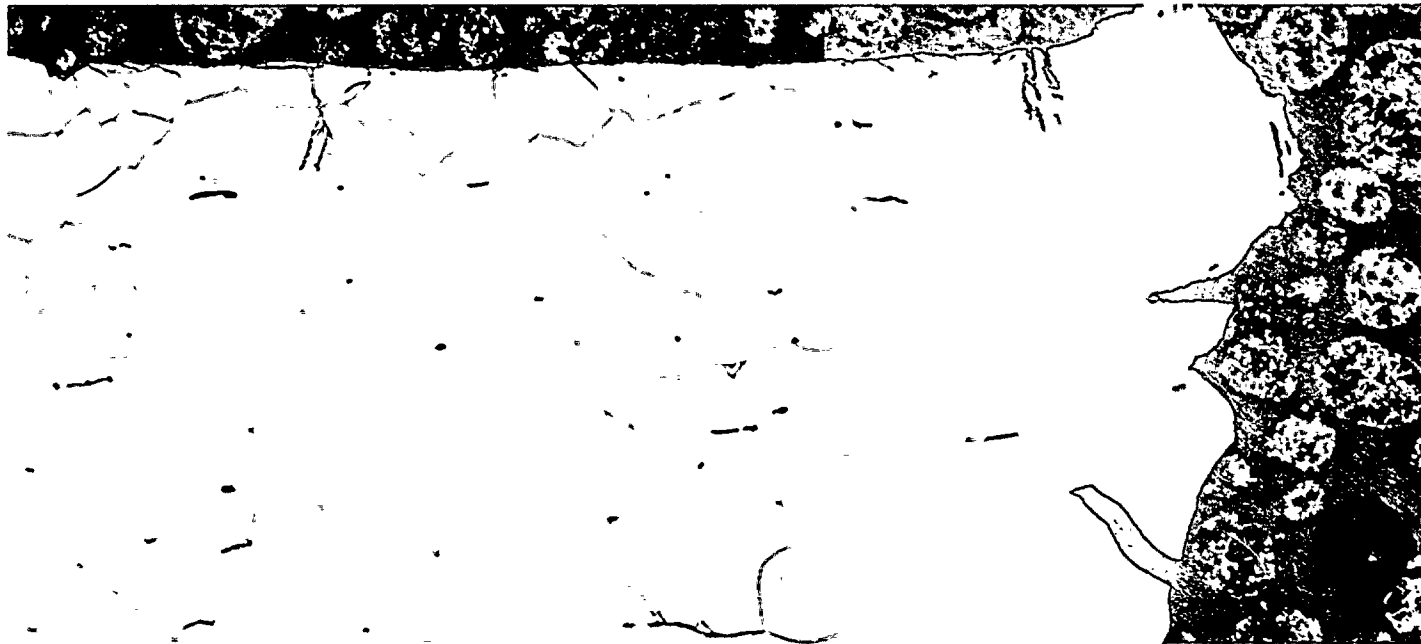
Figure 17. Outside-initiated transgranular cracking on upper left region of Figure 15, Oxalic Acid Etch, 125X.

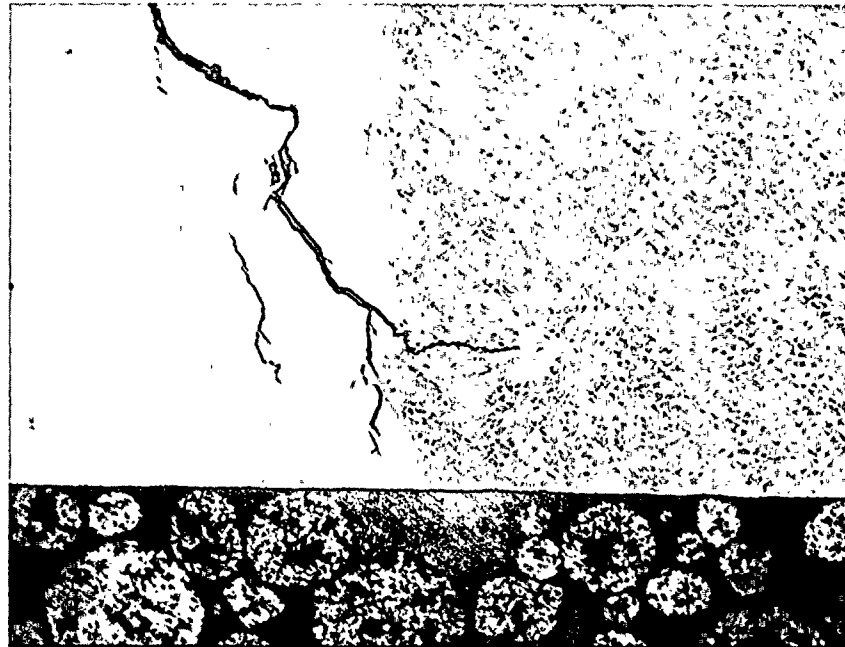
Figure 18. Crack arrest in weld materia, 125X
Oxalic Acid Etch.

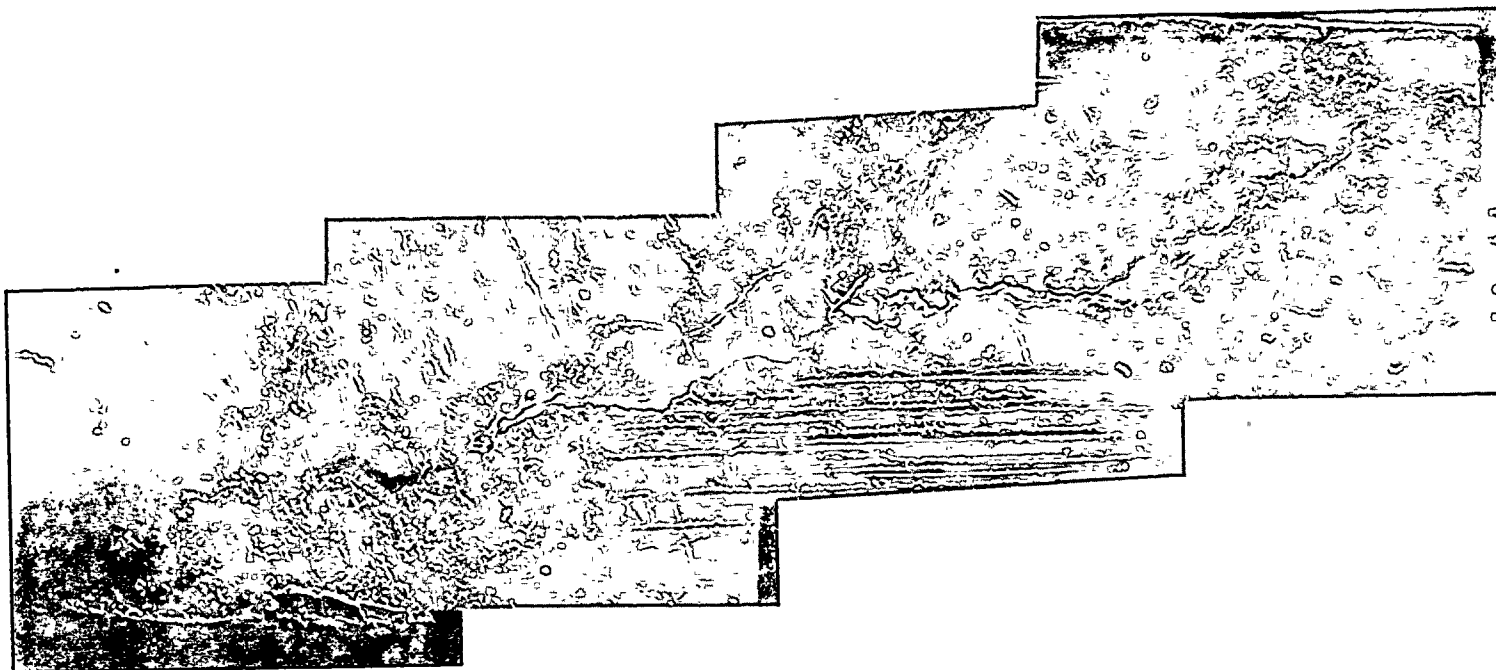
Figure 19. SEM photograph of O.D. surface crack, 50X.

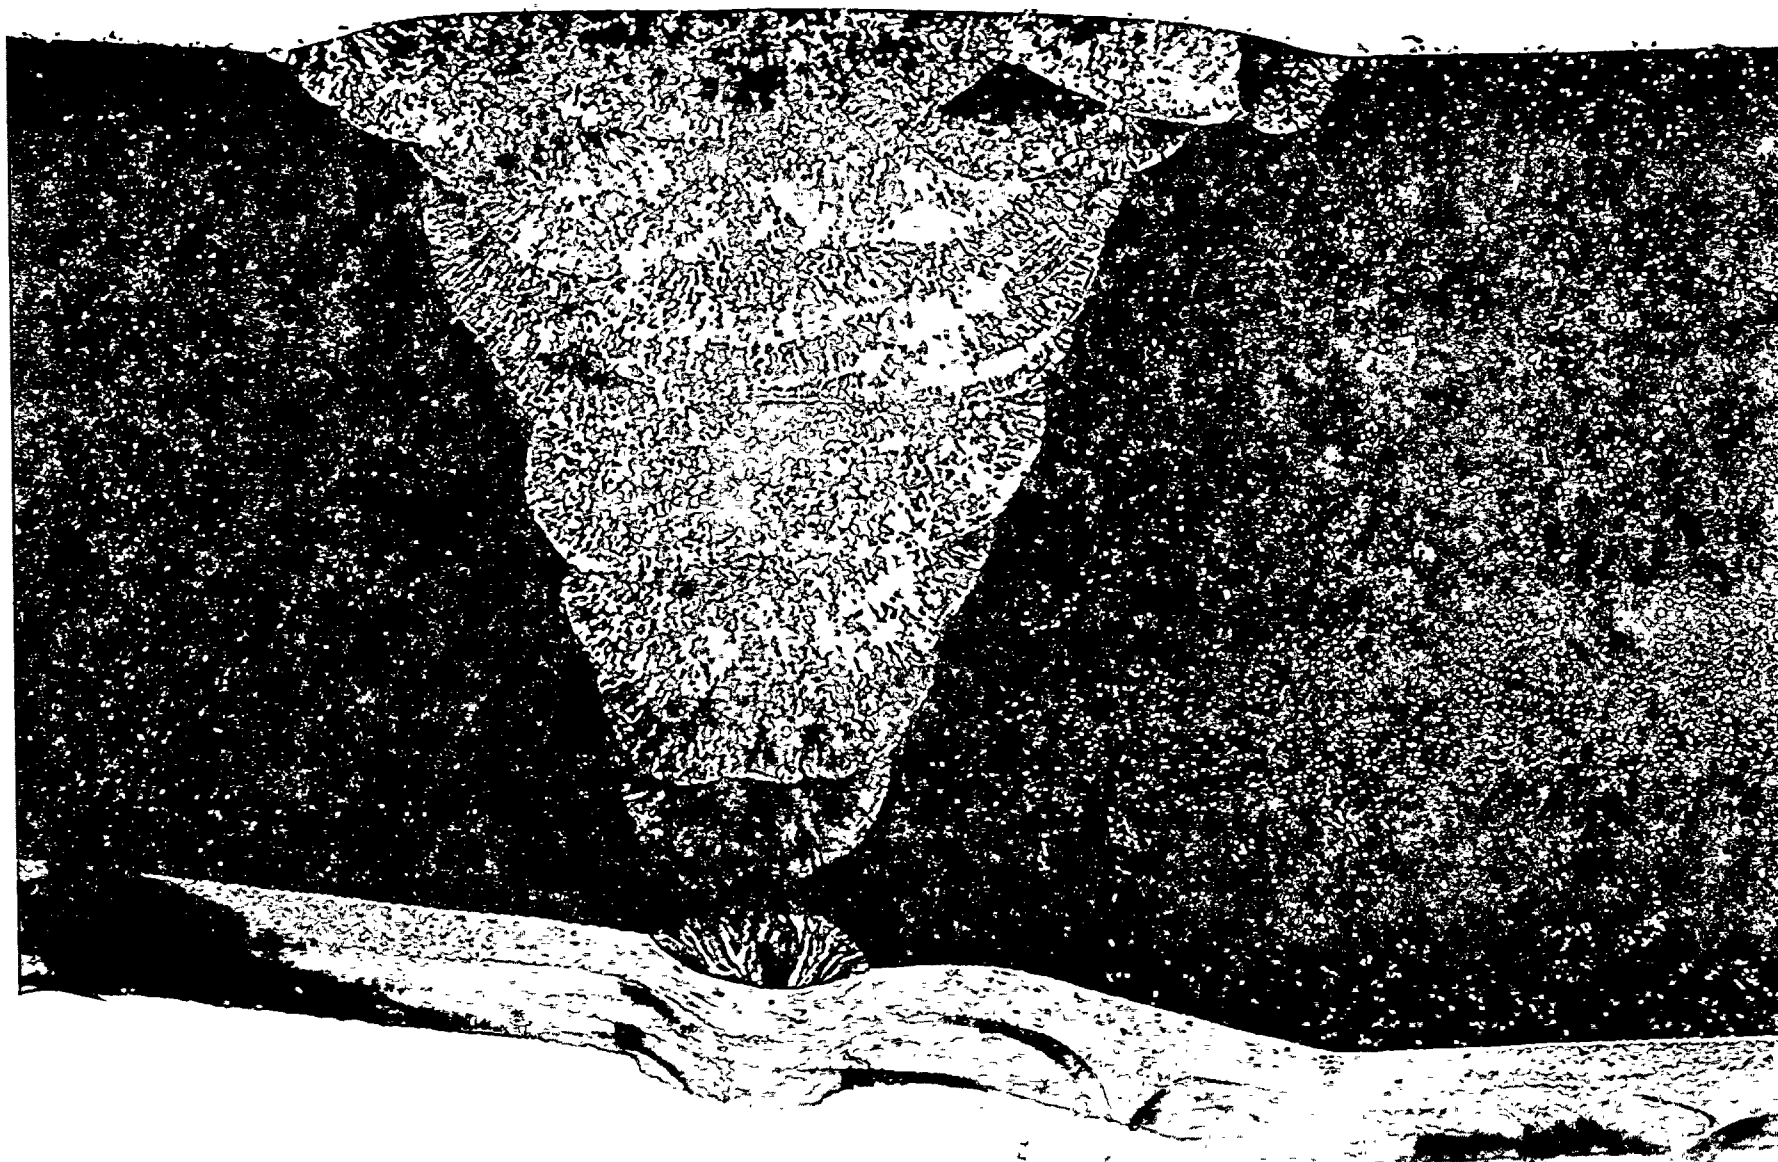
FIGURE 33. SAMPLE A4 SHOWING A CROSS-SECTION THROUGH THE SAFE-END-TO-ELBOW WELD. NO CRACKS WERE OBSERVED IN THIS SAMPLE.

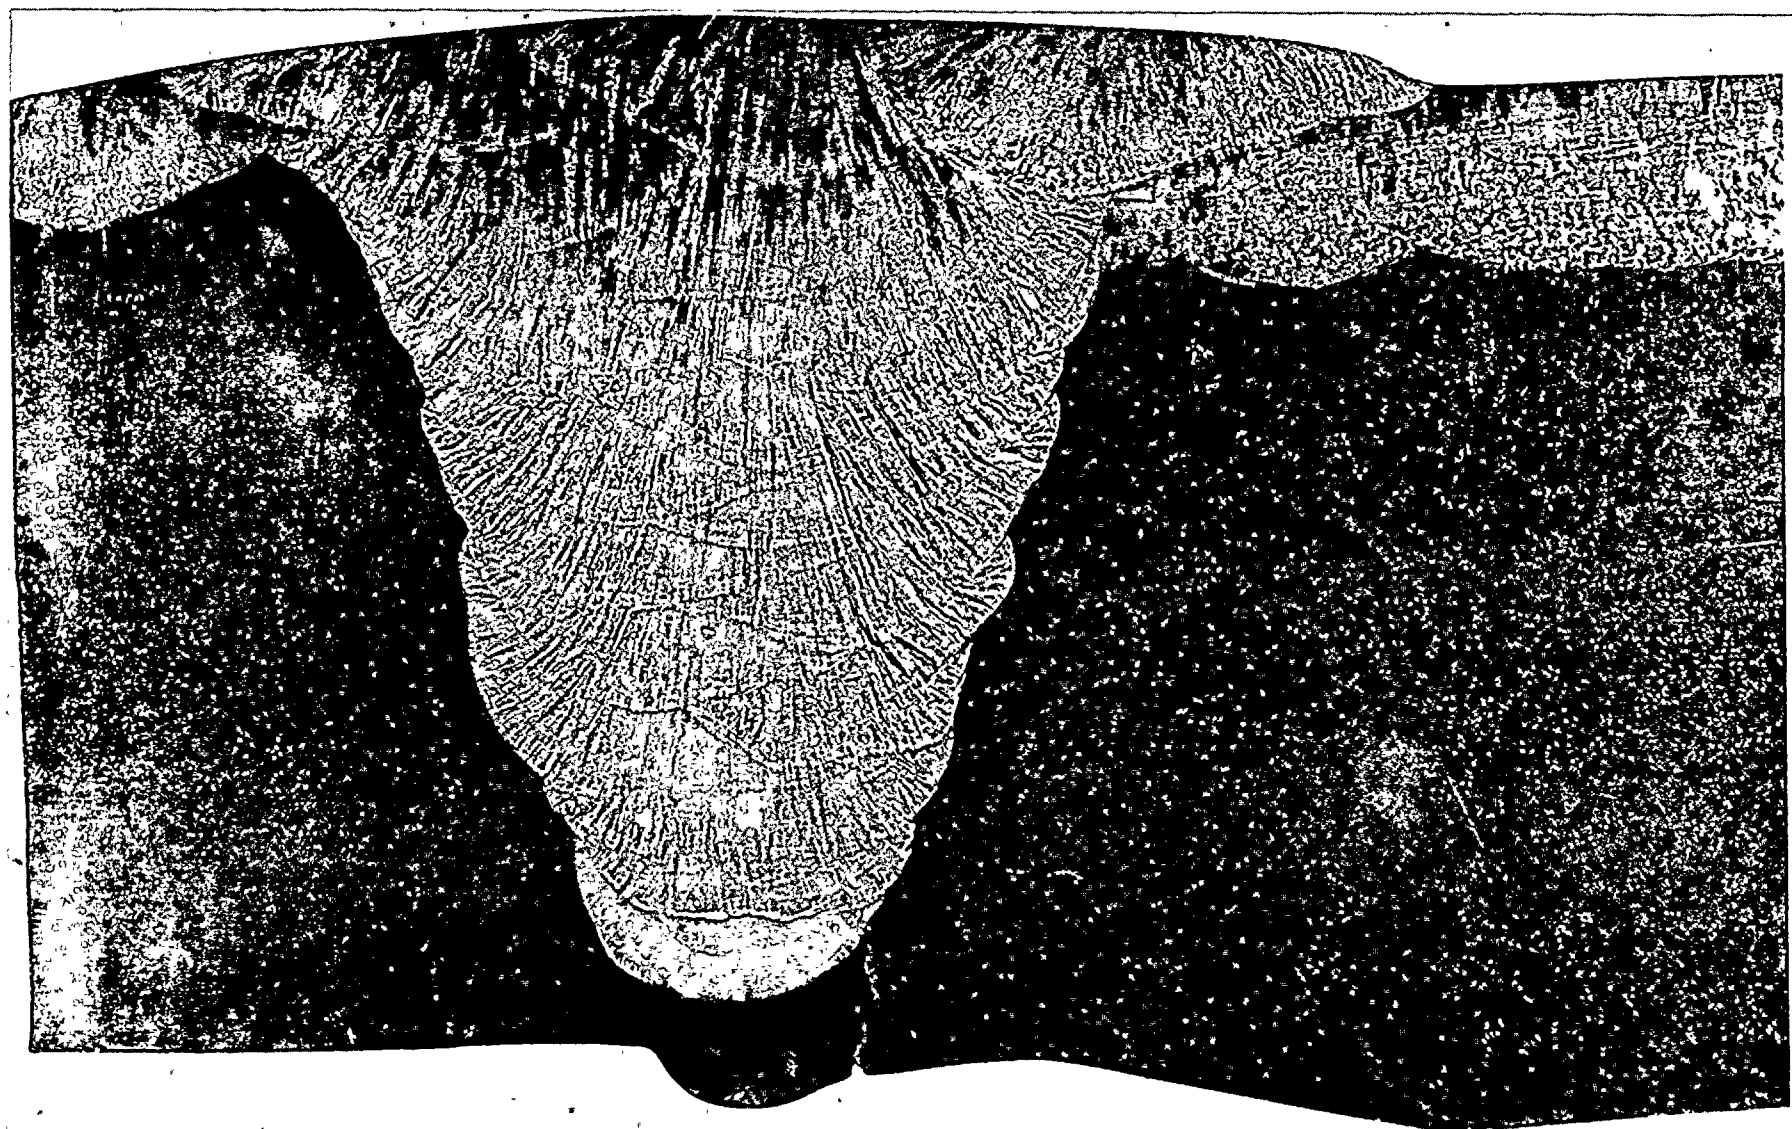
FIGURE 34. SAMPLE B1 SHOWING A SHORT CRACK NEAR THE WELD ROOT ON THE PIPE SIDE OF THE WELD.

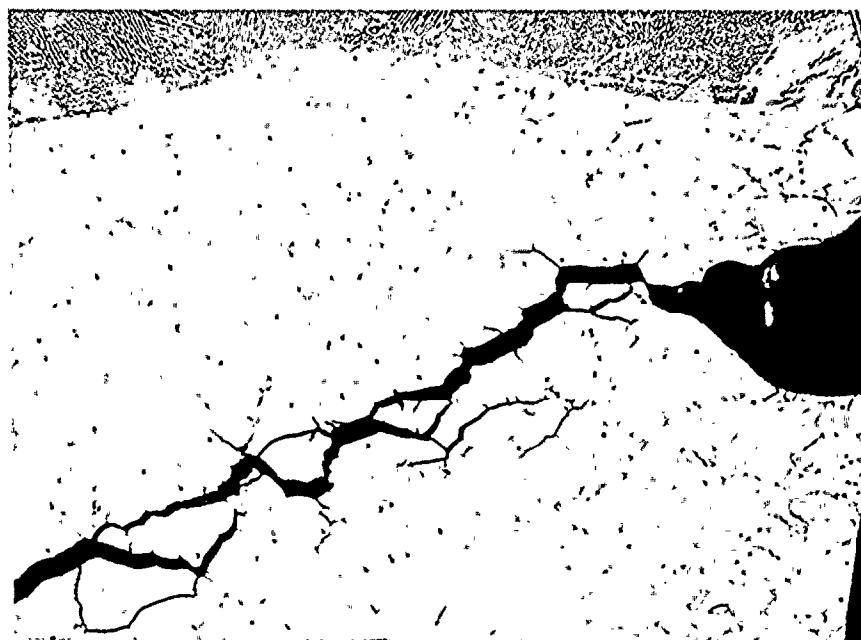
Figure 38. Etched
Crack on elbow side - Boat Sample C.

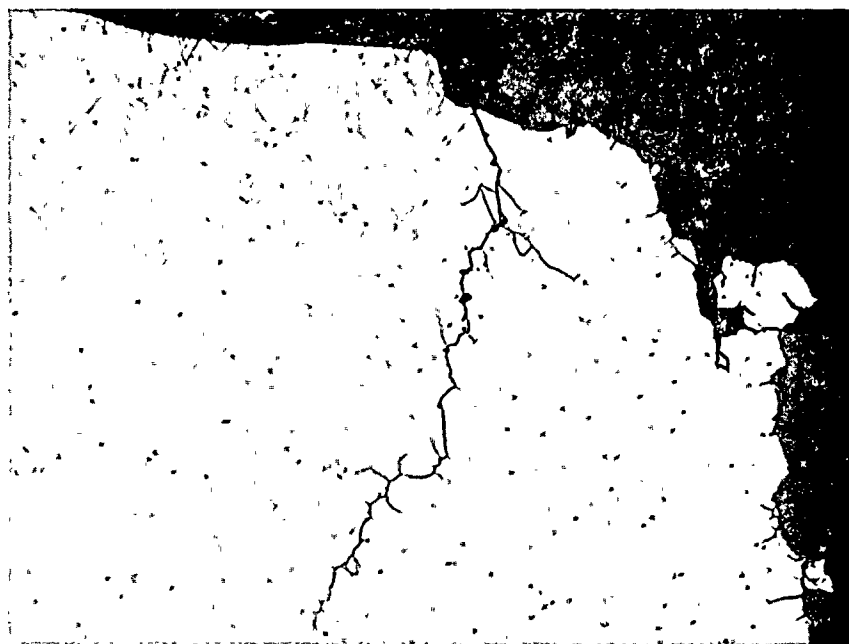
Figure 43. Etched view of Sample D, containing portion of fracture, and adjacent crack. 33X

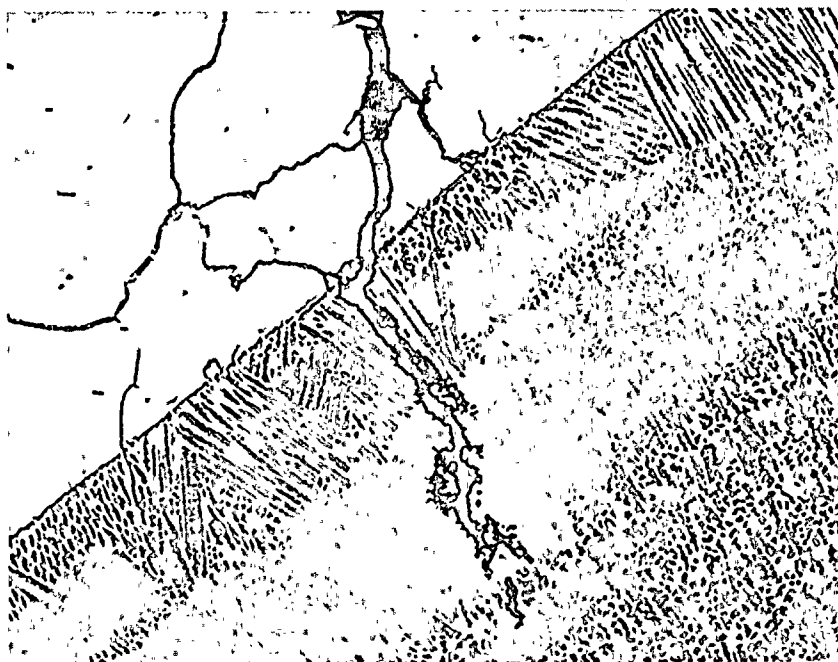
Figure 54. Kahling etched view of crack extending into weld. This view shows crack arrest in weld metal containing significant ferrite.

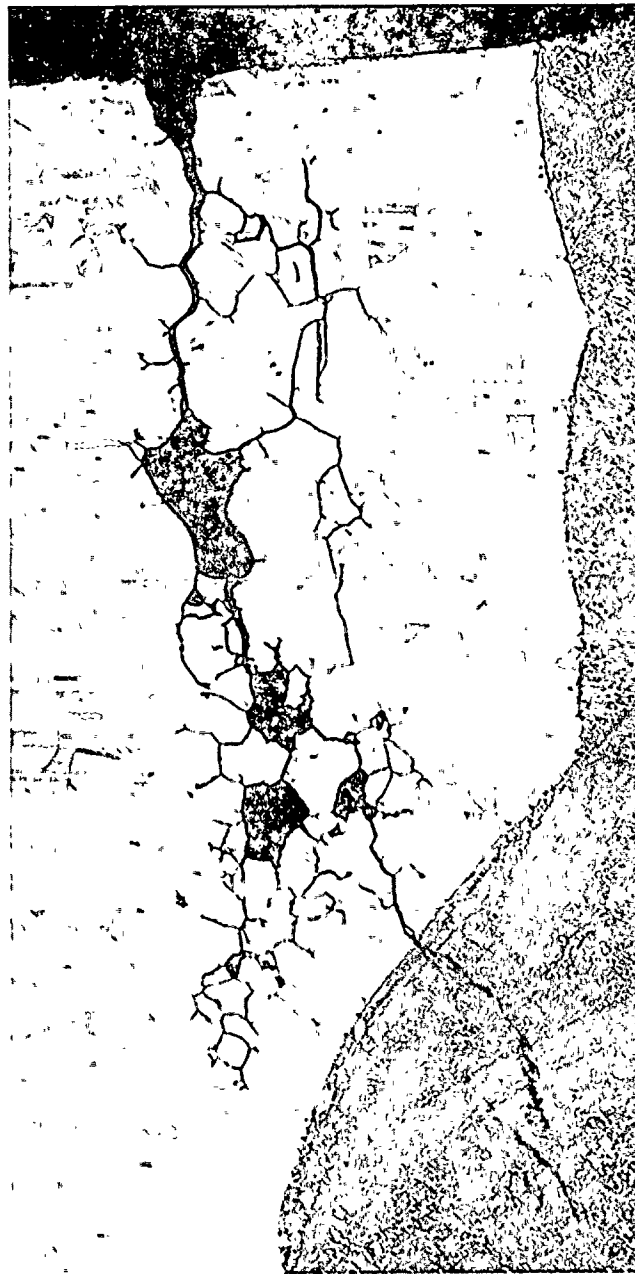
Figure 56. Etched view crack in pipe side. Sample was removed from shop weld SW-12 of Loop 15.

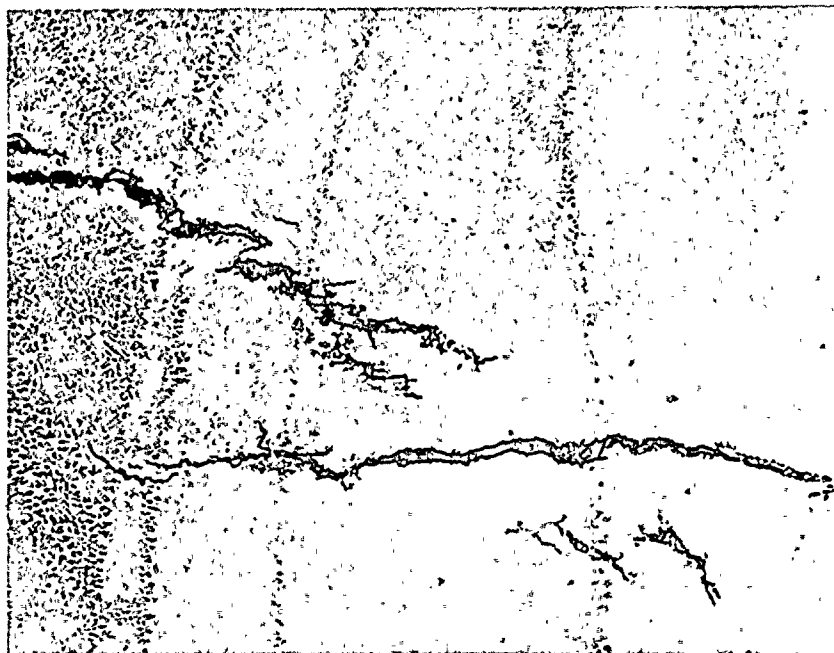
Figure 58. Kahling etched view of end of crack
of Figure 56.

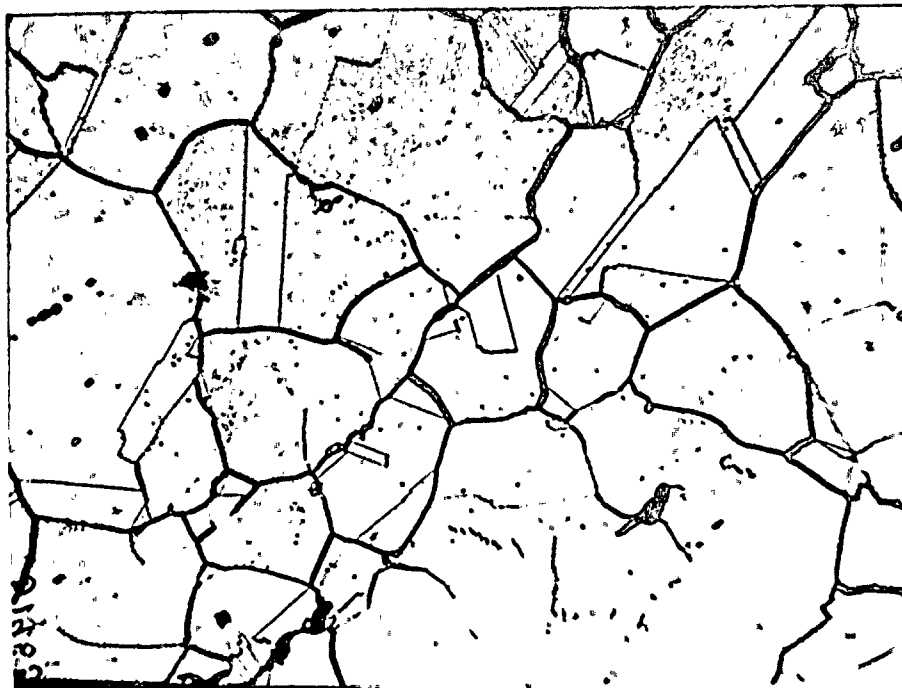
Figure 60. Dark field view of pipe side HAZ, showing carbides precipitated at grain boundaries.

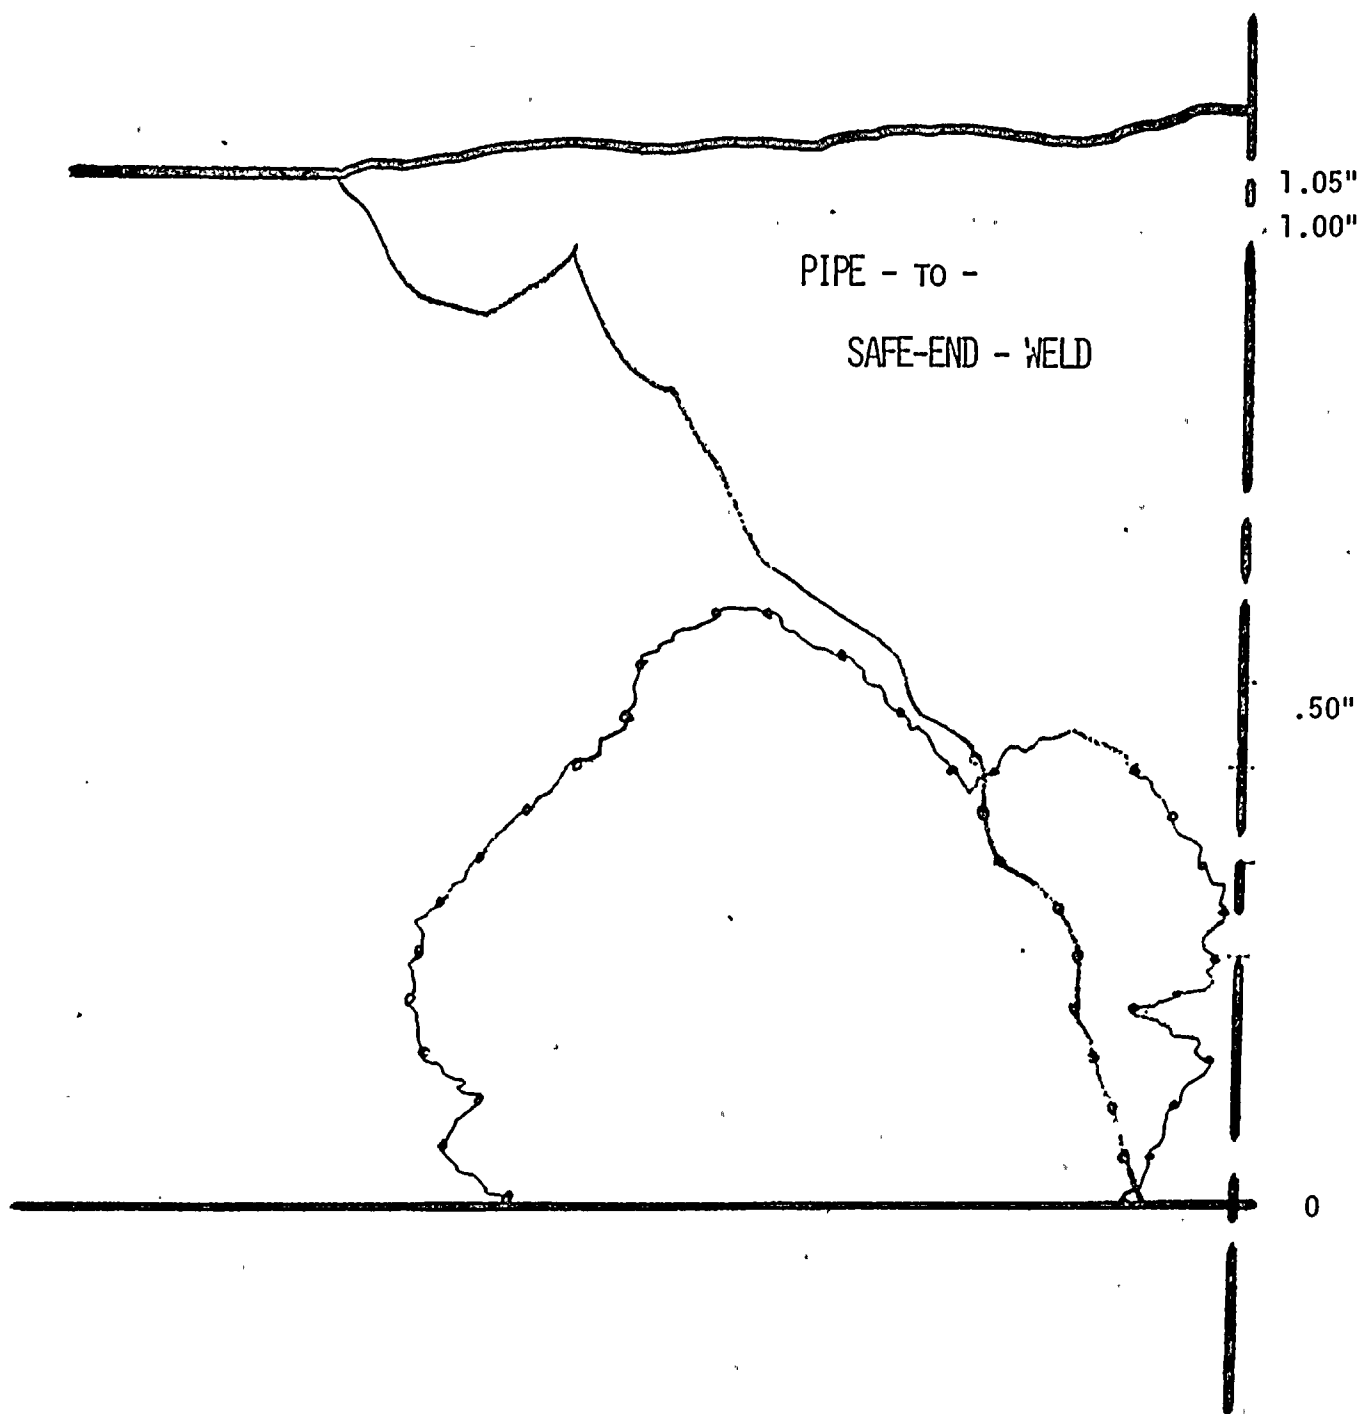
Figure 17. Profile of axial IGSCC crack #1 (of Figure 16) removed from the safe end side of safe-end-to-pipe weld FW-22 of NMP-1 recirculation loop 11. The crack, with a maximum depth of approximately 59% wall, is situated entirely below the weld crown. This crack would not have been a reportable indication as a result of the 1981 ISI examination.

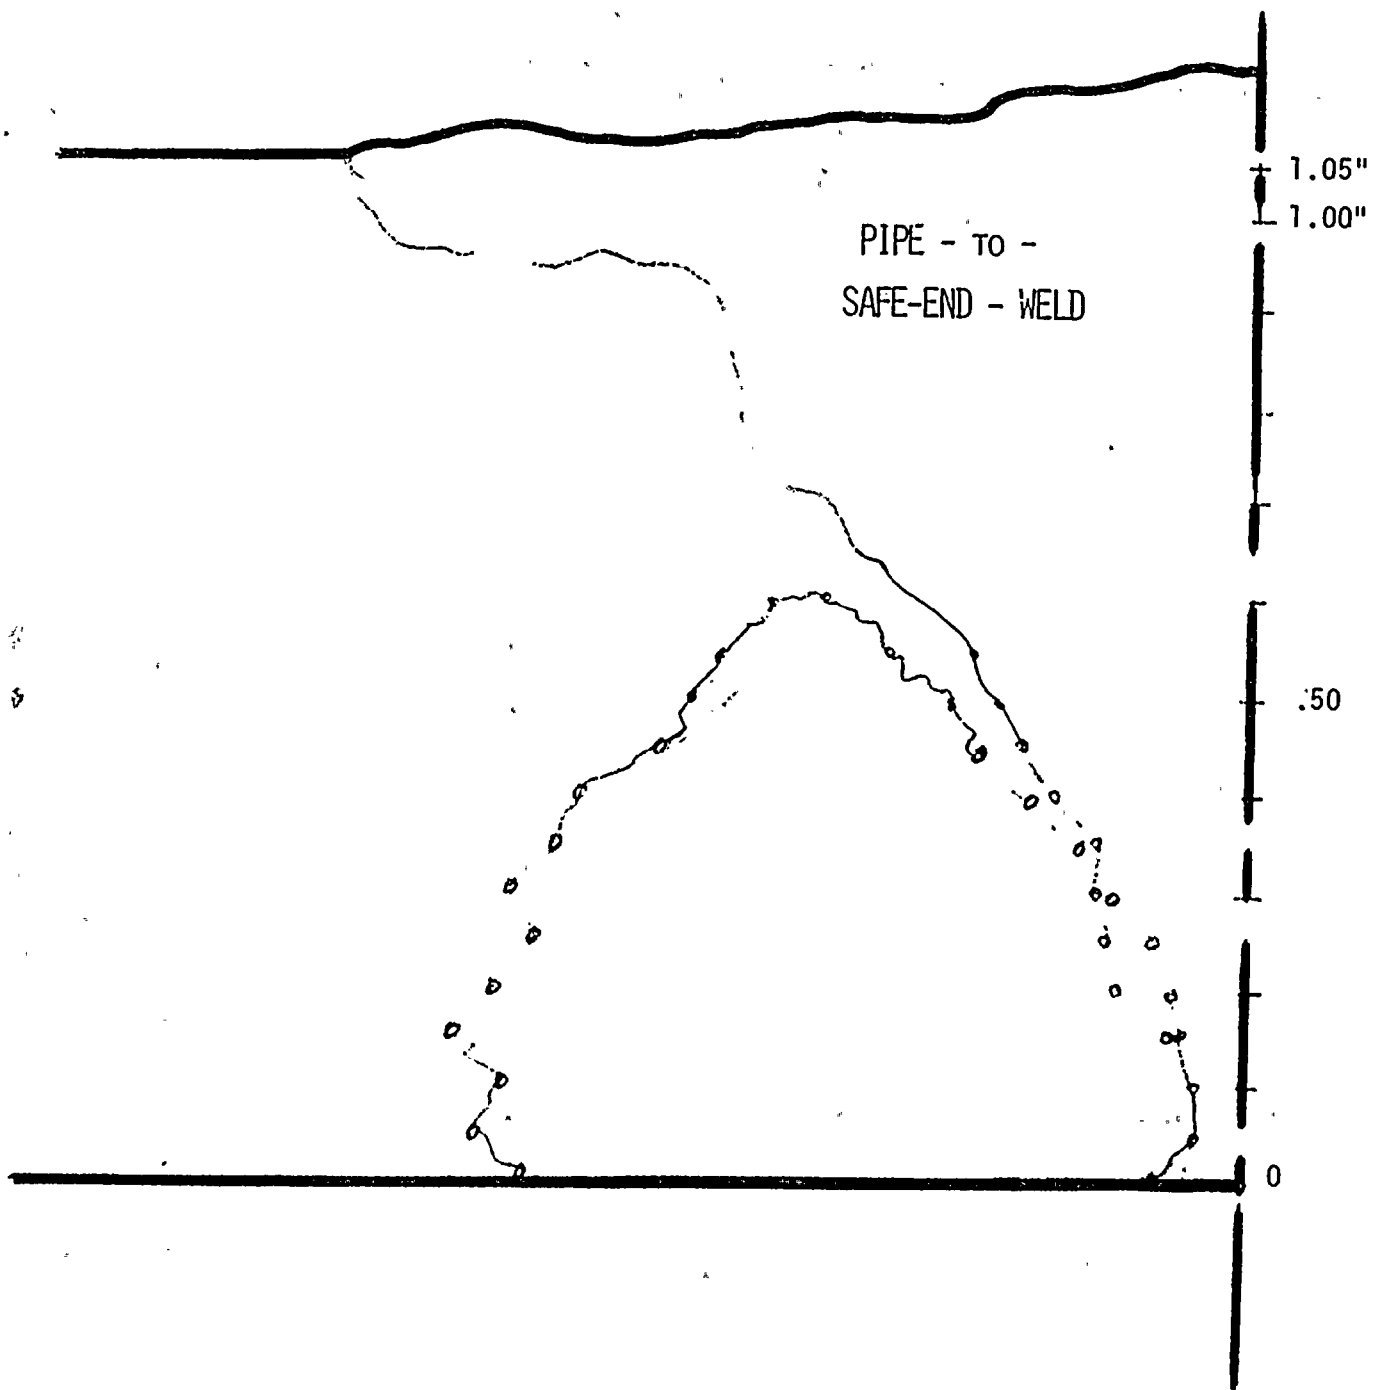
Figure 18. Profile of axial IGSCC crack #4 (of Figure 16) removed from the safe end side of safe-end-to-pipe weld FW-22 of NMP-1 recirculation loop 11. This crack, with a depth of approximately 58% wall would have been marginally detectable with the ISI procedures used in the 1981 examination.
