From: Orlando, Dominick
Sent: Monday, January 22, 2018 5:46 AM
To: 'Denny, Angelita'
Cc: Bush, Richard; Tyrrell, Evan (CONTR); Koenick, Stephen; Arlt, Hans
Subject: RE: Mexican Hat Update

From: Denny, Angelita [mailto:Angelita.Denny@lm.doe.gov]
Sent: Monday, January 08, 2018 2:47 PM
To: Orlando, Dominick <Dominick.Orlando@nrc.gov>
Cc: Bush, Richard <Richard.Bush@lm.doe.gov>; Tyrrell, Evan (CONTR) <Evan.Tyrrell@lm.doe.gov>
Subject: [External_Sender] Mexican Hat Update
Importance: High

Per our conversation this morning, this email is written in response to the voicemail I left with you on December 21, 2017 pertaining to recent observations at the Mexican Hat, Utah, UMTRCA Title I Disposal Site.

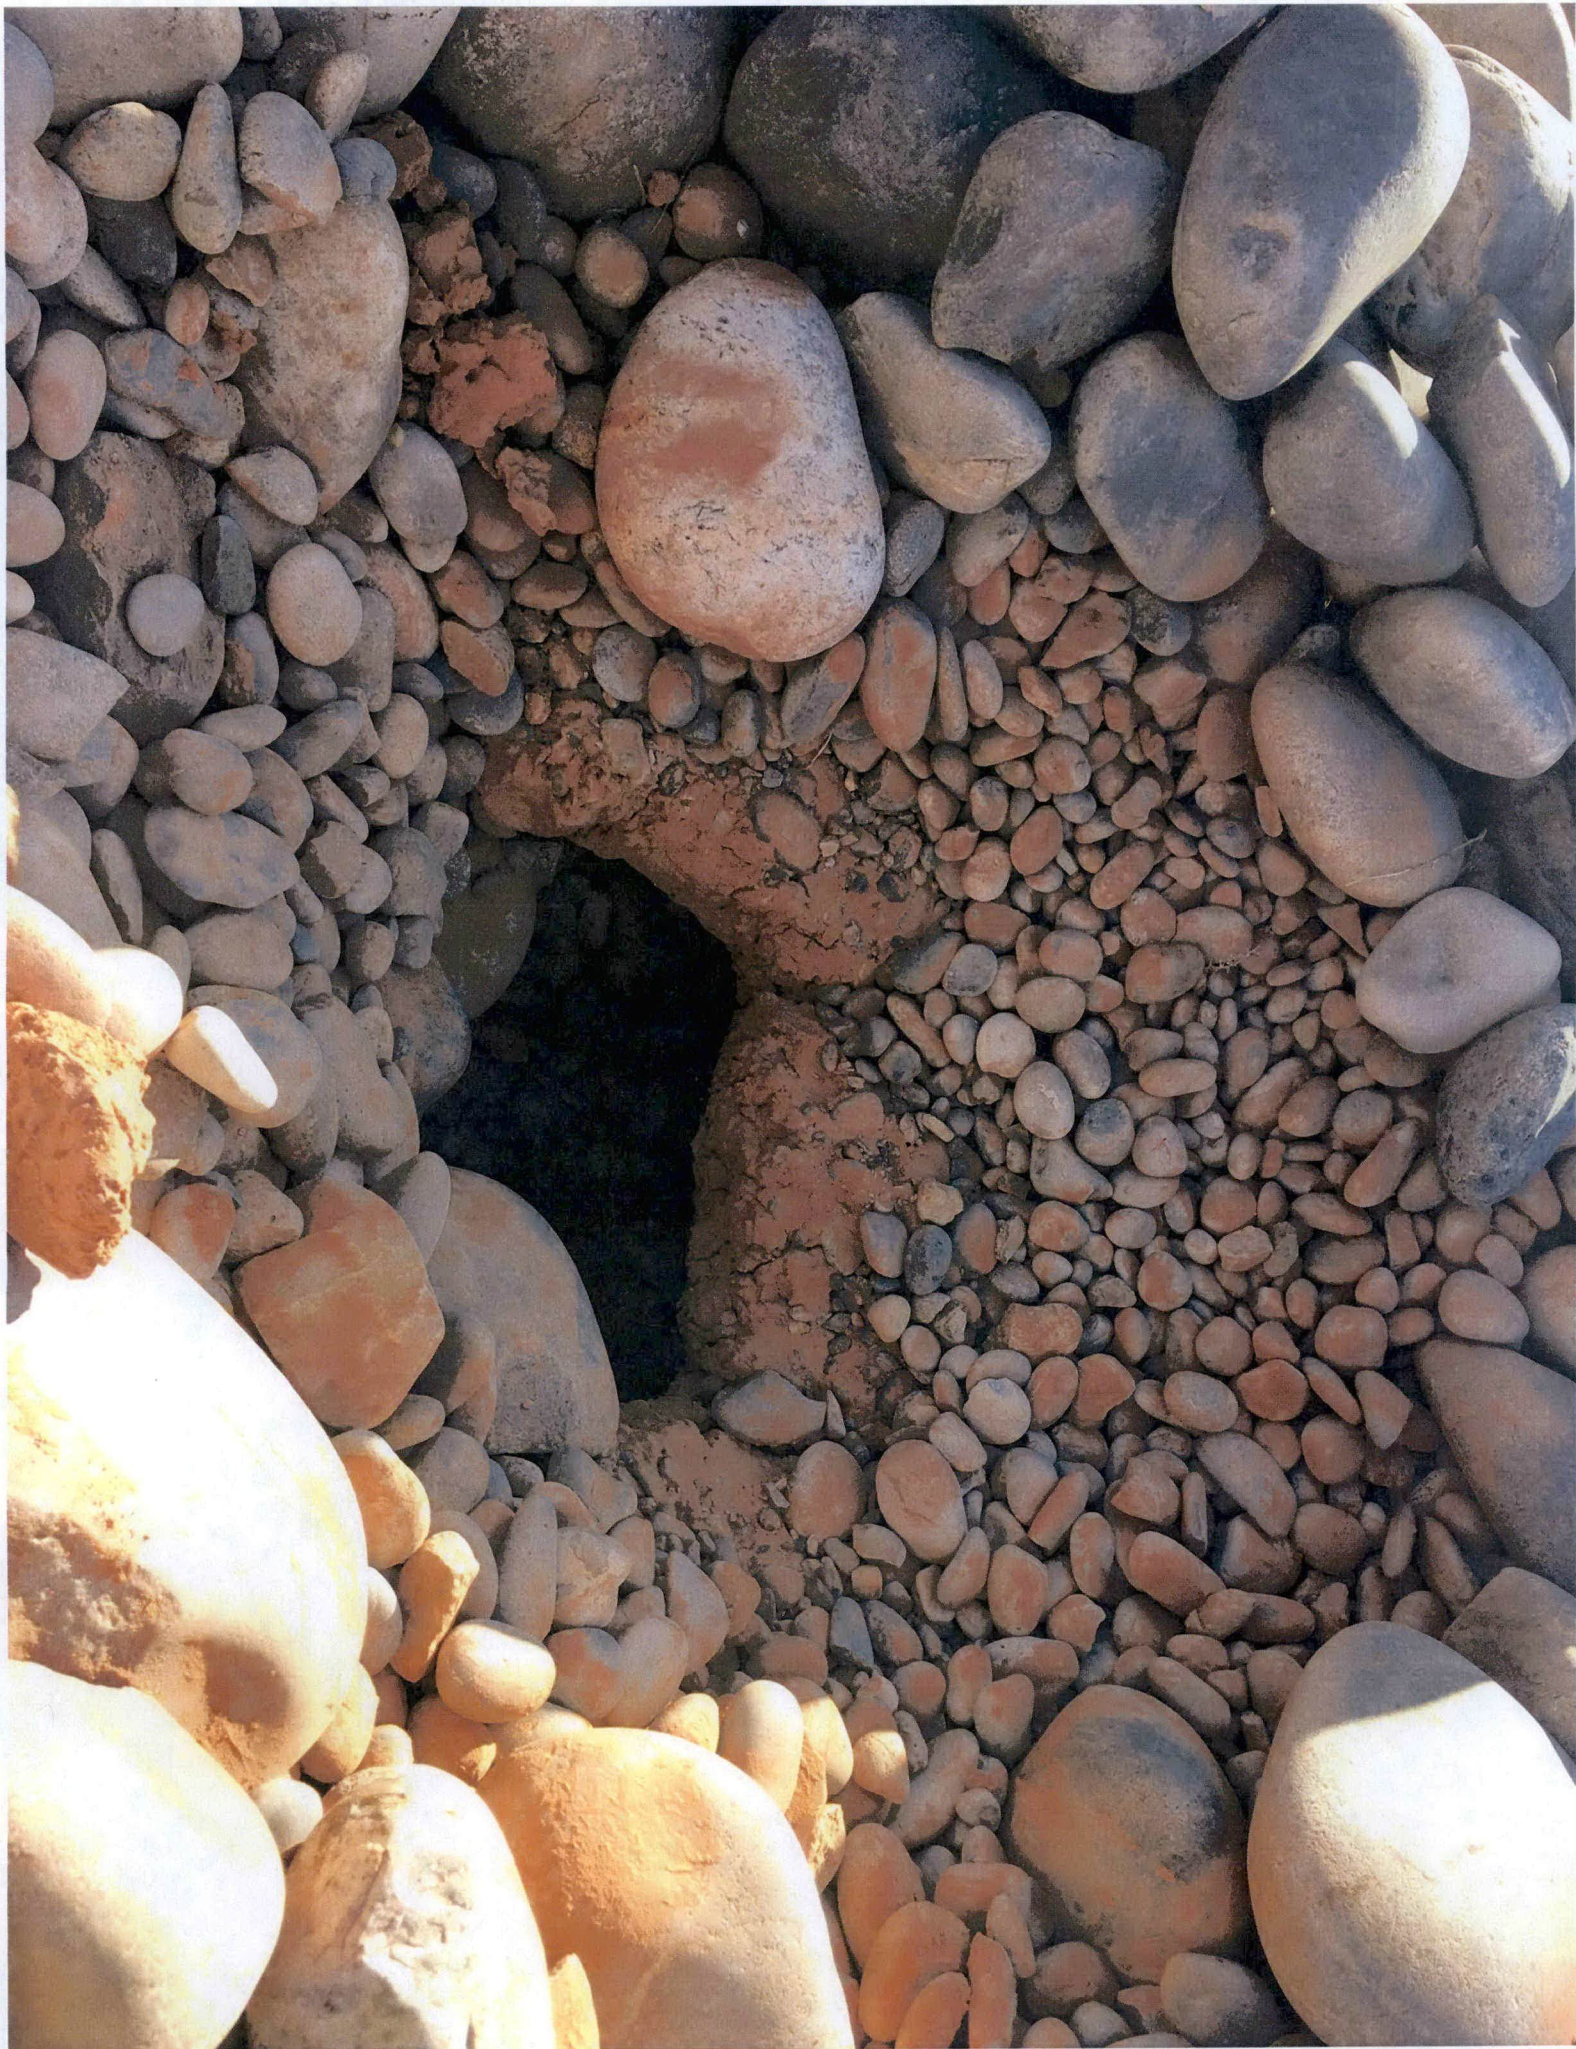
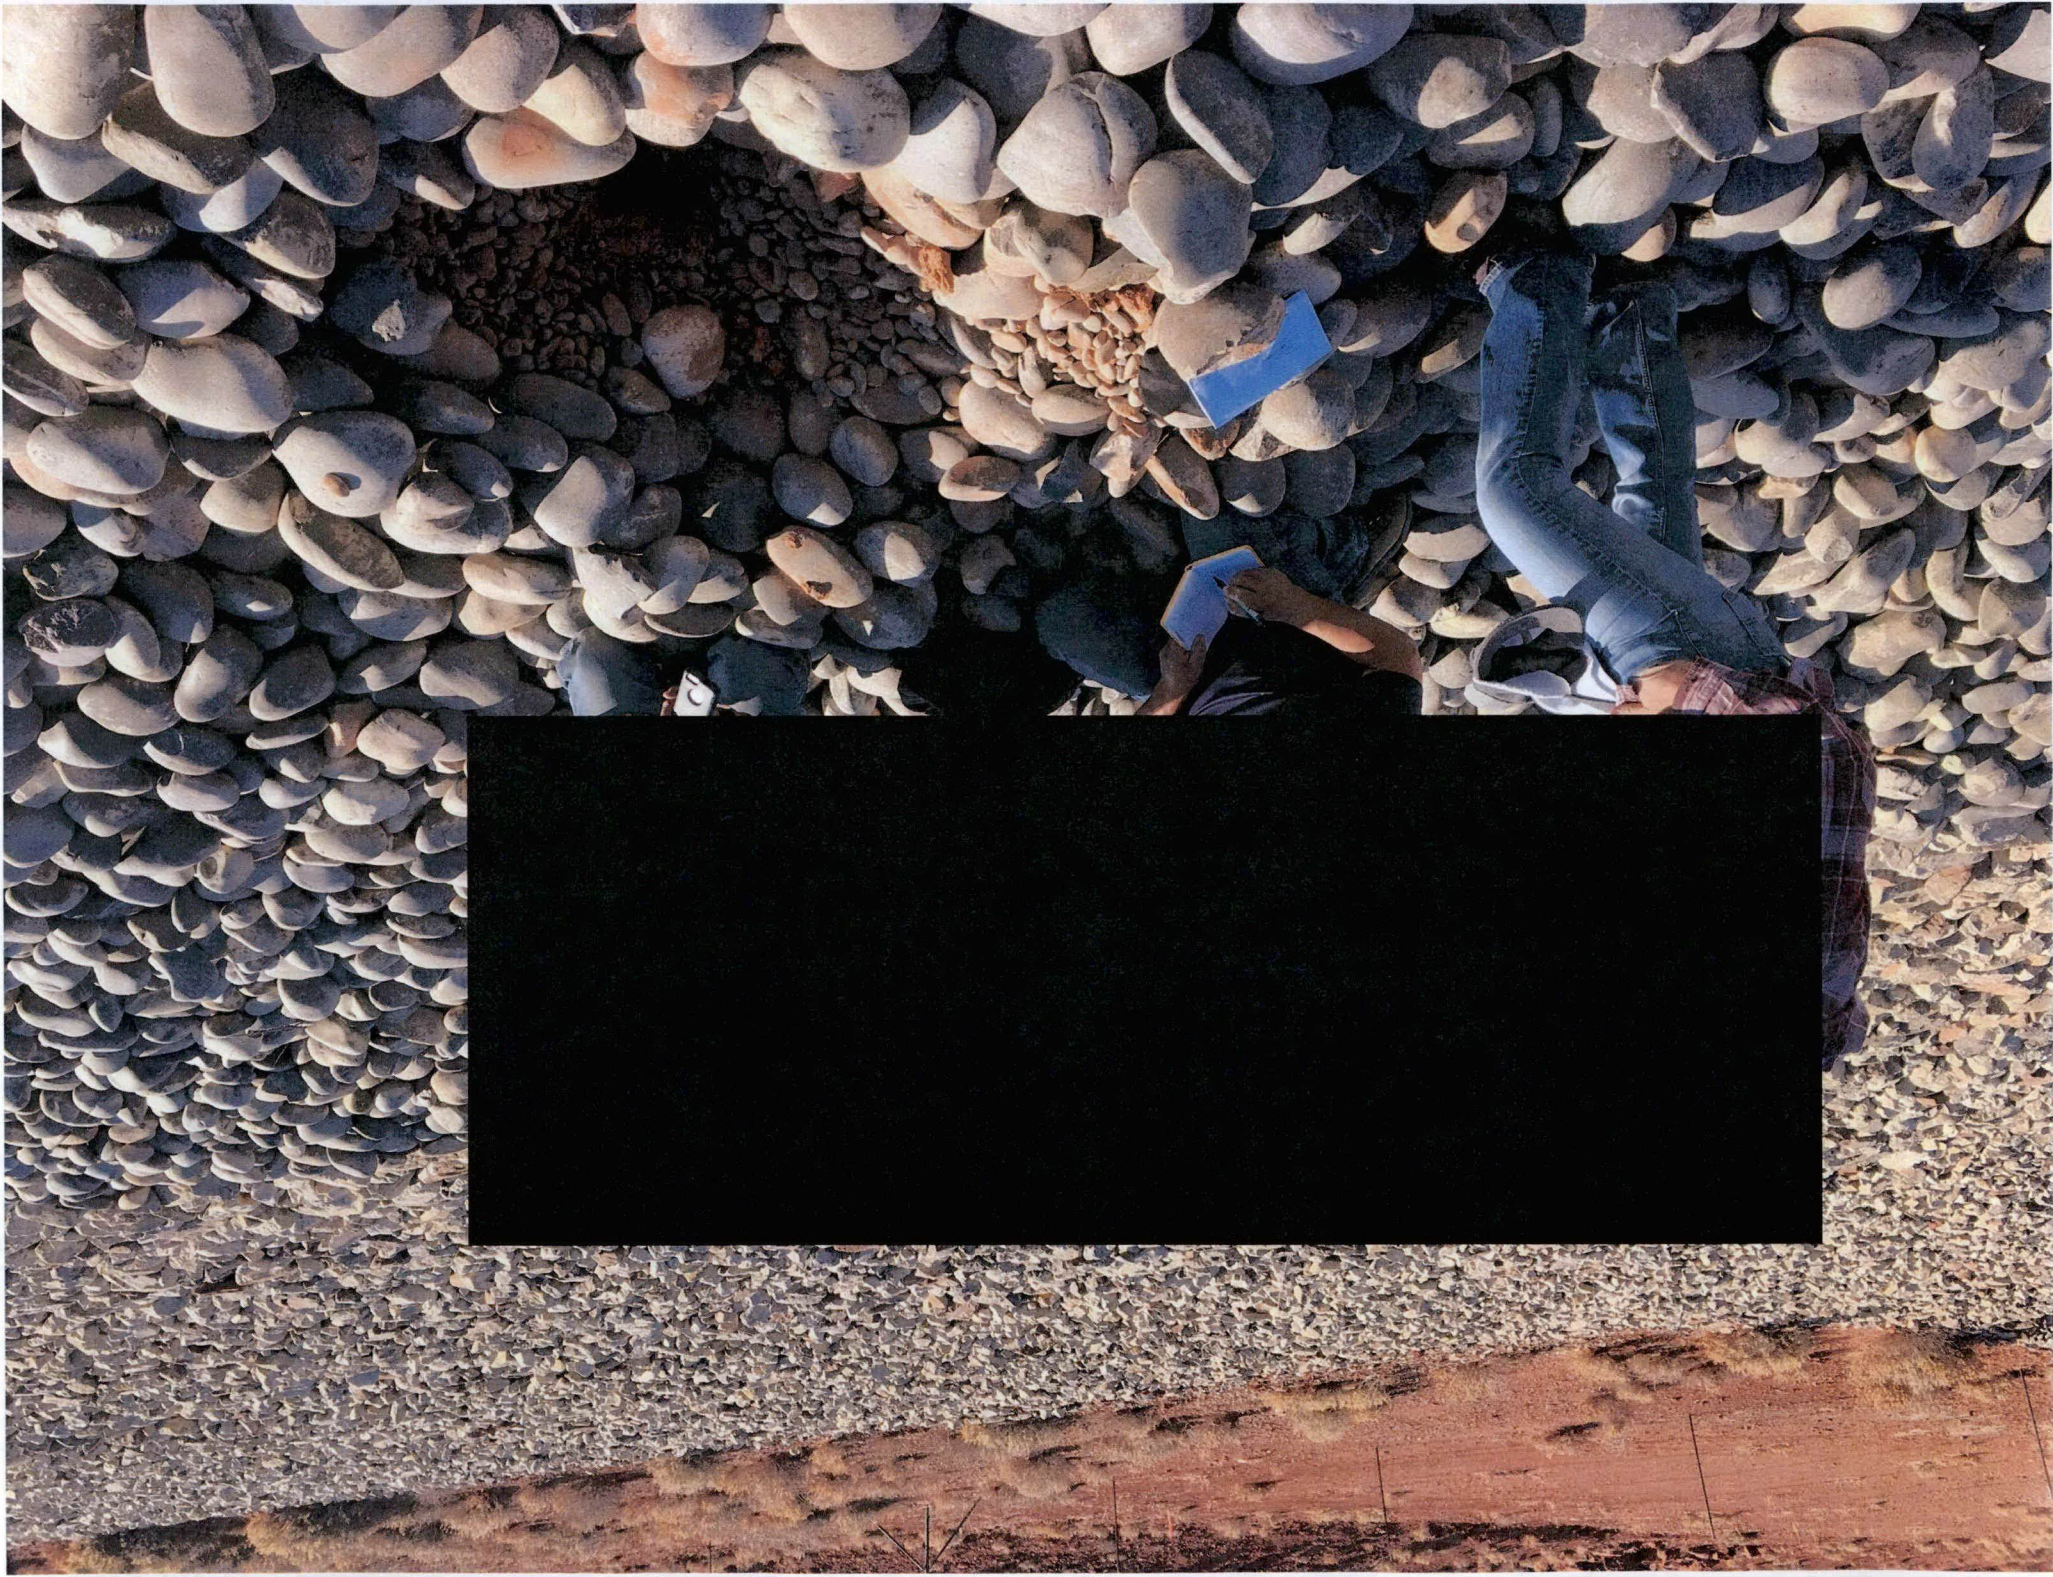
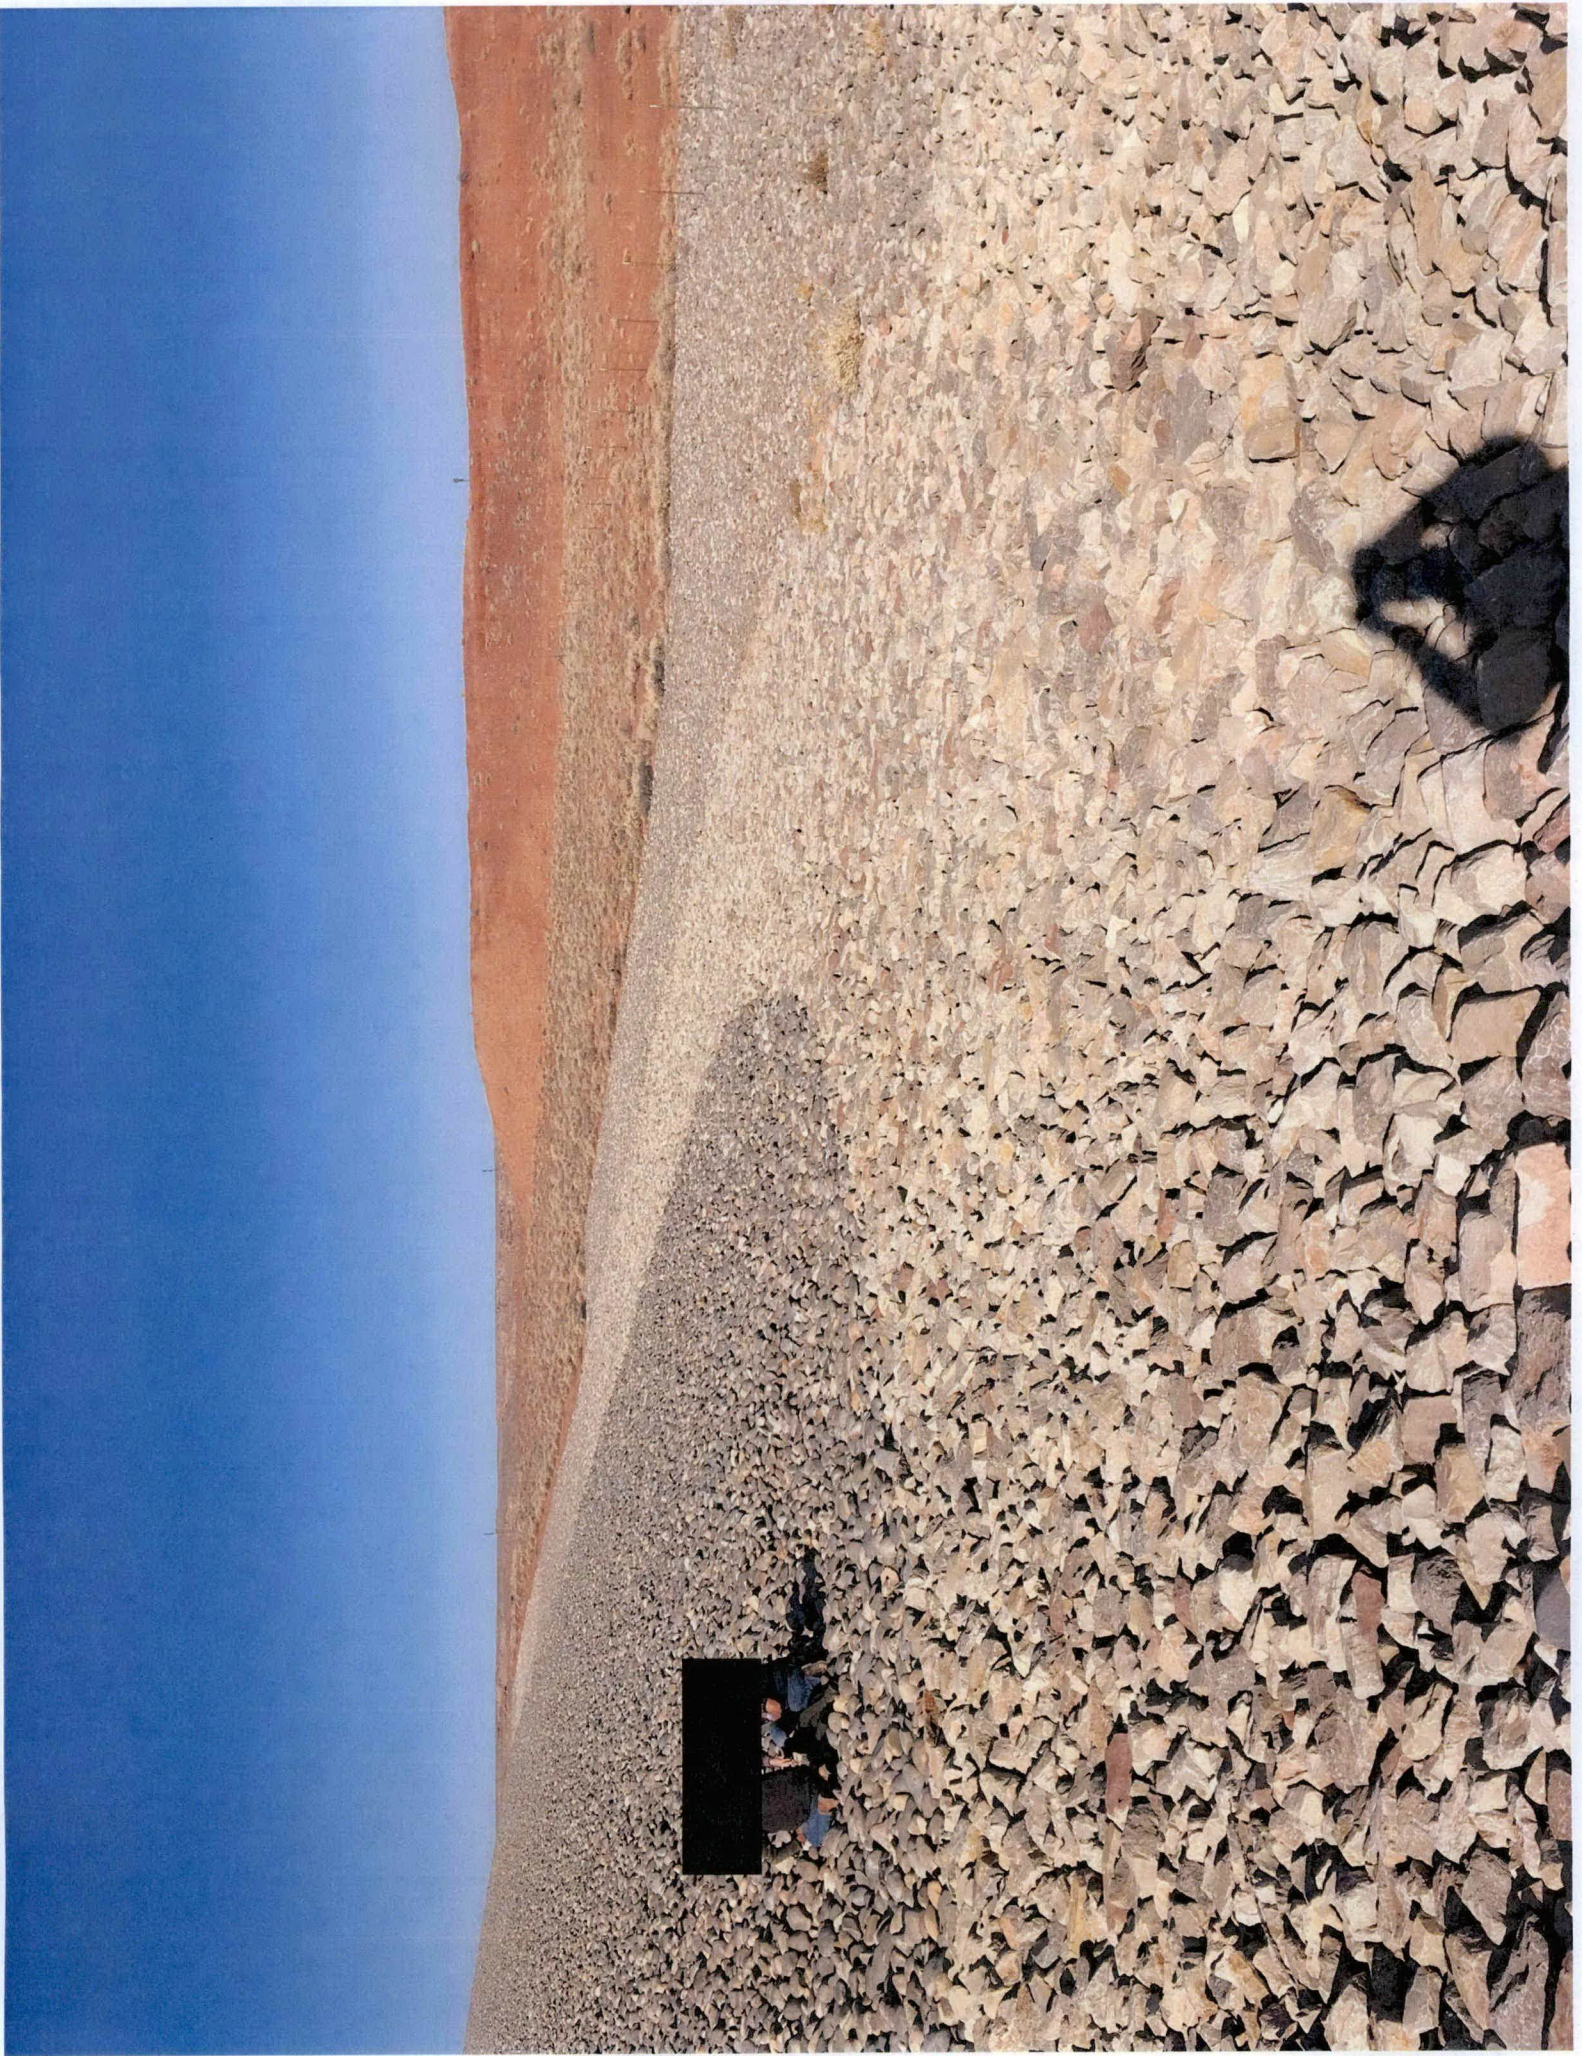
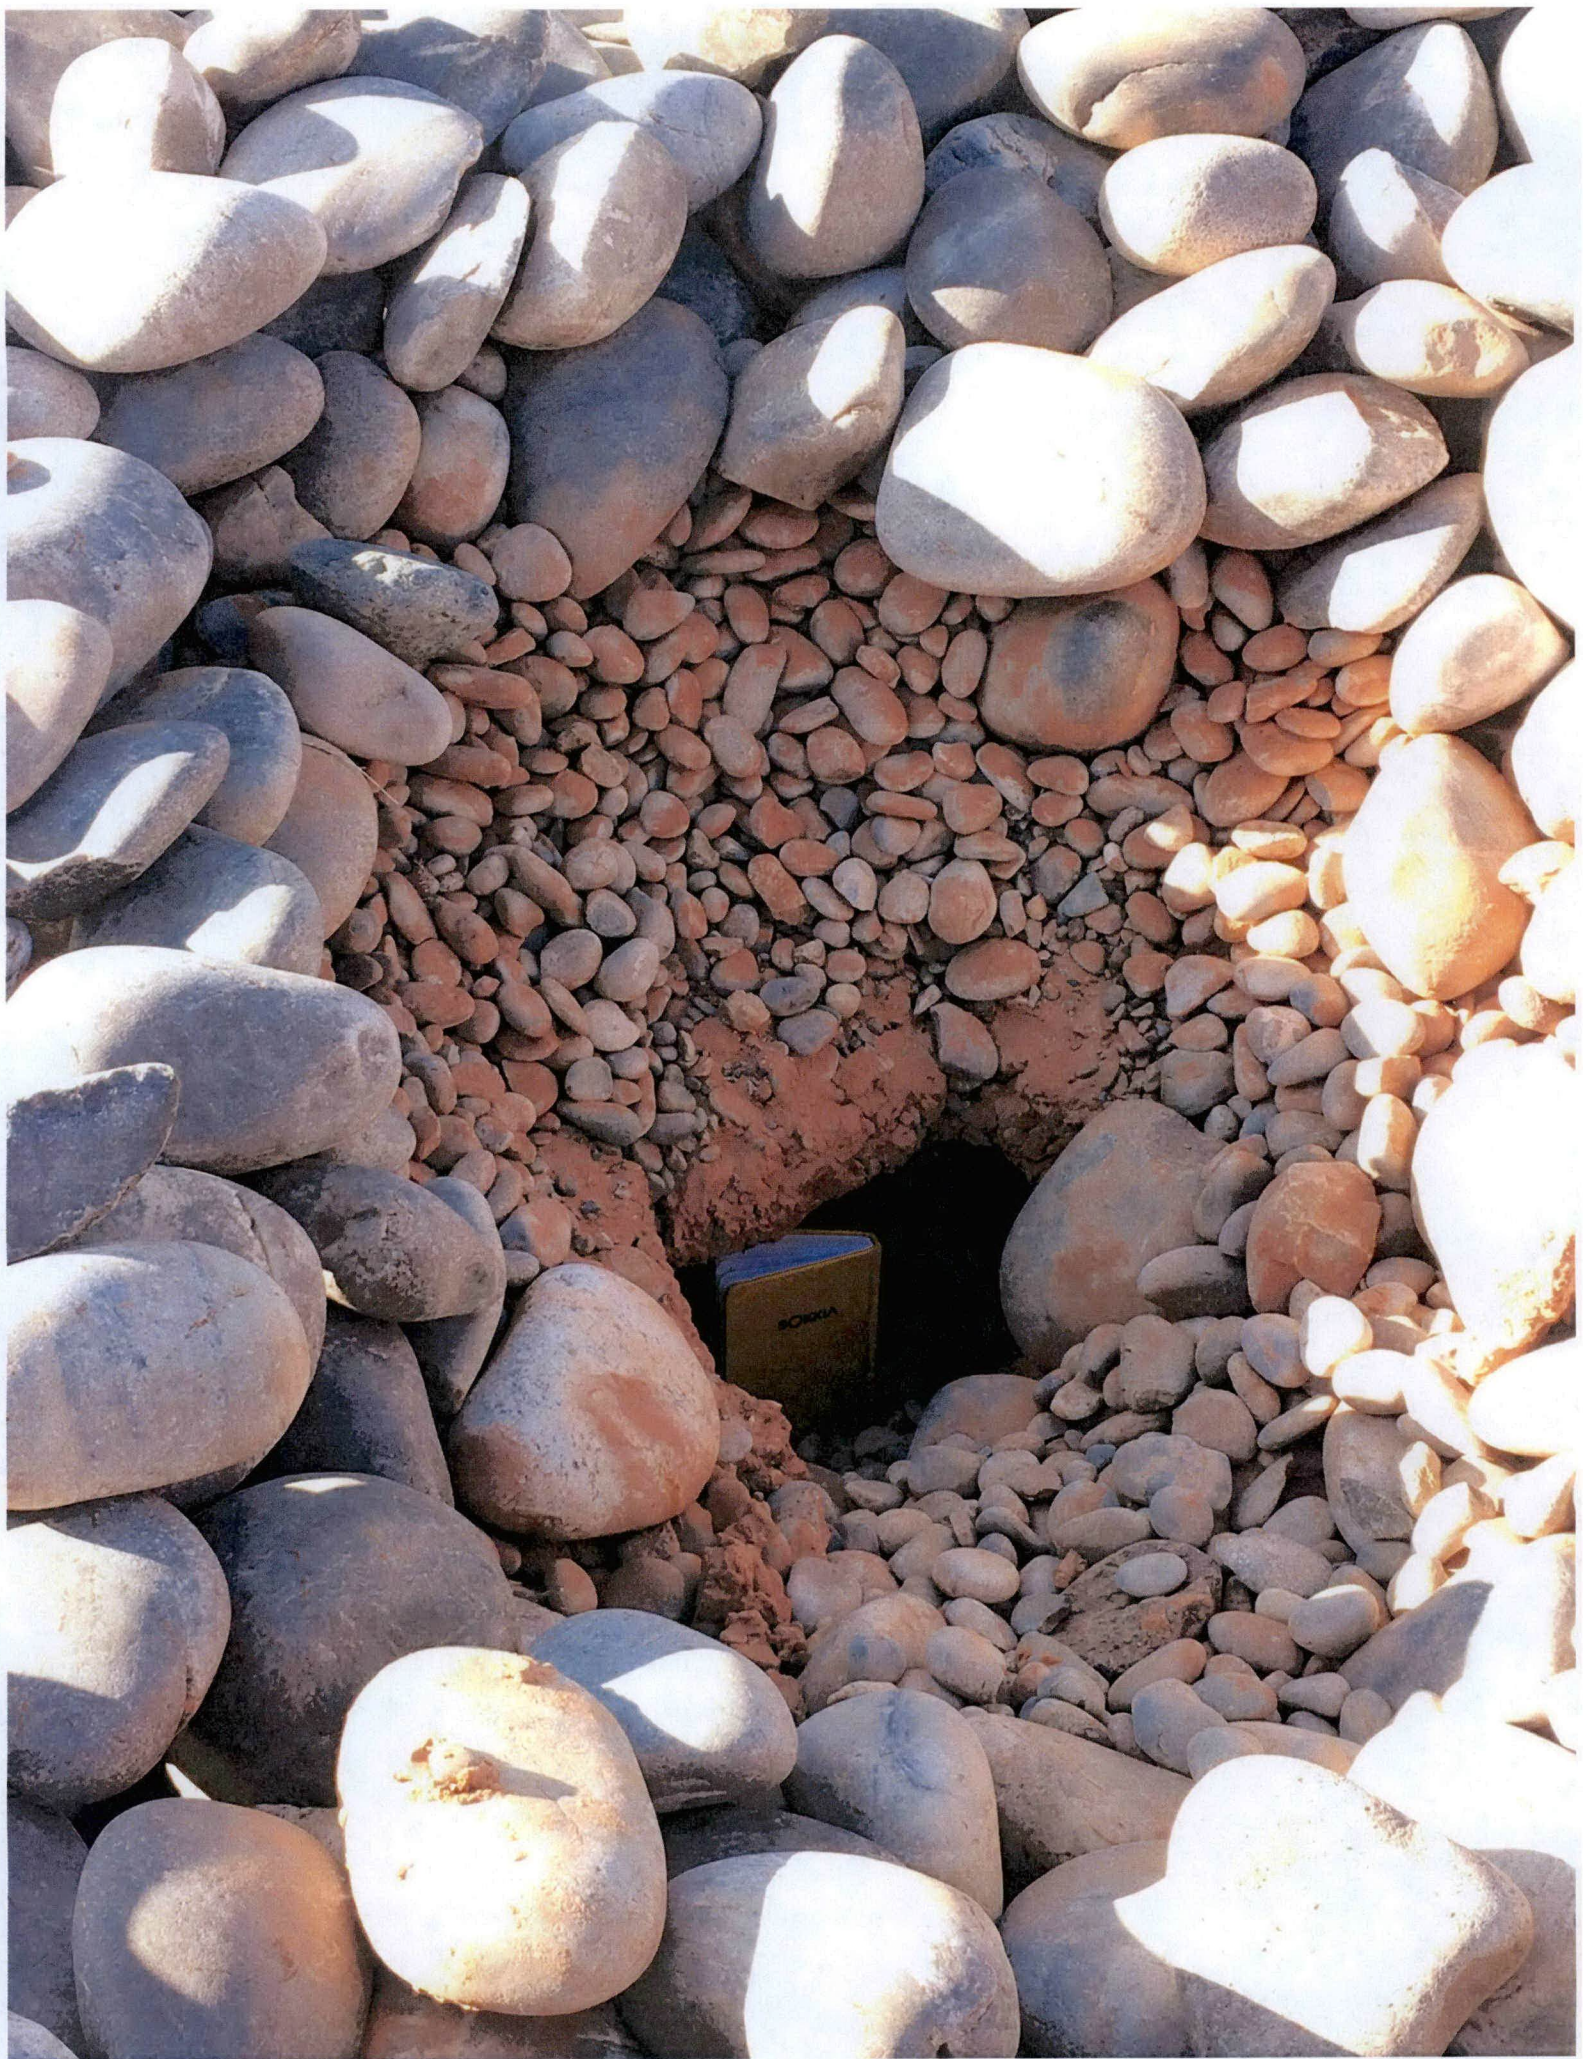
At one of the locations, a small void was observed at the apparent base of the bedding layer and upper portion of the radon barrier. The approximate dimensions of the void were 8 inches by 12 inches wide. The length of the void was unknown, but appeared to extend down slope along the interface of the bedding layer and radon barrier. However, there was no indication that the radon barrier had been breached; hand removal of cover components did not extend into the radon barrier. All removed riprap and bedding materials were ultimately replaced to restore the exposed areas.

Photographs of the void are attached. It appears that windblown materials have accumulated in the area of the observed void resulting in a cementitious layer at the base of the bedding layer that may be inhibiting interstitial flow through the bedding/filter layer, and creating a dam where runoff waters have caused bridging of the underlying materials and associated piping.

An additional site visit to further evaluate the observed void and to assess the potential for additional areas with similar features is planned for this week (January 8-10, 2018). A group of engineers and other SMEs will be visiting the site. Riprap and bedding layer cover components at a minimum of two locations will be removed by hand (down to the top of the radon barrier as practical) to assess the cover conditions beneath a few of the depression areas. One area will include the area where the void was recently discovered. Additionally, cover components in an area that does not visually exhibit surface distress will be removed by hand as a control point to evaluate the underlying cover components to compare to areas where depression

features are evident. All removed riprap and bedding materials will be replaced to restore the exposed areas during this site visit.
