# THE PENNSYLVANIA STATE UNIVERSITY

RE: 44 Fed. Reg. 50925  
Abnormal Occurrence Event

### Abnormal Occurrence Event; Damage to New Fuel Assemblies

### Abnormal Occurrence Event; Indication of Low Water Level in a Boiling Water Reactor

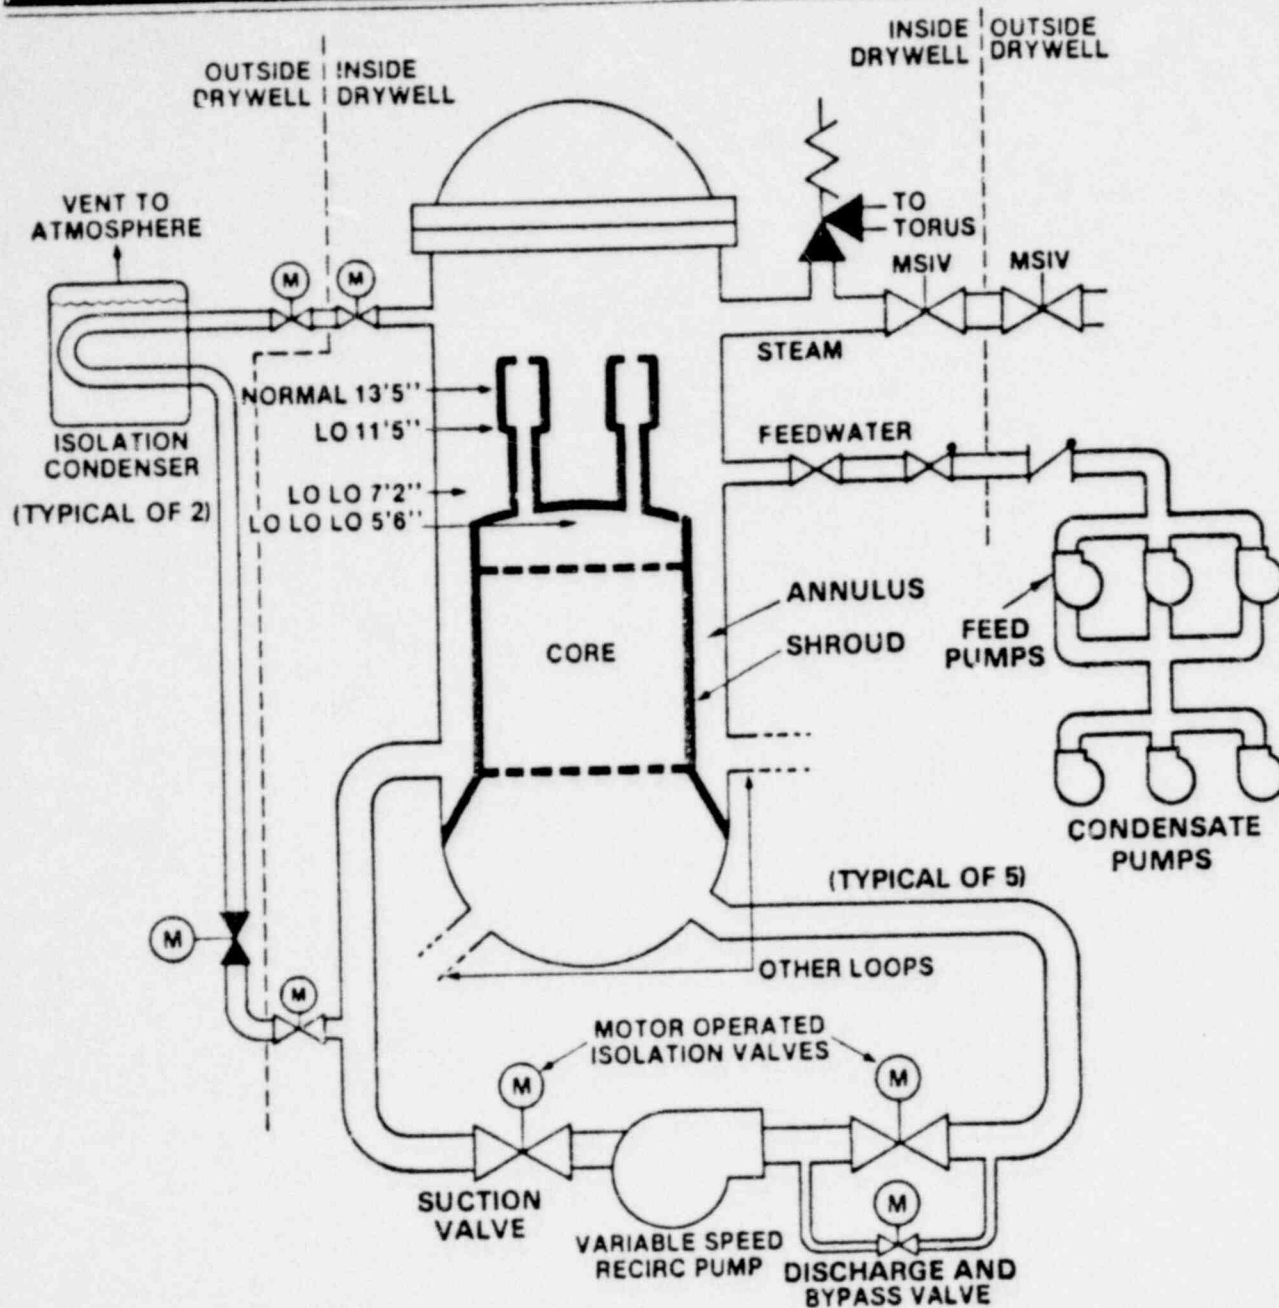
Figure 1. RECIRCULATION, STEAM AND ISOLATION CONDENSER SCHEMATIC

After closure of the MSIV, an isolation condenser was manually placed in service for core decay heat removal. The isolation condenser was condensing steam from the core and returning the condensate to the reactor annulus through a connection to a recirculation loop pump suction line (Figure 1). At approximately a minute and a quarter after the reactor scram, the discharge valves in "A" and "E" recirculation loops were closed in accordance with a Standing Order that was in effect. Closing the "A" and "E" loop discharge valves had been necessary to prevent inadvertent stopping of the isolation condenser due to forced flow from operating recirculation pumps being sensed as if it were an isolation-condenser line break. (This Standing Order was no longer appropriate since an ATWS modification had been made that tripped the recirculation pumps coincident with high-pressure or low-level scrams. The necessary procedure change had not been performed following the plant modification.) At the same time, the "B" and "C" loop discharge valves were apparently closed, in anticipation of restarting the recirculation pumps. The "D" loop discharge valve had been closed prior to the event because the associated pump was out of service.

The triple-low level in the core shroud area resulted from the restriction of the flow path between the annulus and the core region by closure of all recirculation pump discharge valves. With the recirculation pump discharge valves closed (discharge piping is over 2 feet in diameter), the only flow path back to the core region was via the 2-inch bypass lines around the discharge valves. The effect of this flow restriction was to reduce the water level in the core region and to increase the level in the reactor annulus area.
