UNITED STATES OF AMERICA  
NUCLEAR REGULATORY COMMISSION

AFFIDAVIT OF LESLIE A. BOWEN

Subject: Byron Station Units 1 and 2  
Braidwood Station Units 1 and 2  
Waterhammer Prevention  
NRC Docket Nos. 50-454, 50-455,  
50-456 and 50-457

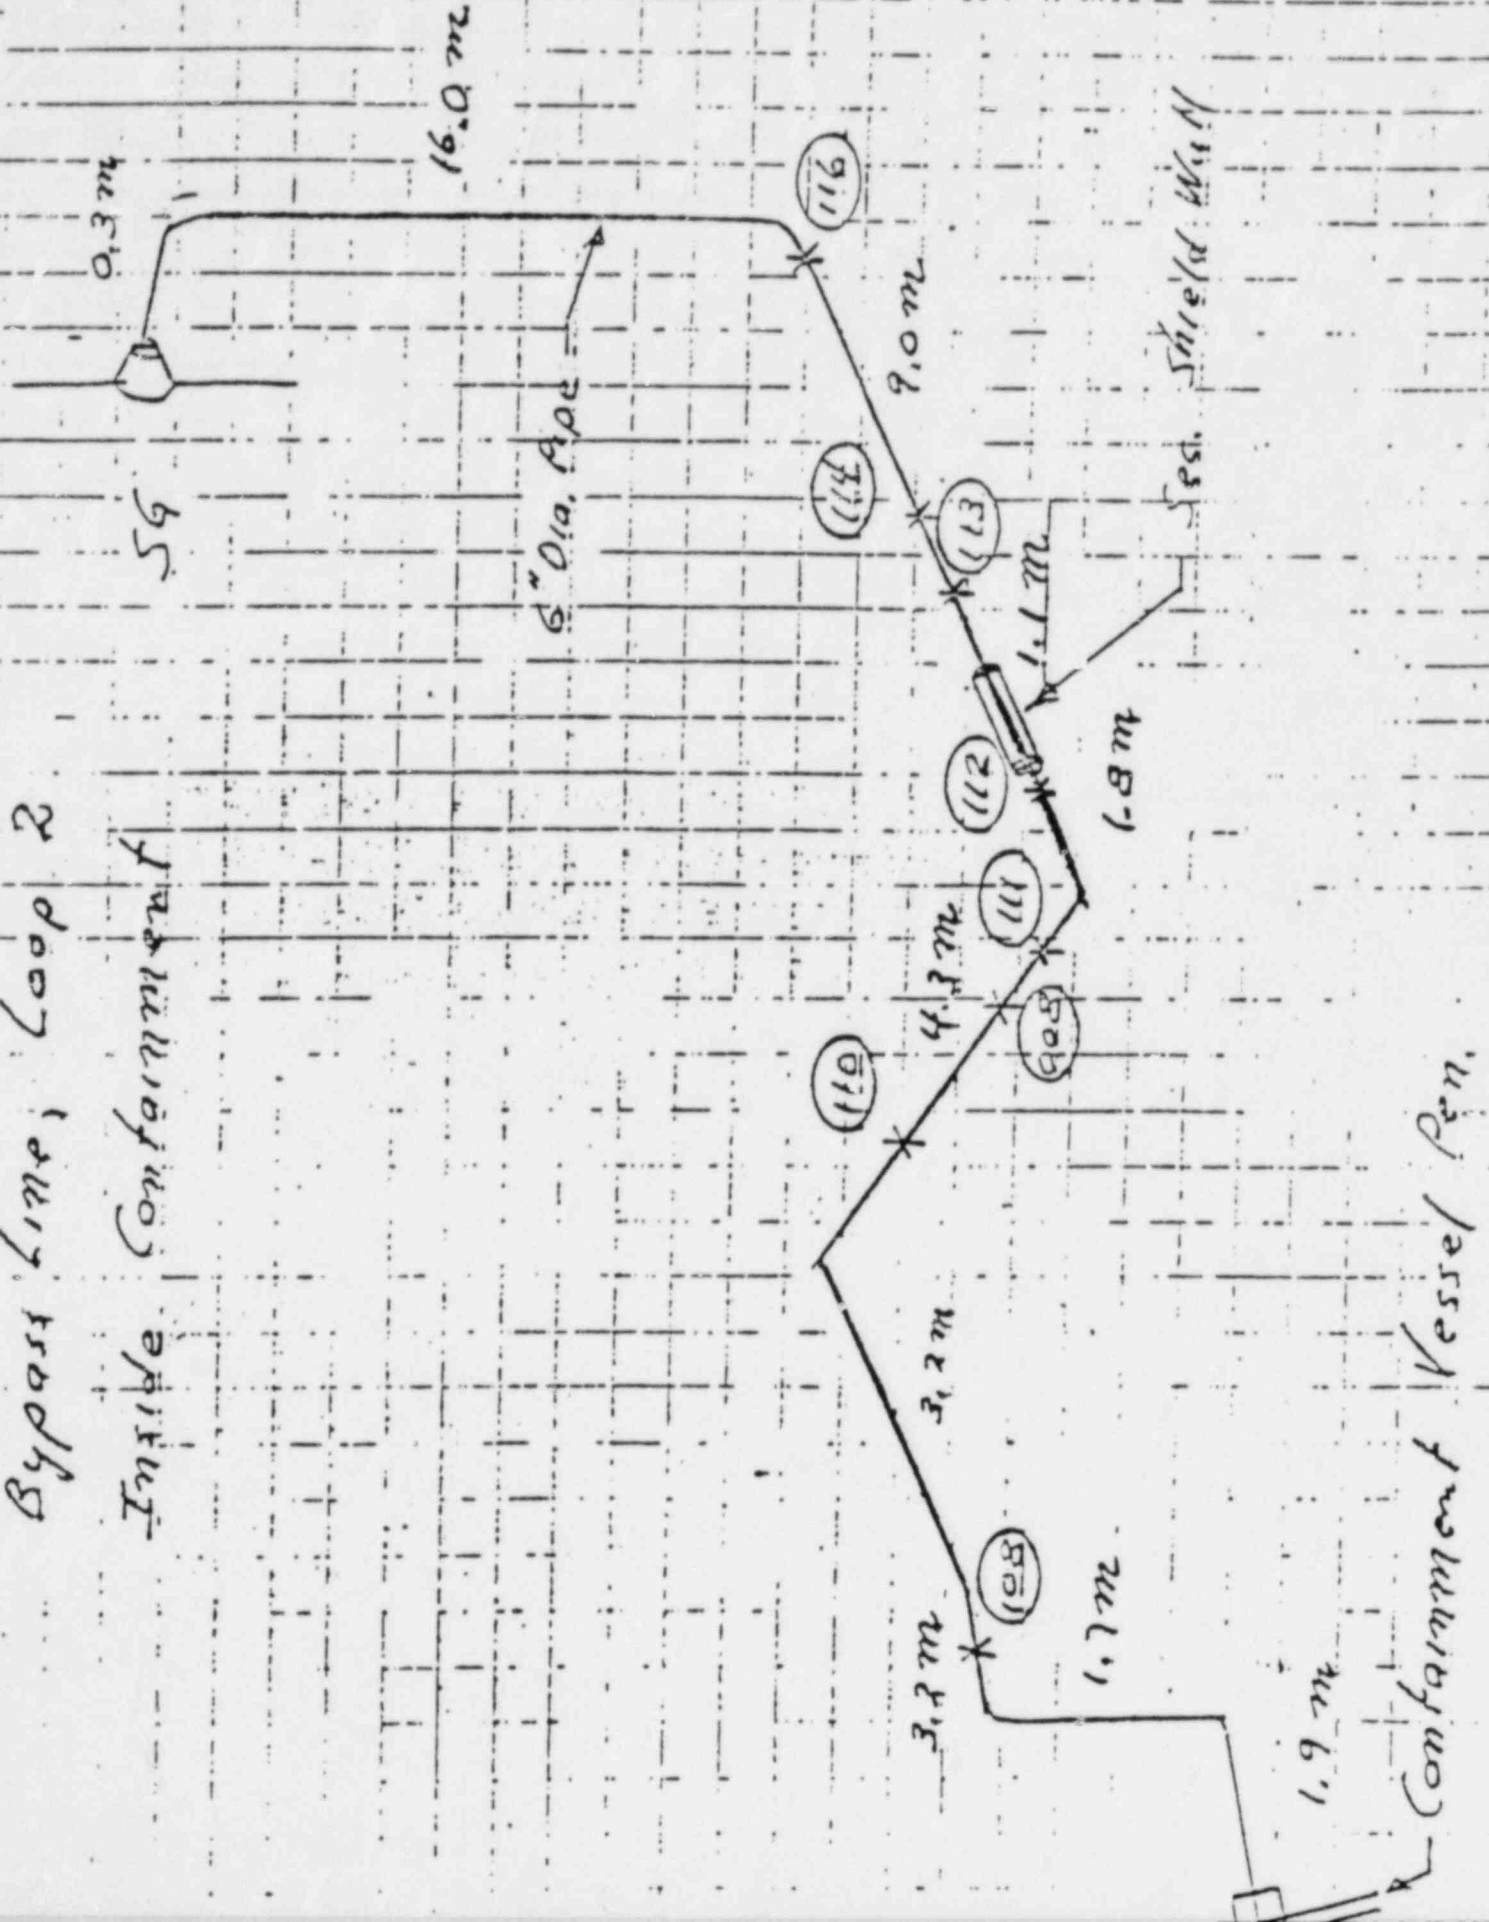
figure 2, AKSNO

The extent of the damage to the loop 2 bypass piping inside and outside containment, is presented in Table 1. In Figure 2, the numbers in ovals identify the pipe hangers which were affected. On both Figures 2 and 3, the length in meters of the pipe sections are given. A bulge or blister was observed in the bypass piping, in the horizontal section, downstream of the secondary shield wall, approximately midway between the shield wall and elbow in Figure 2. The bulged region was approximately six to eight inches long, with the bulge located on the top side of the pipe. At the bulge, the pipe diameter was increased approximately one quarter inch.

- o EMBEDMENT PLATES MOVED, BOLTS LOOSENEED, PIPE CLAMPS LOOSENEED AND MOVED, (AFFECTED HANGERS ARE IDENTIFIED BY NUMBERS IN OVALS),
- o PIPE CHANGED LOCATION
- o PIPE BULGED 1/4 INCH NEAR SECONDARY SHIELD WALL.

With respect to KRSKO plant repair, the section of bypass piping, containing the bulge, between and including the second and third upstream elbows was replaced. Also the hanger damage was repaired.

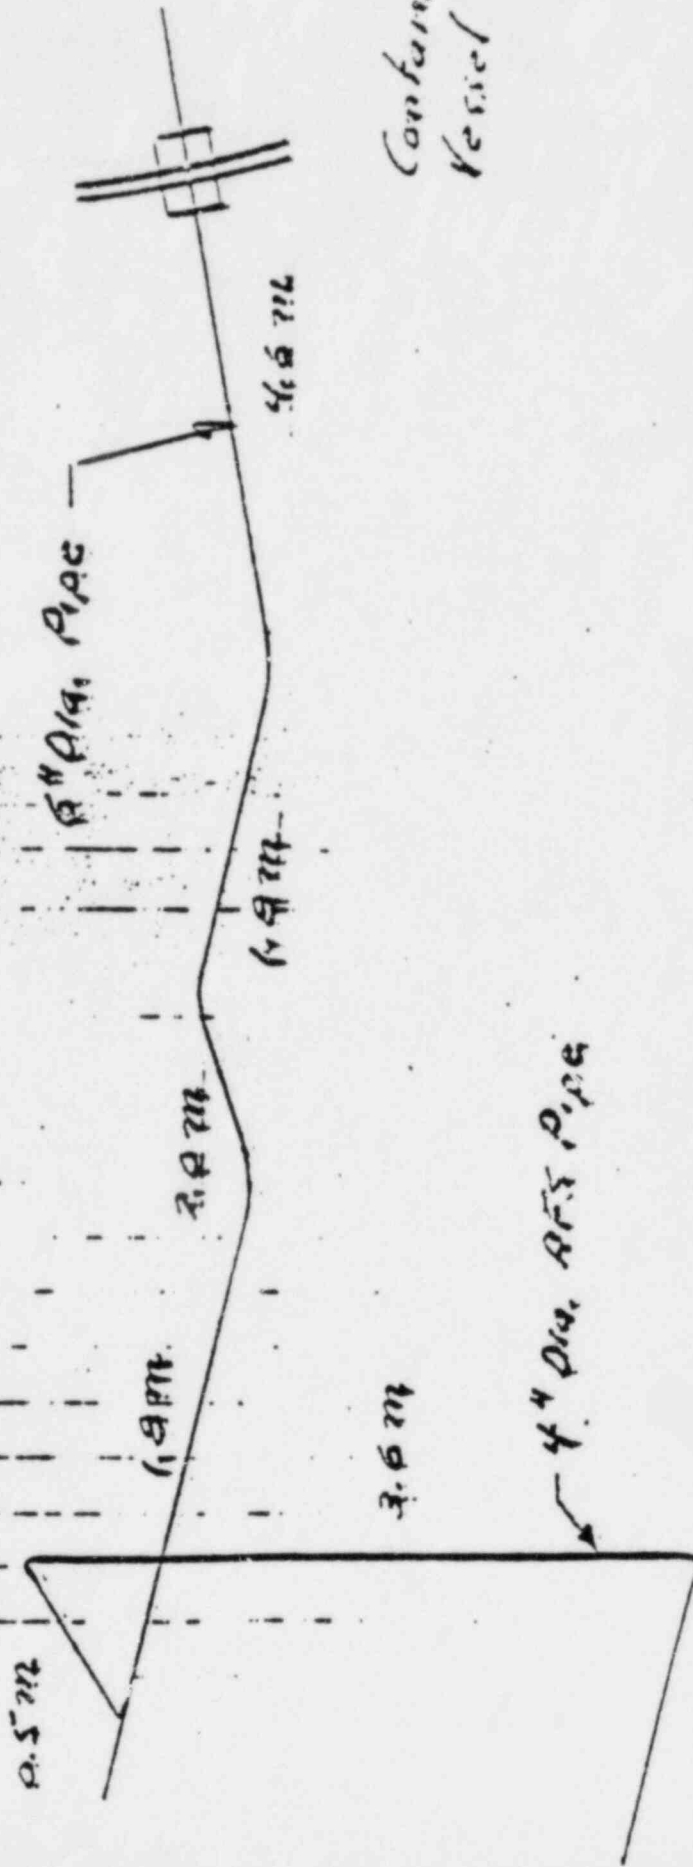
FIGURE 3, KR5K0

- o PIPE MOVEMENT WAS NEGLIGIBLE
- o AUXILIARY PIPE PAINT WAS BLISTERED BACK TO THE MDAFS PUMPS
- o MDAFS PUMP CHECK VALVES WERE FOUND TO HAVE SOME NICKS, SCRATCHES, AND UNEVENNESS.
