Subject: Oyster Creek Nuclear Generating Station (OCNGS)
Docket No. 50-219
Annual Environmental Operating Report

ANNUAL ENVIRONMENTAL OPERATING REPORT

OYSTER CREEK NUCLEAR

LICENSE NO. DPR-16

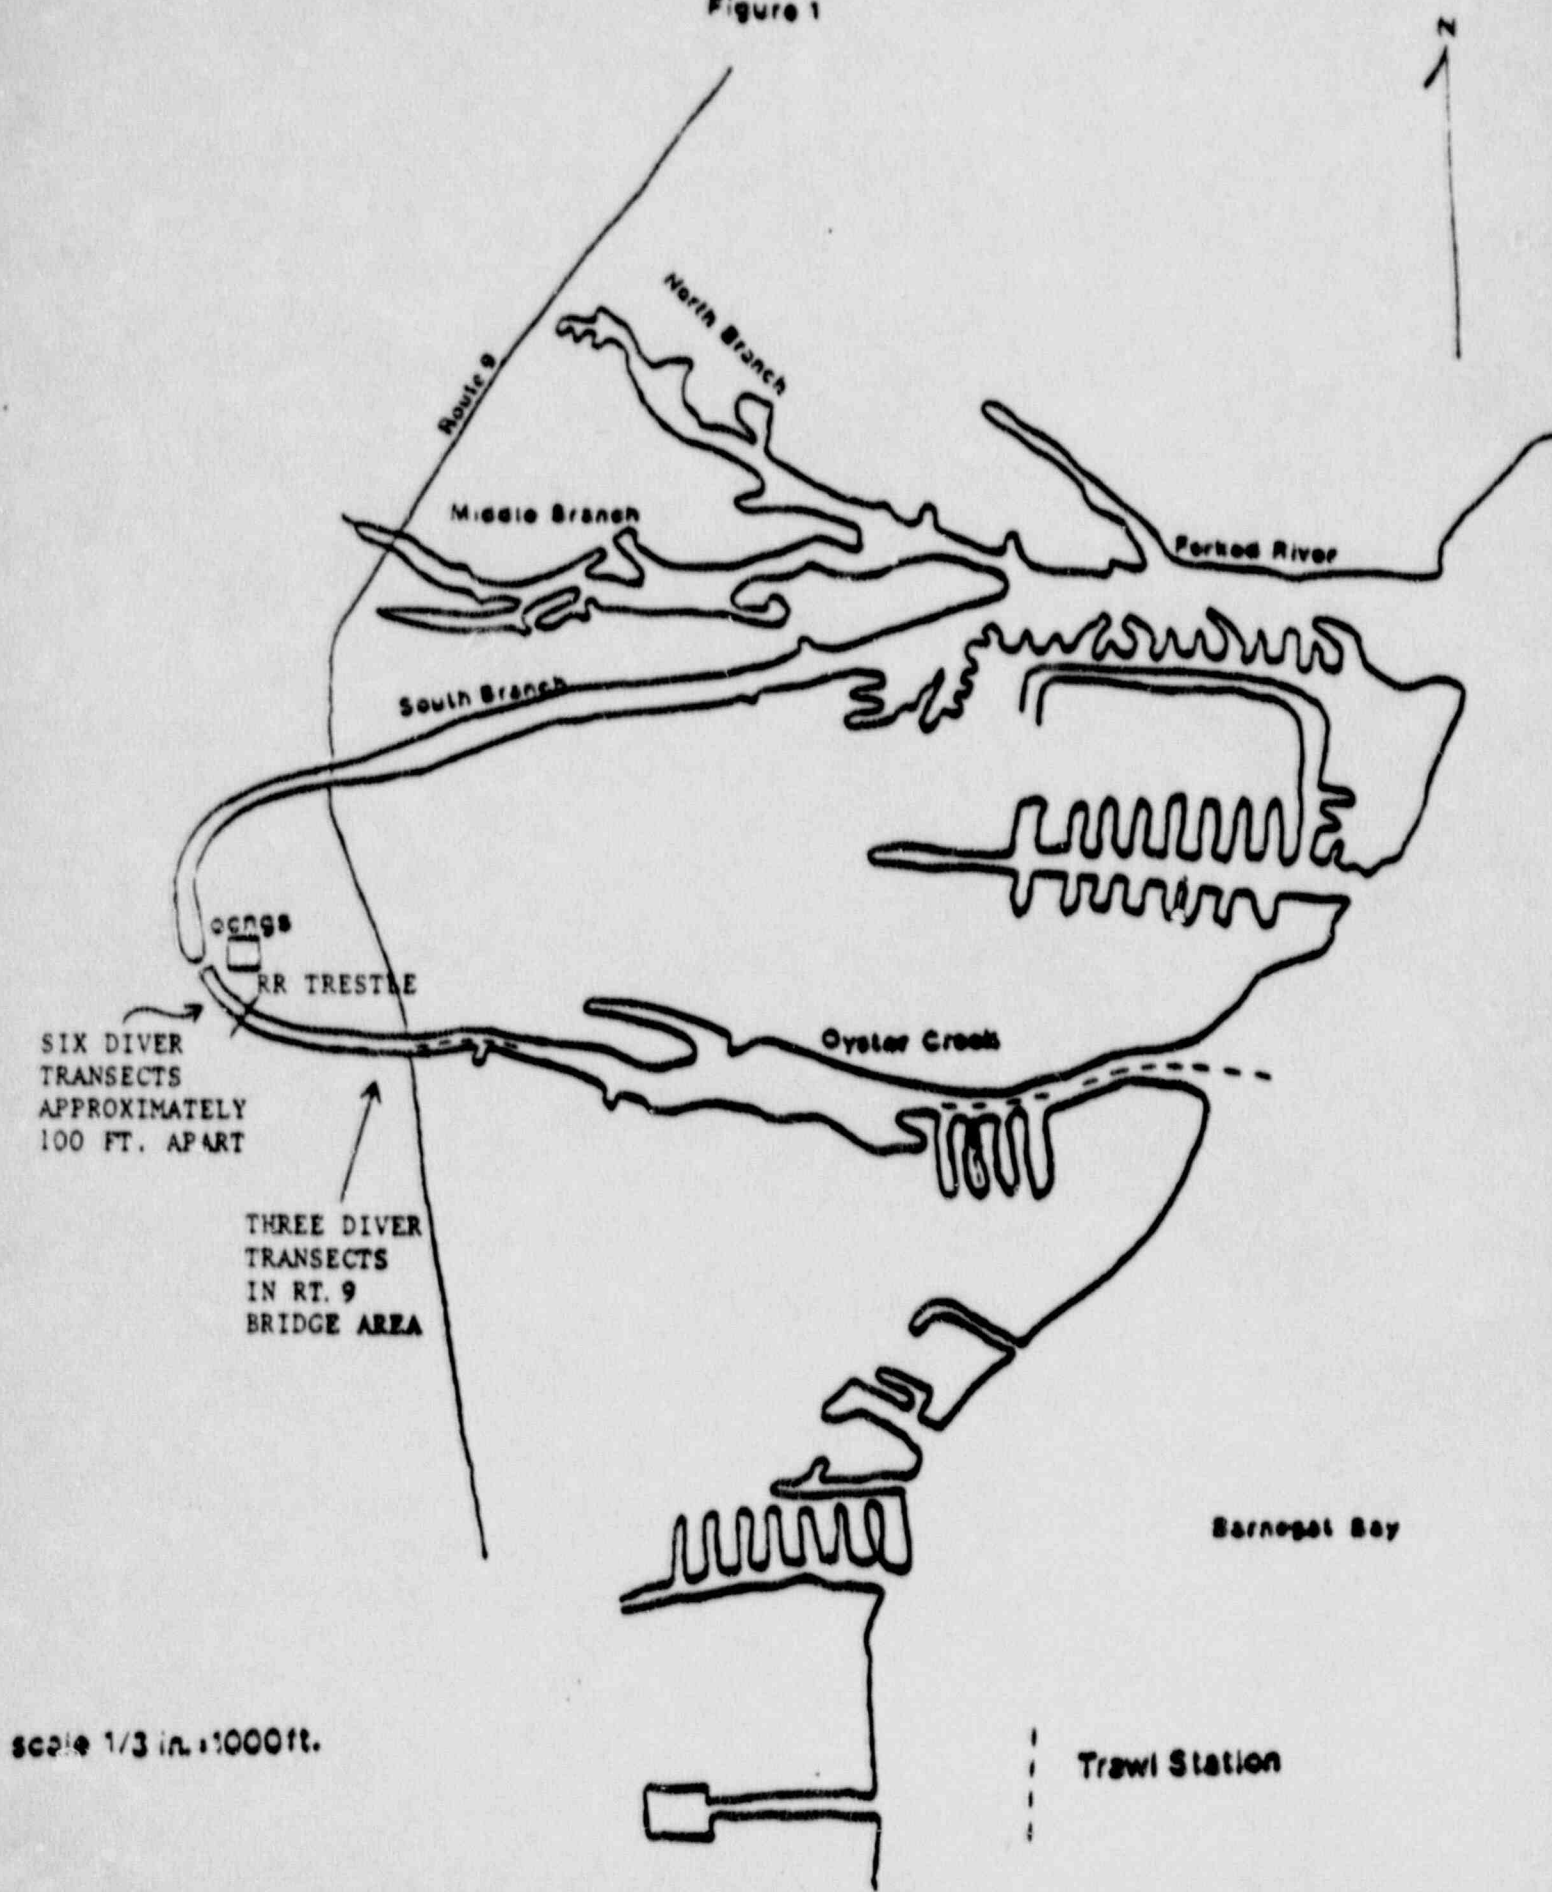
Figure 1

A diver swam nine transects across the OCNGS discharge canal west of the US Route 9 bridge (Fig. 1) in order to determine the species composition and abundance of fish that sank to the bottom after death. All fish within the field of view of the diver (10 ft.) were identified and enumerated. For the only species found in abundance, Atlantic menhaden, the number of individuals per square foot along each transect was determined. These densities were used to estimate the

Diver surveys of the discharge canal west of the US Route 9 bridge yielded 90 Atlantic menhaden, 4 red drum (Sciaenops ocellata), 2 American eel (Anguilla rostrata), 1 northern kingfish, and 1 spiny dogfish (Squalus acanthias). Based upon the number of individuals found by the diver, the total number of Atlantic menhaden on the canal bottom was estimated to be 1,568, including 623 between the condenser discharge and the railroad trestle and 945 from the railroad trestle to the US Route 9 bridge (Tables 1 and 2; Fig. 1).

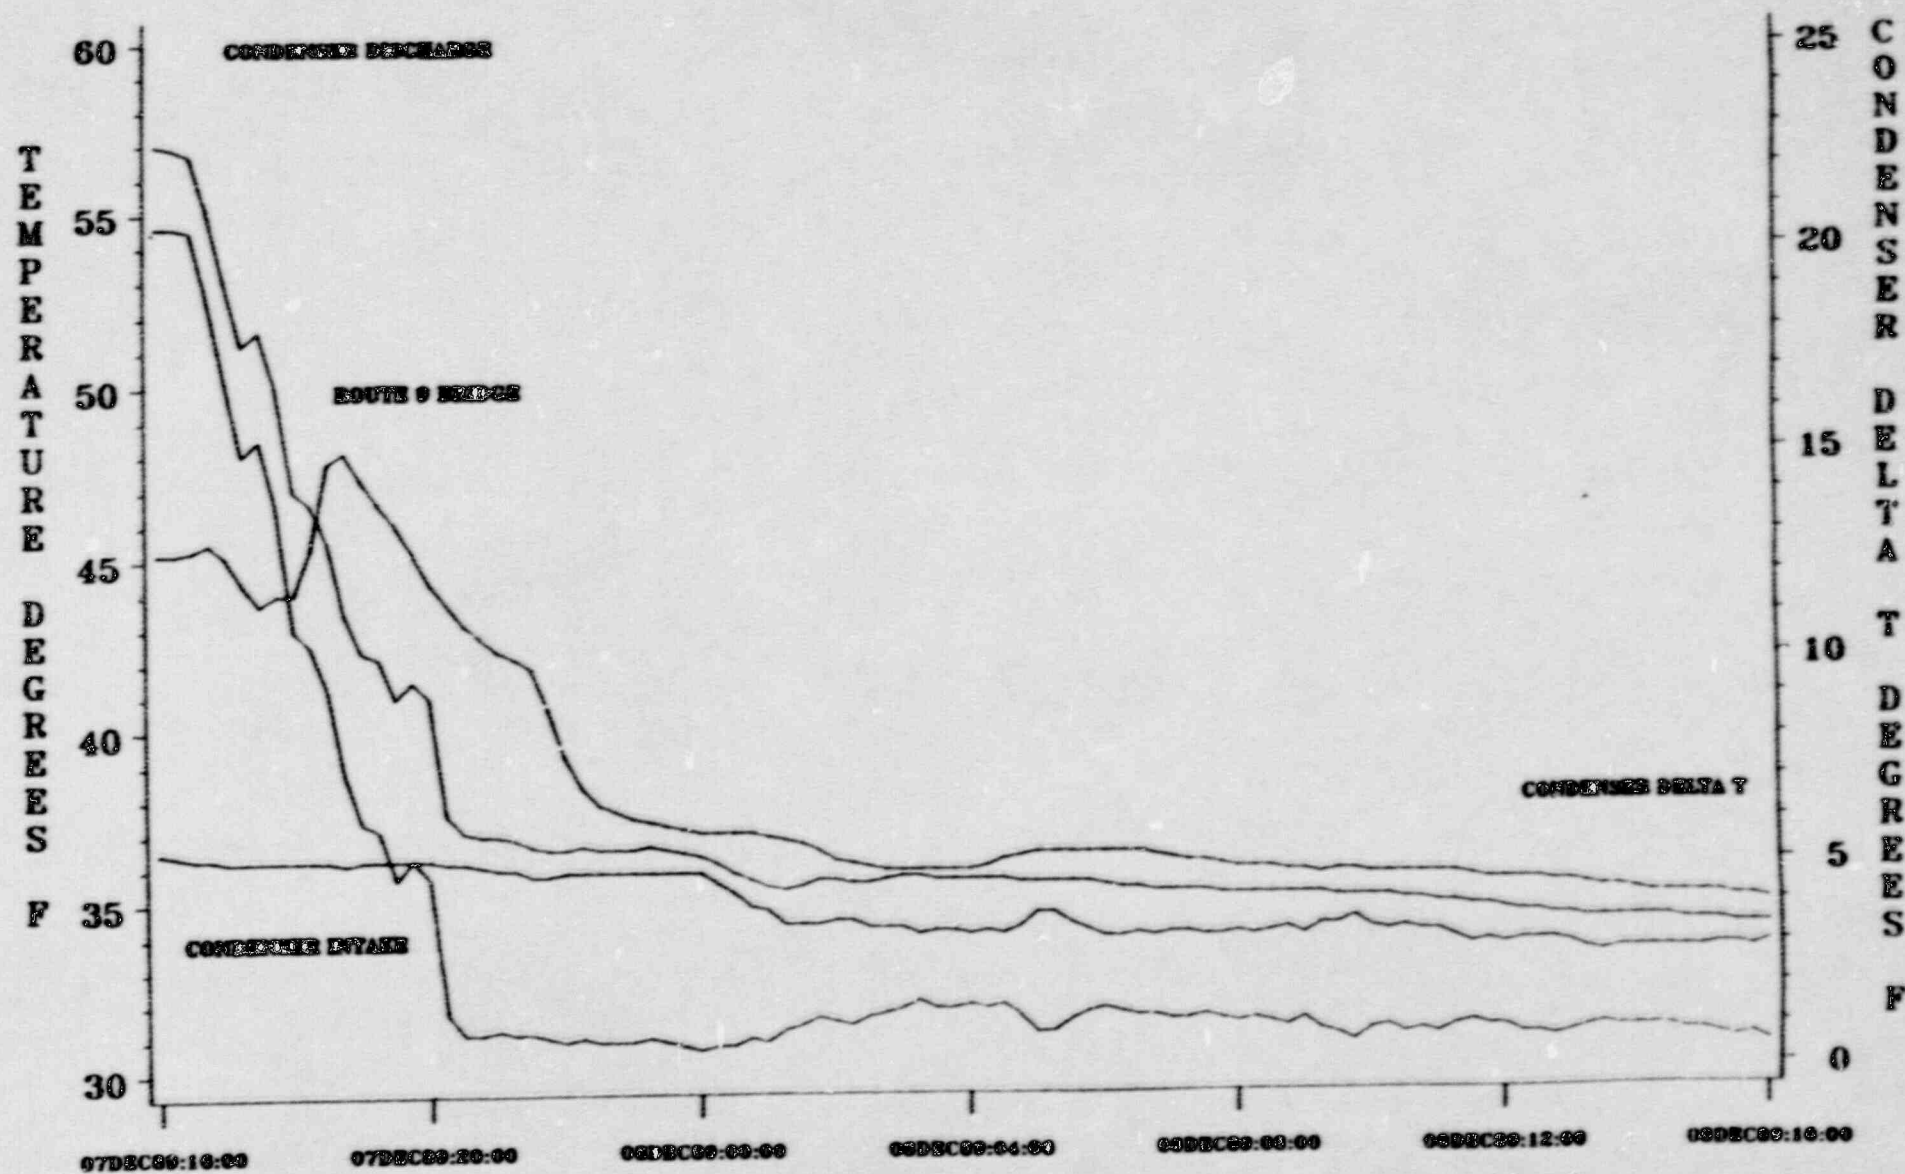
FIGURE 2

Temperature data were obtained from the continuous temperature monitor located approximately 4 ft. below the surface at the condenser intake, condenser discharge, and the US Route 9 bridge on Oyster Creek (Fig. 2).

In summary, approximately 3,330-3,830 fish died as a result of cold shock subsequent to the shutdown of the OCNGS on December 8, 1989. The majority of these fish were Atlantic menhaden (2,641 individuals) although smaller numbers of eight other species were observed.
