# PHILADELPHIA ELECTRIC COMPANY

June 3, 1982

References: Docket No. 50-277, Application for Amendment of Facility Operating License DPR-44, submitted 2/19/82 with respect to the Peach Bottom Atomic Power Station Unit 2 Reload 5 Application.

SUBJECT: Peach Bottom 2 Reload 5 (Cycle 6) Reload Licensing  
Analysis Error

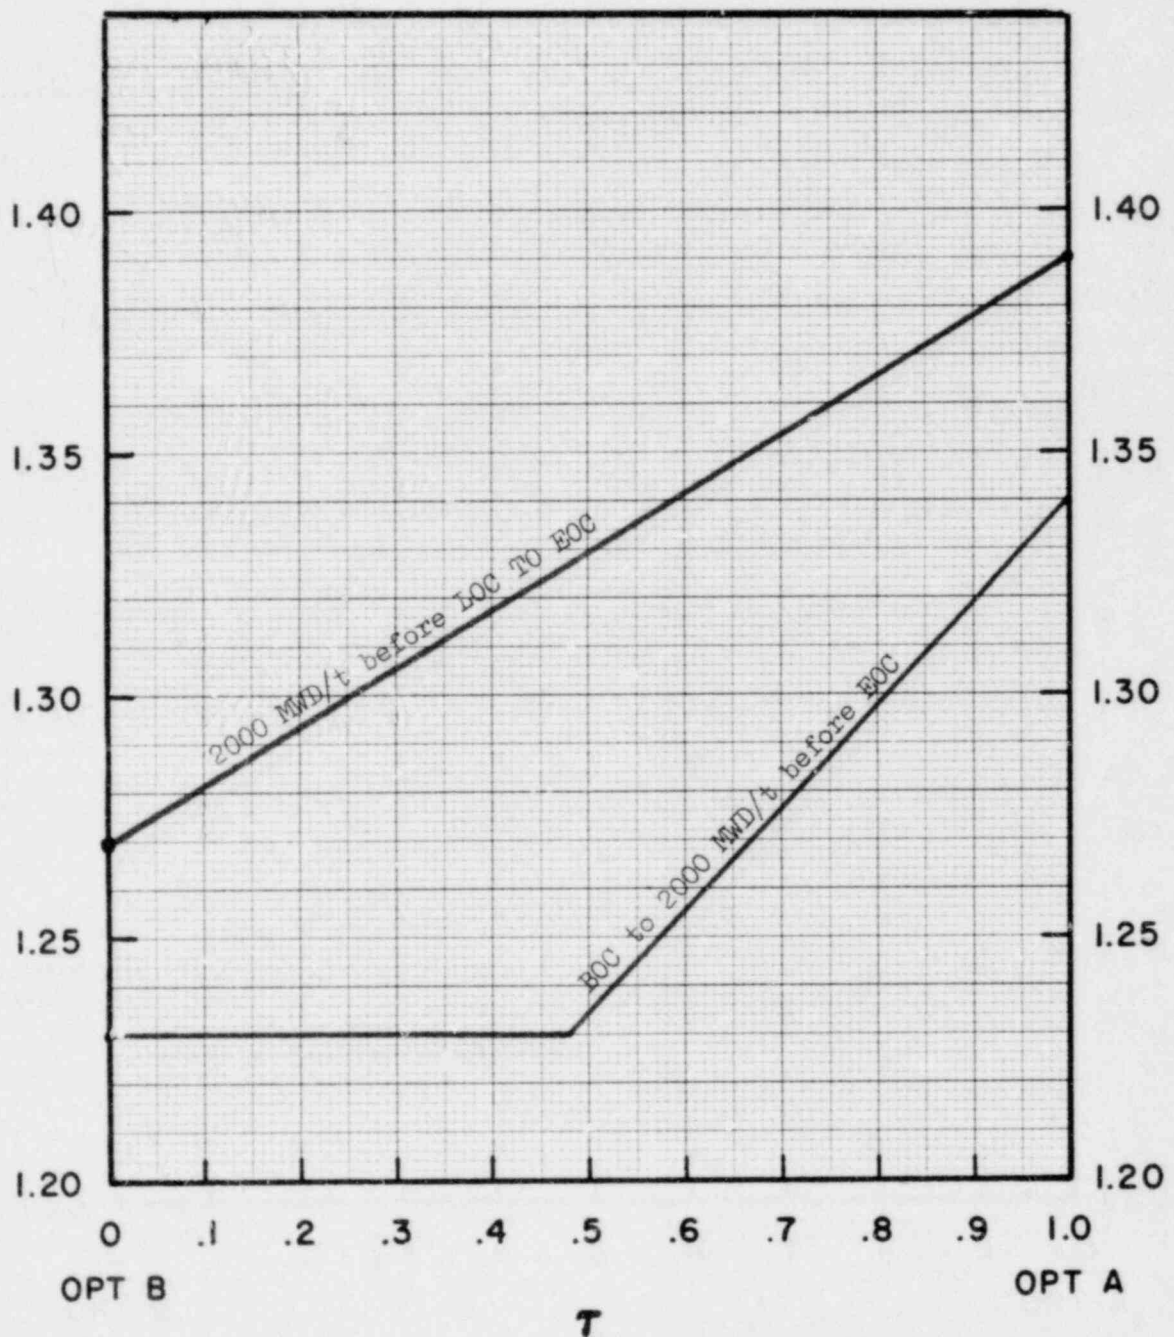
FIGURE 3.5.K.1 MCPR OPERATING LIMIT vs  $T$

FUEL TYPE 8x8R/LTA

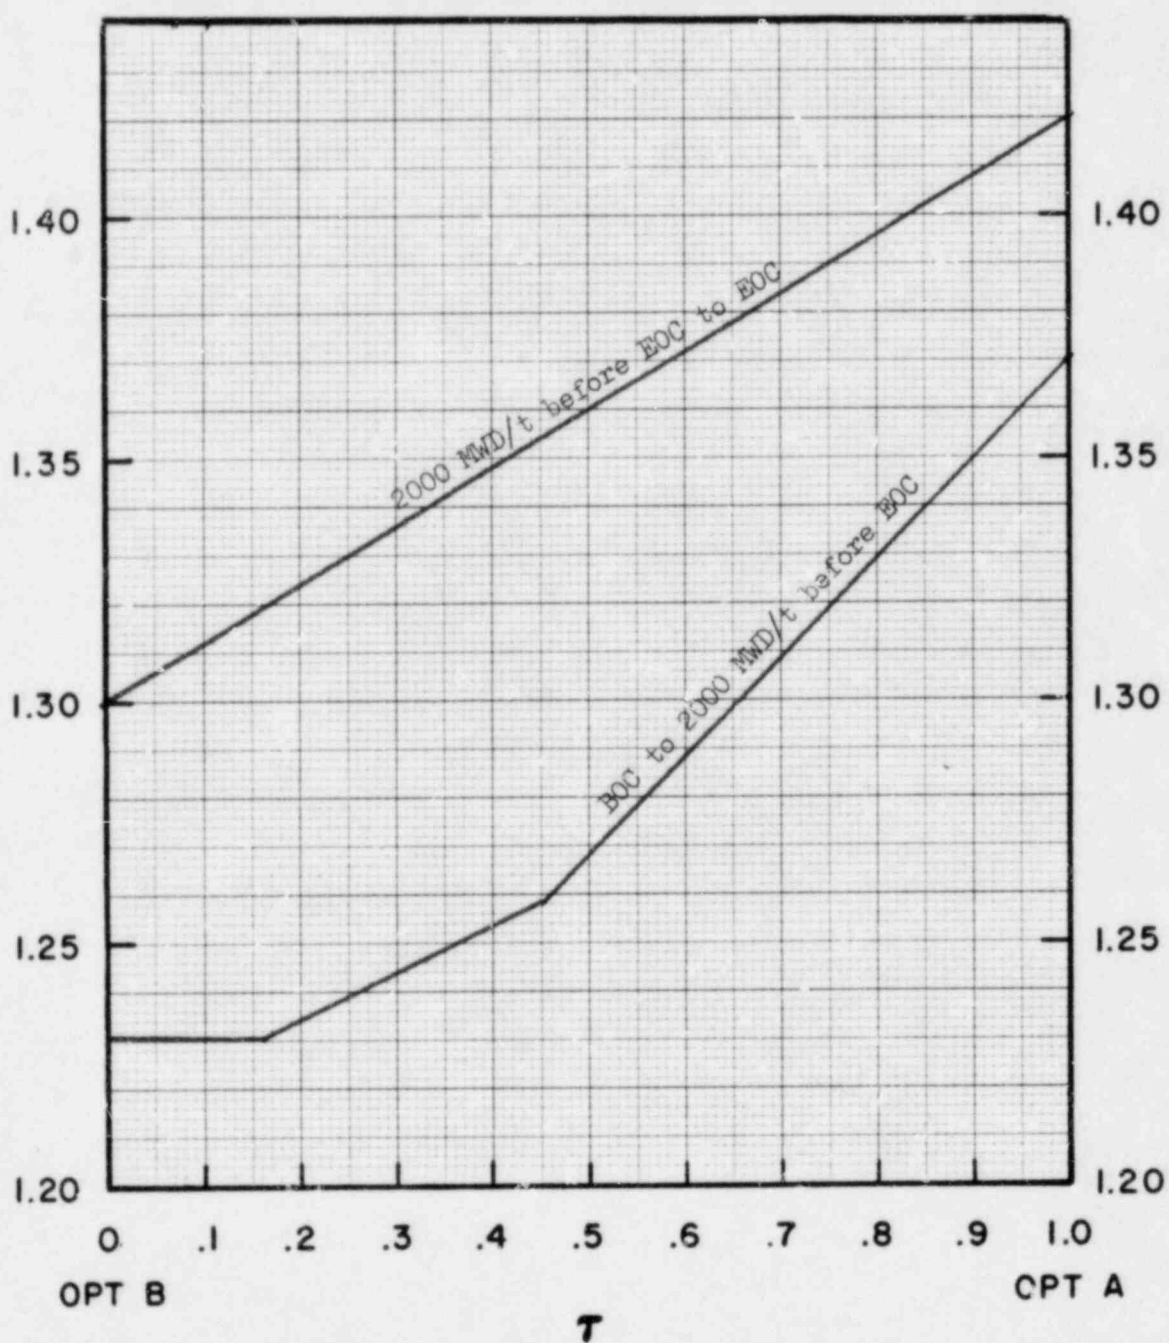
FIGURE 3.5.K.2 MCPR OPERATING LIMIT vs  $T$

FUEL TYPE P8x8R

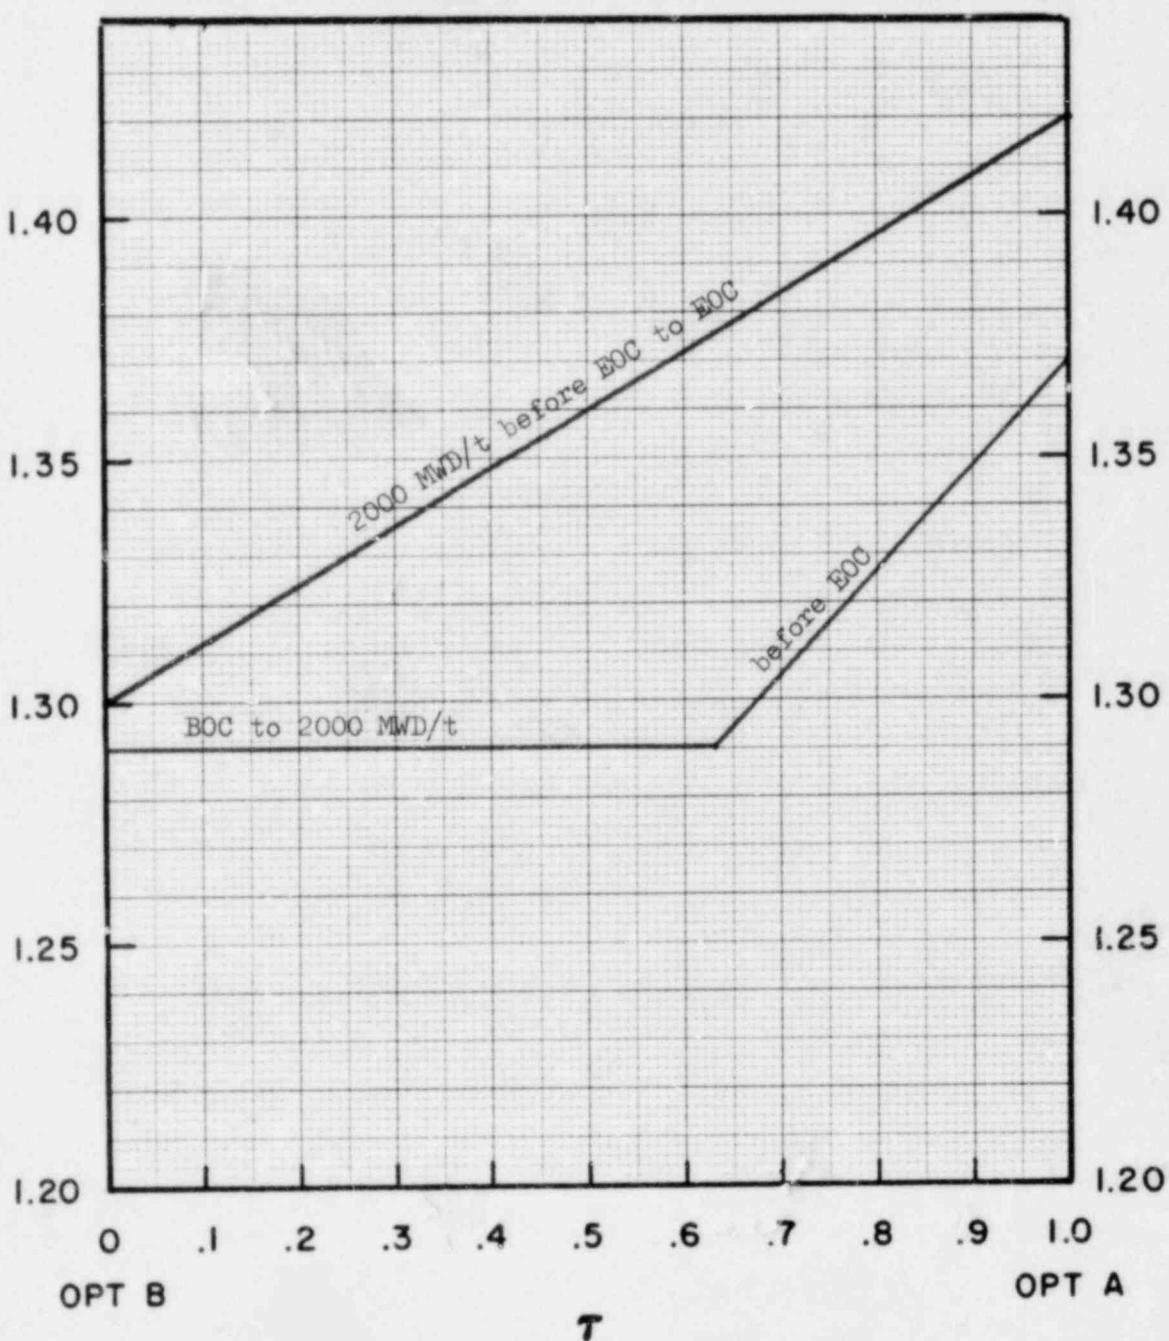
FIGURE 3.5.K.3 MCPR OPERATING LIMIT vs  $T$

FUEL TYPE P8DRB285
