In the Matter of
Metropolitan Edison Company
(Three Mile Island Nuclear Station Unit No. 1)
Docket No. 50-289 (Restart)

Three Mile Island Nuclear Station, Unit 1 (TMI-1)
Operating License No. DPR-50
Docket No. 50-289
Inspection Report 83-30

1 ATTACHMENT I

ATTACHMENT 2 - CORRECTIVE ACTION LIST

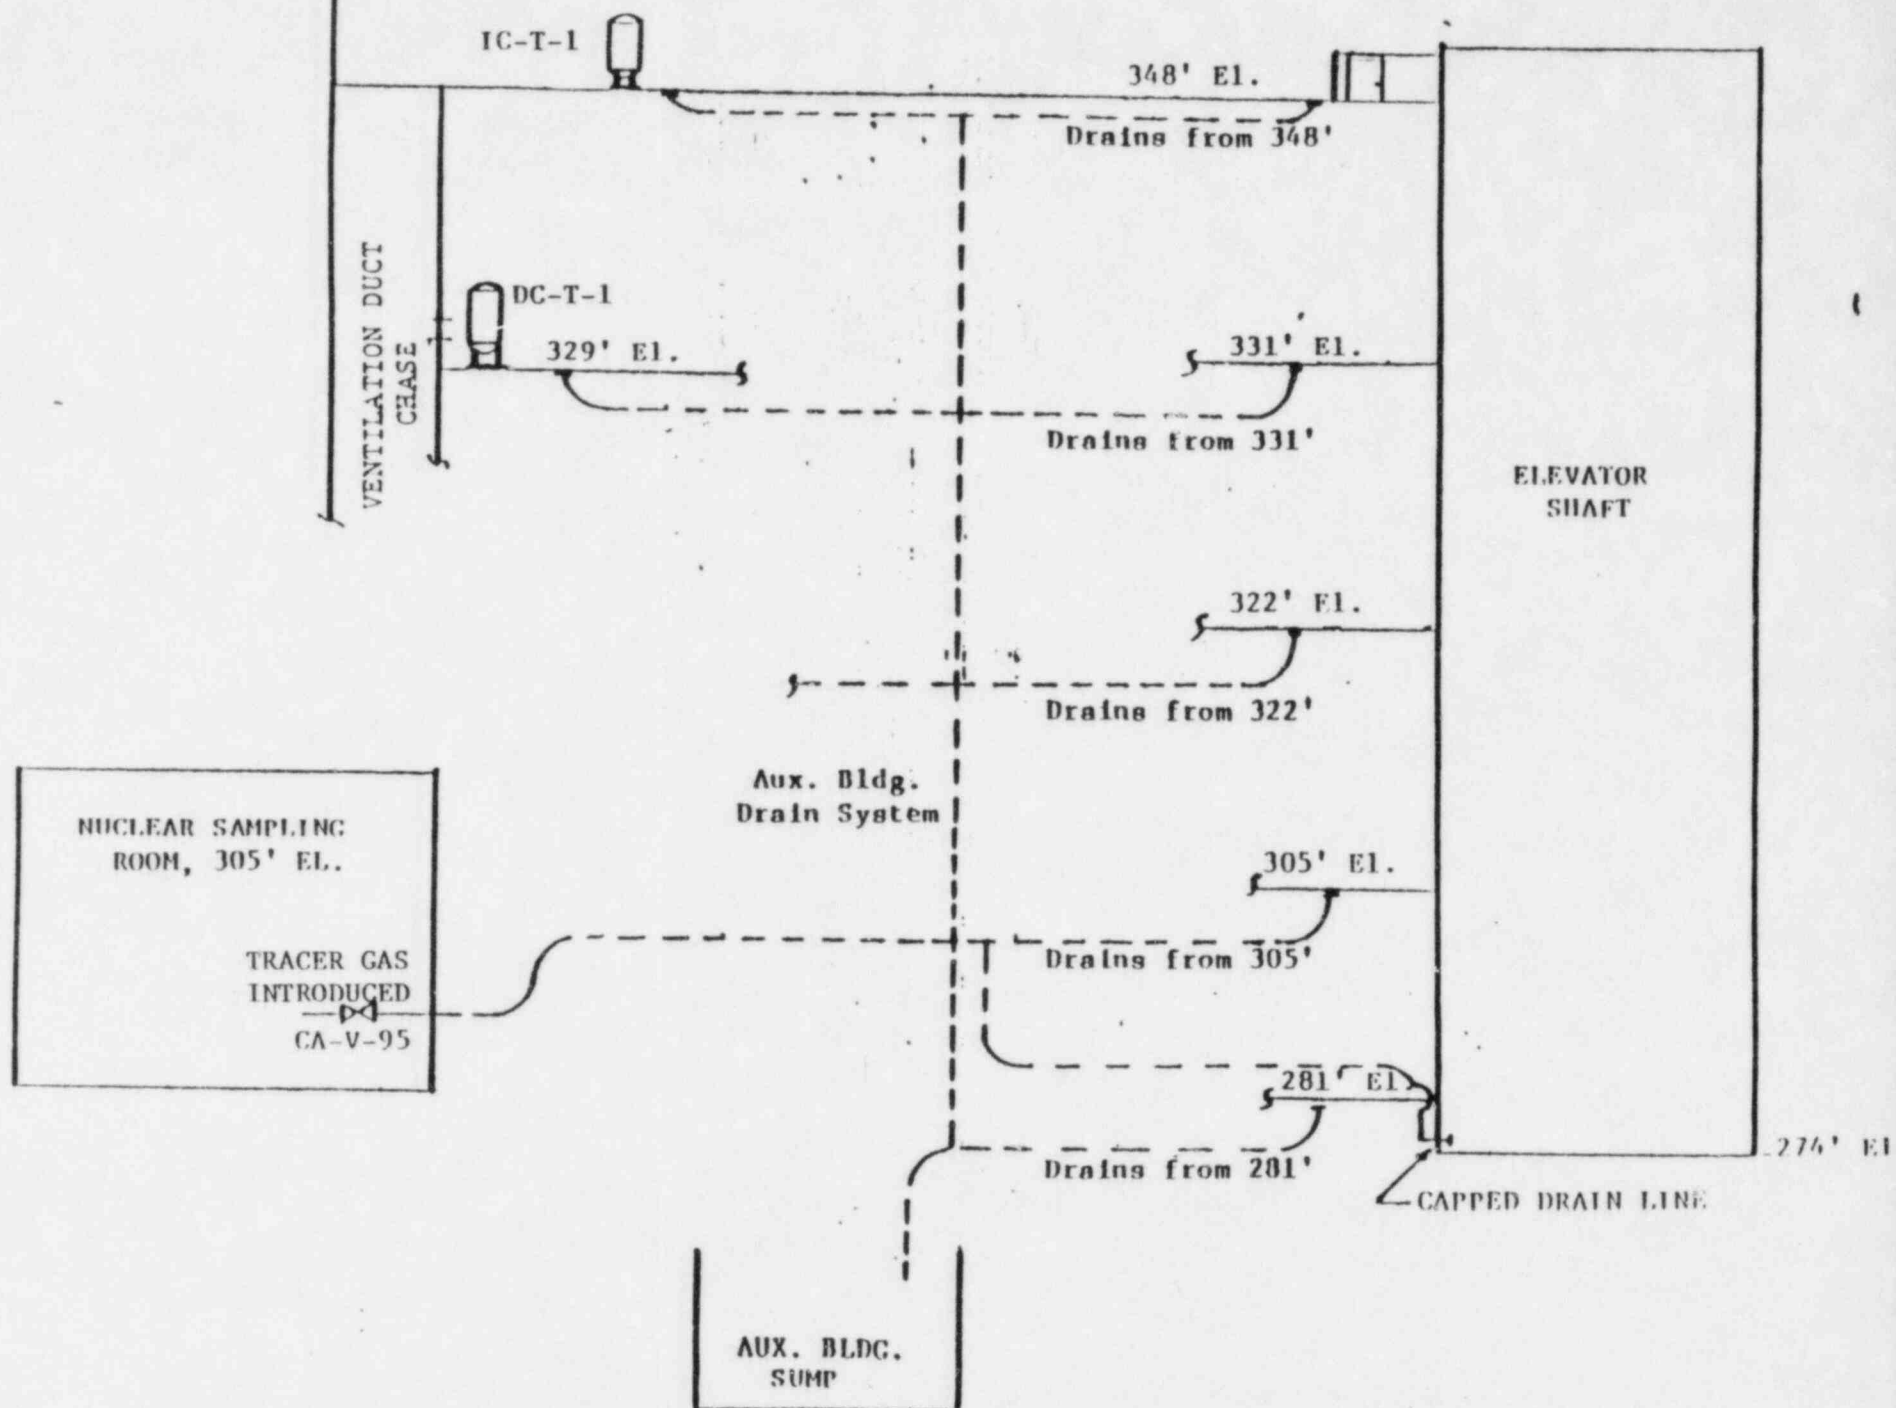
SPENT FUEL POOL AREA

On October 20, 1983, an investigation and test was conducted to determine the actual flowpath of the released krypton gas, the nature of any deficiencies in the environmental barrier, and recommendations for corrective action. The sample and ventilation system conditions of August 29, 1983 were duplicated for the test. A tracer gas (R-12) was introduced at the same point as the krypton gas, and electronic leak detectors were used to identify the flowpath of the R-12. Attachment 3 is a sketch of the test set-up.

The R-12 injection was initiated at 1758 hrs. The first detection of R-12 vapor occurred approximately 18 minutes later at the floor drain and clean out plug under the Intermediate Closed Cooling Surge Tank (IC-T-1) on the 348' elevation in the Spent Fuel Pool Area. R-12 vapor was also detected at the floor drain just inside the entrance door to this area (both in the Unit 1/2 common air space). The next location where a flowpath was suspected was the entrance door to the Spent Fuel Pool Area and the elevator doors leading to this doorway (348' el.). R-12 vapor was detected at this location at 1830 hrs. The personnel performing this test rode the elevator down to the 281' elevation, where R-12 vapor was heavily detected at 1842 hrs. It is suspected that a drain line, that terminates after it penetrates the elevator shaft just above the elevator sump at (~276' el.), as well as the floor drain in the elevator equipment room is the cause of this leak.

Based on the test results, Plant Engineering concluded that when the krypton gas was injected into the Nuclear Sampling Room it travelled the path of least resistance into the drain system. The drain lines throughout the Auxiliary Building provided a path up to the Spent Fuel Pool Area at the floor drains directly below the Intermediate Closed Cooling Surge Tank (IC-T-1) and just inside the doorway to this area. Due to the lack of a loop seal in these floor drains, a flowpath was created for the krypton gas. In addition, the drain line at the bottom of the elevator shaft provided an additional flowpath for the krypton gas. The airflow is drawn up the elevator shaft, where it can leak out around the elevator door seals and be drawn into the Spent Fuel Pool Area through the entrance door. These three (3) flowpaths allowed the krypton gas to disperse into the common air space (348' el. is common to both Unit 1 and 2) and be exhausted by both units' air handling systems which caused the alarms in both units.
