Florida Power

CORPORATION
Crystal River Unit 3
Docket No. 80-302

October 23, 1995
3F1095-06

Subject: Fifth Tendon Surveillance Exempted Tendons

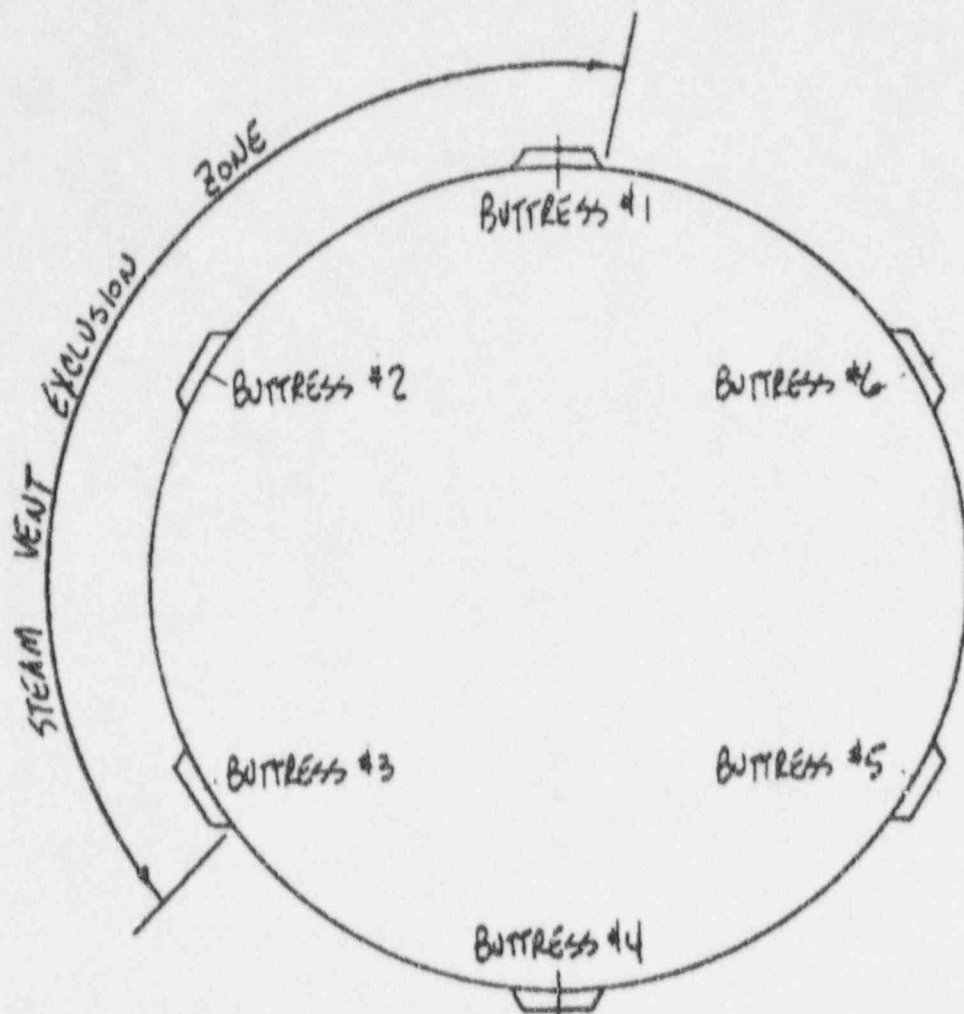
PLAN VIEW : REACTOR Bldg.

The attached sketch (page 3) depicts the Steam Vent Exclusion Zone with regard to tendon surveillances. The Reactor Building contains six (6) external buttresses spaced at sixty degree intervals. The exclusion zone encompasses buttresses #1, #2, and #3. Because of the potential for activation of the steam vents while on line, the following tendon groups are excluded from selection when performing an on-line surveillance:

- 1) Dome Tendons: Eighty five of the 123 dome tendons have at least one end (i.e., tendon cap) falling within the exclusion zone.
- 2) Hoop Tendons: These tendons each encompass three buttresses from end to end (i.e., three hoop tendons make up the circumference of the Reactor Building). There are six groups of hoop tendons: 1-3, 2-4, 3-5, 4-6, 5-1, and 6-2. Tendons above the roof line in the following groups would be excluded: 1-3, 2-4, 3-5, 5-1, and 6-2. This leaves only the 4-6 grouping as accessible while on line. One Hundred Forty (140) of the 282 total hoop tendons fall within the exclusion zone (i.e., are above the roof line and have at least one end on buttresses #1, #2, or #3). Hoop tendons below the roof line are not in the Steam Vent Exclusion Area.
- 3) Vertical Tendons: One third (i.e., 48) of the 144 vertical tendons fall within the exclusion zone.

Of the 549 total tendons, 273 (almost 50%) fall within the steam vent zone and can not be inspected while the plant is on-line.

D231: Dome tendon running from just west of buttress #4 to just west of buttress #6.

D224: Same as D231.

35H1: Hoop tendon running from buttress #3 to buttress #5 located inside building at 95' elevation (i.e. bottom tendon).

46H21: Hoop tendon running from buttress #4 to buttress #6 located outside building about mid-height.

46H47: Same as 46H21 however tendon is located near top of Reactor Building.

42H1: Hoop tendon running from buttress #4 to buttress #2 inside building at 95' elevation (i.e. bottom tendon).

56V15: Vertical tendon between buttresses #5 and #6.

61V14: Vertical tendon between buttresses #6 and #1.
