SUBJECT: SUPPLEMENT TO NUPAC ENVIRALLOY HIC REPORT

EA-142 PROTOTYPE TEST

Supplement to
NUCLEAR PACKAGING, INC.
ENVIRALLOY
HIGH INTEGRITY CONTAINERS

Enviralloy 190 Cubic Foot Prototype Drop Test

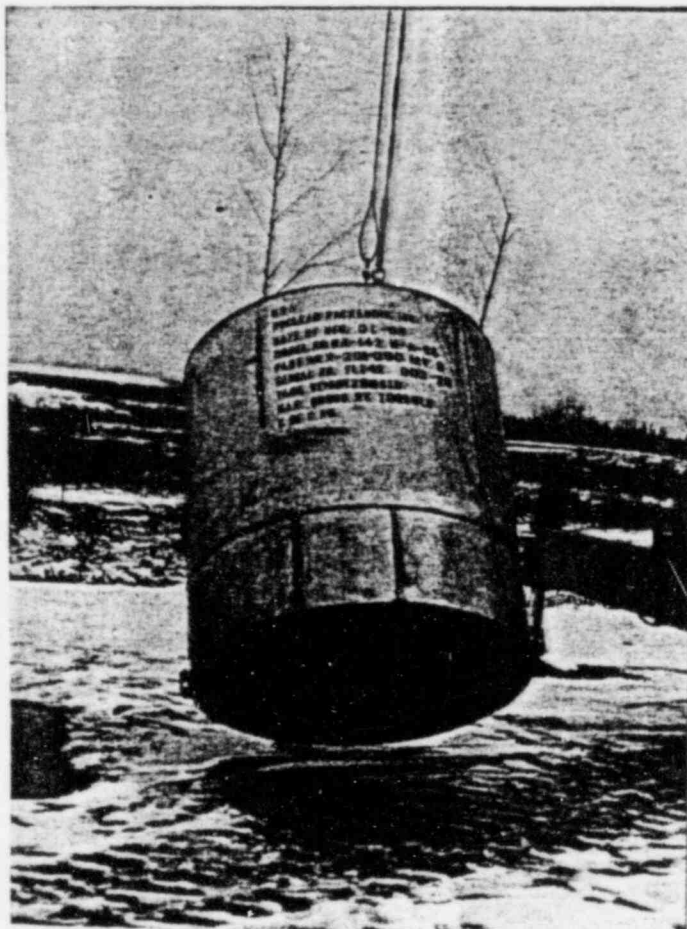
Figure 2 Lug Test

A successful lug load test was also performed on this container. Each lug was load tested to 300% of its rated capacity. All three lugs were used to lift the container by its full weight one lug at a time.

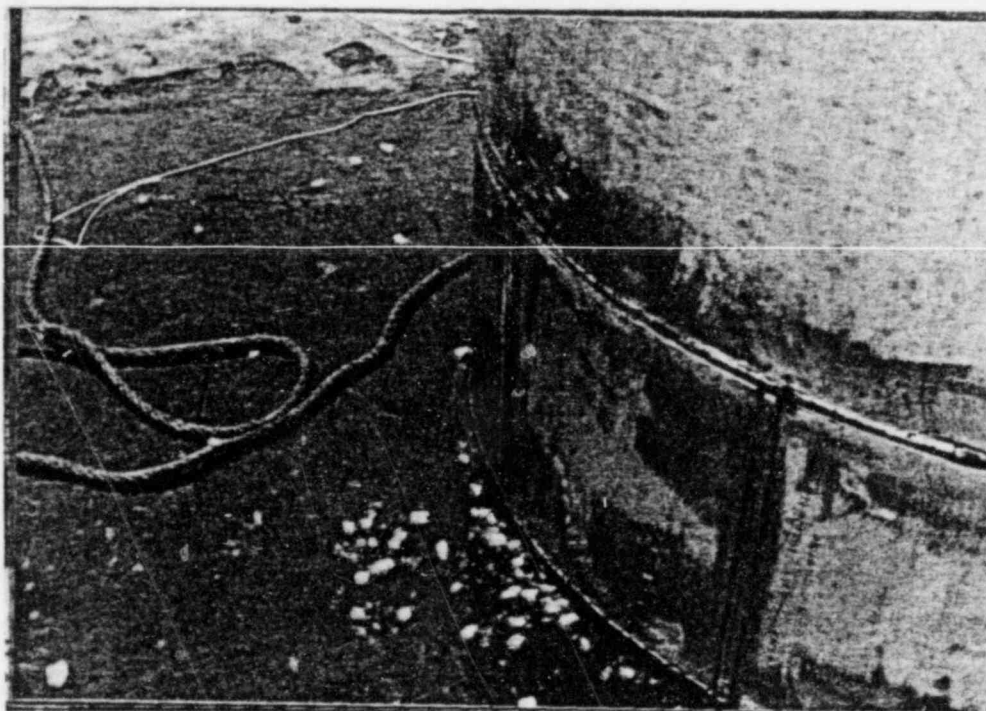
Figure 7 After Four Foot Bottom Corner Drop

The container did not sustain any significant damage from any of the drops. The only damage that was sustained by the container was a slightly dented lift lug on the top due to the four foot drop on the top straight down, and some damage on the corners due to the four foot drop. The lifting lug was not bent or deformed sufficiently to prevent its use. The container was slightly bowed due to the corner drop on the four foot drop. Also the ends, top and bottom were plastically deflected from the corner drop. None of these deformations were in the excess of 1/2 inch. The container did not sustain any loss of contents as a result of any of these drops. The container was not damaged either on the outside or on any of the inside supports, such that it would prevent its use. The container was cleaned up after the drop and all welds were magnetic particle tested to detect any damage to the welds. No damage was detected.

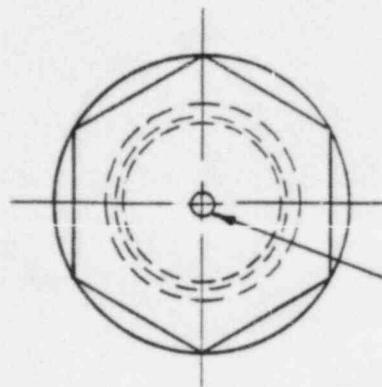
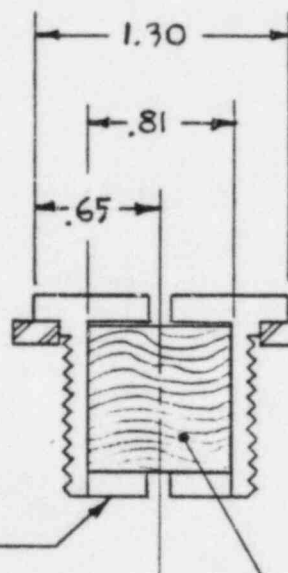
ATTACHMENT 1

The container was drop tested with the polyethylene and carbon optional seal as shown in Attachment 1. The seal was located in the center of the lid. The seal did not fail or cause any release of contents.
