WMGT DOCUMENT REVIEW SHEET

ROCKWELL HANFORD OPERATIONS #: SD-BWI-TP-039

DOCUMENT: Integrity Testing Plans for Selected Hanford Site
Monitoring Wells

REVIEWER: Williams and Associates, Inc.

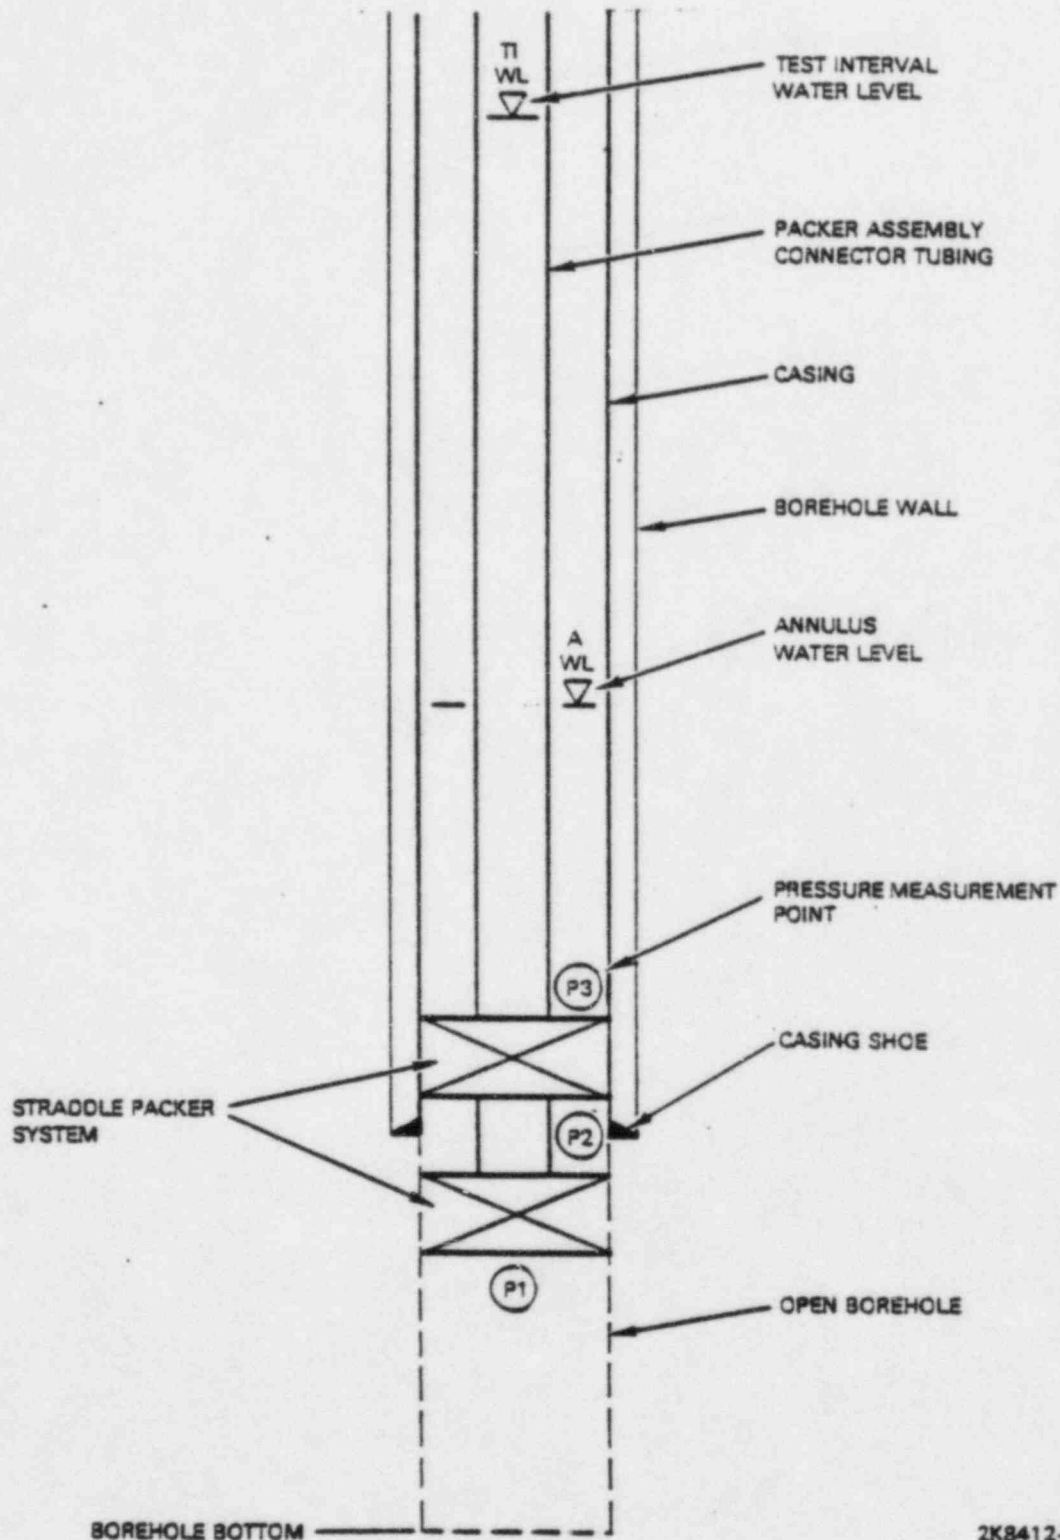
FIGURE 2. Typical Configuration of Straddle Packer System as Used for Integrity Testing.

The above described deficiency in this report can be noted under Item 6 of "Expected Results" on page 14 of the document under review. This item refers to the integrity testing of borehole DB-1. This item states that the pressure remains constant in interval P2 (see attached figure) subsequent to stressing the interval monitored by P2. We wish to point out that a constant pressure is not possible if the basalt has a finite hydraulic conductivity; some pressure bleed-off into the finite hydraulic conductivity basalt must occur. However, the hydraulic conductivity may be so low that the pressure bleed-off from the stress will be minimal over the test period in which case the pressure may appear to be constant when in reality it is not.

The point that the basalt may have a finite hydraulic conductivity is not considered adequately in the discussion on page 14 under "Possible Results", Item 5a, 6a, and 6c. Item 5a assumes that a pressure change in transducer P2 does not occur although a pressure change does occur in the annulus (P3) after the annulus is stressed. The absence of pressure change in interval P2 is stated as being indicative of a casing leak. This conclusion is not warranted because flow could occur around the packer into the interval P2 without detection by the transducers. Pressure build-up would not occur in interval P2 because the hydraulic conductivity of the basalts would allow the dissipation of the influx of water without a concomitant, measurable increase in pressure. This point is especially relevant due to the moderate sensitivity of the transducers to small pressure changes. The report under review does not describe the amount of head (pressure) changes which will be induced on the units being tested.

Item 6a (page 14) considers the stressing of the interval monitored by transducer P2. Item 6a assumes that a constant pressure detected by transducer P1 is indicative of a good straddle packer seal. As noted above, fluid could move into the P1 zone without causing a concomitant pressure change. The high hydraulic conductivity of the zone could prevent the build-up of pressure at P1. Item 6c makes the same tacit assumption in the description of another possible result of stressing the interval monitored by transducer P2. It is assumed that there is a pressure change in transducer P2 but not in transducer P1. Again, it is possible for fluid to move from transducer P2 to transducer P1 without a measurable pressure increase in transducer P1. The high hydraulic conductivity of the basalt at P1 may allow the dissipation of pressure without causing a measurable pressure change at P1.
