Please accept this letter and the enclosed exhibits as a request for an ammendment to License No. 37-04871-01 for the possession and use of 133 Xe to equal 200 mCi per week.

NUCLEAR MEDICINE

SUMMARY

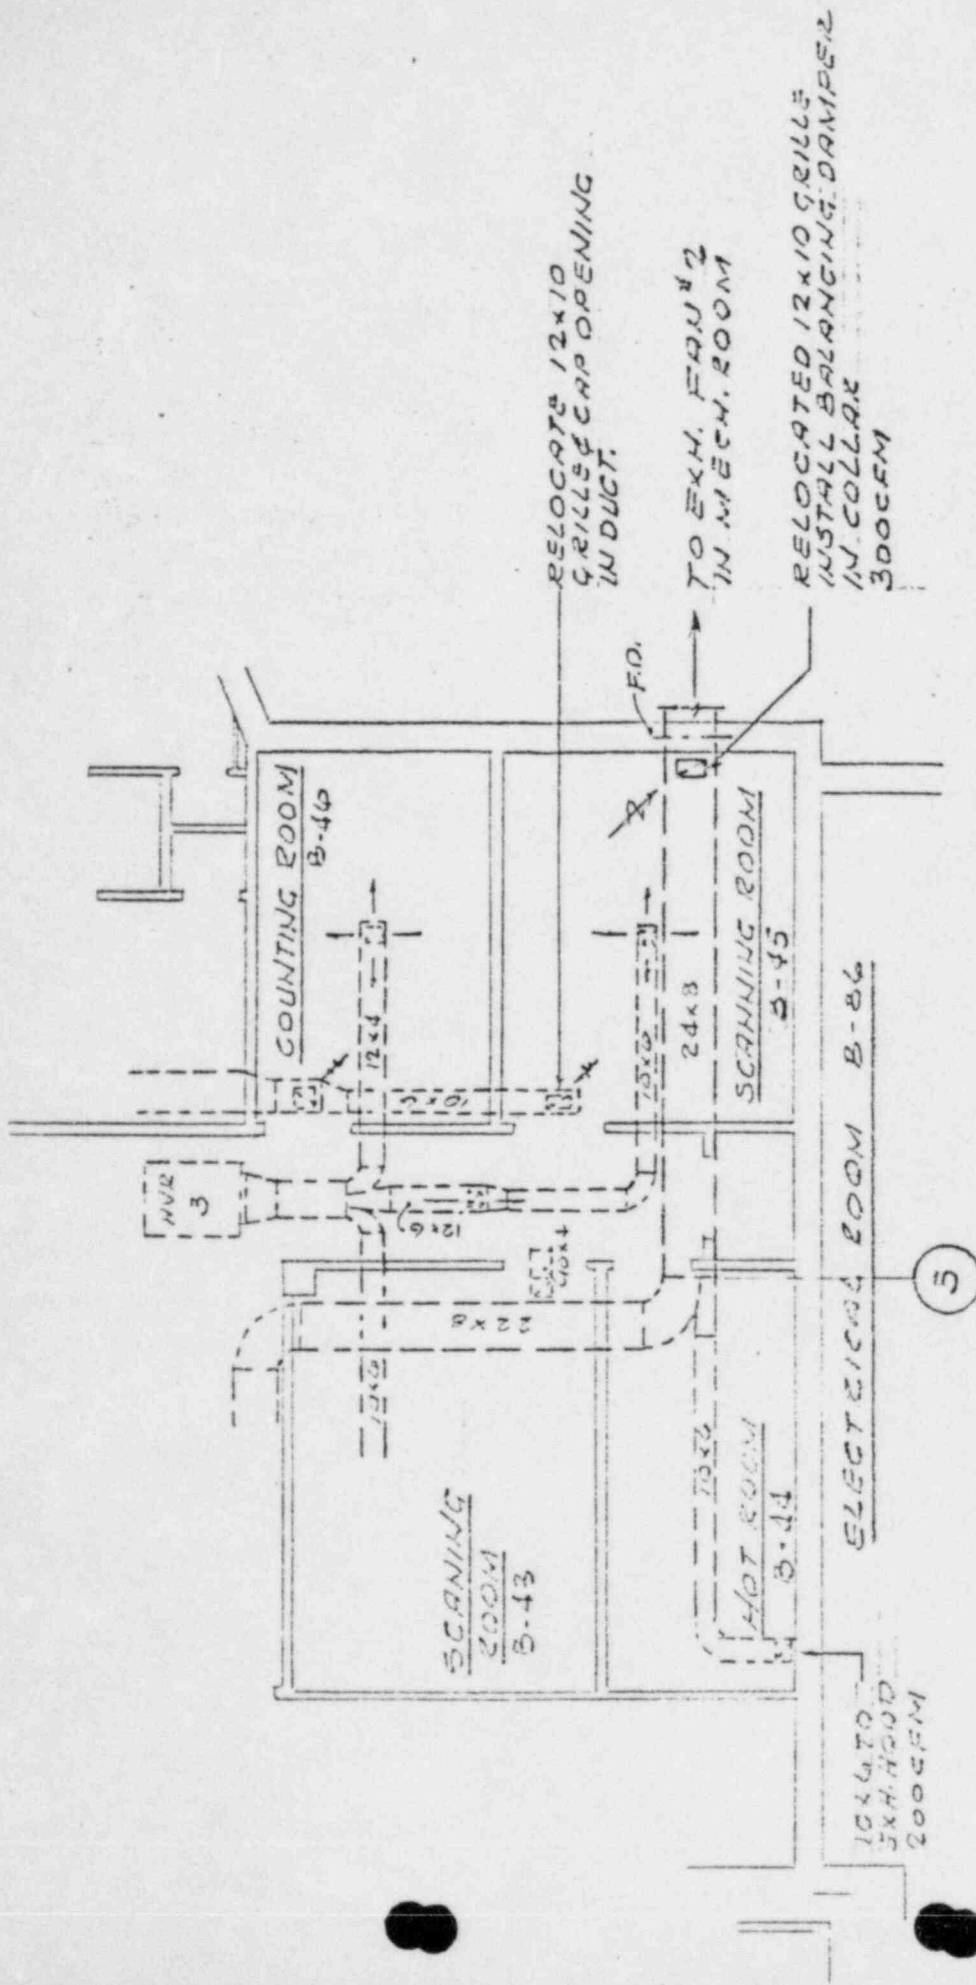
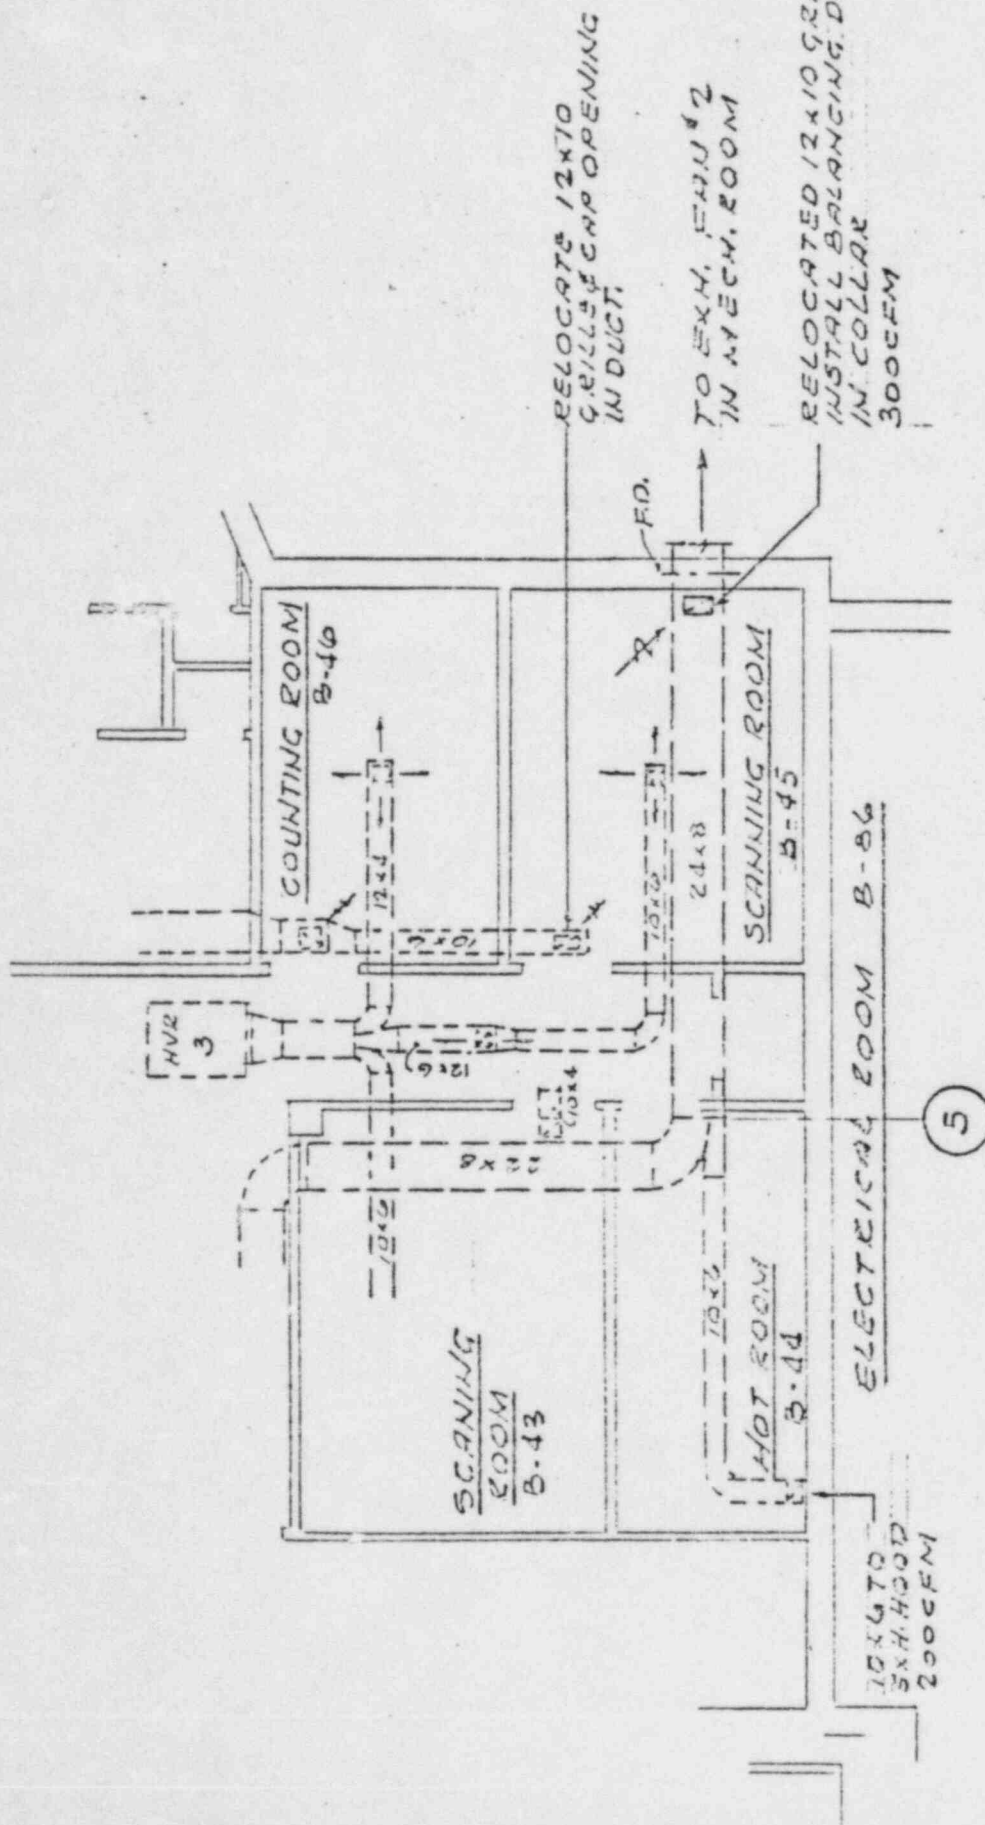
PARTIAL BASEMENT PLAN
SCALE: 1/8" = 1'-0"

At present the Hot Room is supplied with 150 cfm and exhausted at a rate of 200 cfm which results in a negative pressure. The Scanning Room is supplied with 250 cfm and this air is returned to the air handling system. It is recommended the return from this room be blanked off and a new exhaust outlet be cut into the existing duct system as indicated on the enclosed sketch. The writer met with your Mr. Lee M. Covenko at the hospital on March 14, 1977 and it was his opinion this work could be accomplished by hospital personnel.

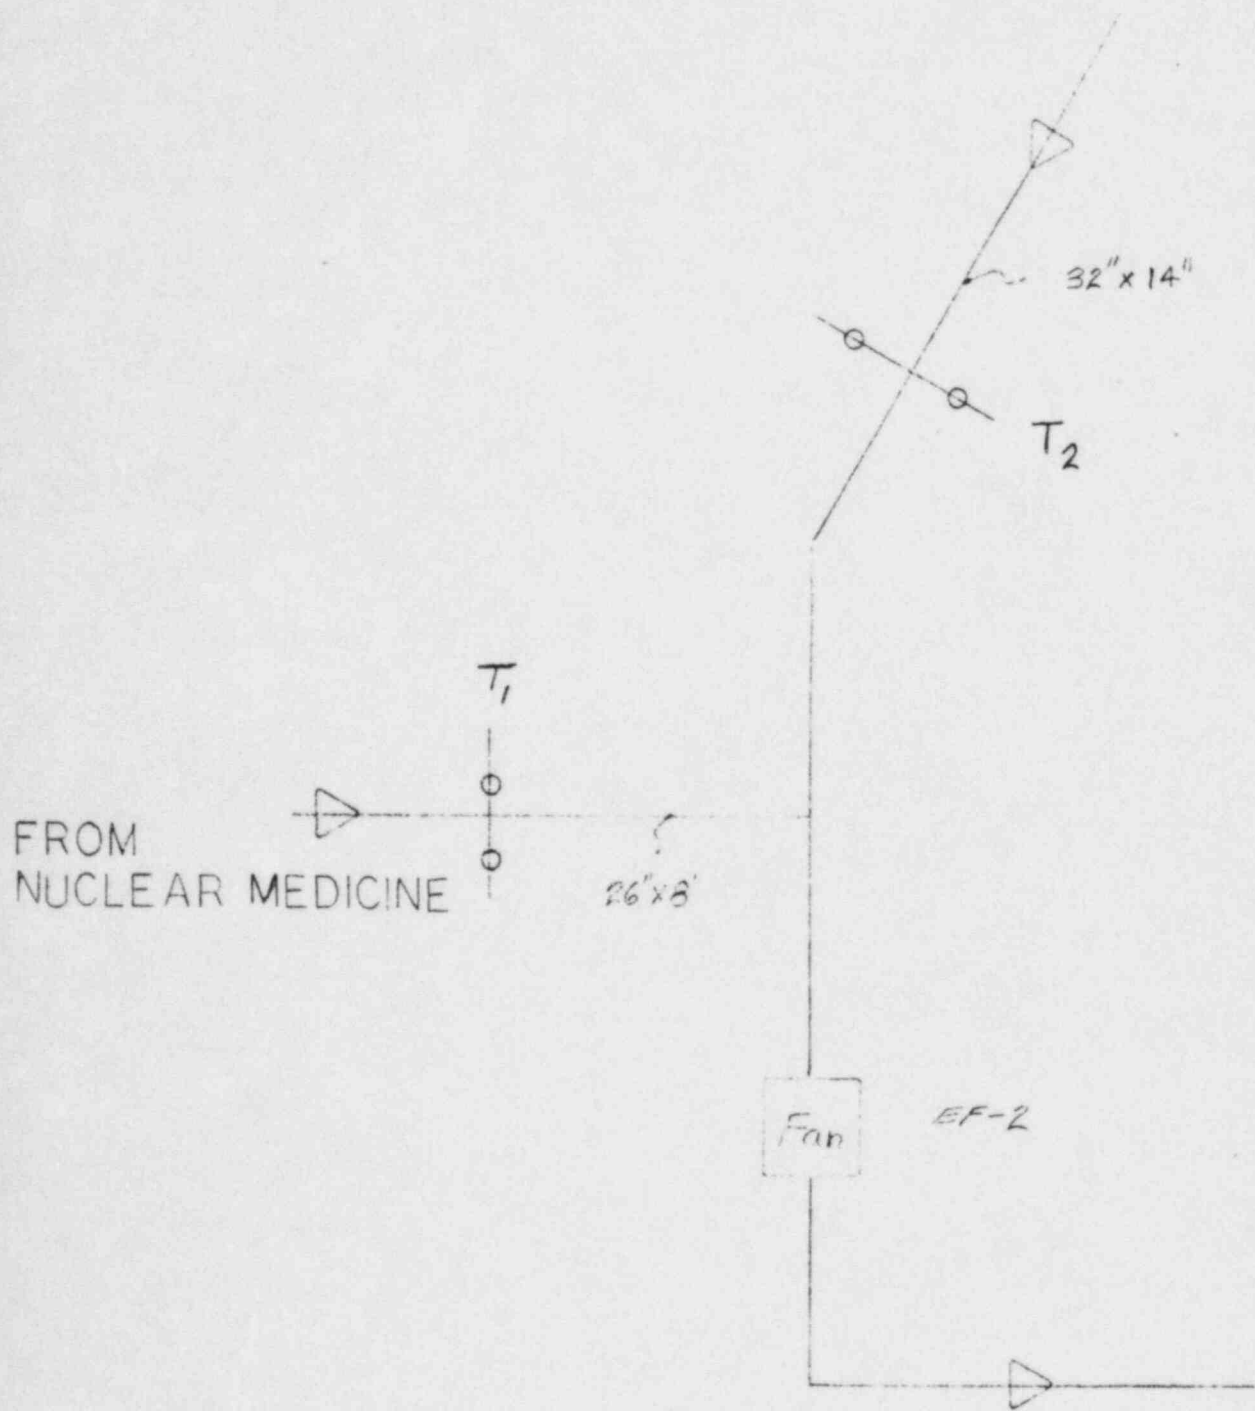
EXHAUST SYSTEM

Room R-33 had its original return air grille removed and a new exhaust grille installed. The exhaust grille was attached to the exhaust system fan No. 2. This exhaust system has two branch ducts, one serving a large portion of the basement, and the other serving another part of the basement which includes the nuclear medicine area. These two ducts are then joined together, both of which are served by exhaust fan # 2, as shown on page D.

Exhaust fan # 2 was designed to deliver 3,550 CFM. This fan total is made up of the CFM total of exhaust grilles in the branch duct coming from the nuclear medicine area and 14 exhaust grilles in the other duct serving the remainder of the basement. This information was taken from the sheet metal drawings. The lab hood in room R-32 is not included in this total. The lab hood could have an air quantity of anywhere from 150 CFM, which would match the supply air quantity into this room, or a maximum of 325 cu.ft. per minute, based on the lab hood gate being open 1/4 of its full opening and a capture velocity of 100 FPM. Excluding the lab hood air quantity, the fan is presently operating 15% below design. There are five amperes left in the motor rating, however the drive package is at its present maximum limit. To achieve the 3,550 CFM would require a new motor and drive package and a review of the fan curve.

Page B shows the design air quantity, less the lab hood to be 1,200 CFM. The actual air quantity is 953 CFM, which is approximately 20% low. Page C shows the design CFM and actual CFM for the other branch which is operating approximately 12% low.

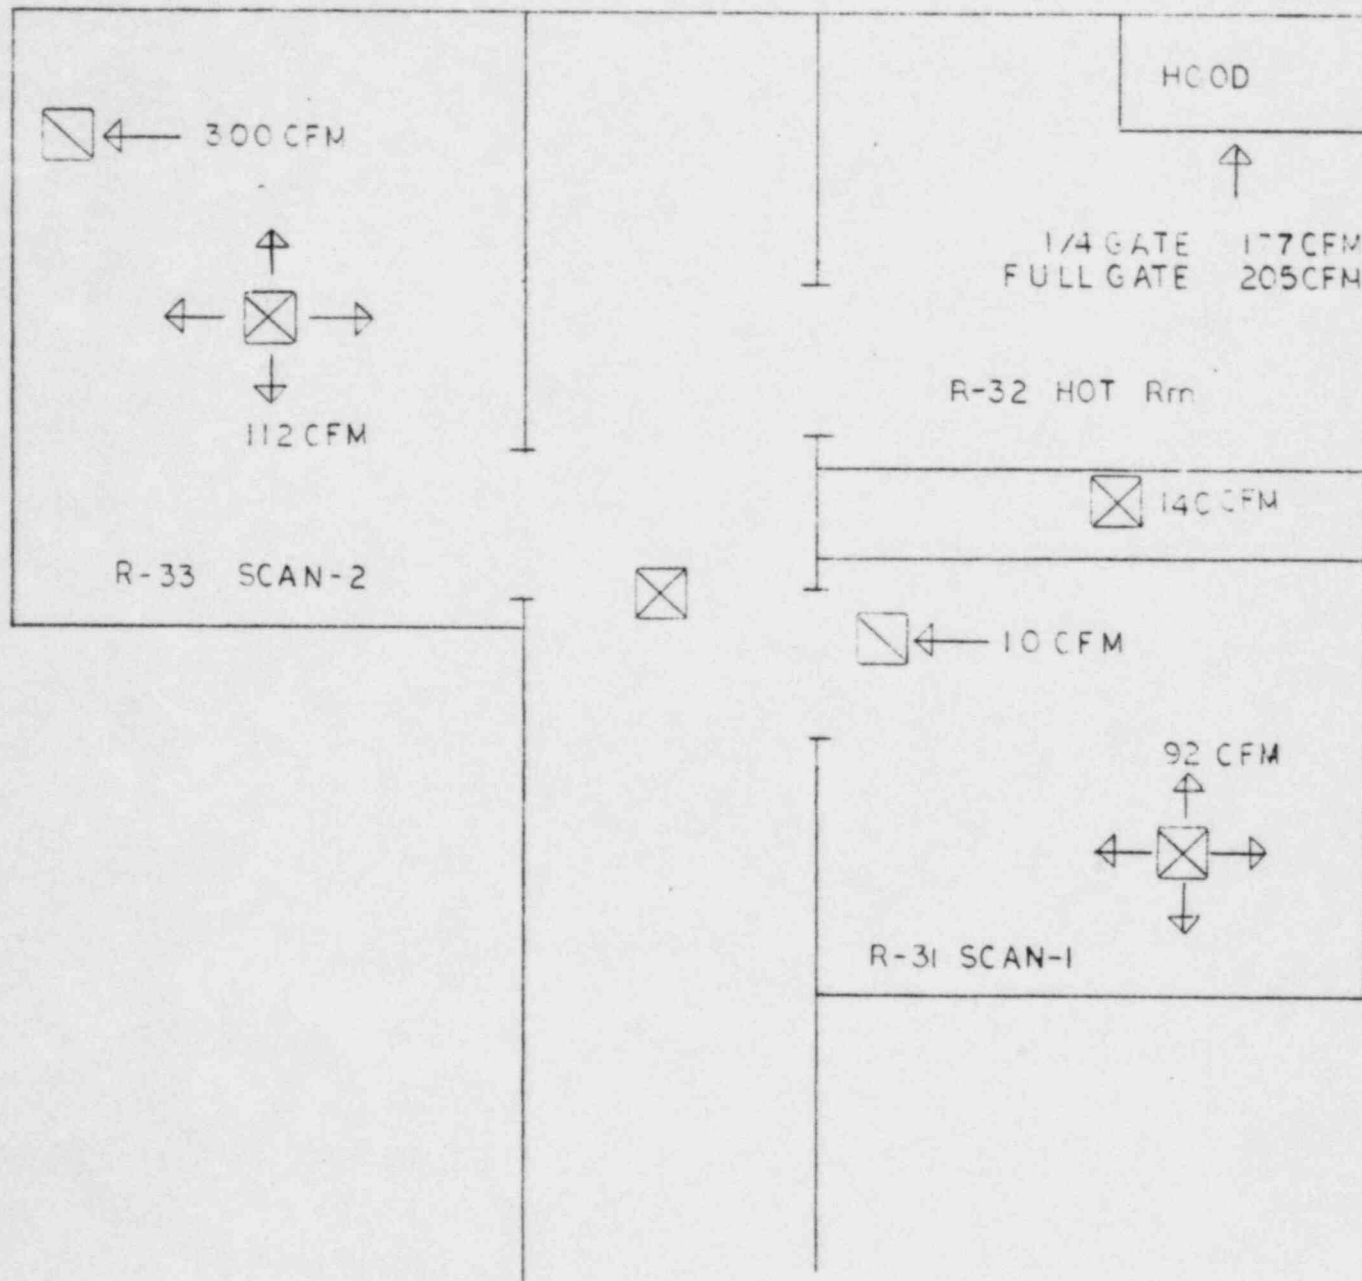
Page F shows the results of the tracer smoke when the smoke was injected in the corridor upstream of the 3 rooms. The smoke indicated a good velocity going down the corridor and into Room R-33. The entrance into room R-32 was somewhat slower and completely by-passed room R-31.

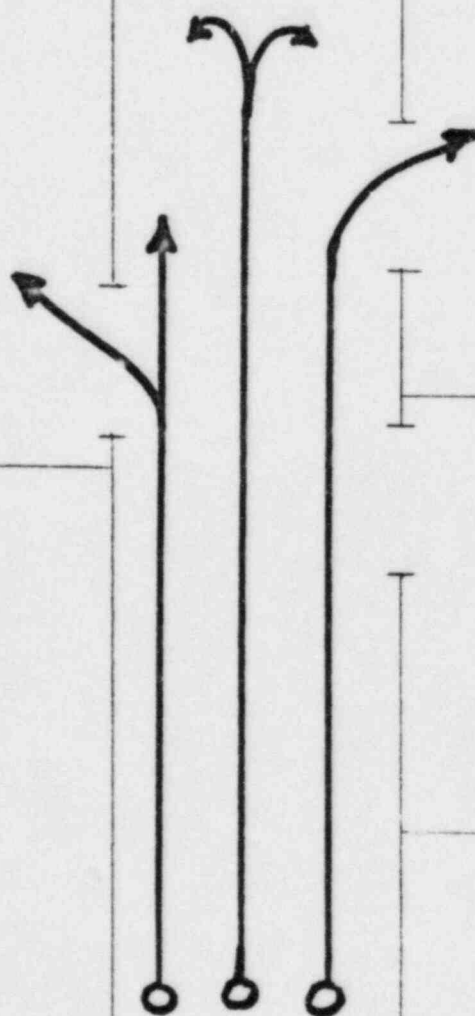
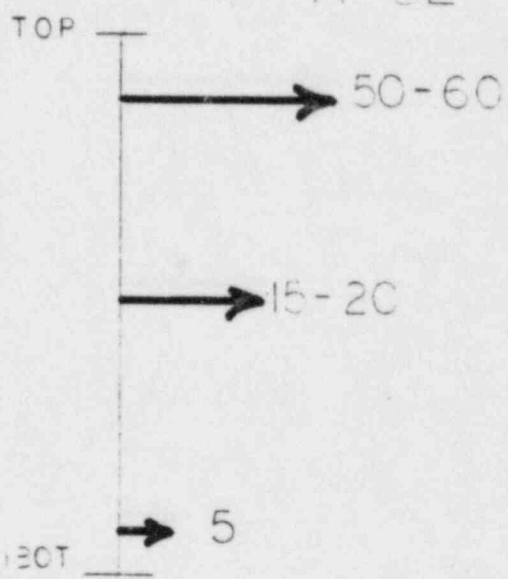
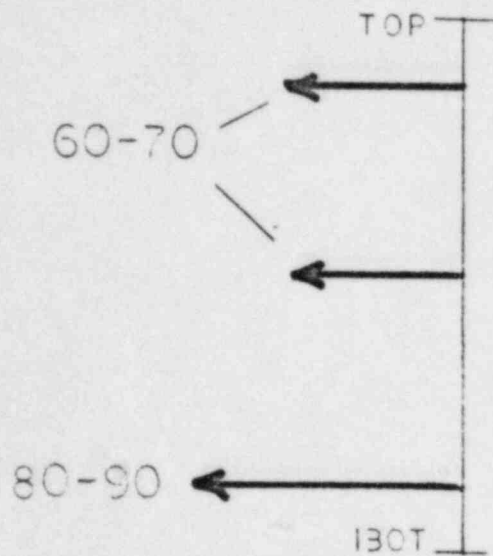
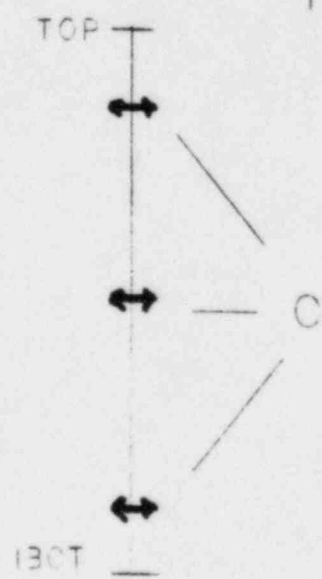
DOOR VEL. IN FPM
INTO ROOM

The new exhaust grille in Room R-33 was scheduled for 200 CFM. The adjustment of this outlet was left higher than design because at the time of adjustment the ceiling in this room was still open to the return air plenum. The added CFM will be required to produce good conducted flow into this room. The supply to this room is below design with the adjusting damper full open.

Room R-31 is in very poor condition. The supply air is far below design, as is the exhaust air quantity. The exhaust (this could very well be a return air grille) would barely remove tracer smoke when the smoke was injected immediately in front of the grille.

Page G shows the results of the tracer smoke test at each door into each of the rooms tested. The tracer smoke was emitted at the door line or slightly outside of the door starting at the top going to the bottom. The heavy dark lines show the results of the smoke test and the numbers indicate the approximate air velocities into the rooms. Room R-31 had almost no motion, either in or out of the

room which was also demonstrated on the previous page.

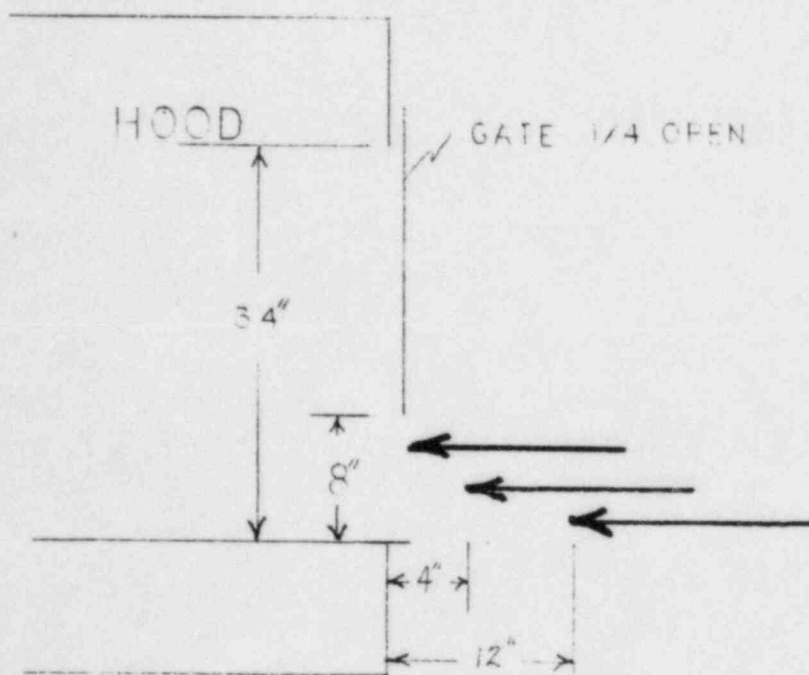
RM-32 HOT ROOM

Room 32 has a supply air inlet that does not have a face plate installed.. The air is dropping straight down on the work bench. The lab hood was measured at the lab hood gate full open and 1/4 open. On page H, the lab hood was tested with smoke to insure that proper capture was being effected. The heavy dark lines indicate the smoke tracer, which was used to demonstrate capture. The top line indicates very good capture right at the gate opening. The middle line had very good capture 4" out from the gate, and the bottom line had good to fair capture 12" out from the gate. Very little backwash occurred under this gate condition. When the gate was full open, the face velocity dropped down to approximately 15 FPM and the capture became very sluggish.
