UNITED STATES
NUCLEAR REGULATORY COMMISSION
REGION III
799 ROOSEVELT ROAD
GLEN ELLYN, ILLINOIS 60137

SUBJECT: DOW CHEMICAL CO.
LICENSE NO. STB-527
BURIAL OF THORIUM SLAG RESIDUE

DECOMMISSIONING OF THE DOW/WELLMAN FOUNDRY SITE IN BAY CITY, MICHIGAN

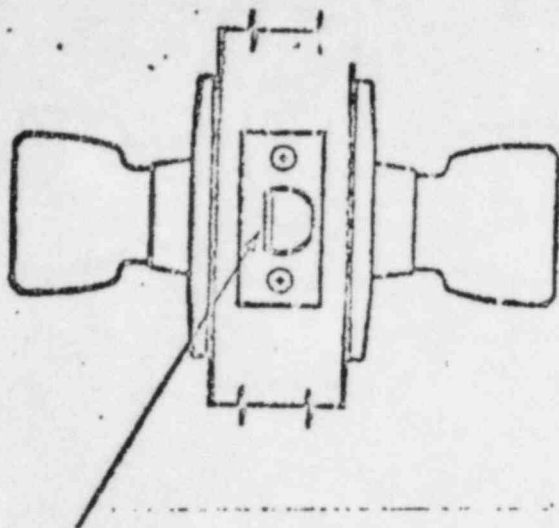
FIGURE 1
LATCH

NO DEADLATCHING
PIN

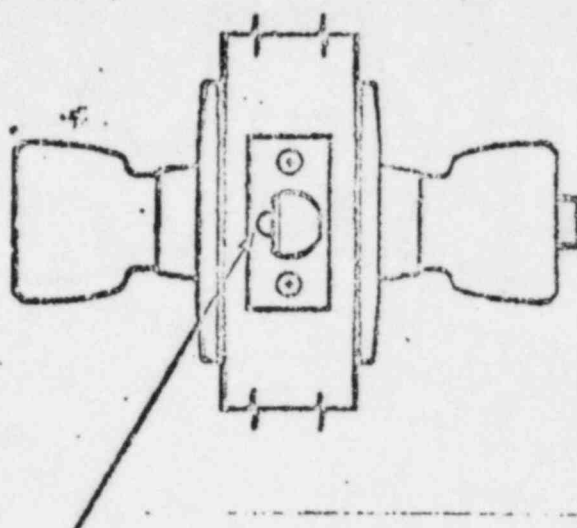
FIGURE 2
DEAD LATCH

DEADLATCHING PIN
