In the Matter of
LONG ISLAND LIGHTING COMPANY
(Jamesport Nuclear Power Station, Units 1 & 2)
Docket Nos. 50-516 & 50-517

SUBJECT: NRC FIRE PROTECTION RESEARCH TEST

SUBJECT: UL FIRE PROTECTION TESTS

NRC Staff Evaluating Results of Test
of Fire Protection Systems

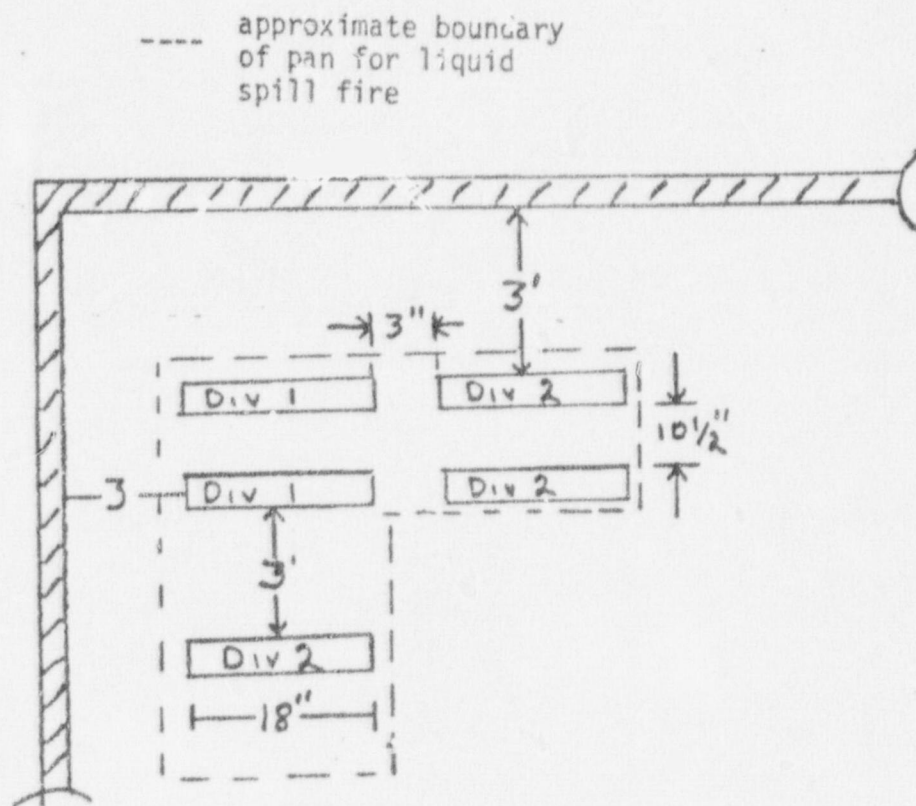
The configuration of the fire test was selected to simulate a section of a plant area with vertical cable trays containing redundant safety divisions arranged such that the redundant divisions could be simultaneously exposed to a potential fire resulting from an inadvertent spill of flammable liquid in the area. The arrangement of the cable trays and the designation of the redundant tray divisions is shown in Figure 1 taken from the User Request Memorandum.^{1/} Figure 2 shows the location of the fire detectors and the three groups of sprinklers. Each of the five cable trays was enclosed in a separate mineral wool blanket fire barrier from floor to ceiling in accordance with the manufacturers specifications currently recommended to their customers. The sprinkler and detector arrangement was as permitted by NFPA Code.

At about 3 minutes there was an indication of a short circuit in cable trays 3, and after 7 minutes indication of a short in tray 1. After 5-7 minutes the height of the flames appeared to subside; however, residual flames continued for about 40 minutes. It was reported that apparently the highest measured temperature inside any cable bundle was less than 150 F; however, damage to the cables indicates that higher temperatures were reached in the trays at the bottom regions, below the location of the thermocouples.

Test results are still being analyzed and no firm conclusions can be drawn at this time. Preliminary information received from RES subsequent to the test indicates that the flammable liquid or flames penetrated an opening in the protective barriers at the bottom of the vertical trays and caused fire damage to the PVC cables in four of the five trays. The electrical short to ground that occurred in cable tray 3 probably was caused by the fire. The second electrical short in tray 1 apparently was caused by a broken instrument connection, and is not considered to be related directly to the fire. On subsequent 500-volt megger tests, it was found that another cable in tray 2 had also experienced some damage.

The most probable cause of the fire damage in certain cable trays appears to be related to the absorption and/or seepage of heptane under the mineral wool blanket at the juncture with the floor. Once the heptane entered the interior regions of the cable tray, then ignition apparently occurred via the small opening at the floor or through a vapor/air path within the joints. It is believed that this type of failure mode could be prevented by using a seal material that would prevent the absorption or the seepage of heptane under the mineral wool blanket. There is some indication that some cable damage was caused by absorption of the inside of the barrier (wicking effect) which heated a cable tray ladder, causing damage to a cable in contact with the ring. The investigation of the results is still underway, and while no definitive findings can be stated, damage did occur to cables in several trays due to the fire. The slow response of the sprinkler system was not predicted. The ingress of the heptane into the mineral wool needs to be further evaluated since this appears to be the most significant failure mode.

Vertical Tray Corner Test

The test results are still being analyzed and it would be premature to establish firm conclusions at this time; however, the results now available indicate: (a) fire detectors located approximately 15 feet away from the fire promptly (~15 sec) detected the fire; (b) some small fires may not actuate sprinkler heads; and (c) protective barriers should be designed to prevent the entry of flammable liquids.
