In the Matter of  
The Detroit Edison Company  
(Greenwood Energy Center, Units 2 and 3)  
Docket Nos. 50-452, 50-453

SUBJECT: NRC FIRE PROTECTION RESEARCH TEST

SUBJECT: UL FIRE PROTECTION TESTS

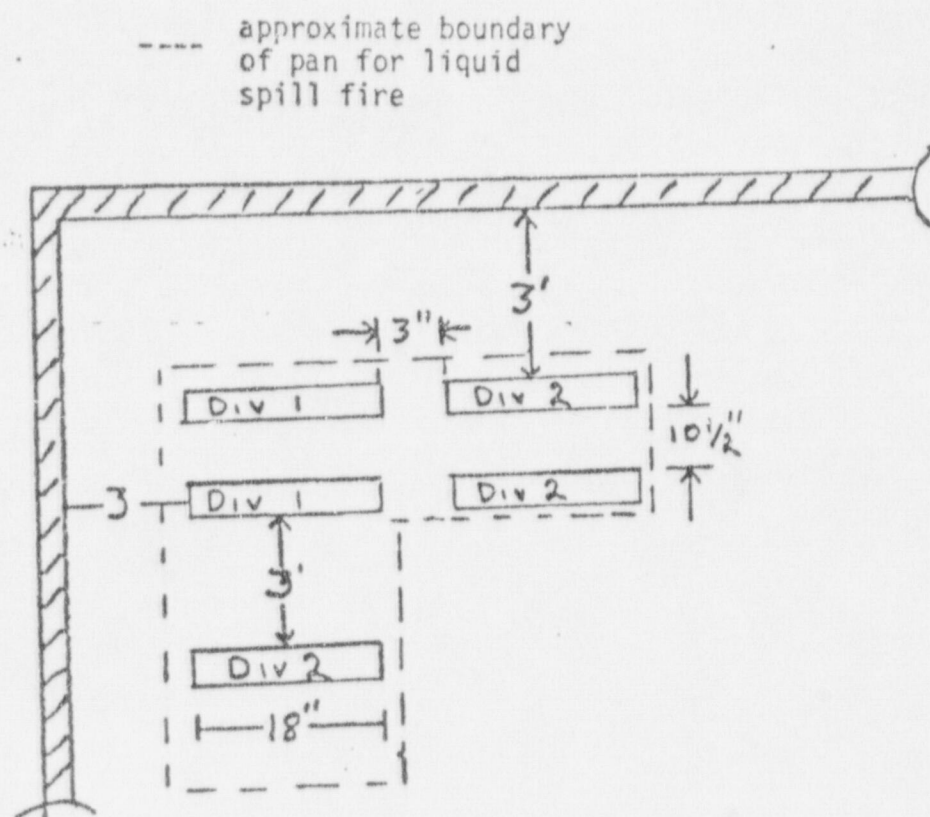
Figure 1

At about 3 minutes there was an indication of a short circuit in cable trays 3, and after 7 minutes indication of a short in tray 1. After 5-7 minutes the height of the flames appeared to subside; however, residual flames continued for about 40 minutes. It was reported that apparently the highest measured temperature inside any cable bundle was less than 150 F; however, damage to the cables indicates that higher temperatures were reached in the trays at the bottom regions, below the location of the thermocouples.

Test results are still being analyzed and no firm conclusions can be drawn at this time. Preliminary information received from RES subsequent to the test indicates that the flammable liquid or flames penetrated an opening in the protective barriers at the bottom of the vertical trays and caused fire damage to the PVC cables in four of the five trays. The electrical short to ground that occurred in cable tray 3 probably was caused by the fire. The second electrical short in tray 1 apparently was caused by a broken instrument connection, and is not considered to be related directly to the fire. On subsequent 500-volt megger tests, it was found that another cable in tray 2 had also experienced some damage.

The most probable cause of the fire damage in certain cable trays appears to be related to the absorption and/or seepage of heptane under the mineral wool blanket at the juncture with the floor. Once the heptane entered the interior regions of the cable tray, then ignition apparently occurred via the small opening at the floor or through a vapor/air path within the joints. It is believed that this type of failure mode could be prevented by using a seal material that would prevent the absorption or the seepage of heptane under the mineral wool blanket. There is some indication that some cable damage was caused by absorption of the inside of the barrier (wicking effect) which heated a cable tray ladder, causing damage to a cable in contact with the ring. The investigation of the results is still underway, and while no definitive findings can be stated, damage did occur to cables in several trays due to the fire. The slow response of the sprinkler system was not predicted. The ingress of the heptane into the mineral wool needs to be further evaluated since this appears to be the most significant failure mode.

Vertical Tray Corner Test

The test results are still being analyzed and it would be premature to establish firm conclusions at this time; however, the results now available indicate: (a) fire detectors located approximately 15 feet away from the fire promptly (~15 sec) detected the fire; (b) some small fires may not actuate sprinkler heads; and (c) protective barriers should be designed to prevent the entry of flammable liquids.
