**Subject:** [External\_Sender] Salem Generating Station - Incidental Take Reports: Atlantic  
Sturgeon 04/06/2021  
**Sent Date:** 4/7/2021 9:25:54 AM  
**Received Date:** 4/7/2021 9:26:39 AM  
**From:** Cary, Richard H.

### Appendix C, Part 2A (Sturgeon)

# STURGEON DATA COLLECTION FORM

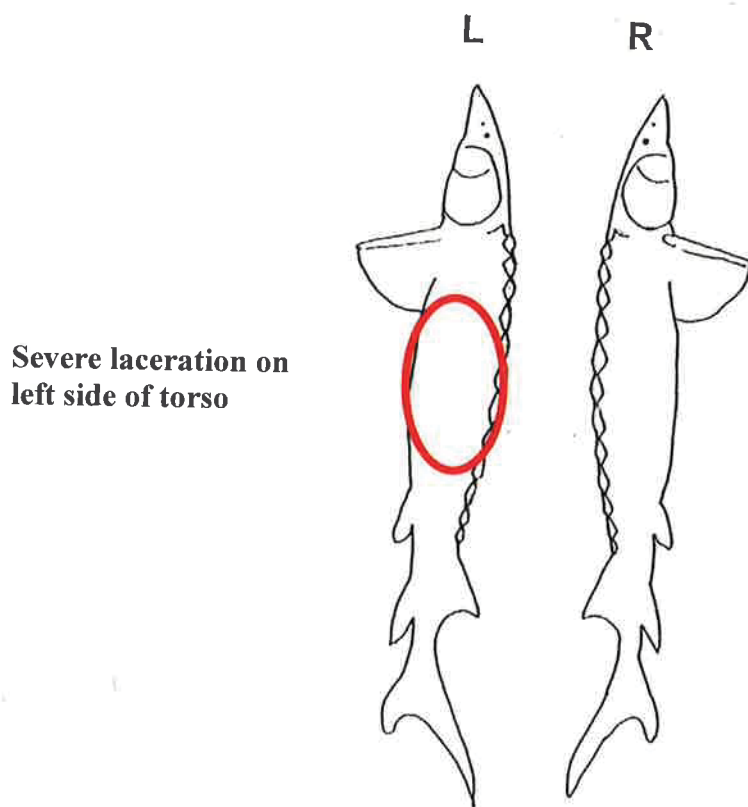
Describe any wounds / abnormalities (note tar or oil, gear or debris entanglement, propeller damage, etc.). Please note if no wounds / abnormalities are found. Specimen was deceased at the time of collection likely due to an existing severe laceration observed mid torso on the left side, and was found to extend from the dorsal scutes to the belly, exposing tissue and internal organs (refer to diagram above).

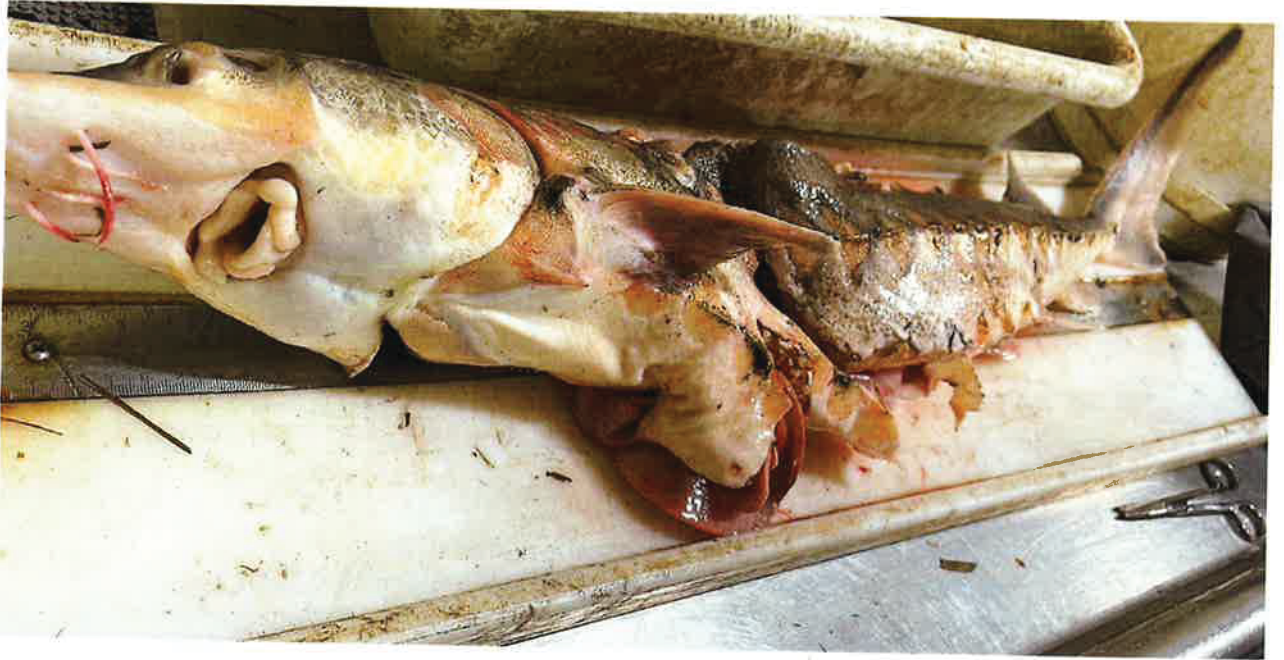
A ventral view showing the size and condition of the damaged and deceased Atlantic sturgeon (*Acipenser oxyrinchus*), retrieved at approximately 08:40AM on 04/06/2021 from the Salem Circulating Water Intake by Salem Yard Crew personnel during routine trash rack cleaning at Salem Nuclear Generating Station (04/06/2021).

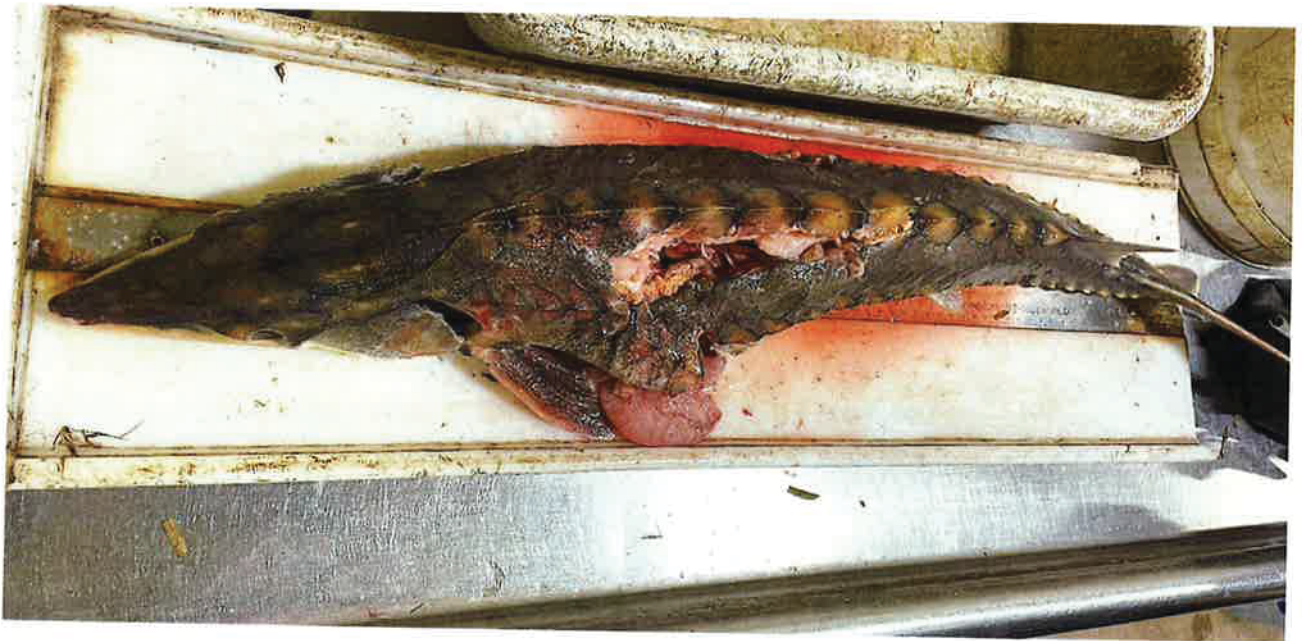
A dorsal view showing the extent of damage observed at the time of processing. A severe laceration, located mid torso on the left side, was found to extend from the dorsal row of scutes down to the belly, exposing damaged tissue and internal organs (04/06/2021).

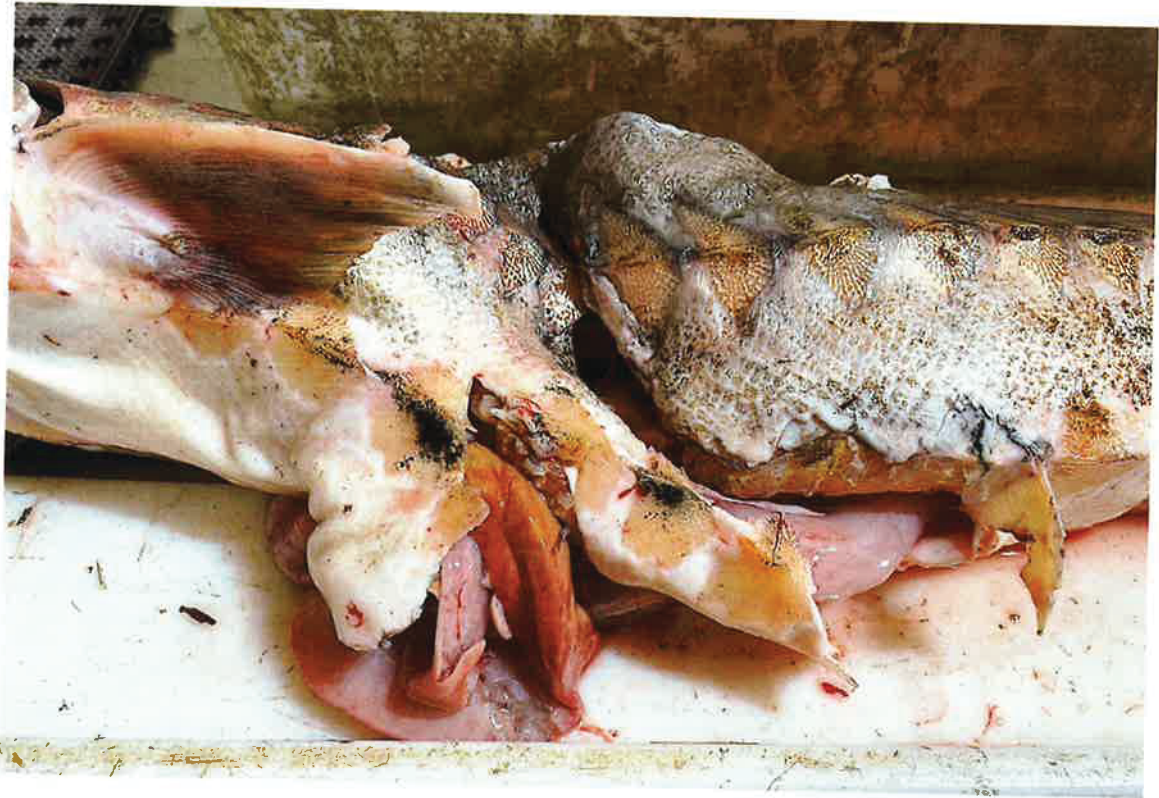
A close-up of the damage to the specimen, caused by a severe laceration to the left torso, which exposed damage tissue and internal organs (04/06/2021).

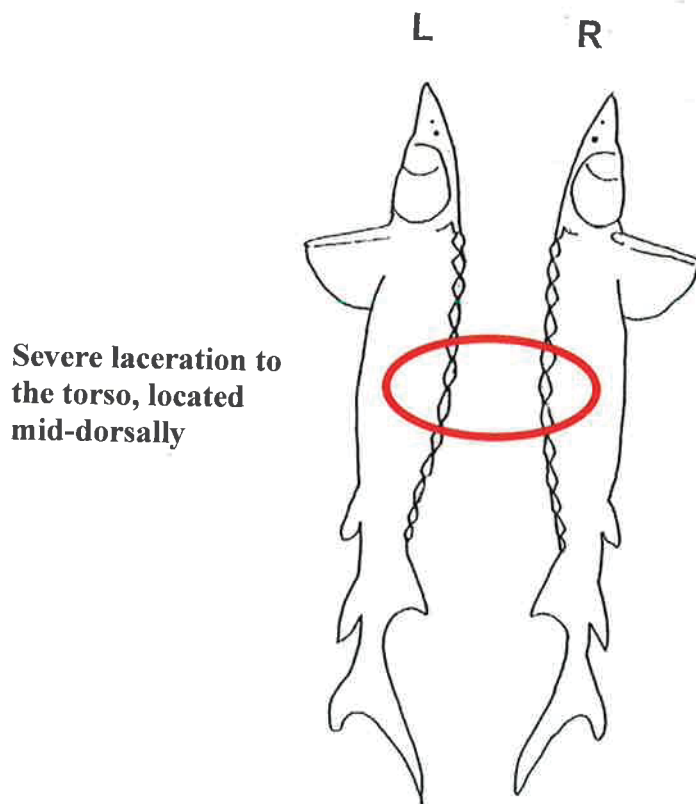
Describe any wounds / abnormalities (note tar or oil, gear or debris entanglement, propeller damage, etc.). **Please note if no wounds / abnormalities are found. Specimen was deceased at the time of collection due to an existing severe laceration, located dorsally and mid torso, which exposed damaged tissue, cartilage, and internal organs (refer to diagram above).**

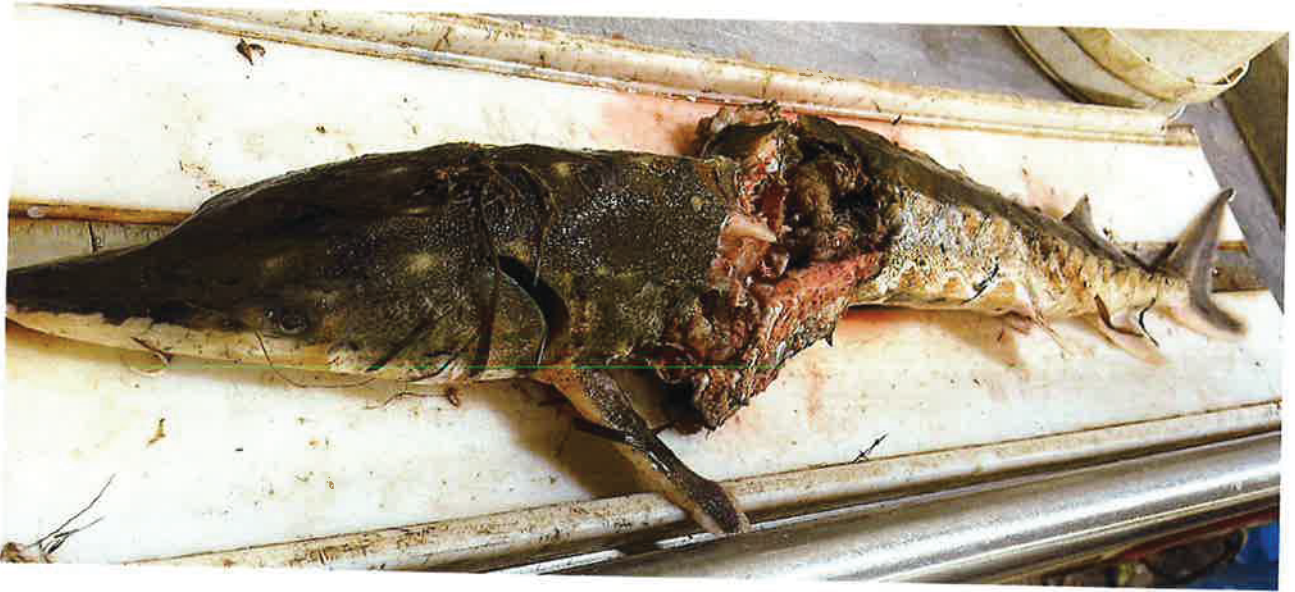
A dorsolateral view showing the size and condition of a second, severely damaged and deceased Atlantic sturgeon (*Acipenser oxyrinchus*), retrieved at approximately 09:30AM on 04/06/2021 from the Salem Circulating Water Intake by Salem Yard Crew personnel during routine trash rack cleaning at Salem Nuclear Generating Station (04/06/2021).

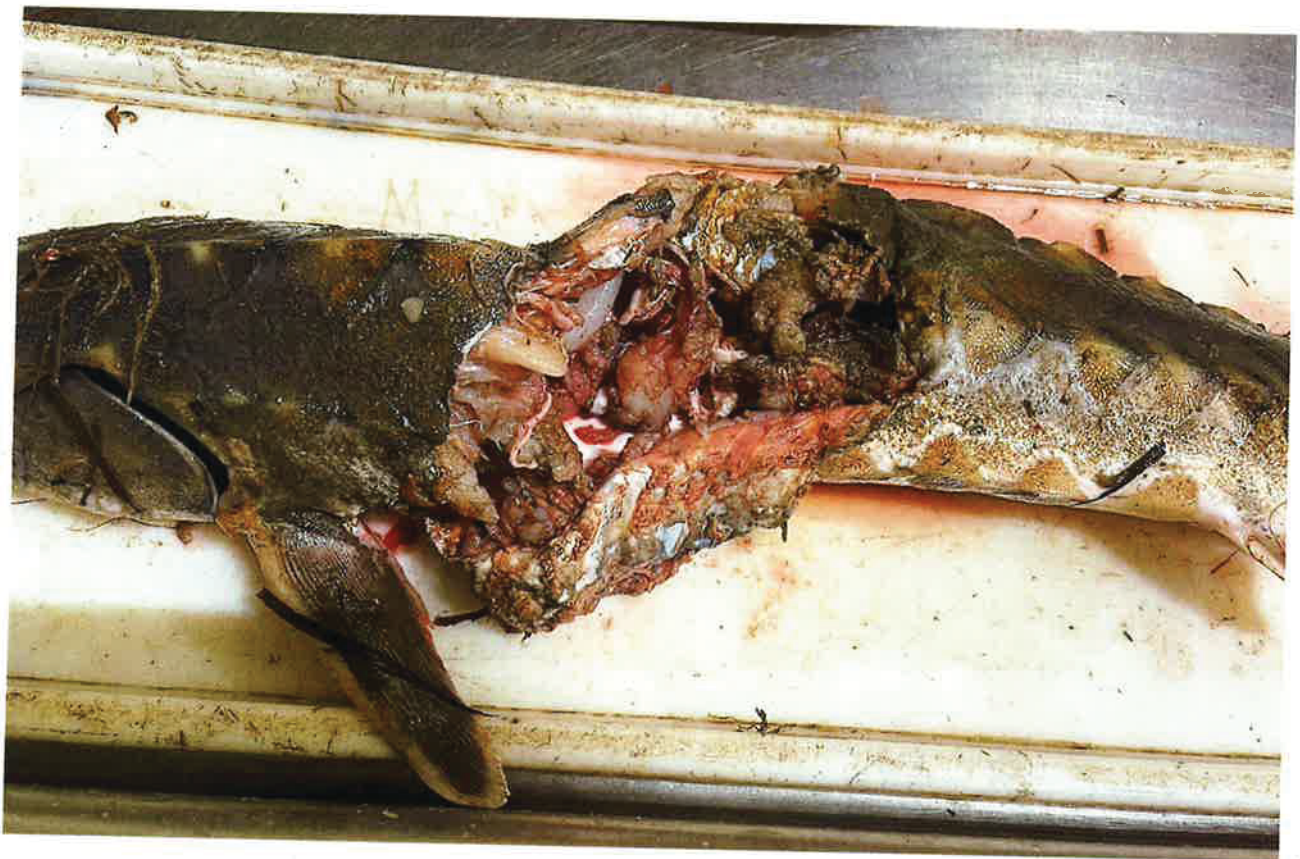
A dorsal view showing the extent of damage observed at the time of processing. A severe laceration, located dorsally and mid-torso, was exposing flesh, cartilage, and internal organs (04/06/2021).

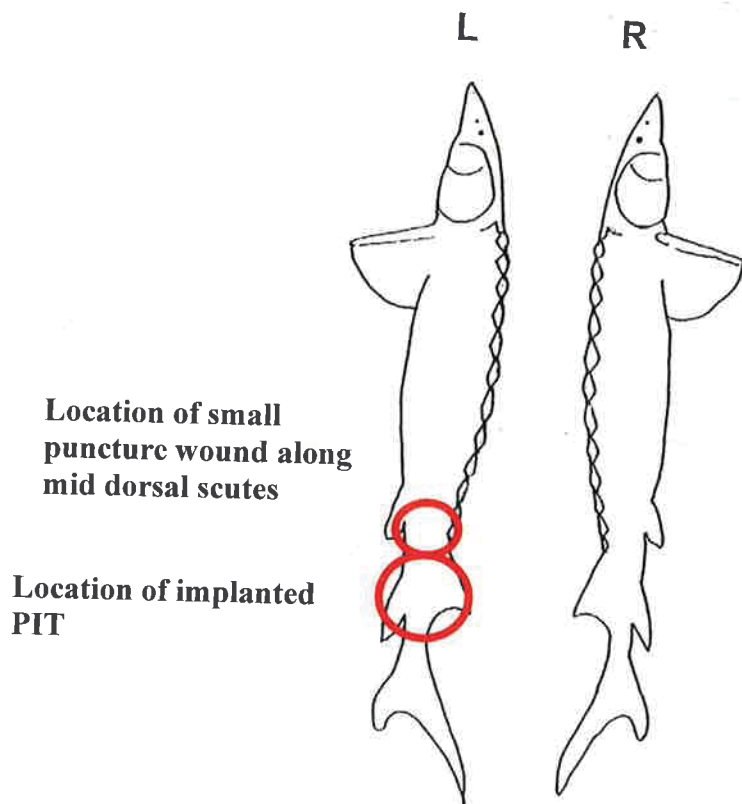
Describe any wounds / abnormalities (note tar or oil, gear or debris entanglement, propeller damage, etc.). Please note if no wounds / abnormalities are found. Specimen was alive at the time of collection, but shown evidence of minor damage in the form of a small puncture wound on the left side of the torso, along the mid-dorsal line of scutes (refer to diagram above). No PIT was indicated, so tagging procedures were implemented. Specimen received a PIT (#933000320184001), implanted below the dorsal fin on the left side.

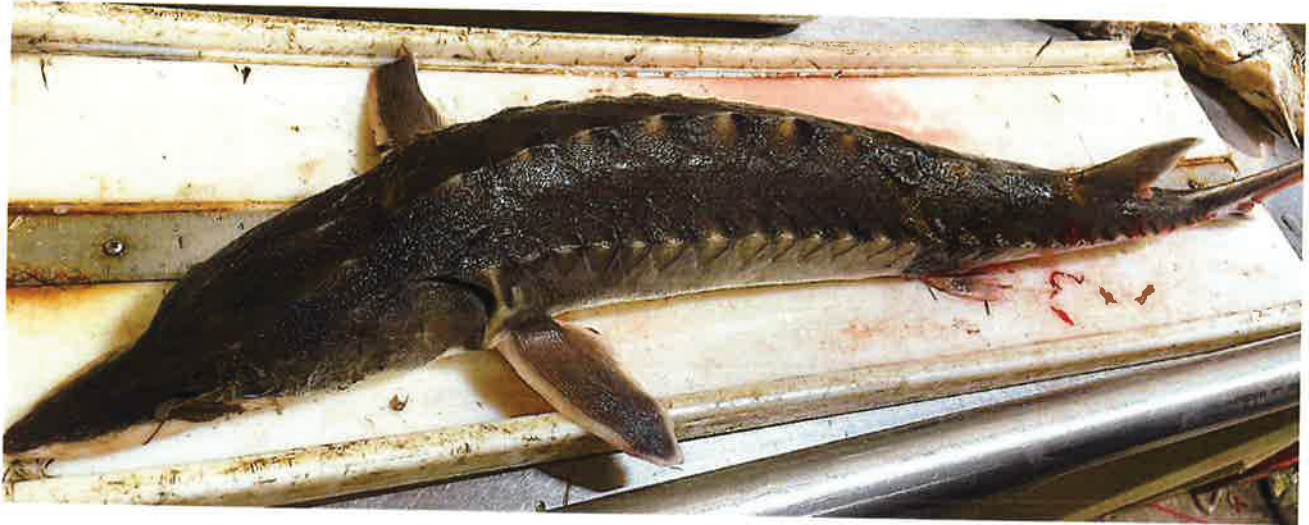
A ventral view showing the size and condition of a third Atlantic sturgeon (*Acipenser oxyrinchus*), retrieved alive at approximately 09:45AM on 04/06/2021 from the Salem Circulating Water Intake by Salem Yard Crew personnel during routine trash rack cleaning at Salem Nuclear Generating Station (04/06/2021).

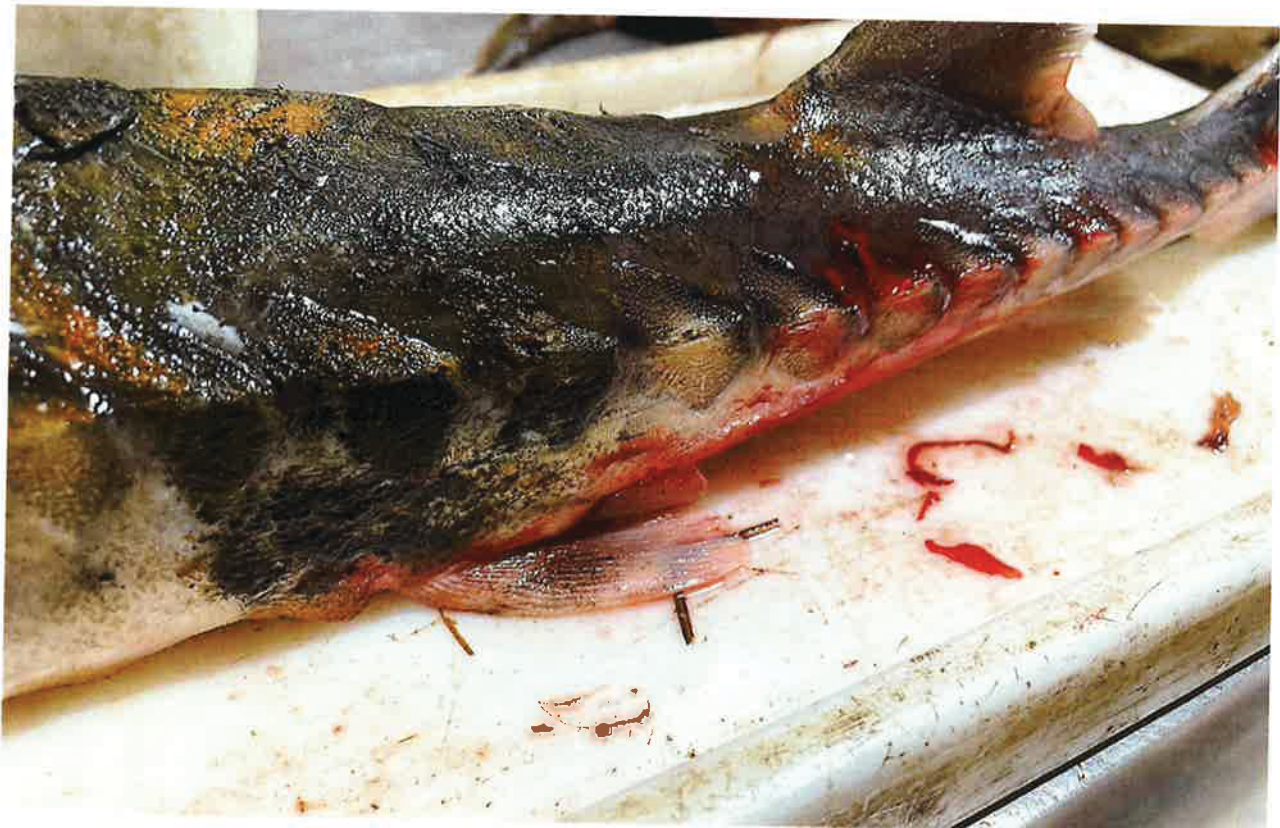
A dorsolateral view showing the extent of damage to the specimen observed at the time of processing. A puncture wound was observed below the dorsolateral line of scutes on the left side of the torso, and near the pelvic fin (04/06/2021).

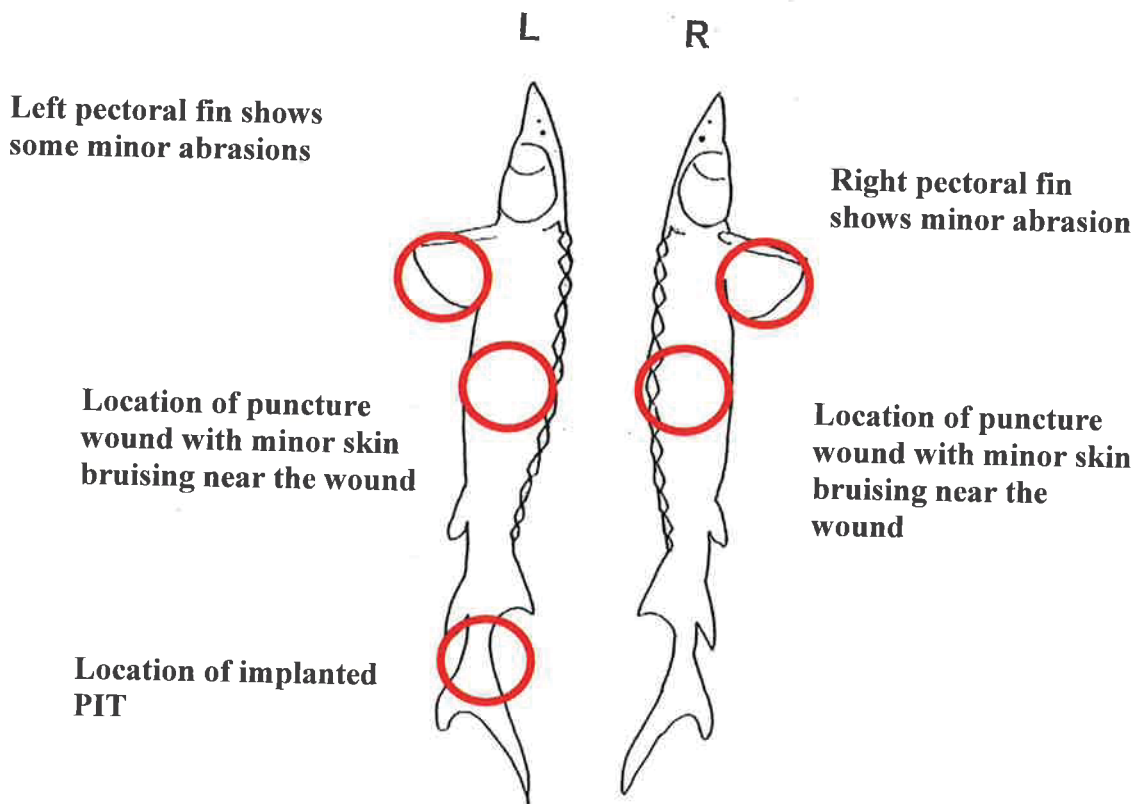
Describe any wounds / abnormalities (note tar or oil, gear or debris entanglement, propeller damage, etc.). Please note if no wounds / abnormalities are found. Specimen was alive at the time of collection, but exhibited damage in the form two puncture wounds located mid-torso, in the vicinity of the dorsolateral line of scutes on both the right and left sides. Specimen also exhibited evidence of surface bruising of the skin along and below the scutes near the puncture wounds, as well as minor abrasions to the pectoral fins. No PIT was indicated, so tagging procedures were implemented. Specimen received a PIT (#933000320184022), implanted below the dorsal fin on the left side (refer to diagram above).

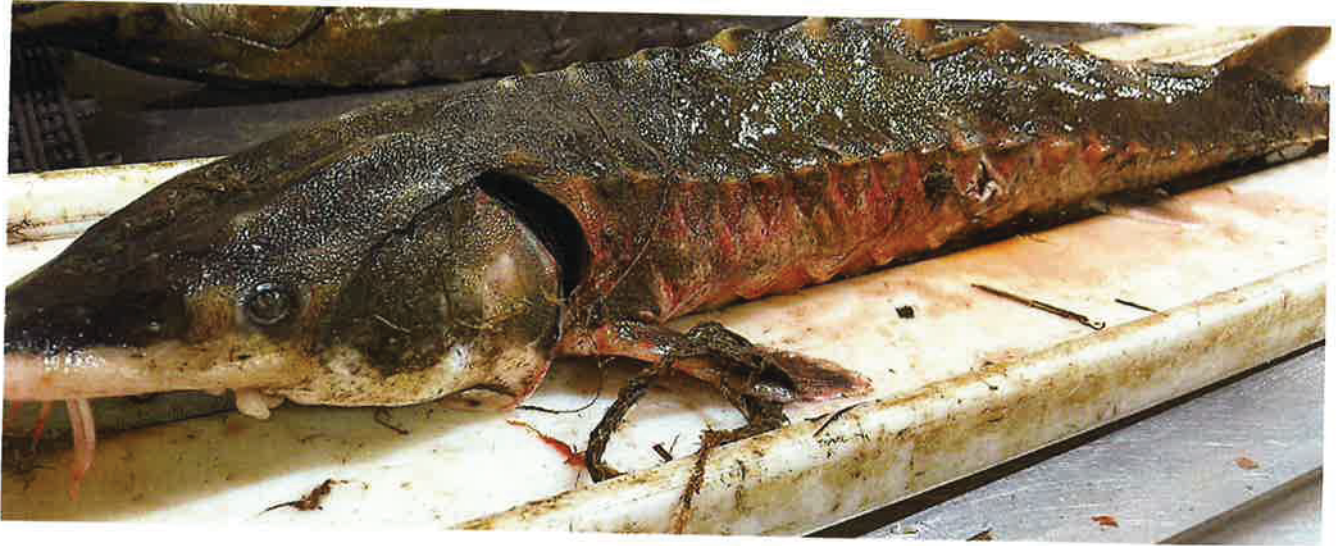
A dorsolateral view showing the size and condition of a fifth Atlantic sturgeon (*Acipenser oxyrinchus*), retrieved alive but showing moderate damage, at approximately 10:12AM on 04/06/2021 from the Salem Circulating Water Intake by Salem Yard Crew personnel during routine trash rack cleaning at Salem Nuclear Generating Station (04/06/2021).

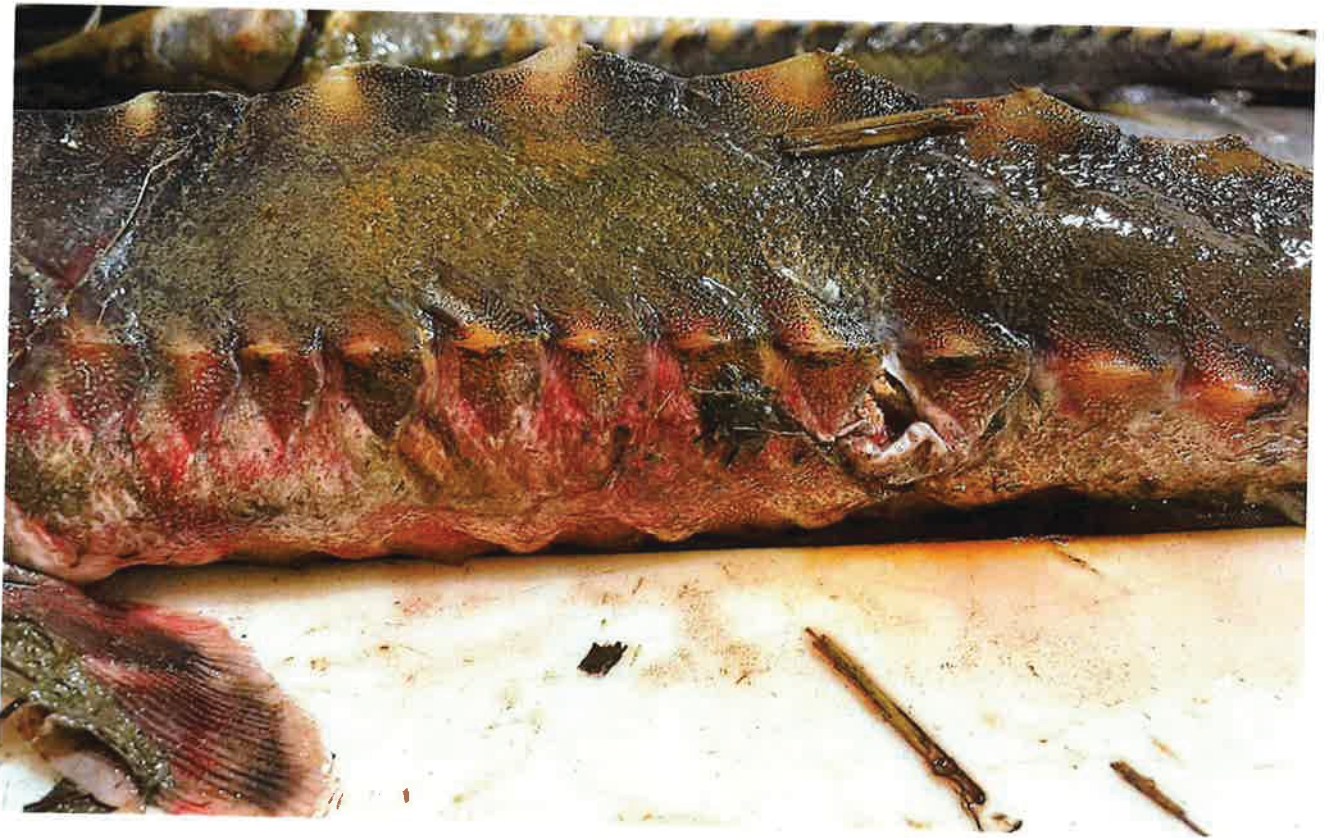
Dorsolateral view showing a close up of a puncture wound observed on the left side of the torso. Evidence of surface bruising on the side of the torso as well as on the pectoral fin was also evident (04/06/2021).

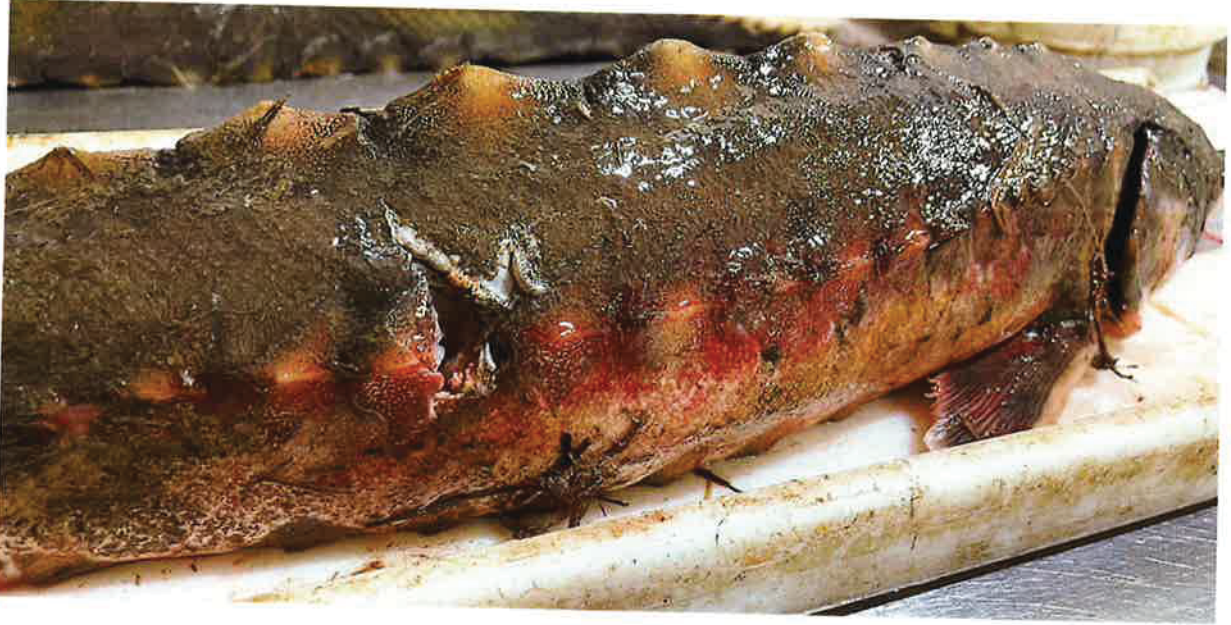
Dorsolateral view showing a close up of a puncture wound observed on the right side of the torso. Evidence of surface bruising on the side of the torso, as well as abrasions on the pectoral fin, are also evident (04/06/2021).

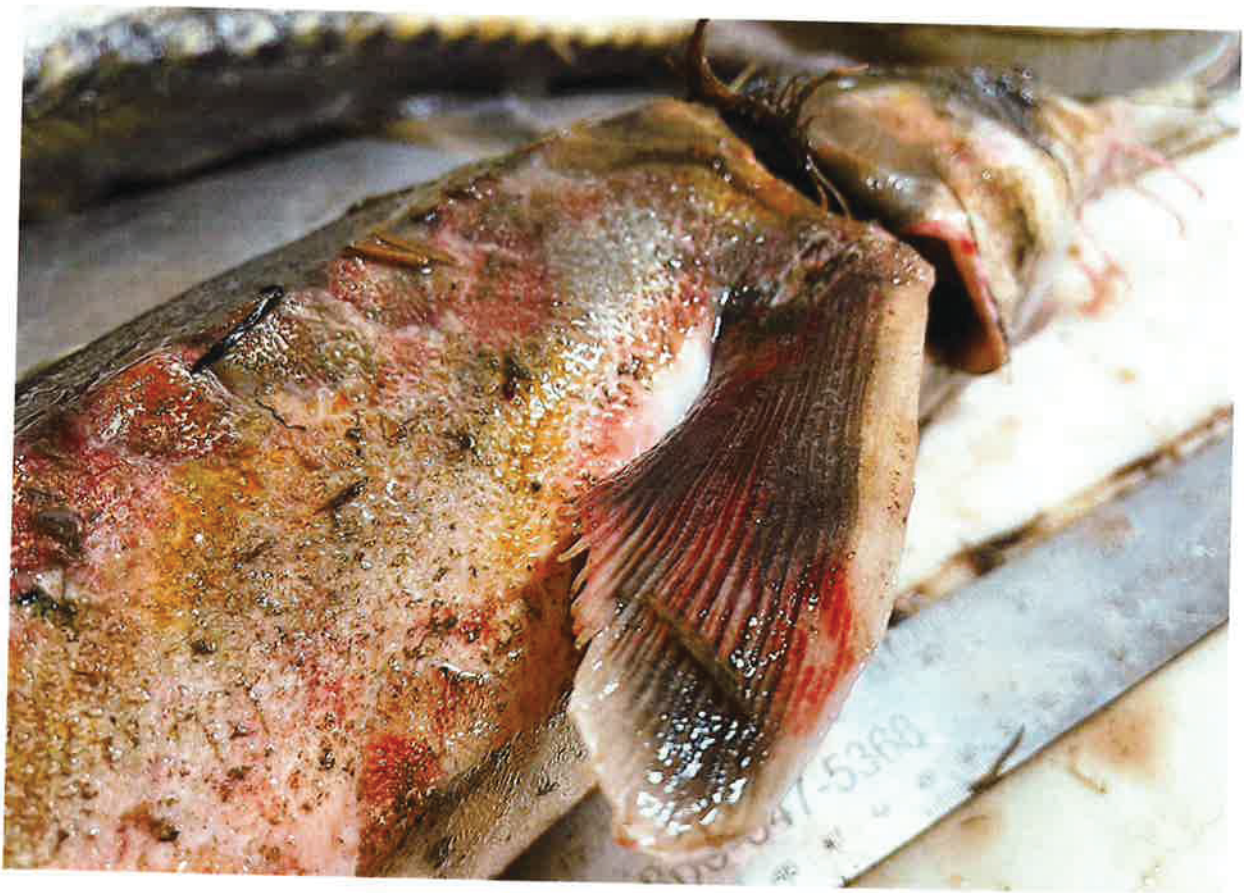
Dorsolateral view of the right side, showing a close-up of surface bruising on the torso and surface abrasions on the pectoral fin (04/06/2021).

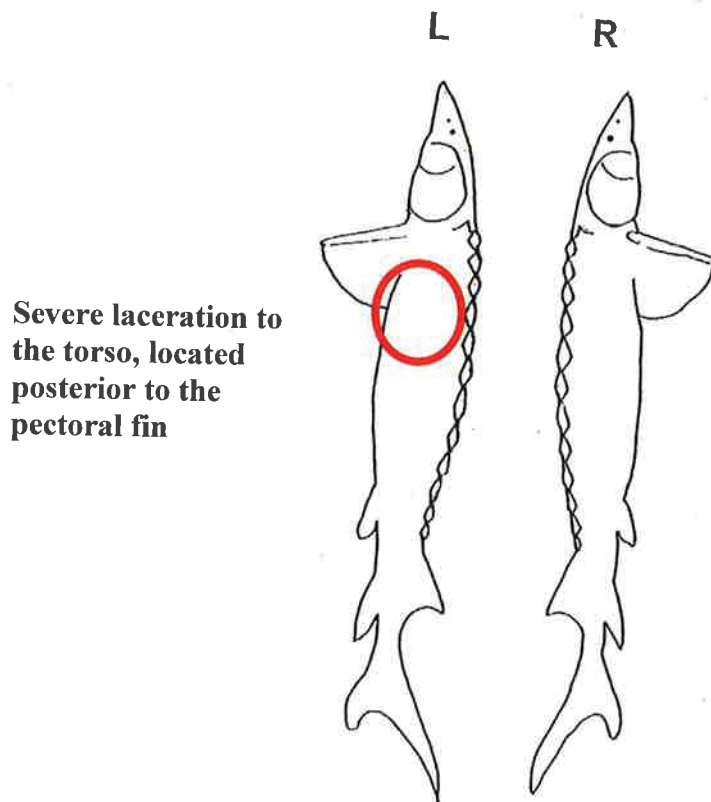
Describe any wounds / abnormalities (note tar or oil, gear or debris entanglement, propeller damage, etc.). Please note if no wounds / abnormalities are found. Specimen was deceased at the time of collection due to an existing severe laceration to the torso, located posterior to the left pectoral fin, which exposed damaged tissue and internal organs (refer to diagram above).

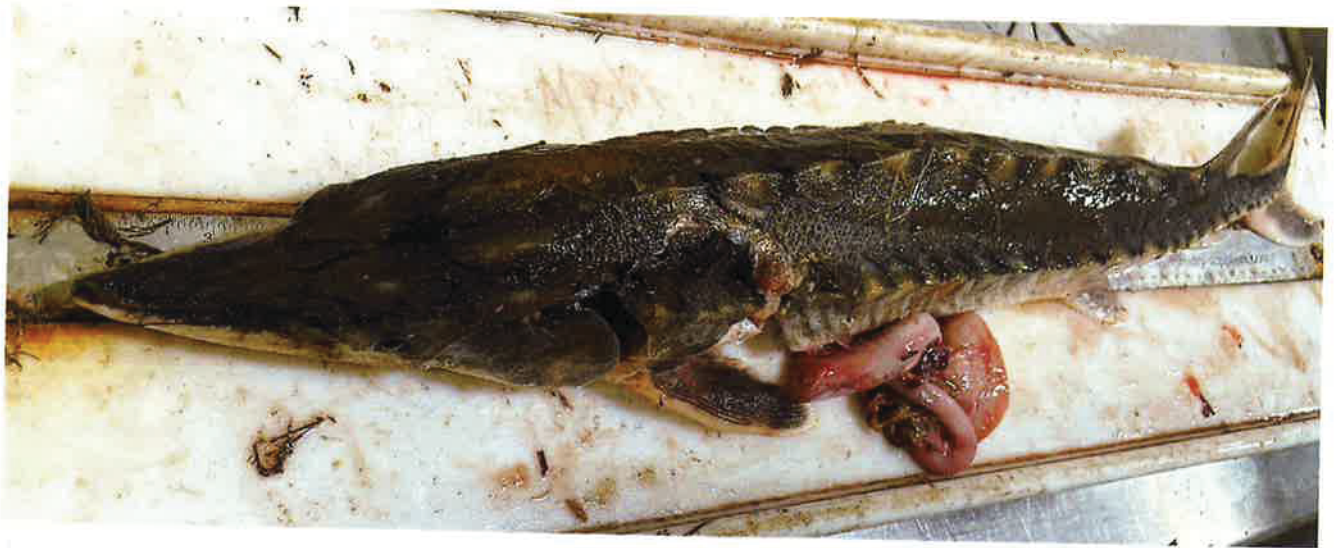
A dorsal view showing the size and condition of a sixth, severely damaged and deceased Atlantic sturgeon (*Acipenser oxyrinchus*), retrieved at approximately 10:12AM on 04/06/2021 from the Salem Circulating Water Intake by Salem Yard Crew personnel during routine trash rack cleaning at Salem Nuclear Generating Station (04/06/2021).

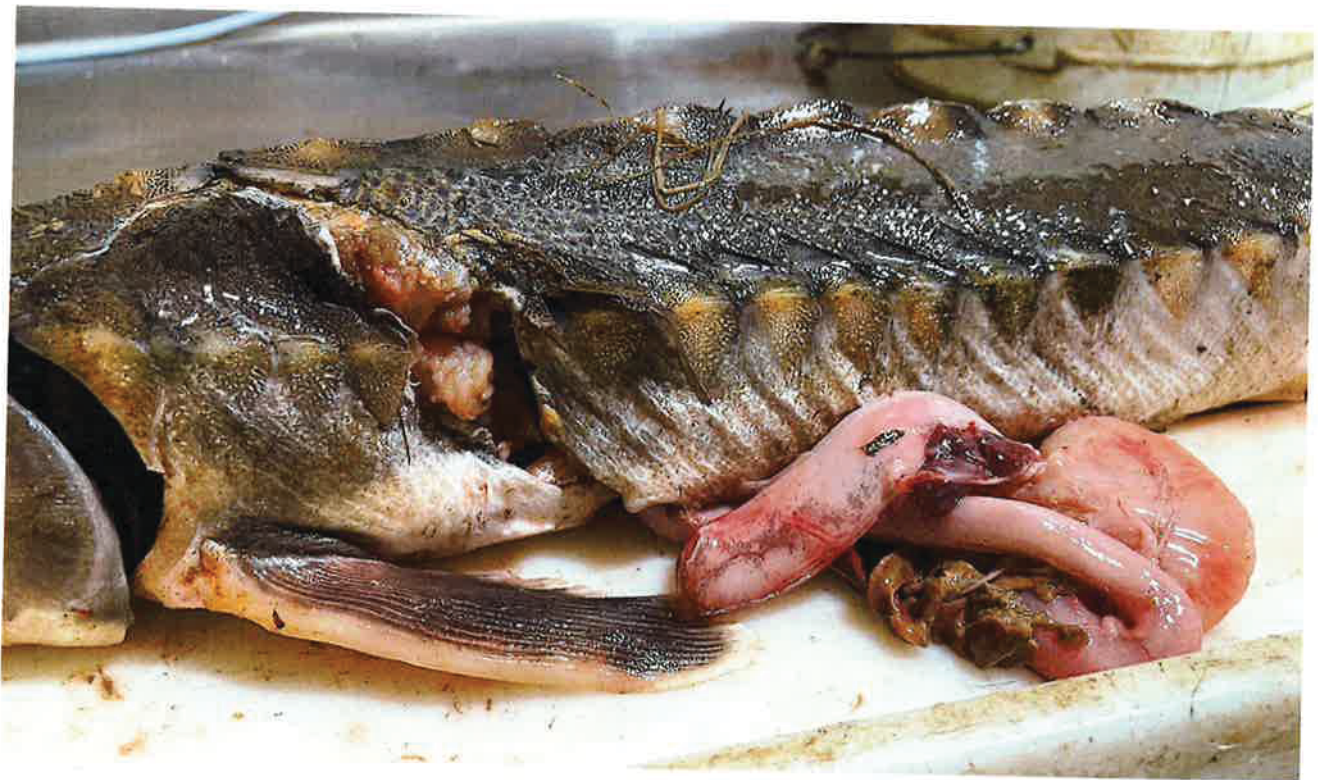
A dorsal view showing a close-up of damage observed to the left side of the torso, which included a severe laceration, located immediately posterior to the pectoral fin, which has exposed internal organs (04/06/2021).
