# Pre-Submittal Meeting: Containment Inservice Inspection (CISI) Relief Request

June 1, 2023

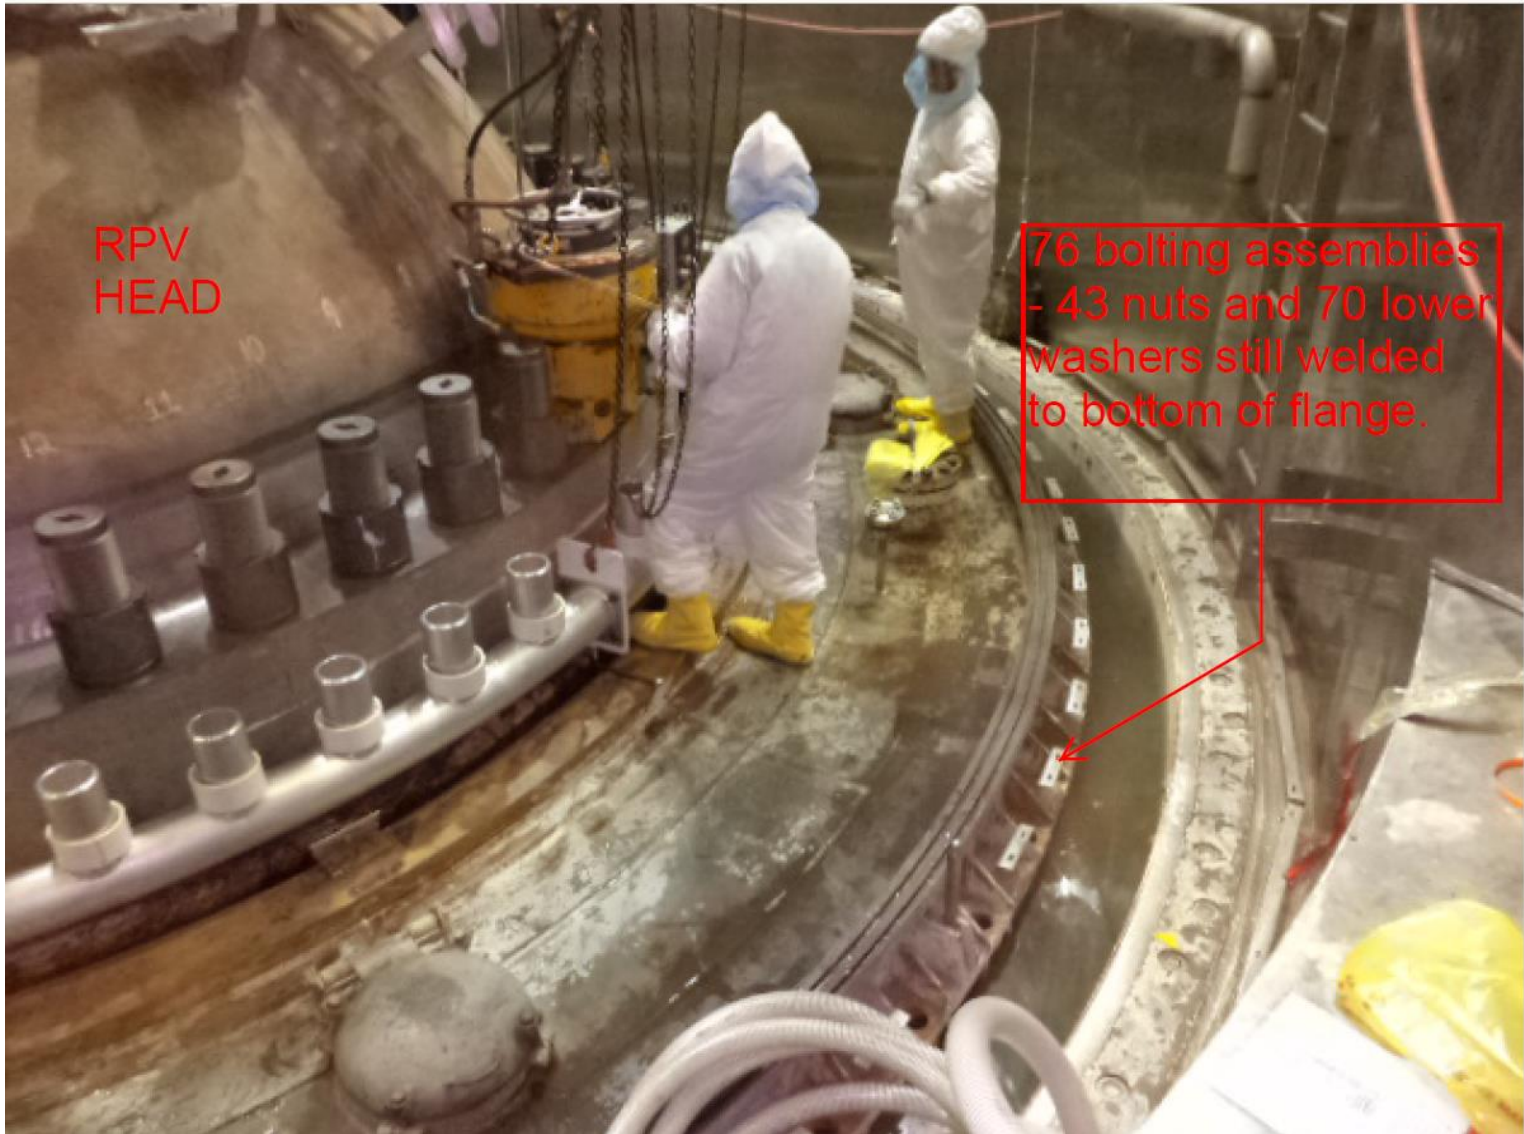
RPV  
HEAD

76 bolting assemblies  
- 43 nuts and 70 lower  
washers still welded  
to bottom of flange.

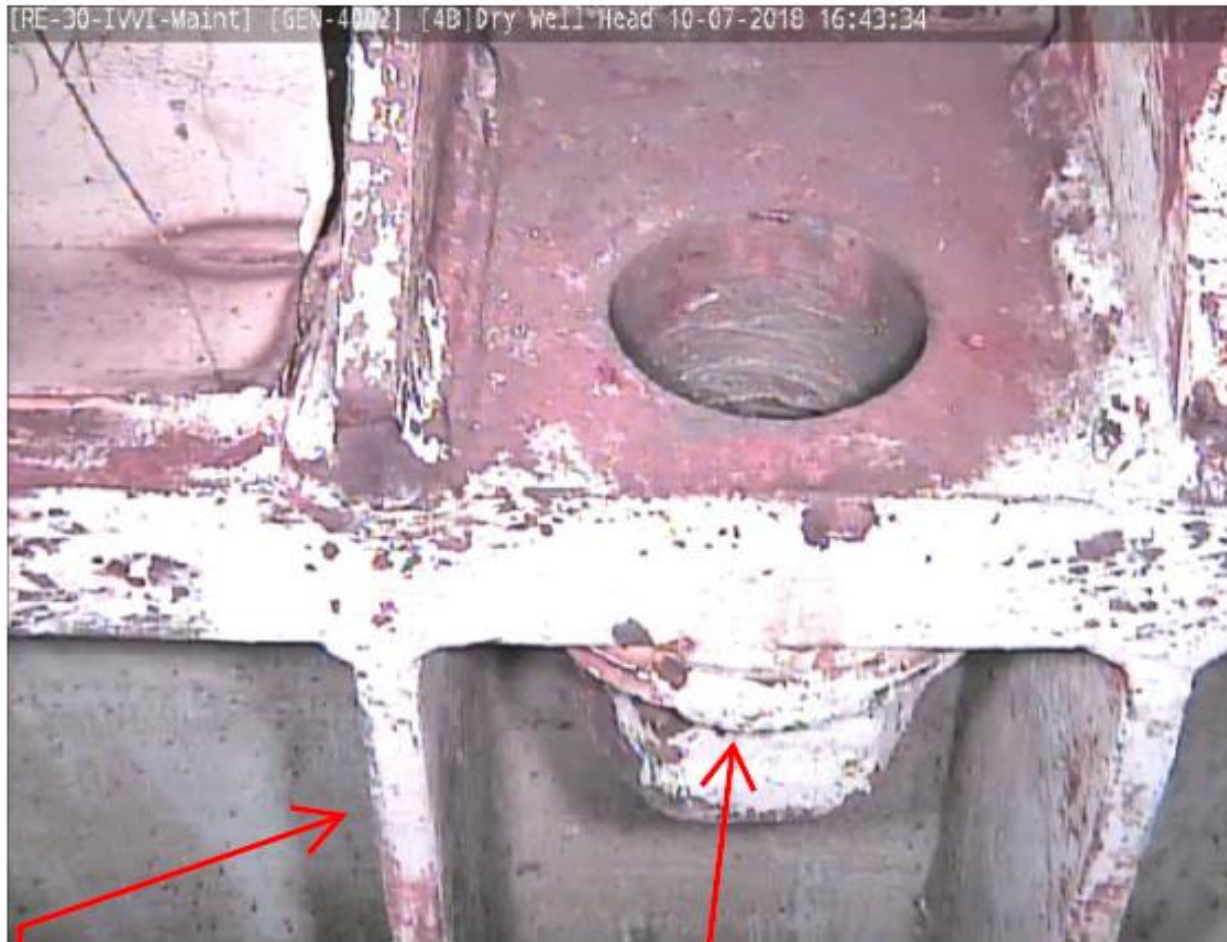
Gussets

Washer/nut assembly

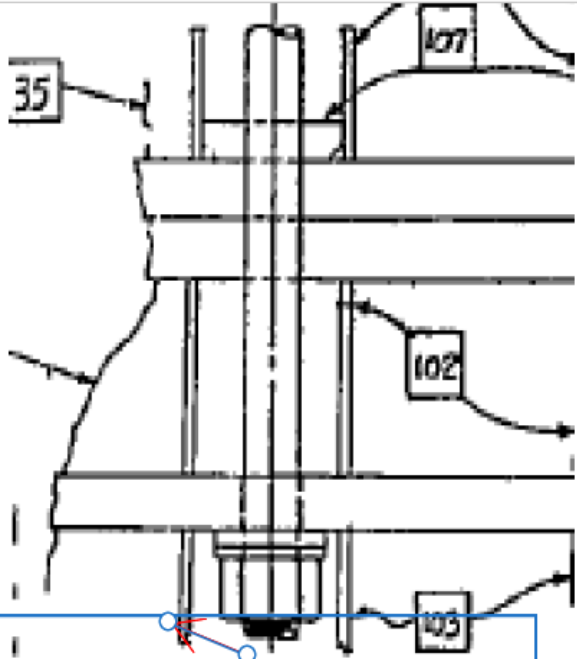
Gusset interference (typ.)  
(Looking axially to reactor)

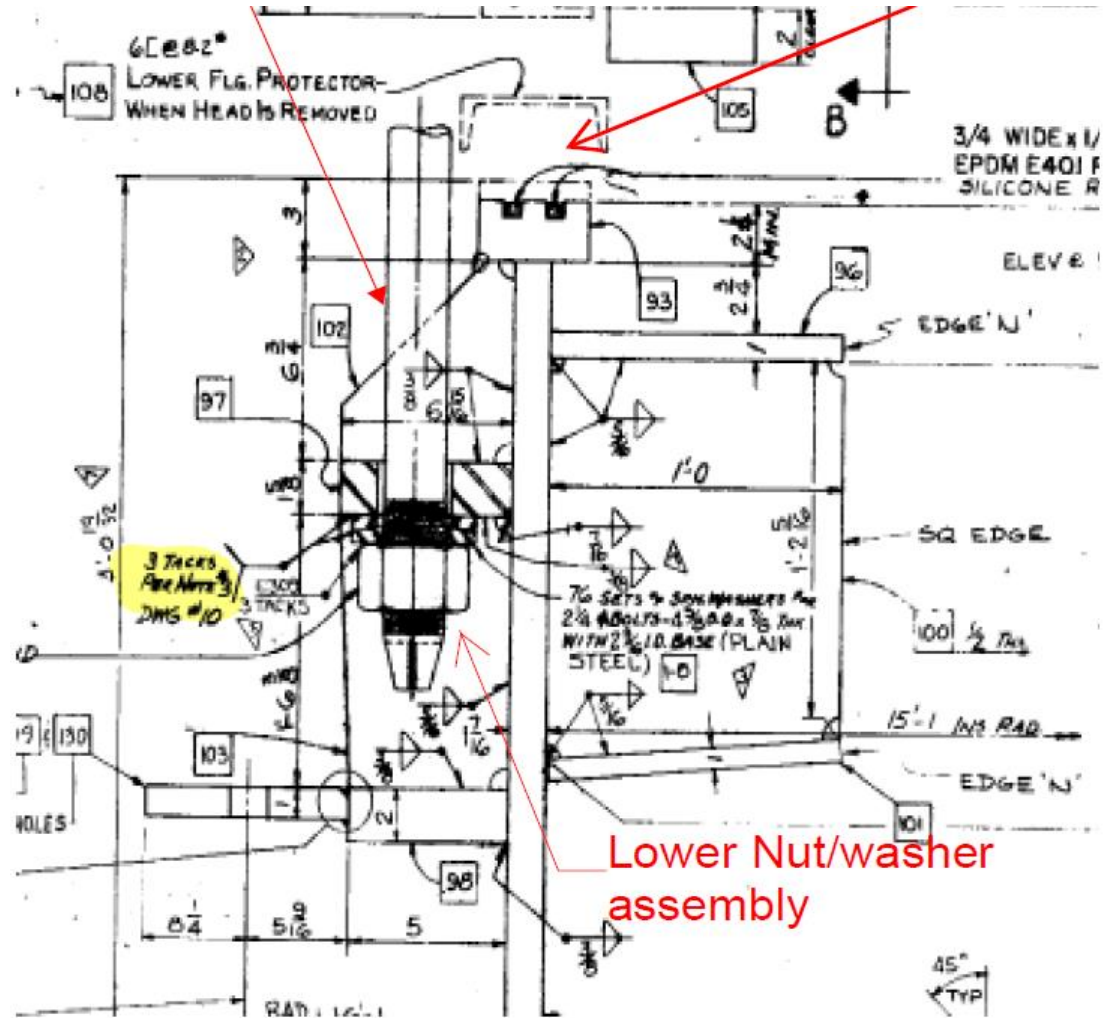
Lower Nut/washer  
assembly
