Sequoyah Nuclear Plant

1B Emergency Diesel Generator Regulatory Conference May 02, 2024

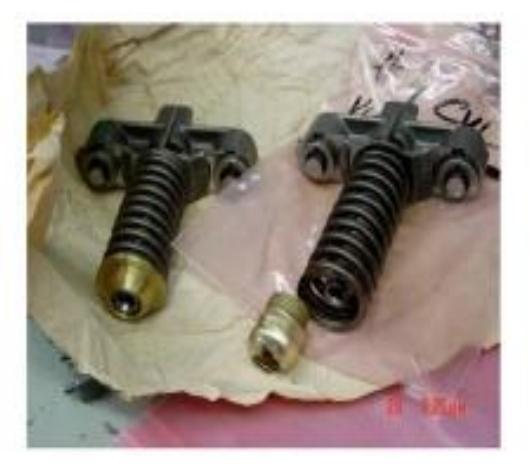
Fig. 3 Davis Besse Damaged Bridge Stem Spherical Brass Seat

- Tapping noise was heard
- Damage to bridge stem brass seat
- Dislodging of the bridge stem
- Damaged cylinder head socket

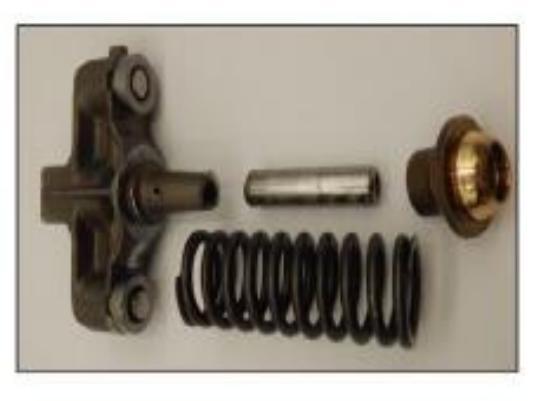
Fig. 4 Sequoyah Event (No Damage to Bridge Stem Spherical Brass Seat)

- No noise heard in multiple opportunities
- No Bridge Stem brass seat damage
- Bridge stem not dislodged
- No damage to cylinder head socket

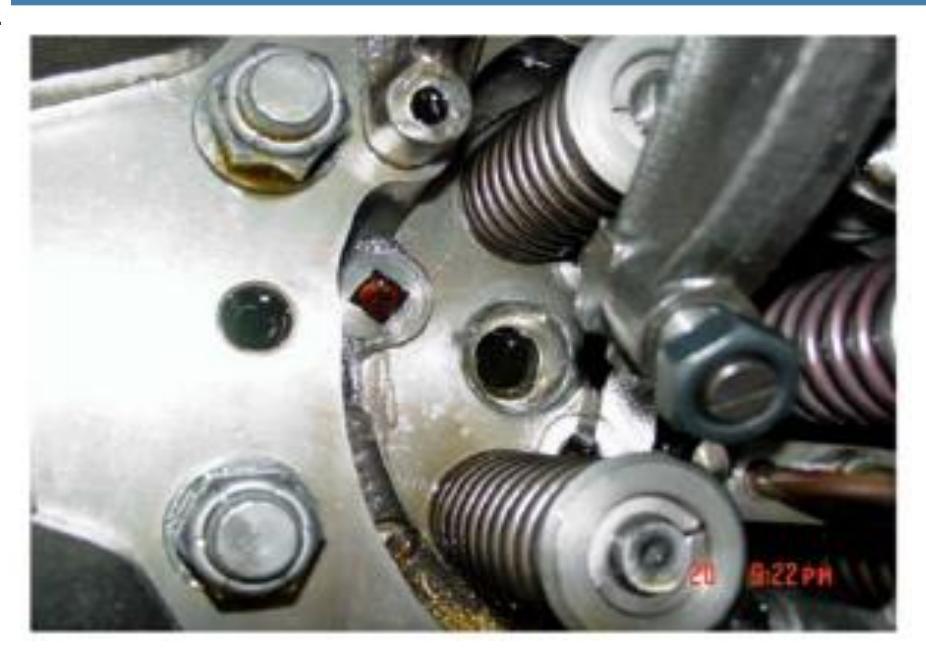
Figure 5 Davis Besse Damaged Bridge Stem Cylinder Head Socket with Brass Shavings from Bridge Stem Seat

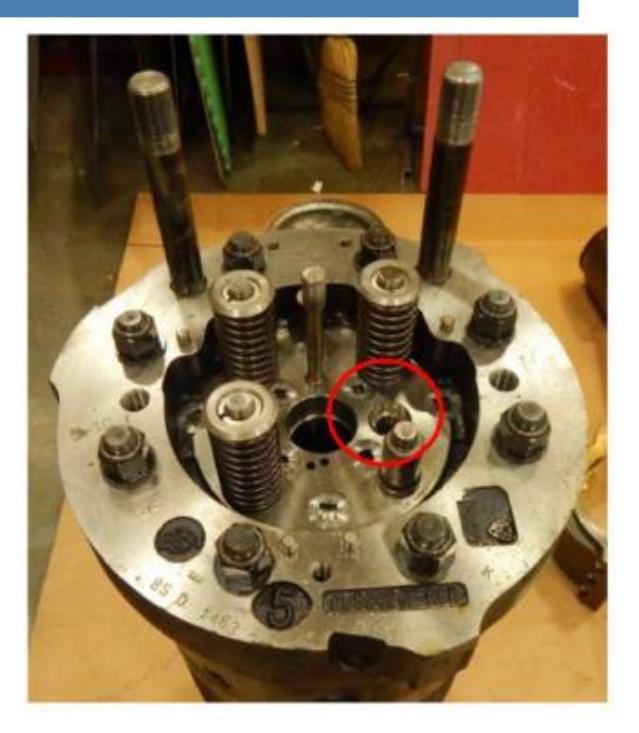
Figure 6 Sequoyah Bridge Stem Cylinder Head Socket (No Elongation Damage)

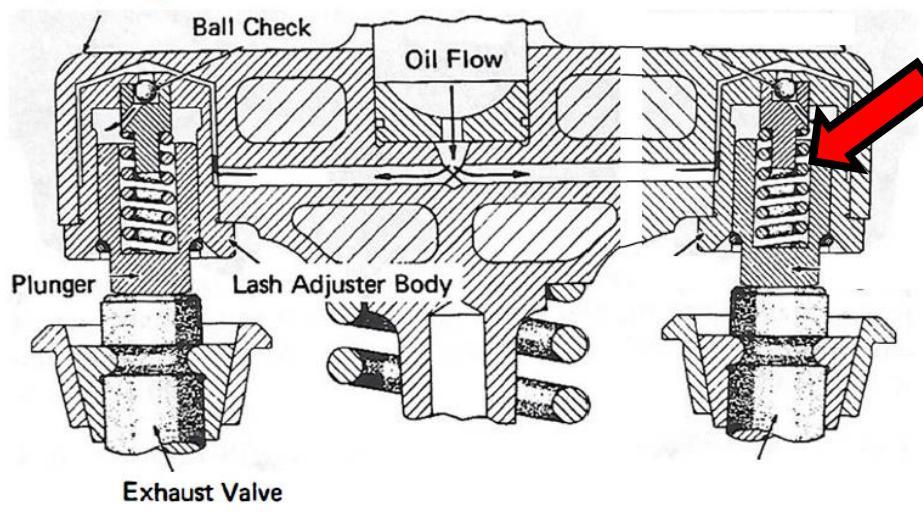
Figure 7 Exhaust Valve Bridge Internals

Metallurgic analysis found a pre-existing
fatigue crack on the plunger spring.

• The exhaust valve spring seats had a highly undesirable microstructure that would have made it more susceptible to fracture.

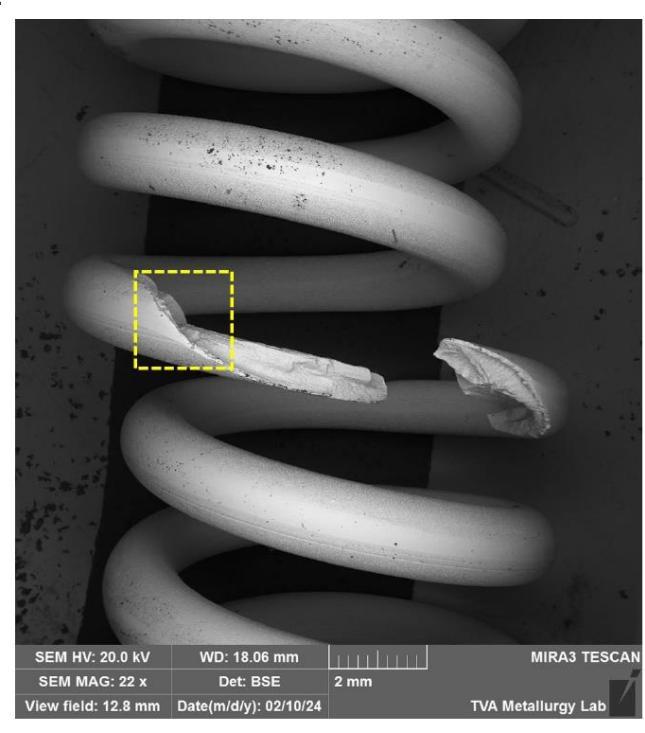
Figure 8 Rear Outboard Lash Adjuster Spring

The rear outboard lash adjuster spring was examined in a scanning electron microscope for fractographic analysis.

The fracture has a helicoidal shape that is indicative of fatigue in springs.

A fatigue crack initiation site w as found at the indicated location on the opposite, inside surface of the spring.

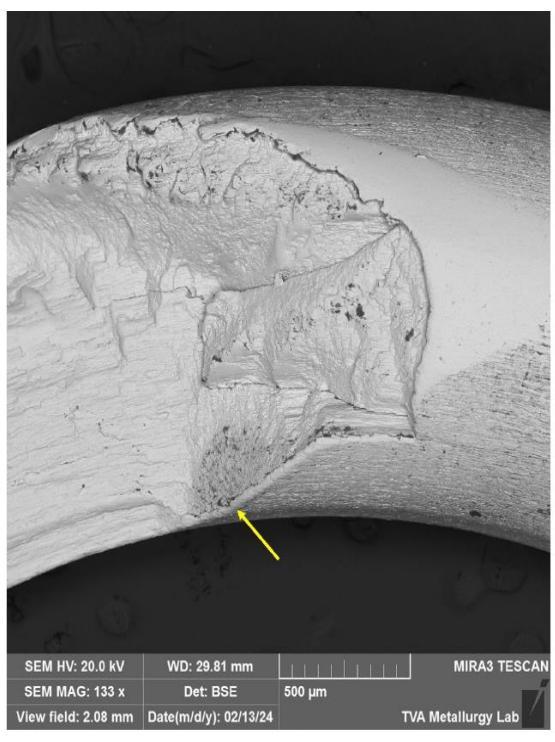
Figure 9 Inside Surface of Adjuster Spring

A small thumbnail region oriented 45° from the main spring axis w as found on the inside surface of the rear outboard lash adjuster spring.

Fig 9 is a backscattered electron (BSE) image of the fracture.

The contrast mechanism in BSE images is that of atomic number contrast where lighter areas contain elements with higher atomic numbers and vice versa. In effect, the light areas on fracture are the spring material and the dark areas are typically carbonaceous deposits and/or oxides. This fracture surface was sonicated in alcohol to remove any loose deposits on the surface. How ever, oily deposits persisted around the fatigue

initiation site.

This indicates that this fracture has been present for a long period of time, i.e., there is a good likelihood that this fatigue crack predated the fracture event.

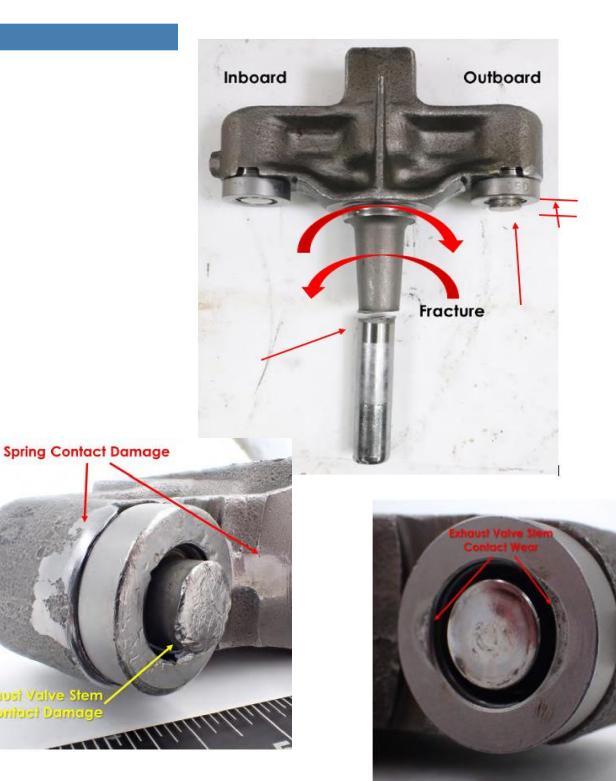
- 1. Lash Adjuster spring cracks
- 2. Lash Adjuster spring fails
- 3. Lash Adjuster Plunger collapses
- 4. Local Lash (gap) forms between exhaust valve stem and lash adjuster
- 5. Hammering effect on valve stem and valve bridge assembly
- 6. The magnitude of the vibrations and impact forces increases as the local lash increases. Excess vibrations and impact forces on the following:
 - i. Exhaustvalve
 - ii. Rocker arm adjusting screw
 - iii. Lash adjuster
 - iv. Rocking force on valve bridge stem
- 7. Global Lash (gap) forms between bridge assembly and rocker arm adjusting screw (after the locknut loosens sufficiently)
- 8. Retaining Ring failure, dropped exhaust valve, exhaust valve bridge stem fracture, inboard lash adjuster fails, etc
