Assessment of Environmental Qualification Practices and Condition Monitoring Techniques for Low-Voltage Electric Cables

LOCA Test Results

Brookhaven National Laboratory

**U.S. Nuclear Regulatory Commission
Office of Nuclear Regulatory Research
Washington, DC 20555-0001**

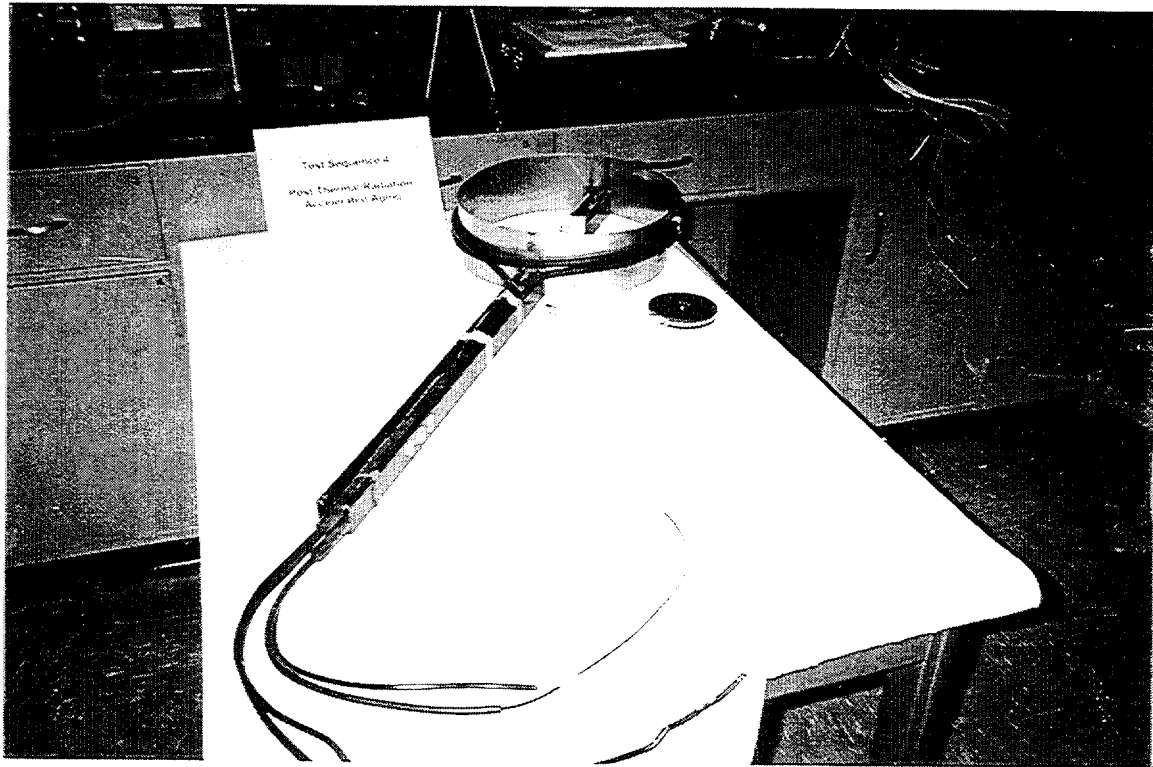
Figure 2.4 Typical specimen mounted on a mandrel with a modified design for tests 4, 5 and 6

mitigate the potential for handling damage to the test specimens. The pigtails were shielded from the thermal and radiation aging, to the extent possible, to keep them from becoming brittle. After aging, the facility lead wires were connected to the pigtails using a second splice. Figure 2.4 shows a typical specimen mounted on the modified mandrel with pigtails attached, as used for tests 4, 5 and 6.

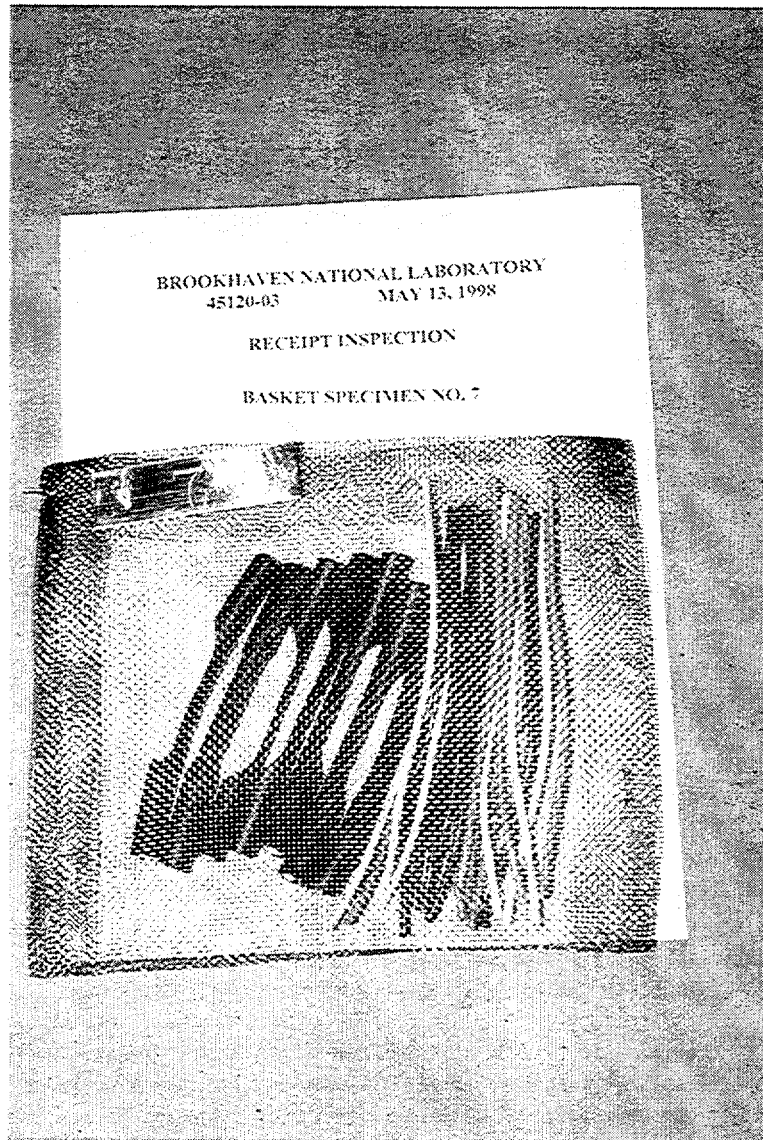
Figure 2.5 Typical basket of short specimens

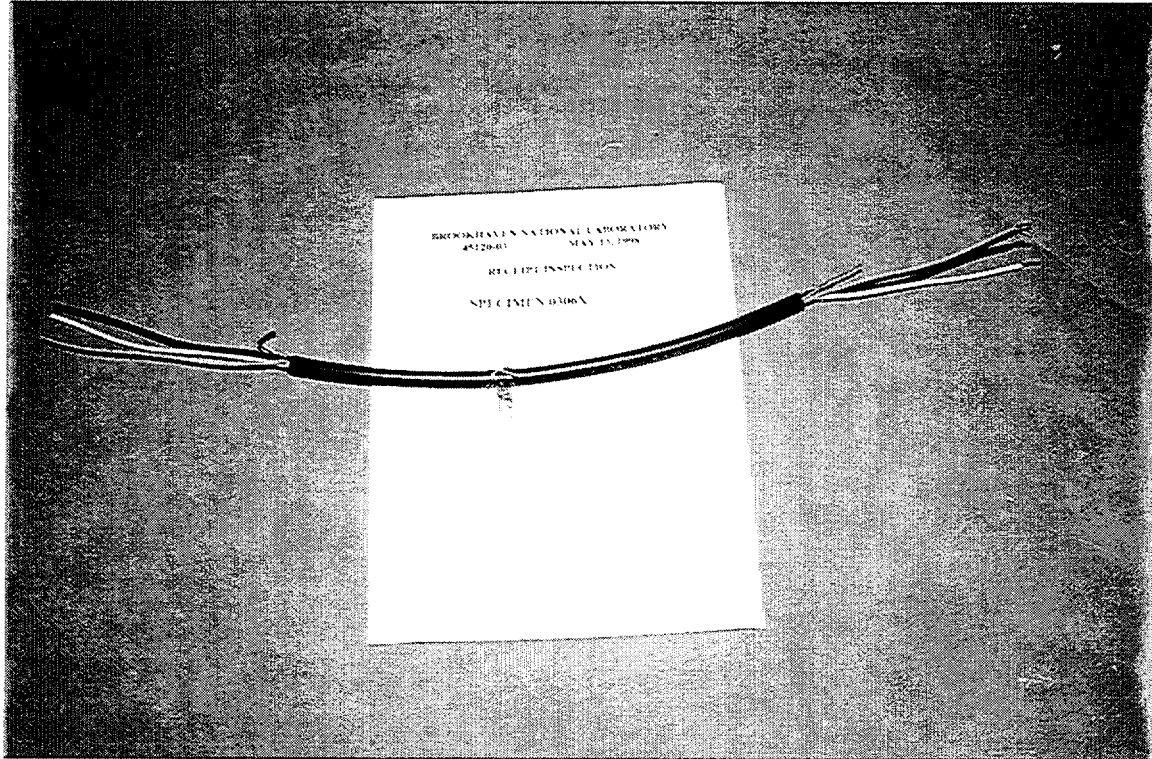
Figure 2.6 Typical 2-foot specimen for indenter testing

In order not to damage the long specimens, an additional two foot specimen was prepared from the same source as each long specimen to be used specifically for indenter testing. This 2-foot specimen followed the “parent” long specimen throughout the test sequence. Approximately 6 inches of outer jacket material was removed from both ends of the 2-foot specimen to allow indenter testing of the underlying insulation material. Figure 2.6 shows a typical 2-foot specimen used for indenter testing.

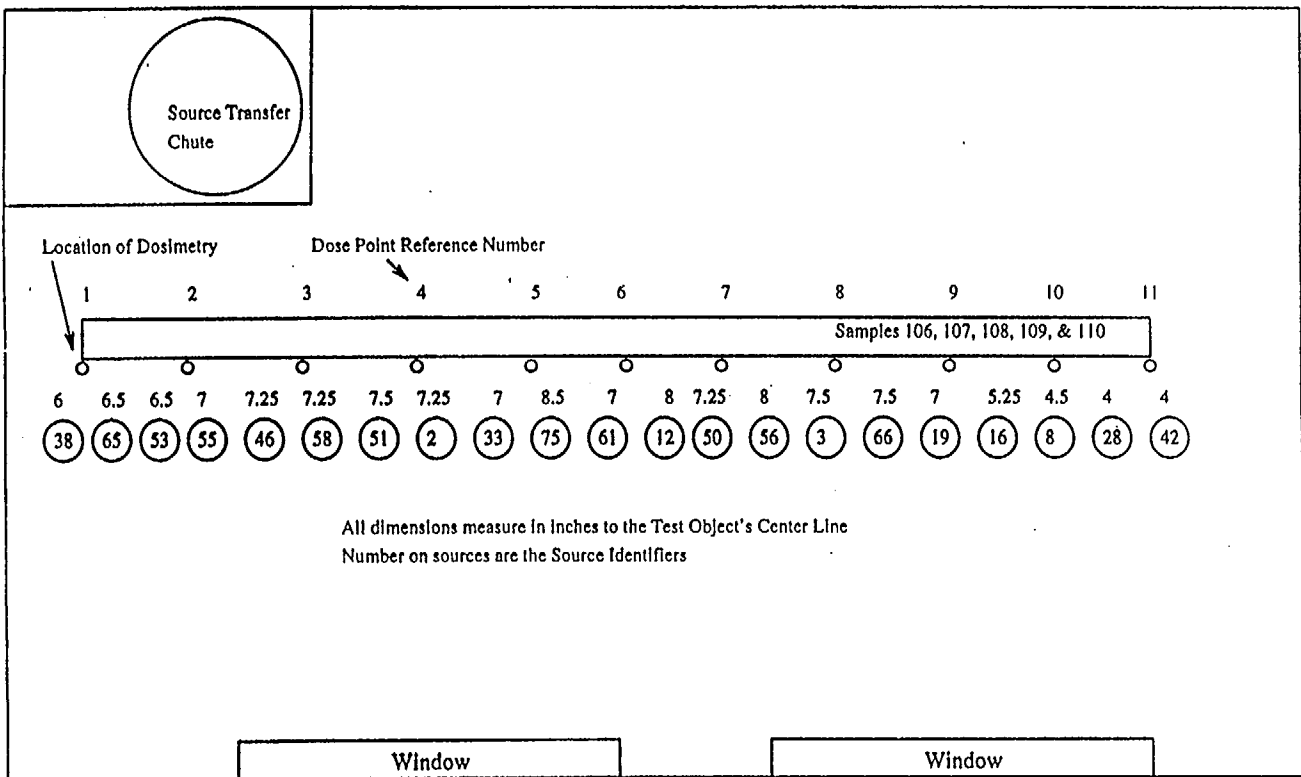
Figure 2.8 Diagram of the Hot Cell at Georgia Institute of Technology with typical arrangement of long specimens

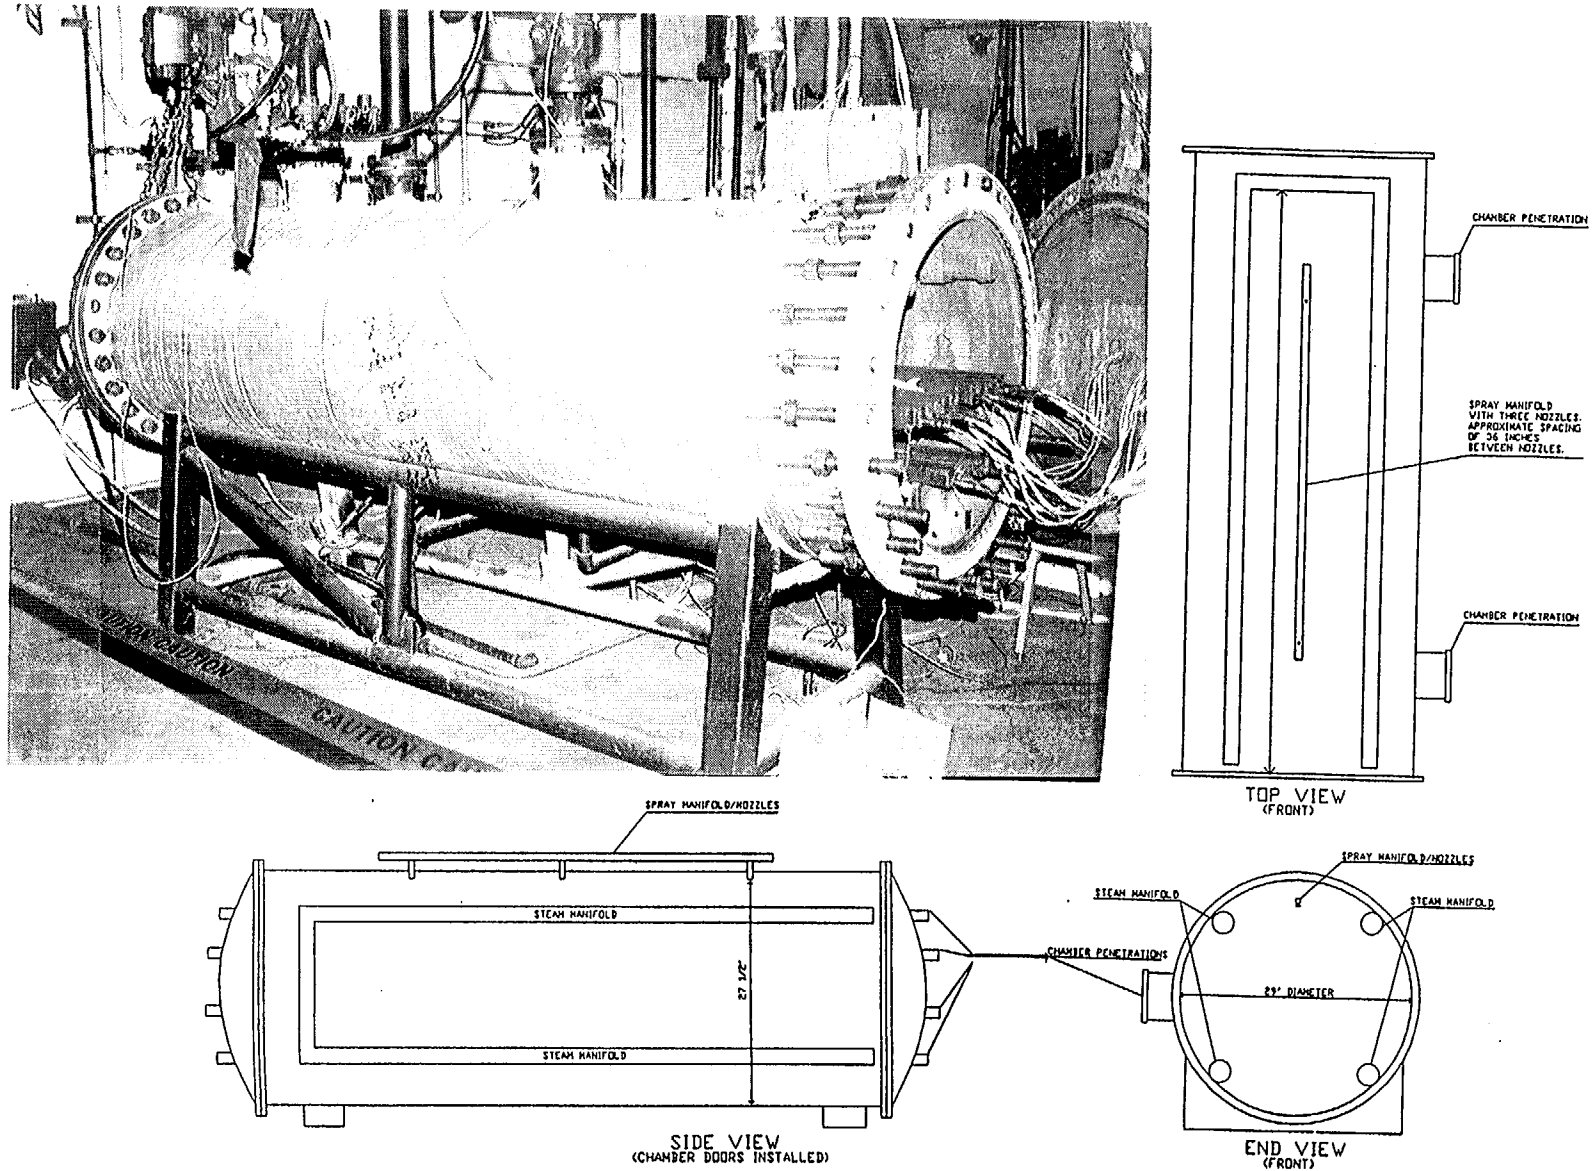
Figure 2.9 Photograph and diagram of the LOCA test chamber at Wyle Laboratories used for Tests 1, 2 and 3

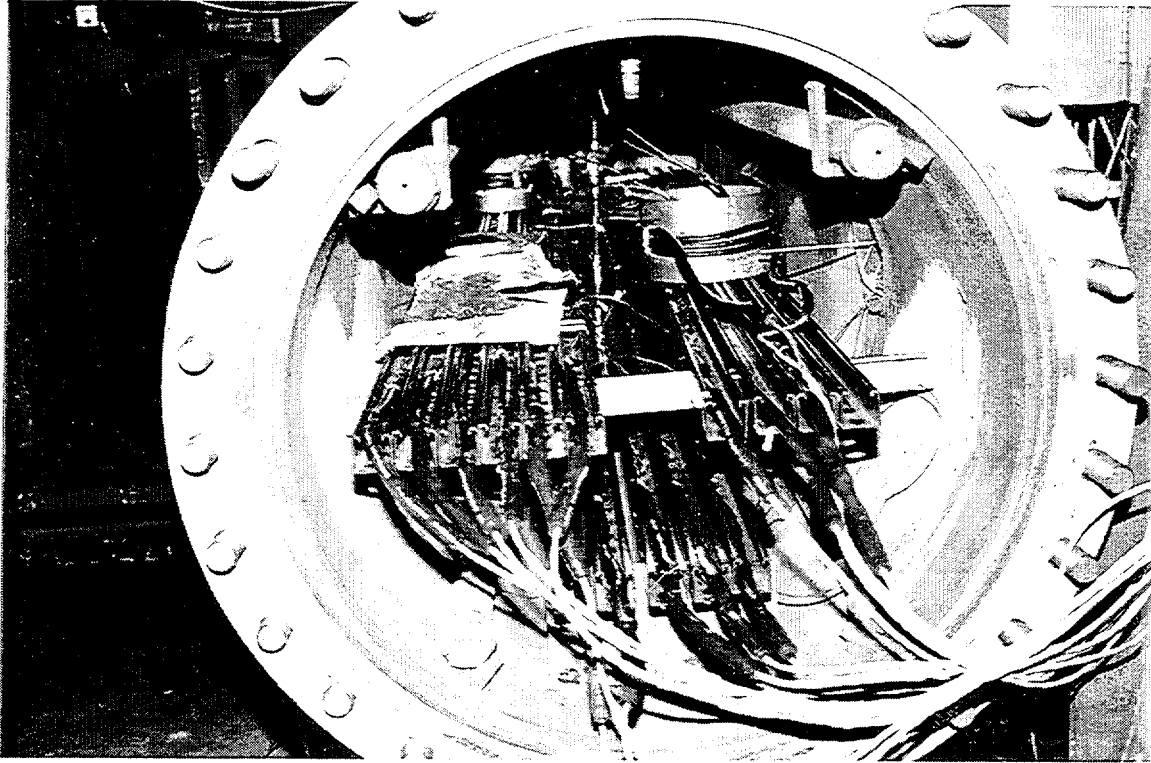
Figure 2.10 End view of the LOCA test chamber with the cable specimens loaded prior to testing

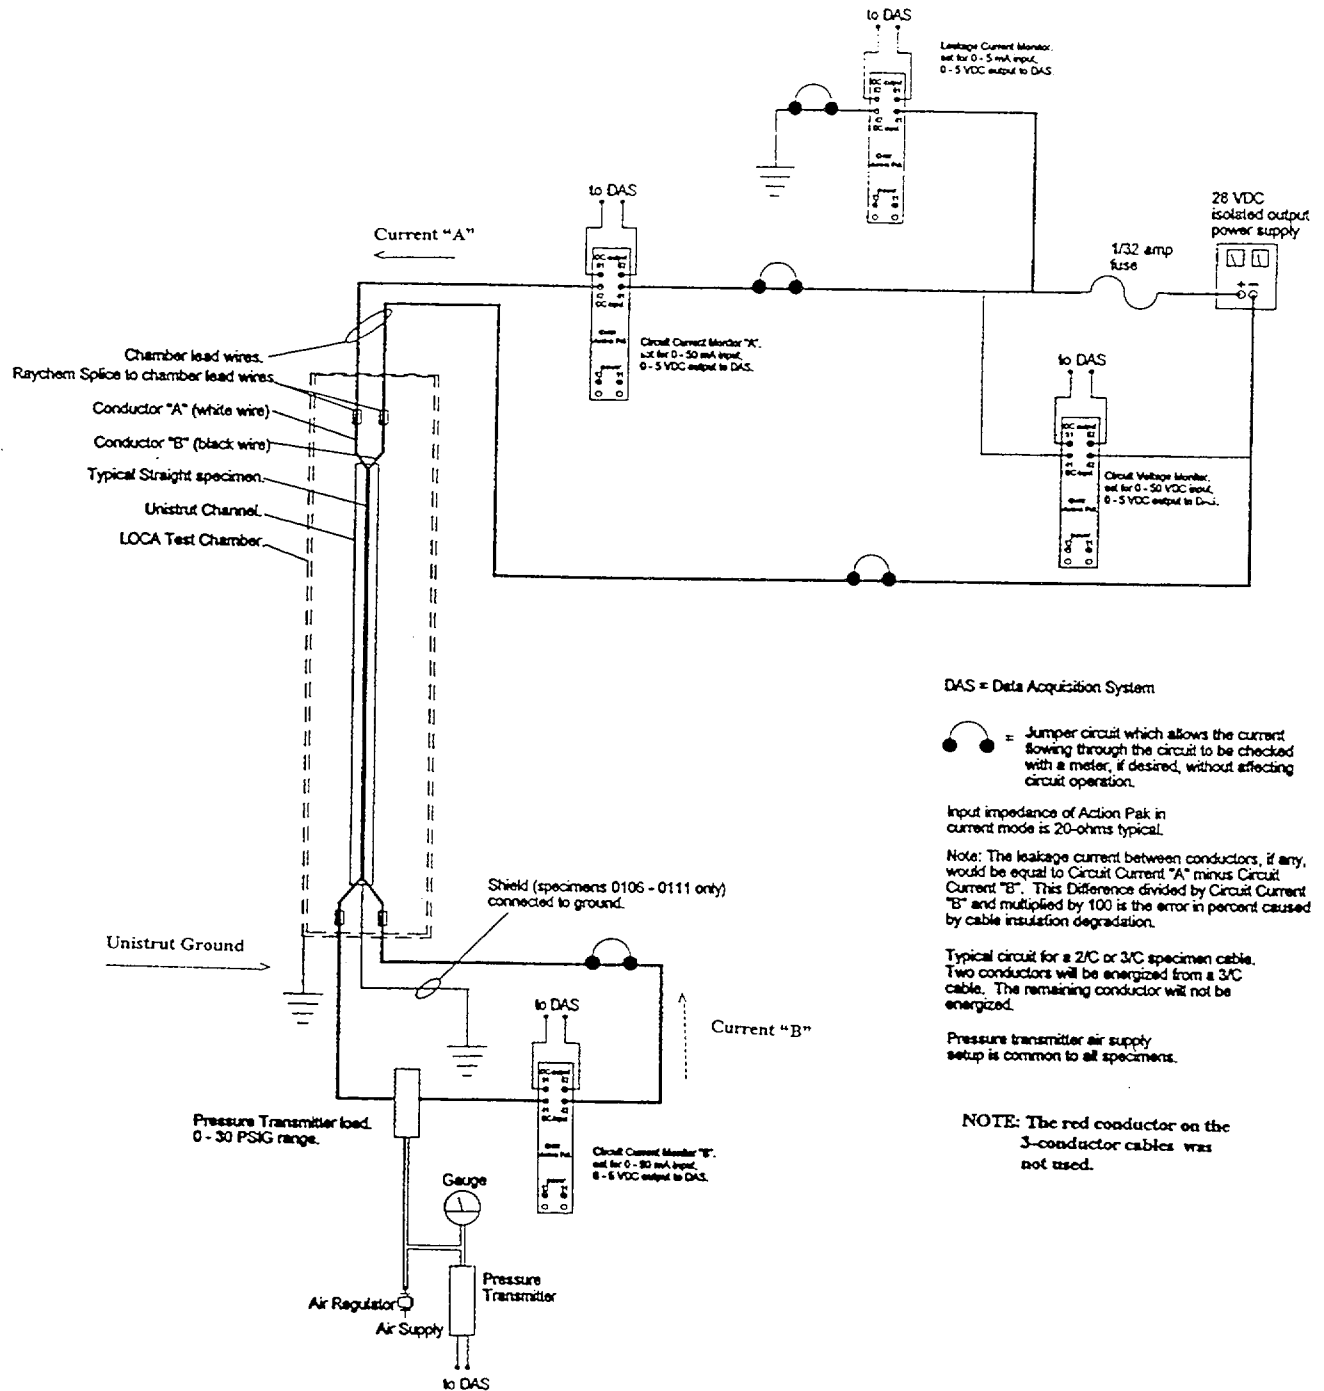
Figure 2.13 Monitoring circuit diagram for straight Unistrut® mounted specimens

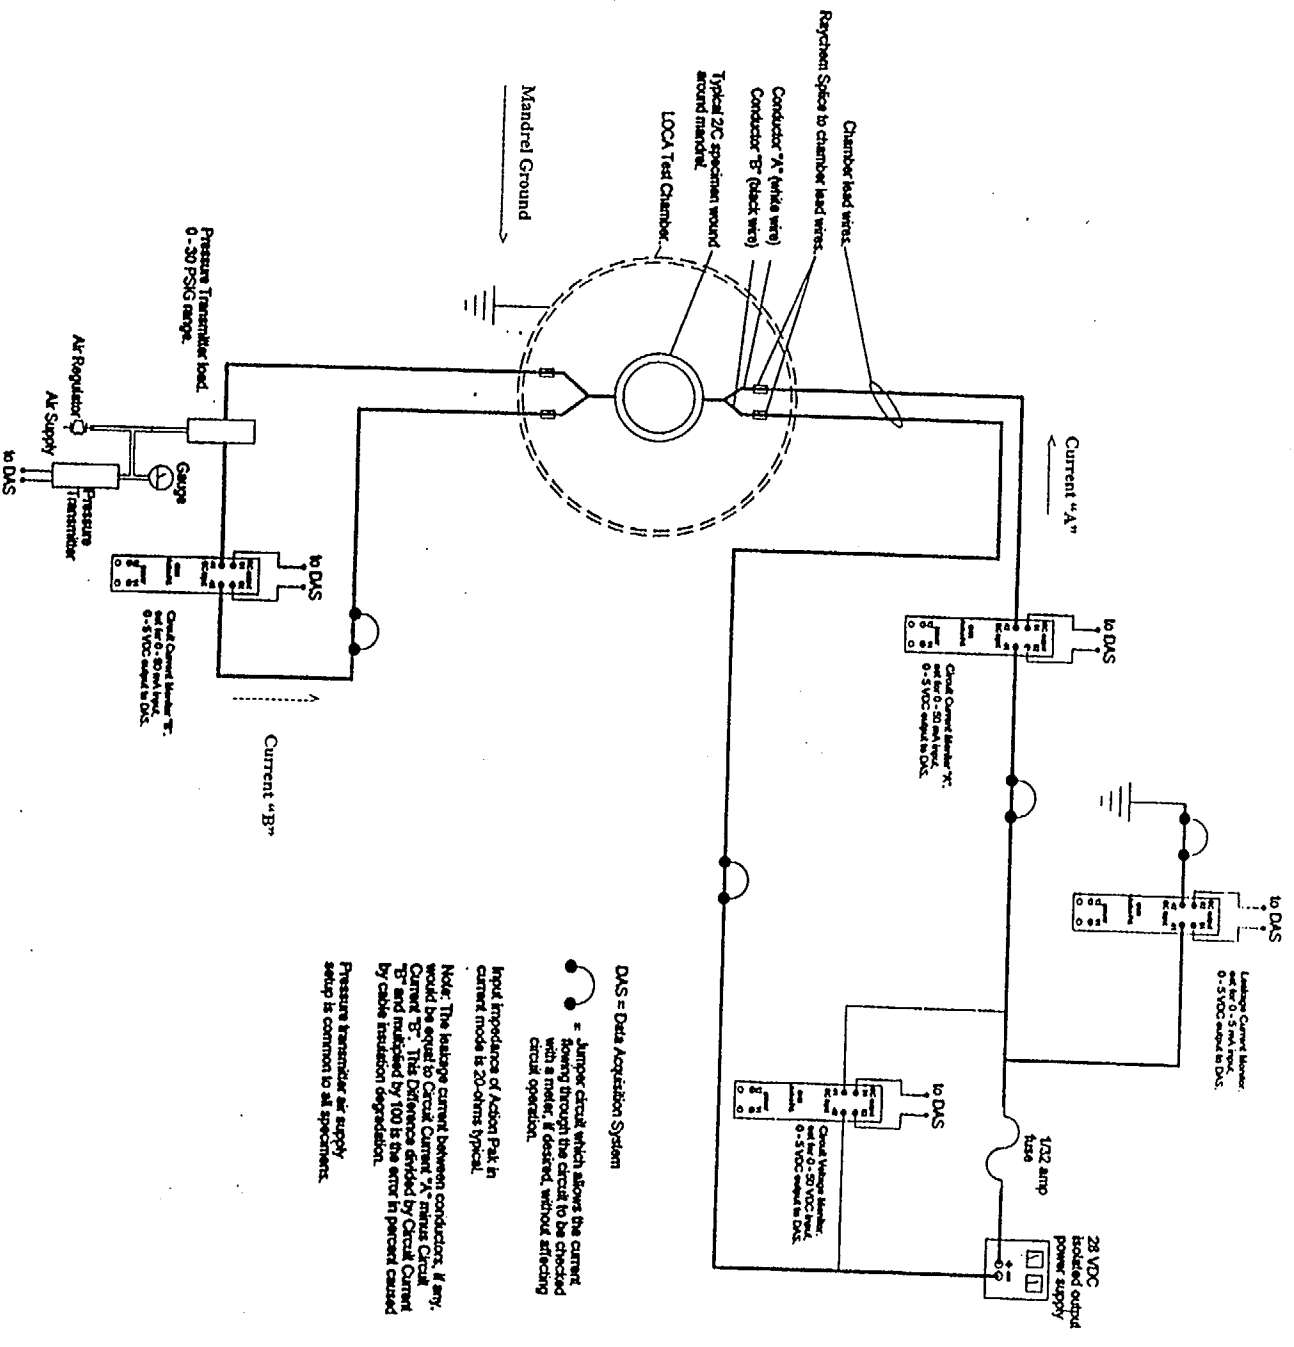
Figure 2.14 Monitoring circuit diagram for mandrel mounted specimens

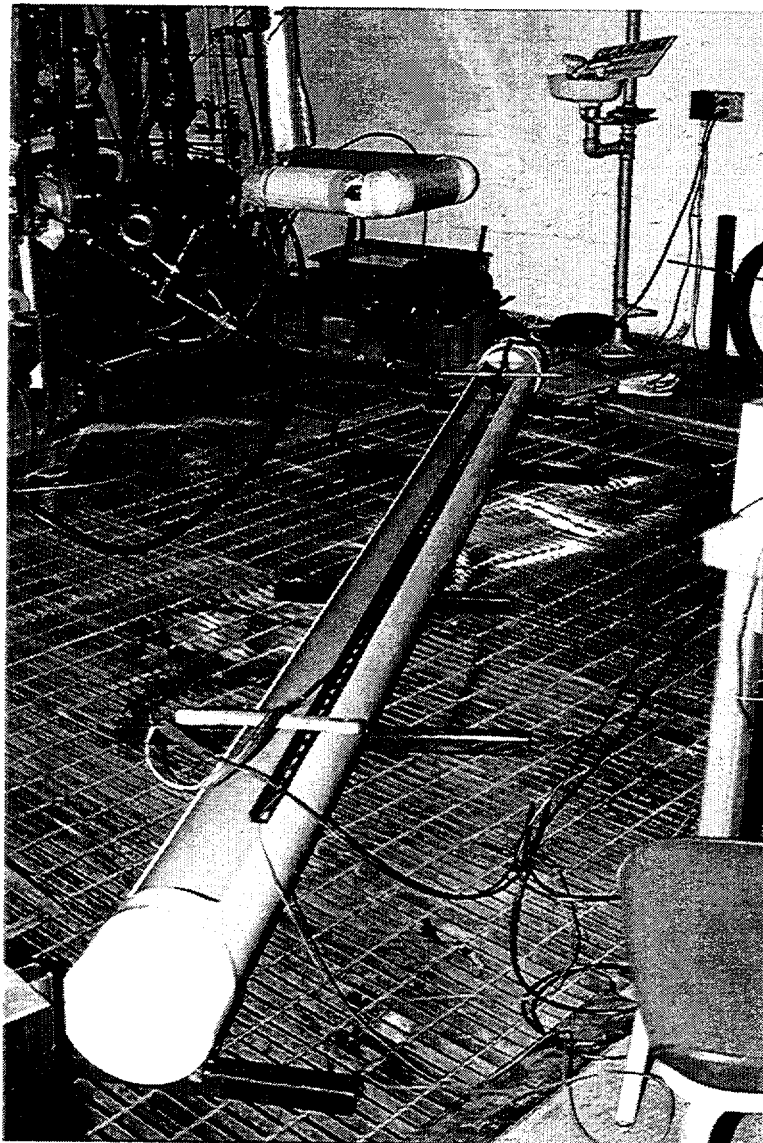
Figure 2.17 Test setup for the submerged voltage withstand test

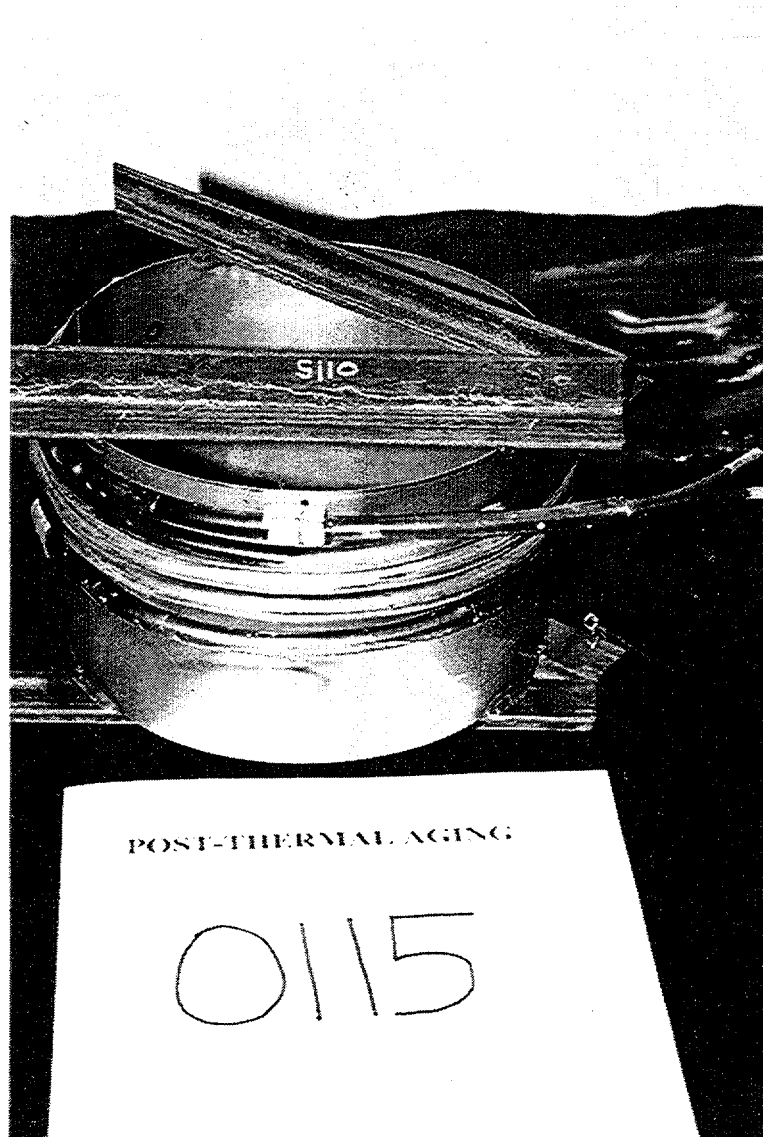
**Figure 3.1 Rockbestos specimen 0115 from Group 1.4 (pre-aged to 20 years)
after accelerated thermal aging**

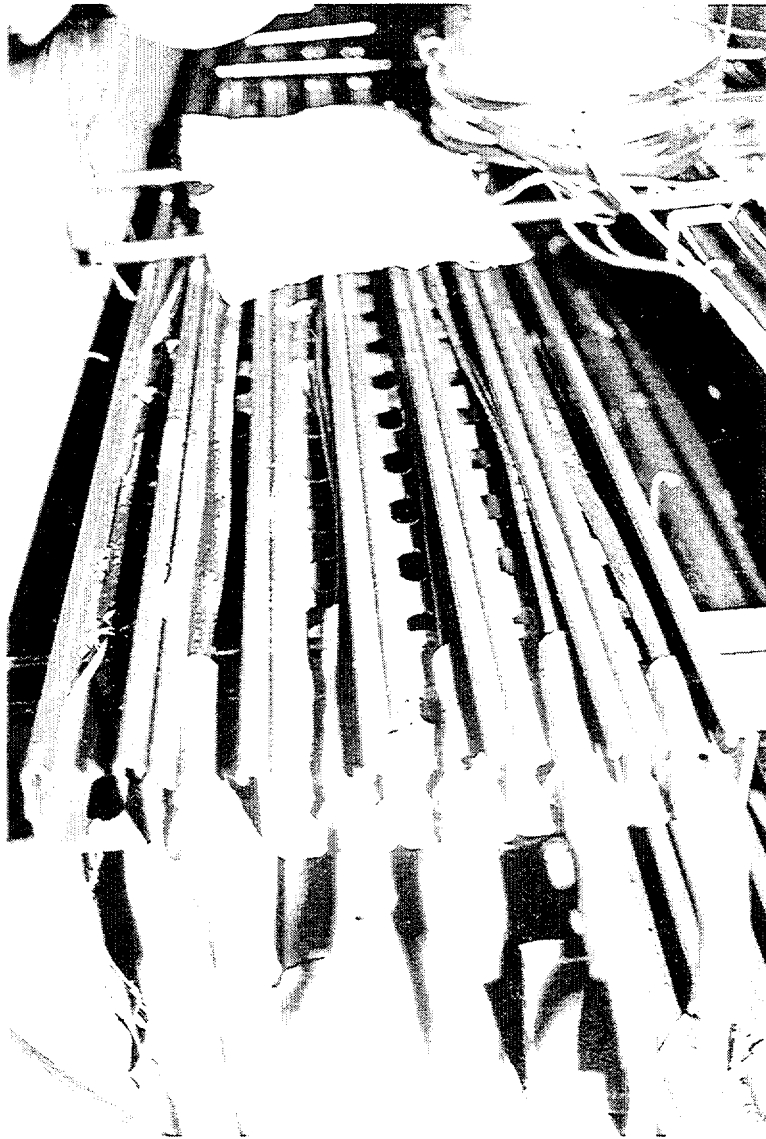
Figure 3.2 Rockbestos specimens loaded in LOCA chamber after accelerated aging plus LOCA radiation

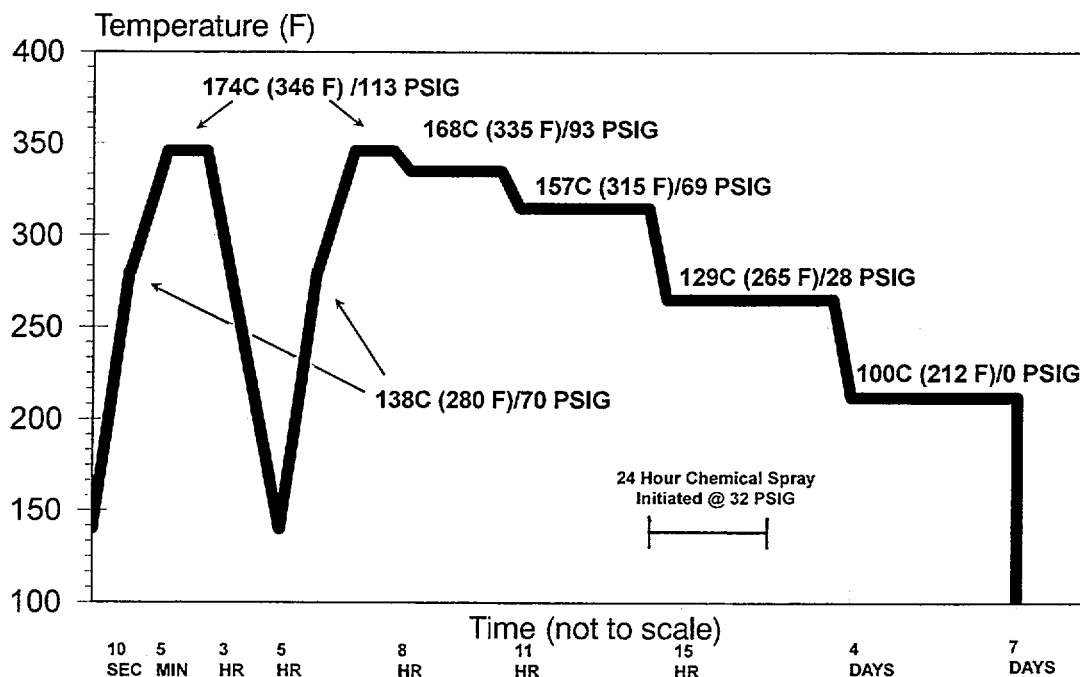
Figure 3.3 Test chamber temperature/pressure profile used in LOCA Tests 1, 3, 4, 5 and 6
 (Note: LOCA Tests 4, 5 and 6 were 10 days in duration)

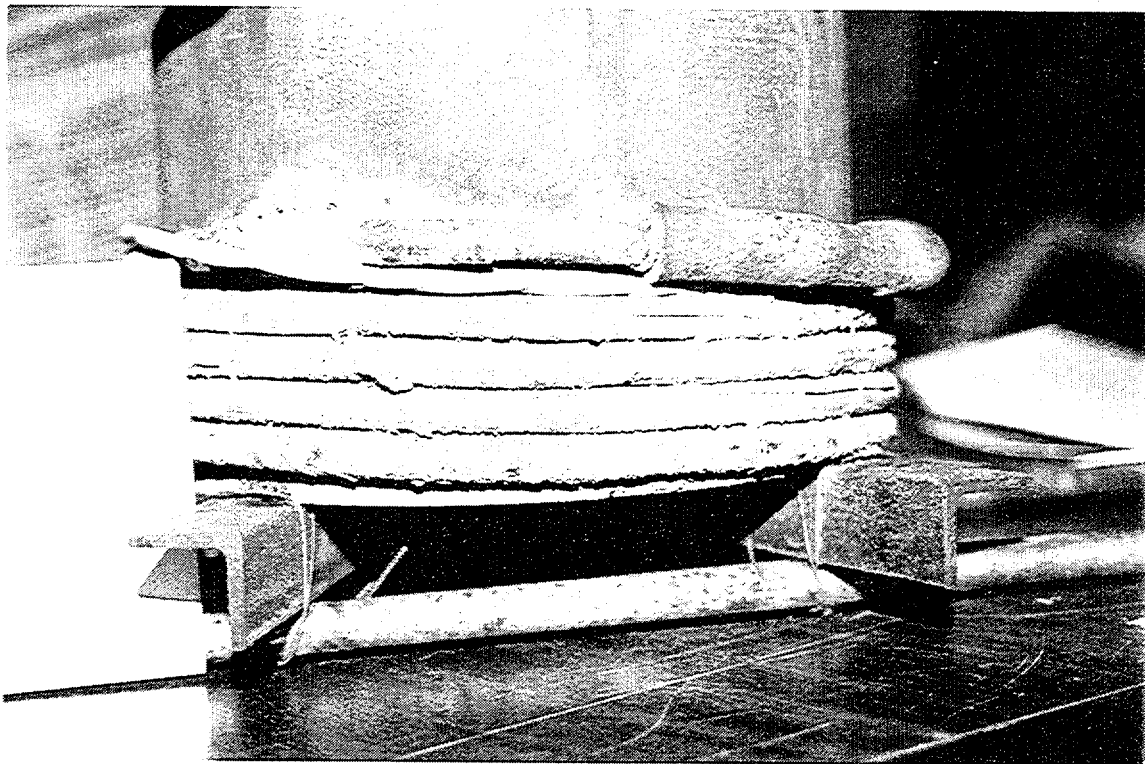
Figure 3.5 Post-LOCA condition of Rockbestos specimen 0115 from Group 1.4 (pre-aged to 20 years)

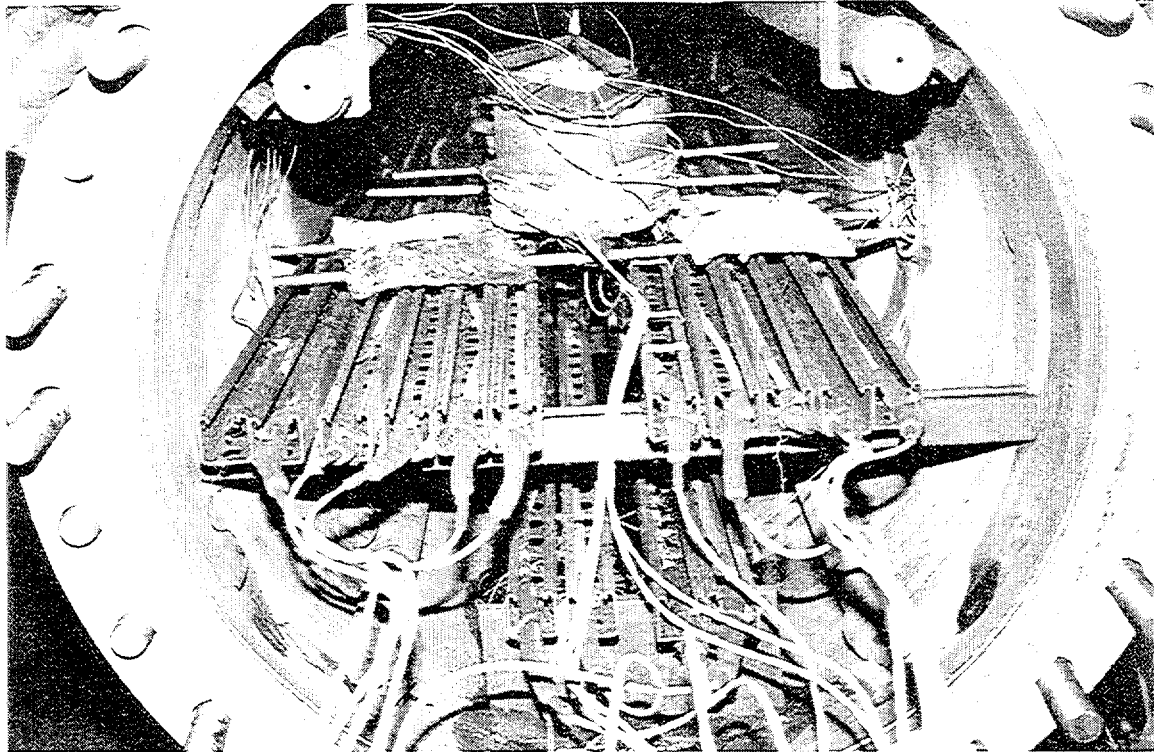
Figure 3.6 Rockbestos specimens in LOCA chamber after steam/chemical spray exposure

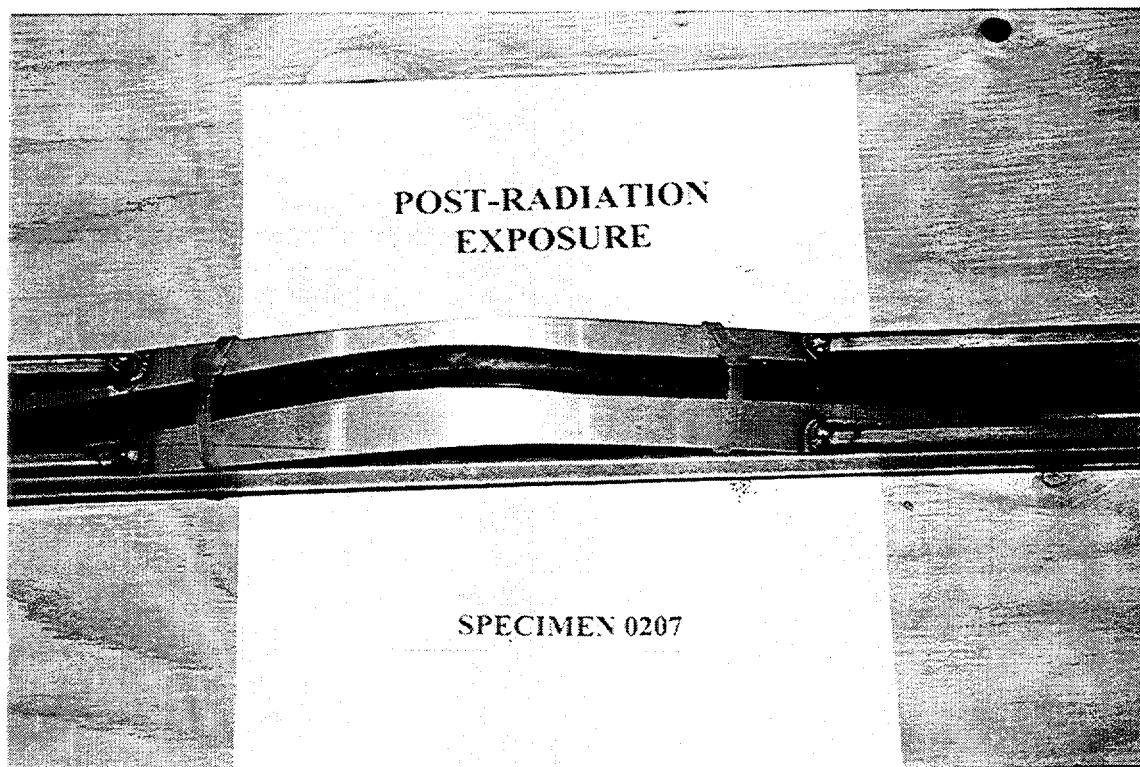
Figure 3.11 AIW specimen 0207 from Group 2.3 (naturally aged 24 years) after LOCA radiation

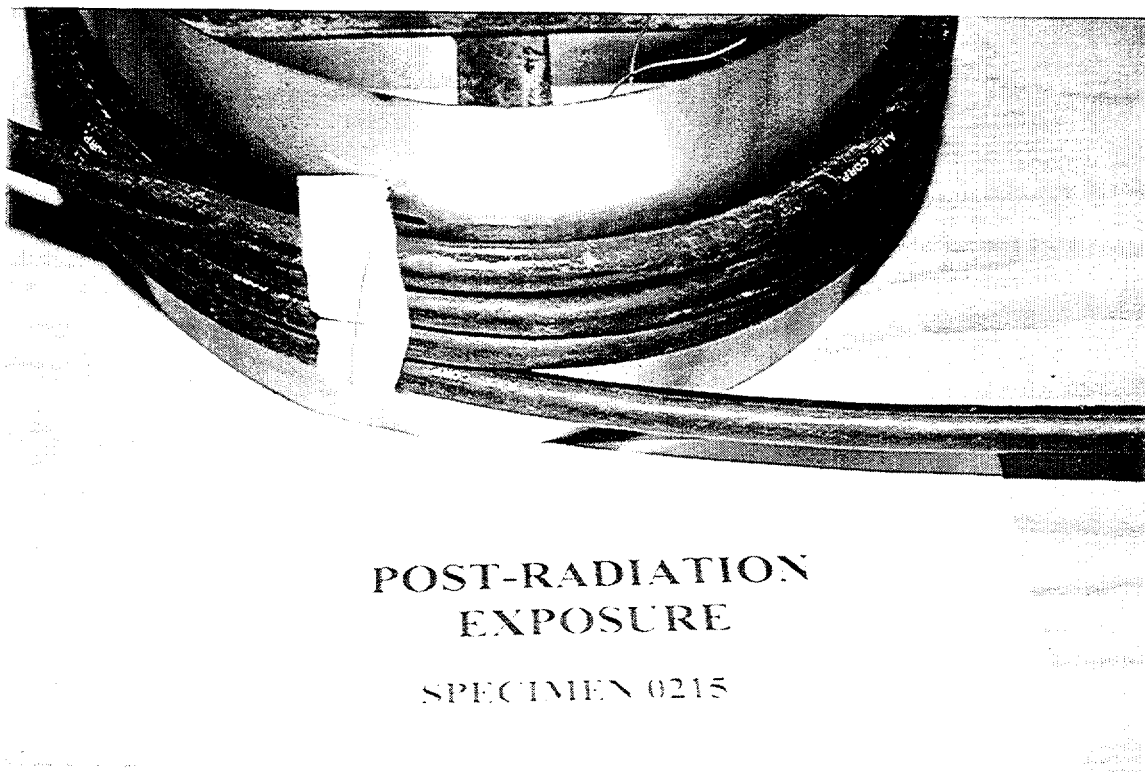
Figure 3.12 AIW specimen 0215 from Group 2.4 (pre-aged to 20 years) after service aging plus LOCA radiation

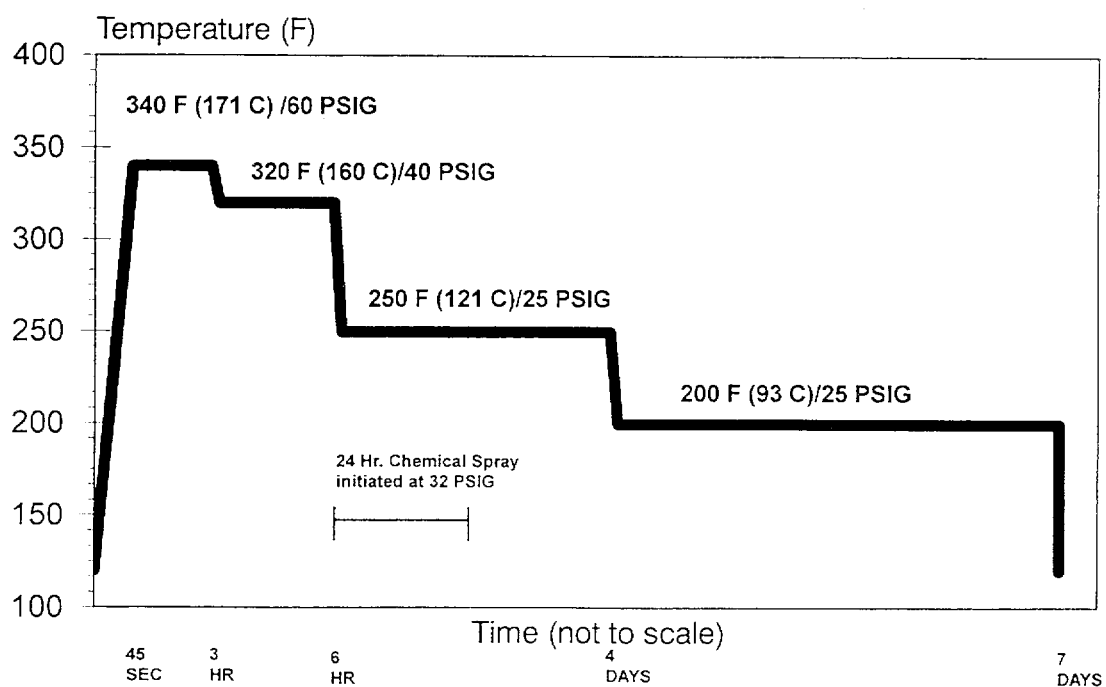
Figure 3.13 Test chamber temperature/pressure profile used in LOCA Test 2

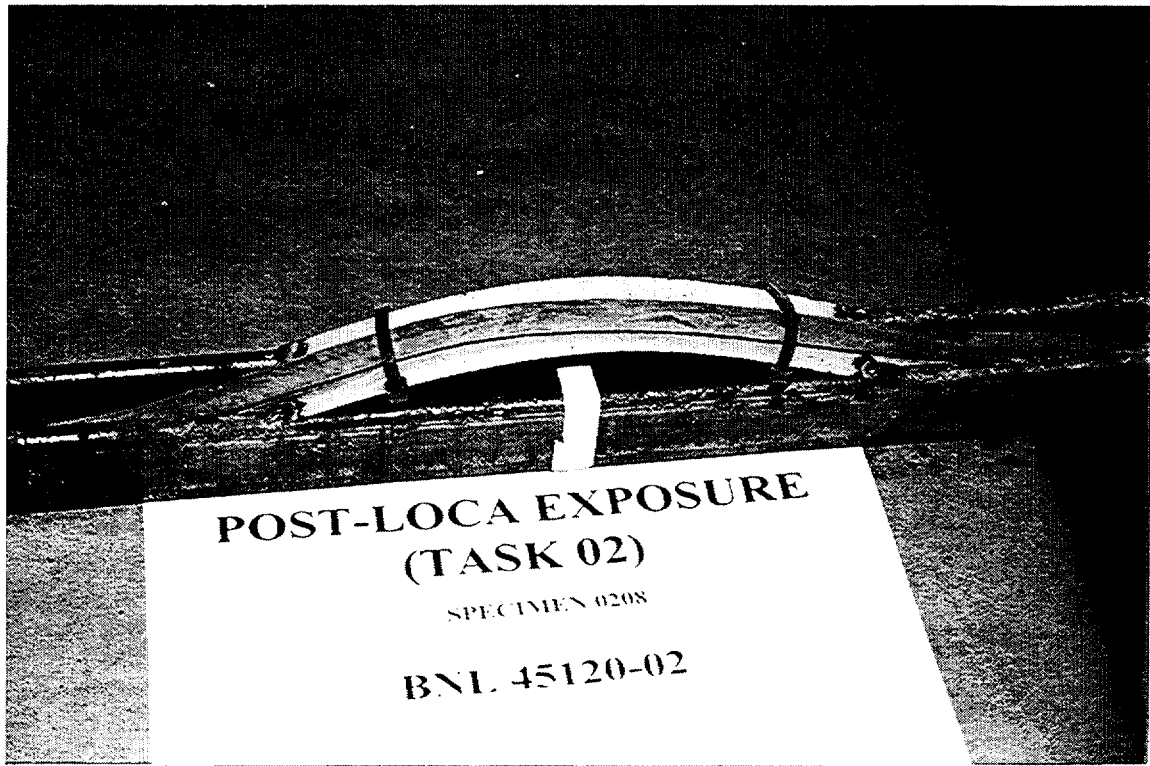
Figure 3.15 Post-LOCA condition of AIW specimen 0208 from Group 2.3 (naturally aged 24 years)

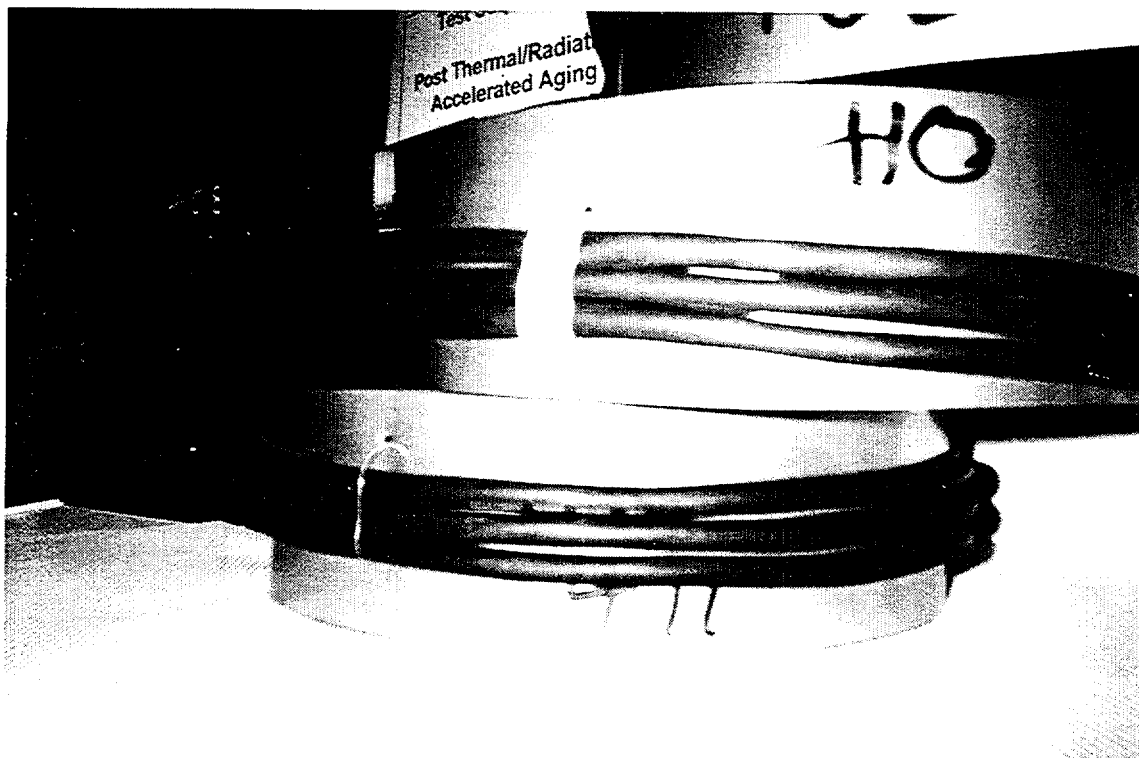
Figure 3.20 Anaconda multiconductor specimens 0410 and 0411 from Group 4.3 (pre-aged to 40 years) after accelerated service aging

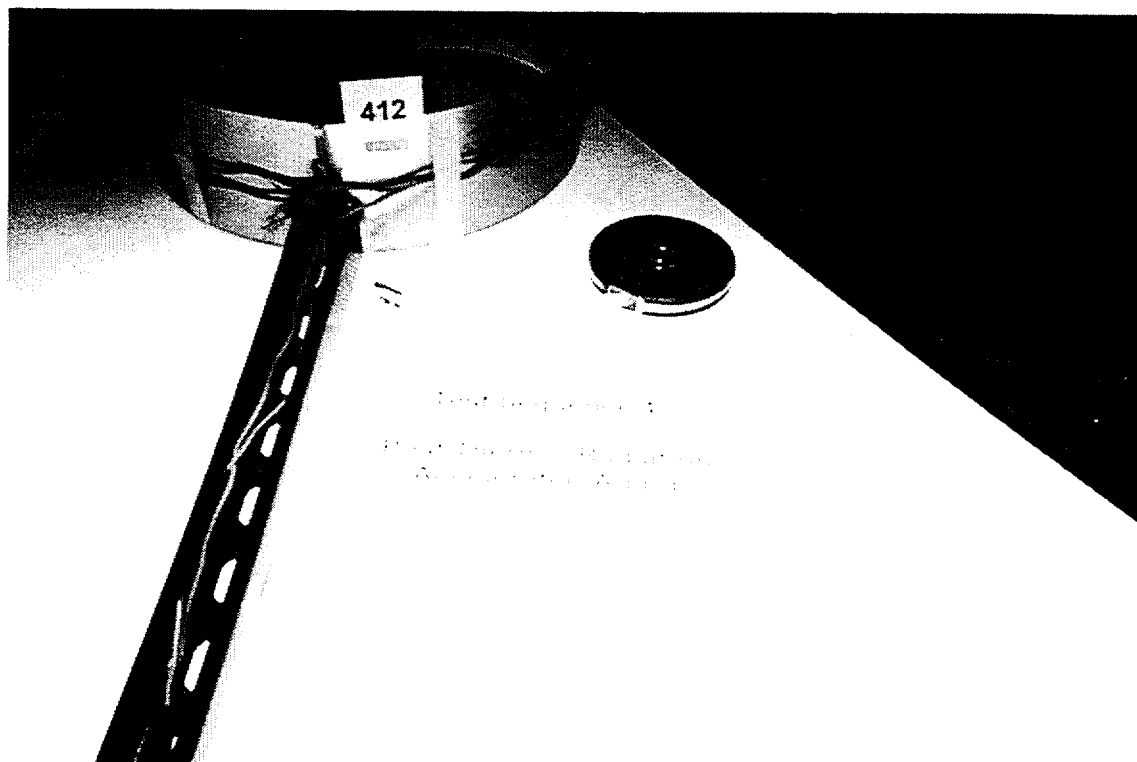
Figure 3.21 Samuel Moore single conductor specimen 0412 from Group 4.3 (pre-aged to 40 years) after accelerated service aging

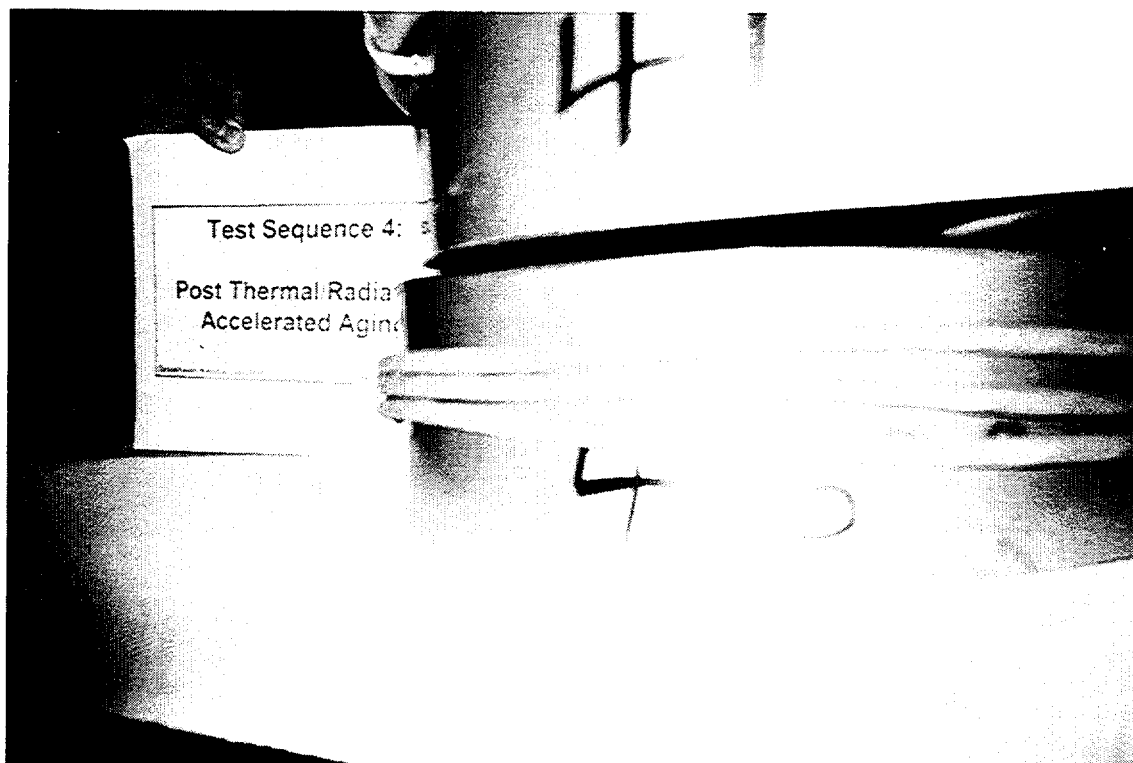
Figure 3.22 Samuel Moore multiconductor specimen 0415 from Group 4.3 (pre-aged to 40 years) after accelerated service aging

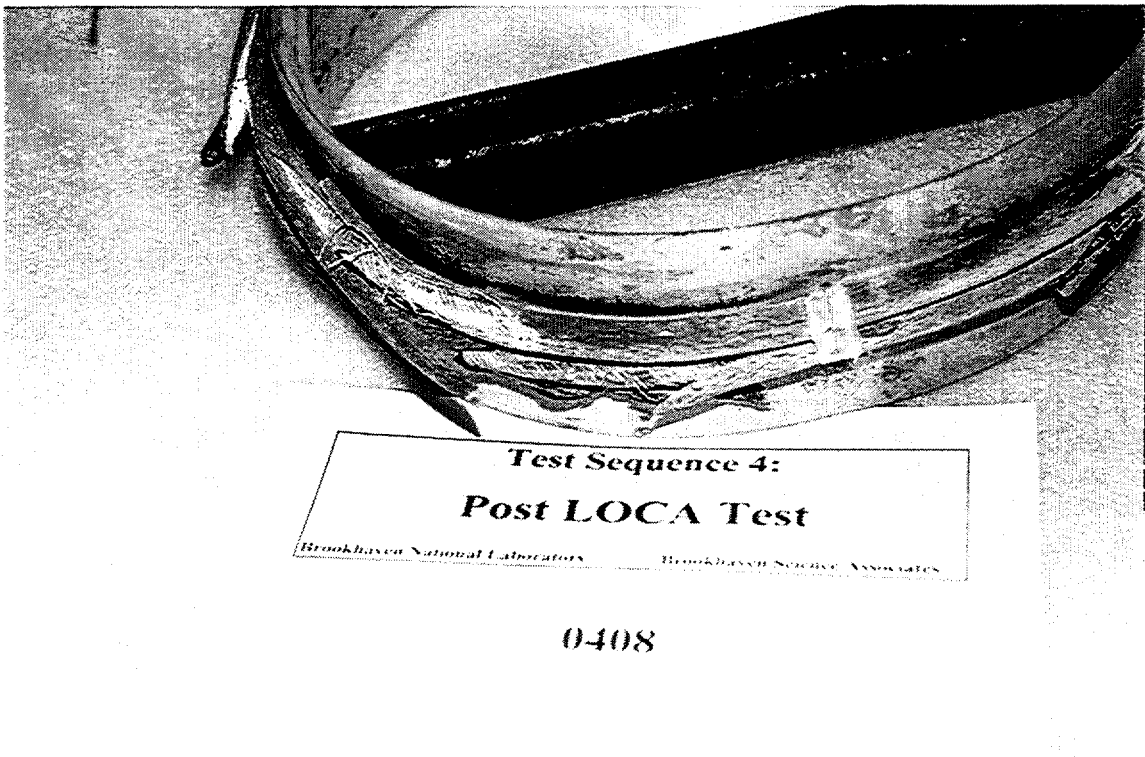
Figure 3.25 Post-LOCA condition of Anaconda multiconductor specimen 0408 from Group 4.3 (pre-aged to 40 years)
