Assessment of Environmental Qualification Practices and Condition Monitoring Techniques for Low-Voltage Electric Cables

LOCA Test Results

Brookhaven National Laboratory

**U.S. Nuclear Regulatory Commission
Office of Nuclear Regulatory Research
Washington, DC 20555-0001**

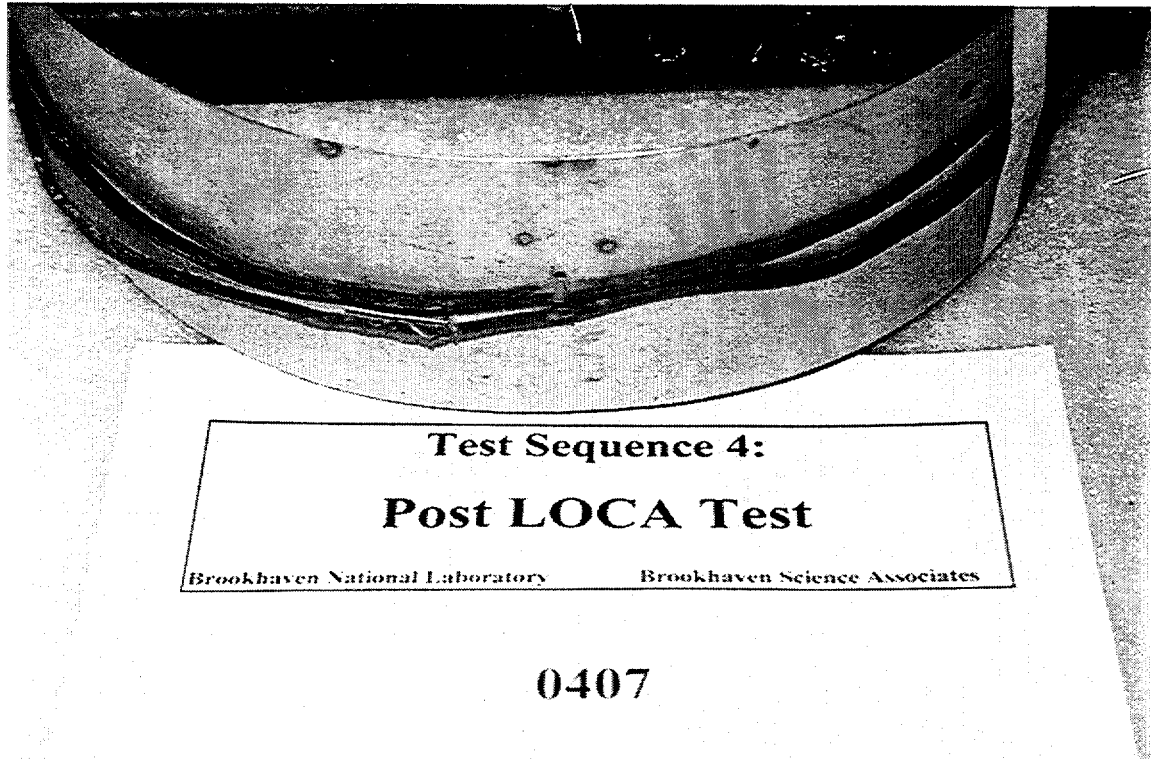
Figure 3.26 Post-LOCA condition of Anaconda single conductor specimen 0407 from Group 4.3 (pre-aged to 40 years)

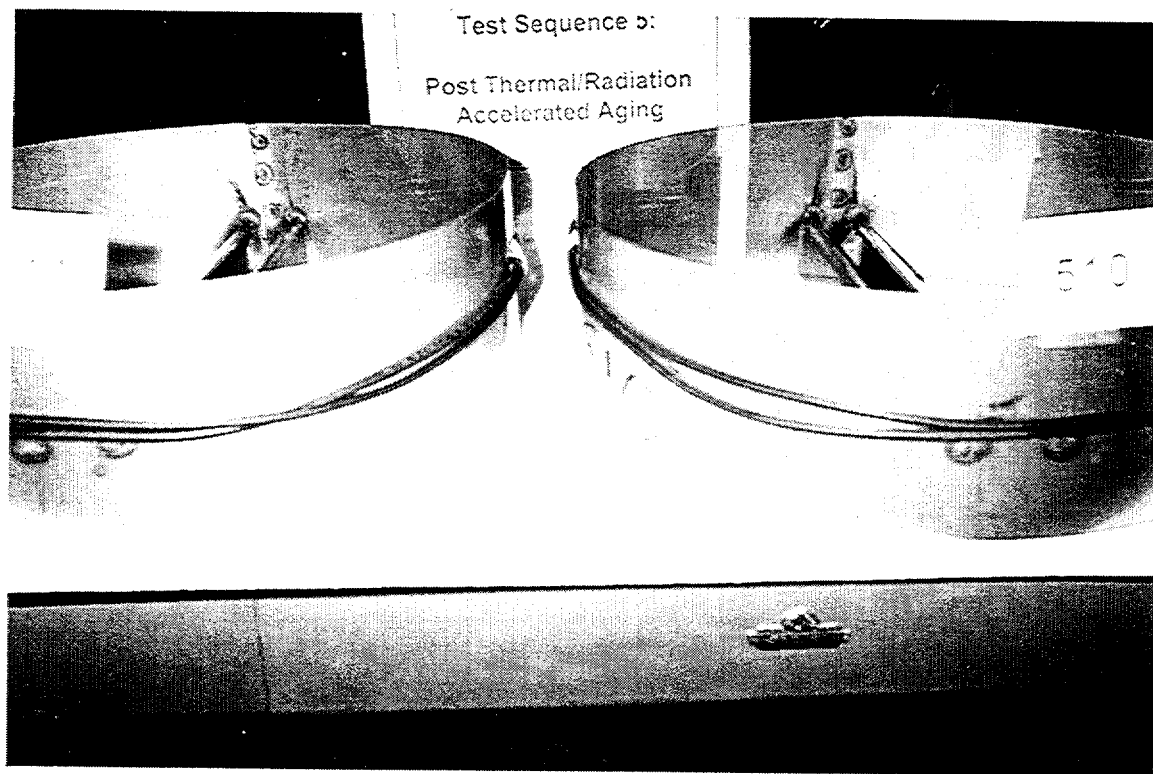
Figure 3.27 Okonite specimens 0510 and 0511 from Group 5.3 (pre-aged to 40 years) after accelerated service aging

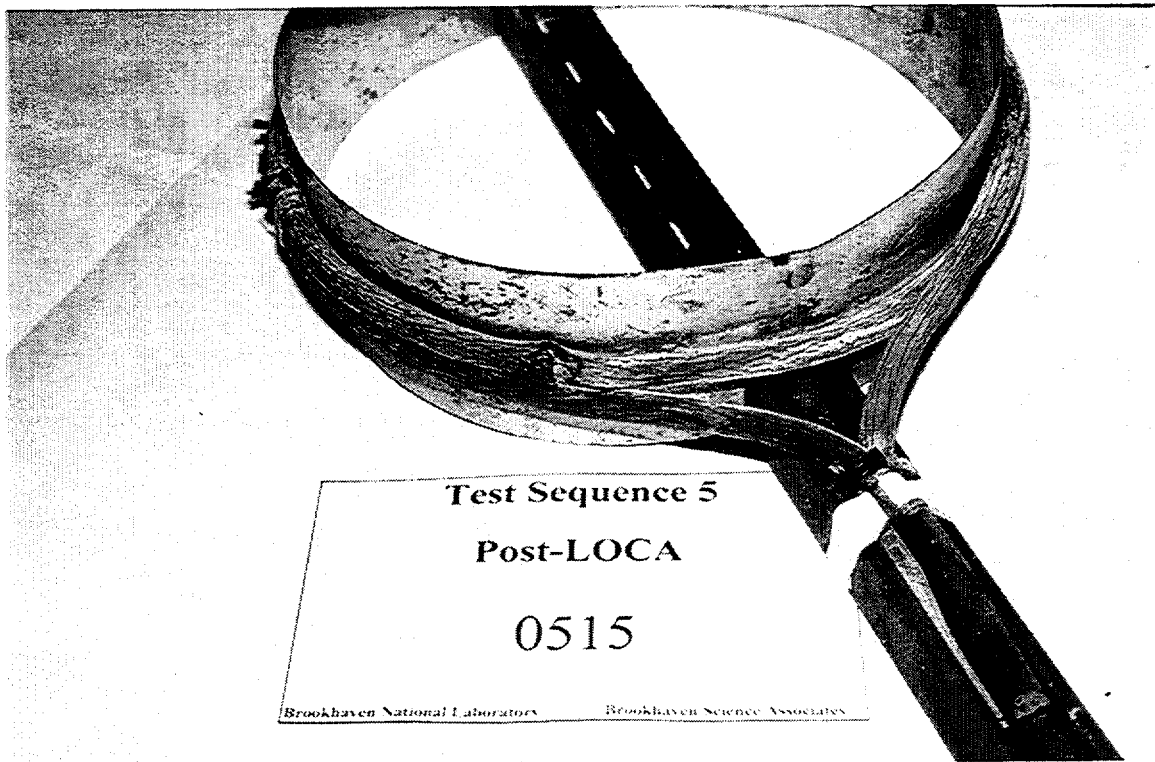
Figure 3.29 Post-LOCA condition of Anaconda specimen 0515 from Group 5.3 (pre-aged to 40 years)

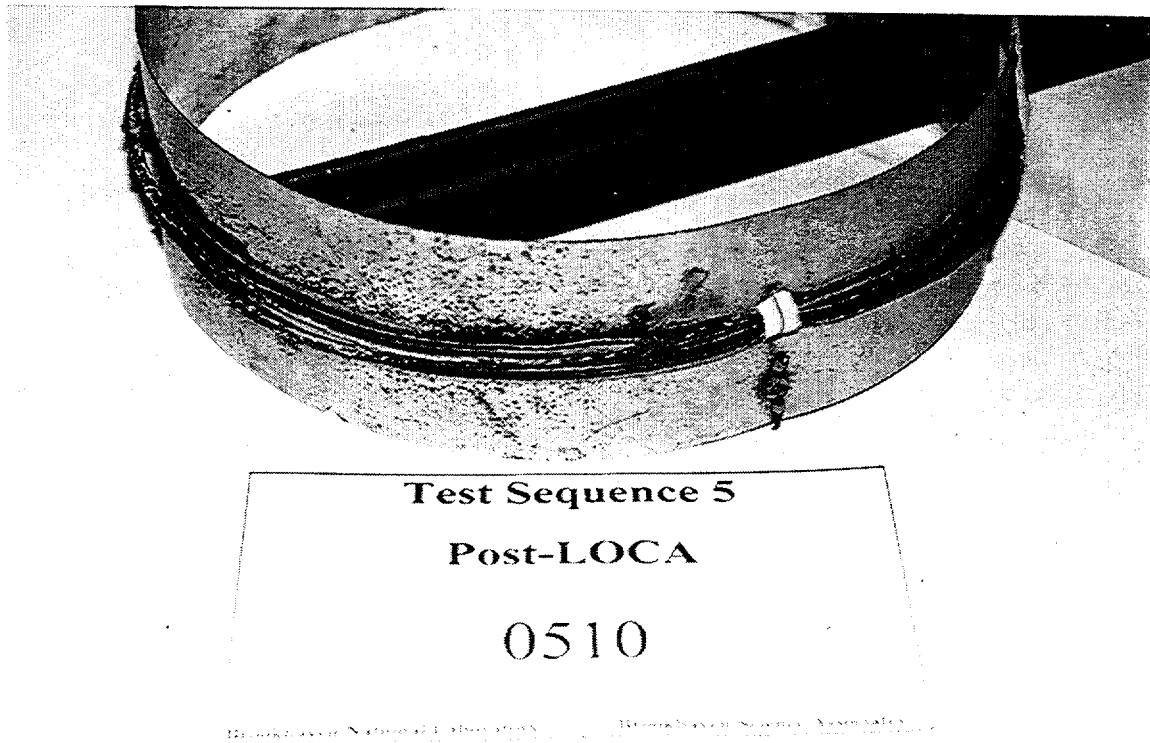
Figure 3.30 Post-LOCA condition of Okonite specimen 0510 in Group 5.3 (pre-aged to 40 years)

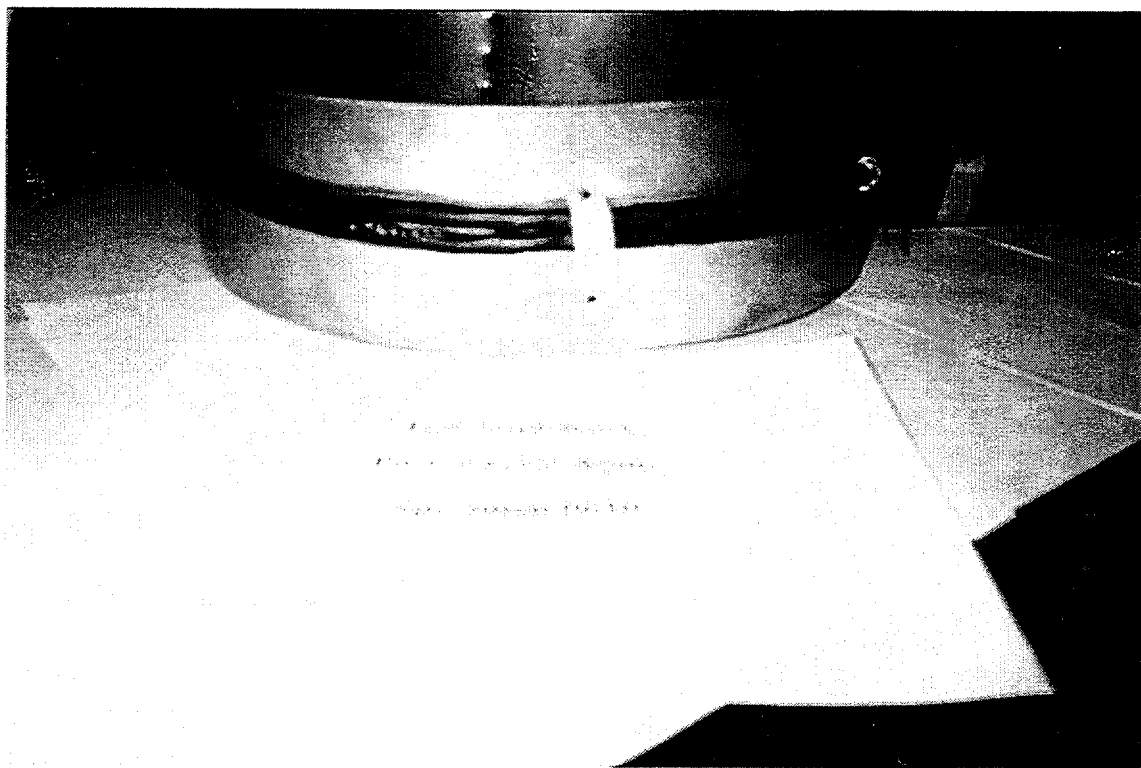
**Figure 3.33 Samuel Moore specimen 0610 from Group 6.2 (pre-aged to 60 years)
after accelerated service aging**

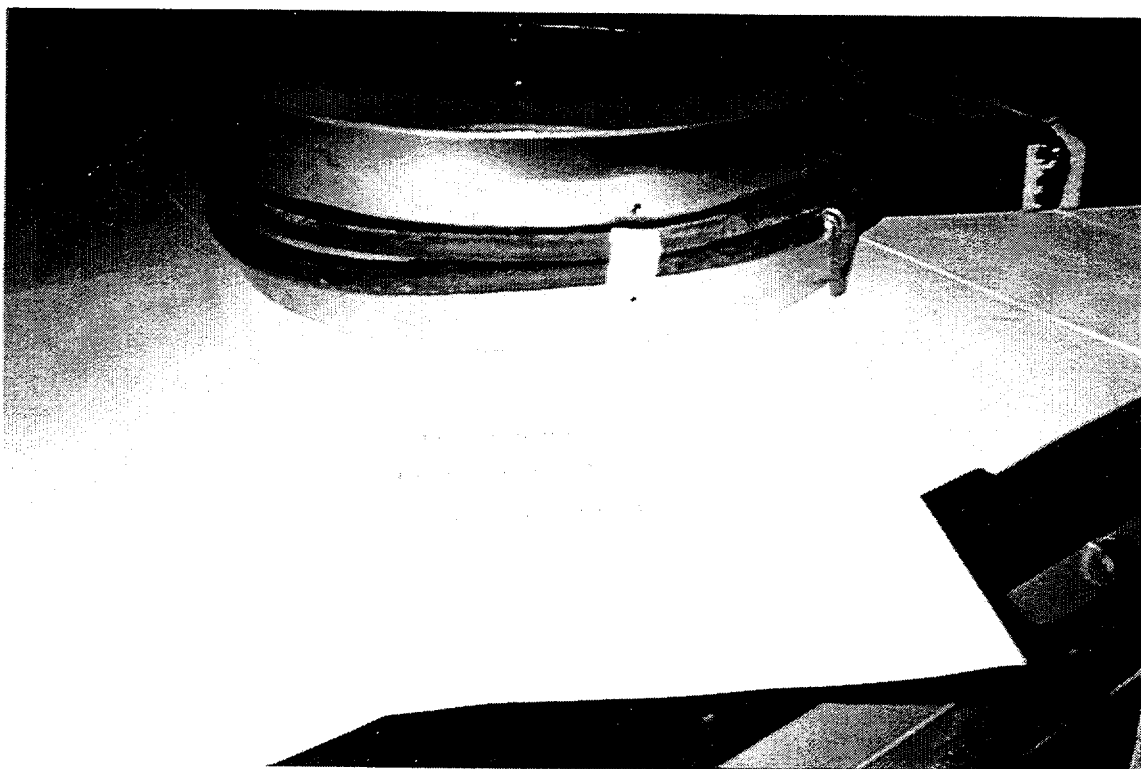
Figure 3.34 AIW specimen 0611 from Group 6.2 (pre-aged to 60 years) after accelerated service aging

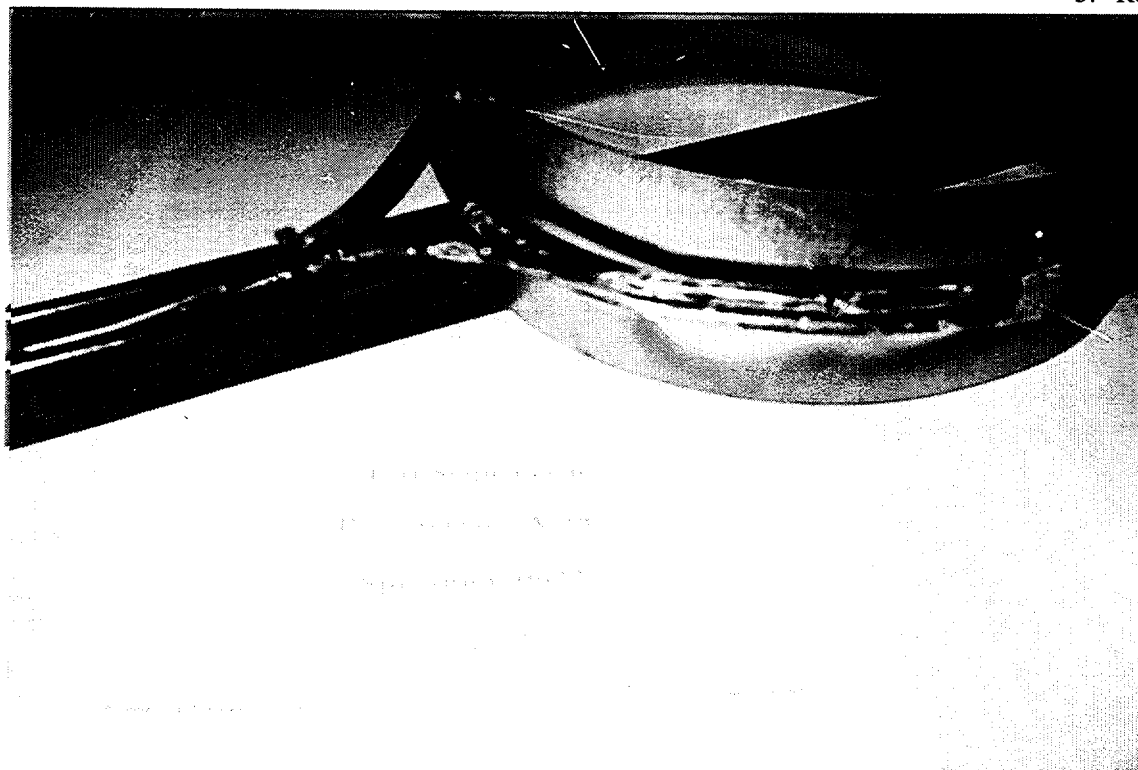
**Figure 3.35 Rockbestos specimen 0622 from Group 6.2 (pre-aged to 60 years)
after accelerated service aging**

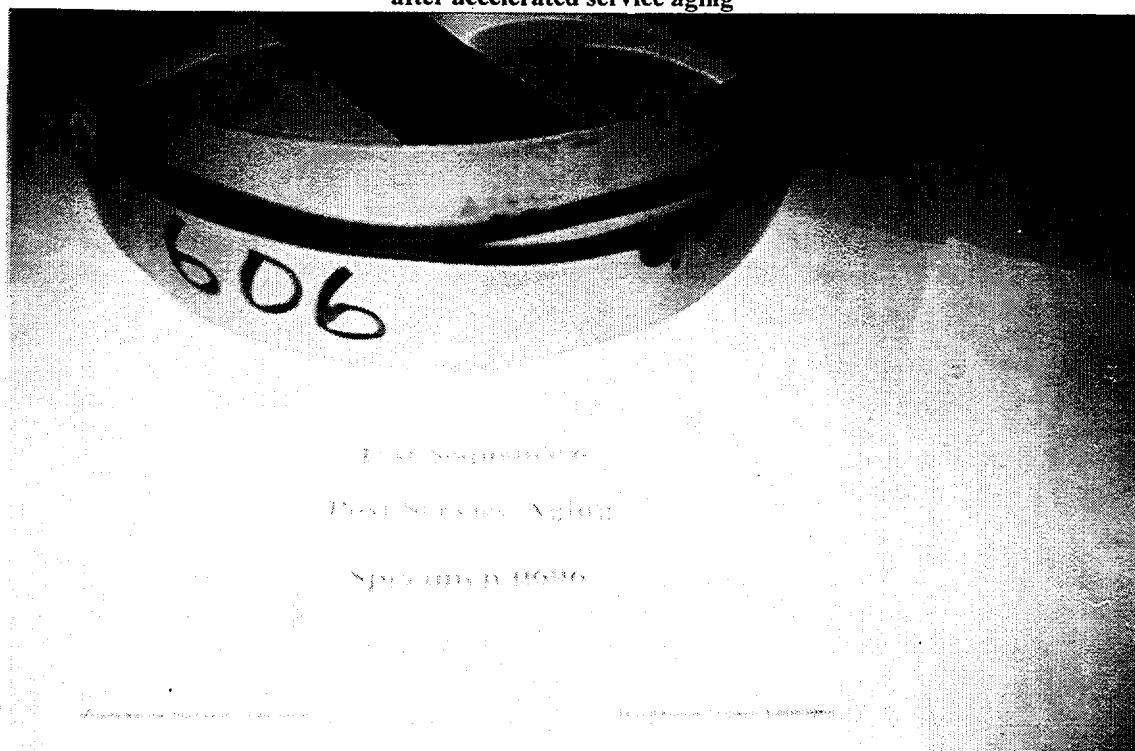
Figure 3.36 Okonite specimen 0606 from Group 6.2 (pre-aged to 60 years) after accelerated service aging

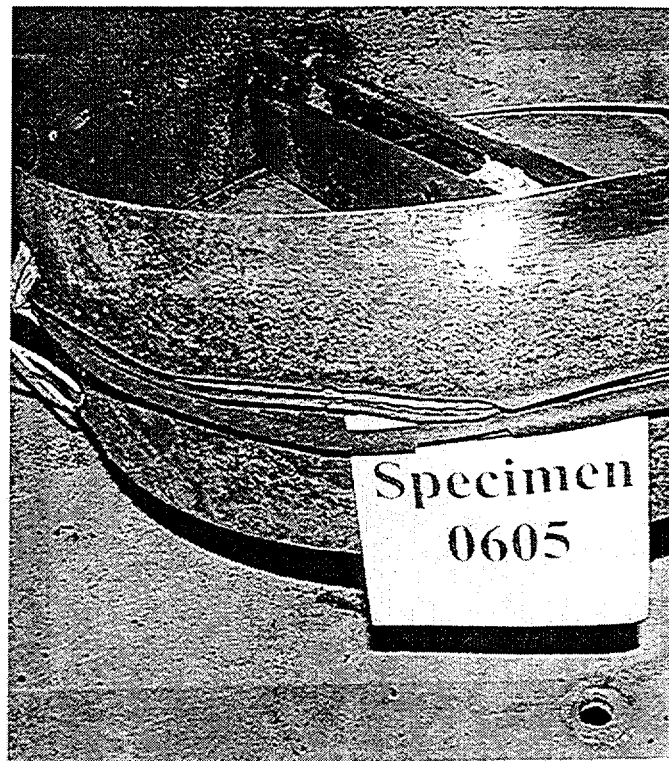
Figure 3.37 Post-LOCA condition of Okonite specimen 0605 from Group 6.2 (pre-aged to 60 years)
