Experiments With VVER Fuels to Confirm Safety Criteria

Zoltán Hózer, László Maróti, Lajos Matus, Péter Windberg
KFKI Atomic Energy Research Institute
H-1525 Budapest, P.O.Box 49, Hungary

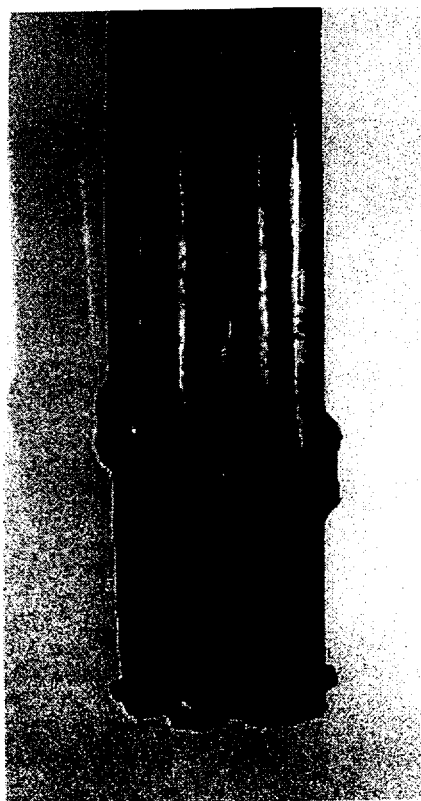
Fig. 7.a
7-rod ballooning test in argon, 20 bar
initial pressure

After the tests the bundles were filled up with epoxy and several cross sections were prepared from each bundle for post-test examination (Fig. 8.a and. 8.b). The axial distribution of deformation of each rod of each bundle was measured. The typical blockage rate (which shows the cross section reduction compared to the nominal value) was between 40-50% and the maximum was below 80%. The ballooning took place on the hottest 4-5 cm long part of the bundle (Fig. 7.a and 7.b).
