SUBJECT: PWR Reactor Piping and Head Penetrations

- EPRI Report TP1001491, Part 1, *Materials Reliability Project, Interim Alloy 600 Safety Assessment for U. S. PWR Plants, Part 1: Alloy 82/182 Pipe Butt Welds*, (Proprietary), April 2001 (10 Copies)
- EPRI Report TP1001491 NP, Part 1, *Materials Reliability Project, Interim Alloy 600 Safety Assessment for U. S. PWR Plants, Part 1: Alloy 82/182 Pipe Butt Welds*, (Non-Proprietary), April 2001 (10 Copies)
- EPRI Affidavit

As a consequence of the hot leg nozzle weld leak at V.C. Summer in October 2000, the industry, acting through the EPRI Materials Reliability Project, has undertaken development of a comprehensive program to address this issue. Interim safety assessments have been completed to assure continued safe operation. The interim safety assessments will be used to guide development of comprehensive inspection and evaluation guidance, as well as potential repair and mitigation strategies, where warranted. This report provides the interim safety assessments for Alloy 82/182 pipe butt welds.

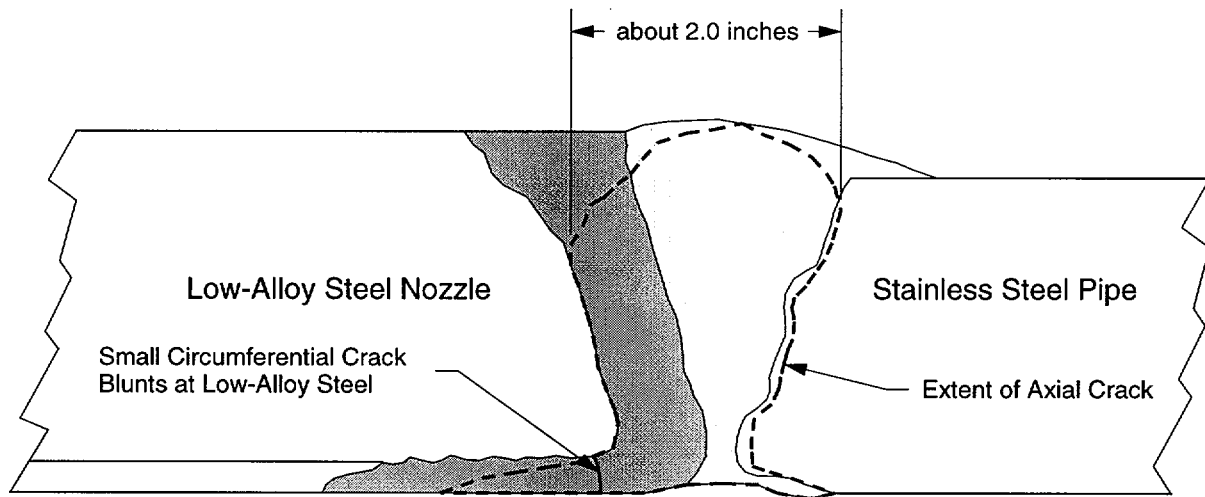
Figure 2-1
Location of Axial and Circumferential Cracks in V.C. Summer Hot Leg Nozzle to Primary Coolant Pipe Weld

Destructive examination after removing a short spool piece containing the weld showed that there was 1) a through-wall axial crack of about 2 inch maximum length covering most of the Alloy 82/182 weld width, 2) several other part-depth axial cracks, and 3) one shallow circumferential crack that initiated in the Alloy 182 cladding. These conditions are illustrated in Figure 2-1. As shown in this figure, the large axial crack arrested when it reached the low-alloy steel nozzle and the stainless steel pipe. The circumferential crack arrested when it reached the low-alloy steel nozzle material, giving it a maximum depth of 0.2 inches.

Ultrasonic inspections from outside of the pipe were inconclusive. Ultrasonic inspections from inside the pipe revealed a single flaw near the top of the pipe. Destructive examination confirmed axial primary side initiated cracking confined to the Alloy 182 nozzle-to-pipe weld and to the Alloy 182 buttering on the inside surface of the low-alloy steel nozzle near the weld, and a short shallow circumferential crack in the buttering which arrested at the low-alloy steel nozzle.
