Table 1
Chronology of Site Events
Homestake Mining Company Site, New Mexico

Attachment 3**Site Inspection Roster for Site Inspection Conducted August 16, 2001****Homestake Mining Company Superfund Site**

Attachment 4
Site Inspection Photographs

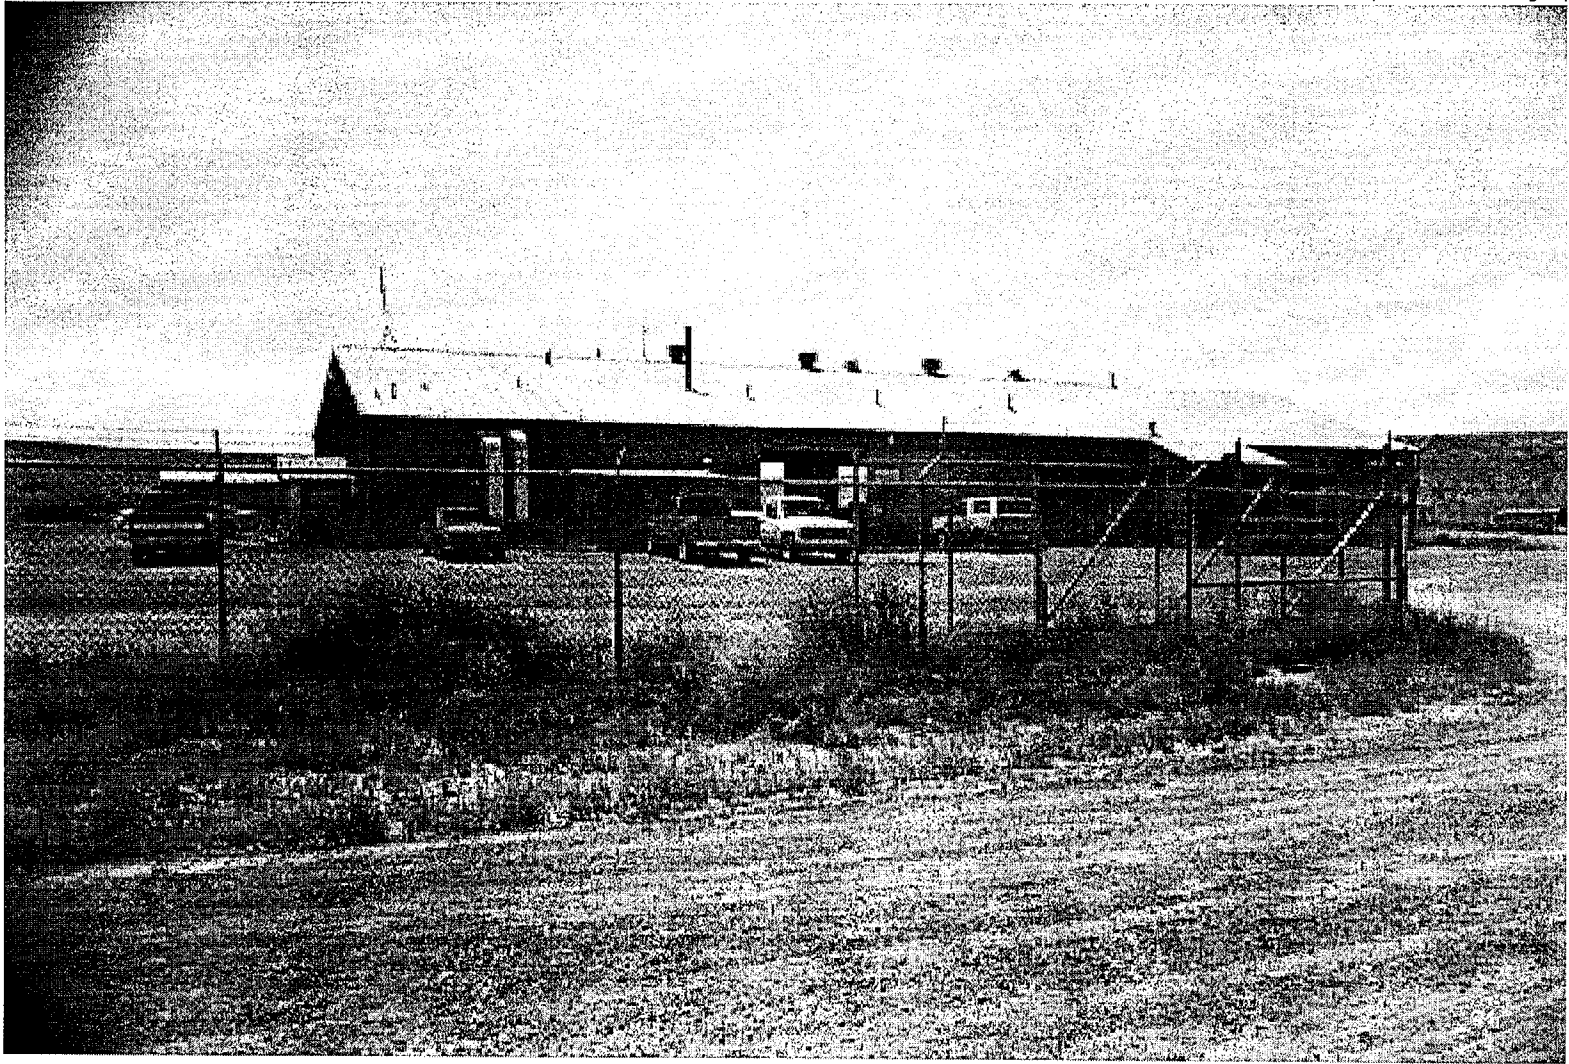
Main site building and entrance to site (gate is at right) along County Road 63.

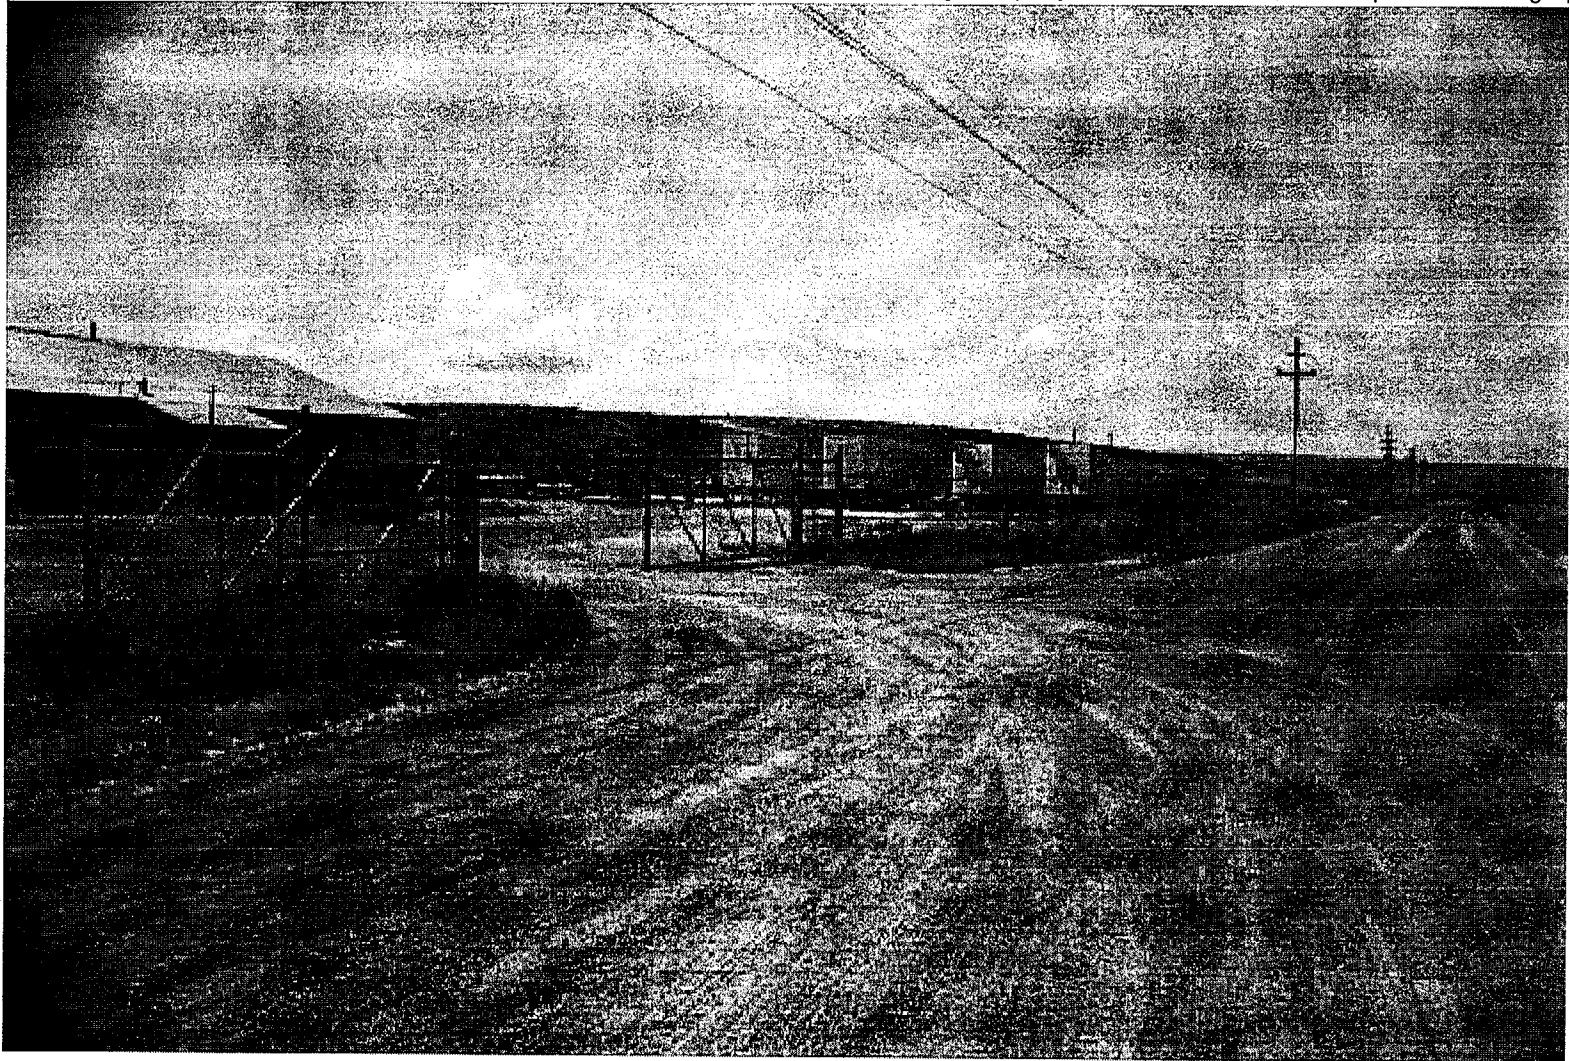
Slightly right of previous view, showing open site entrance gate, facing west-southwest along County Road 63. Large tailings pile is visible in background center.

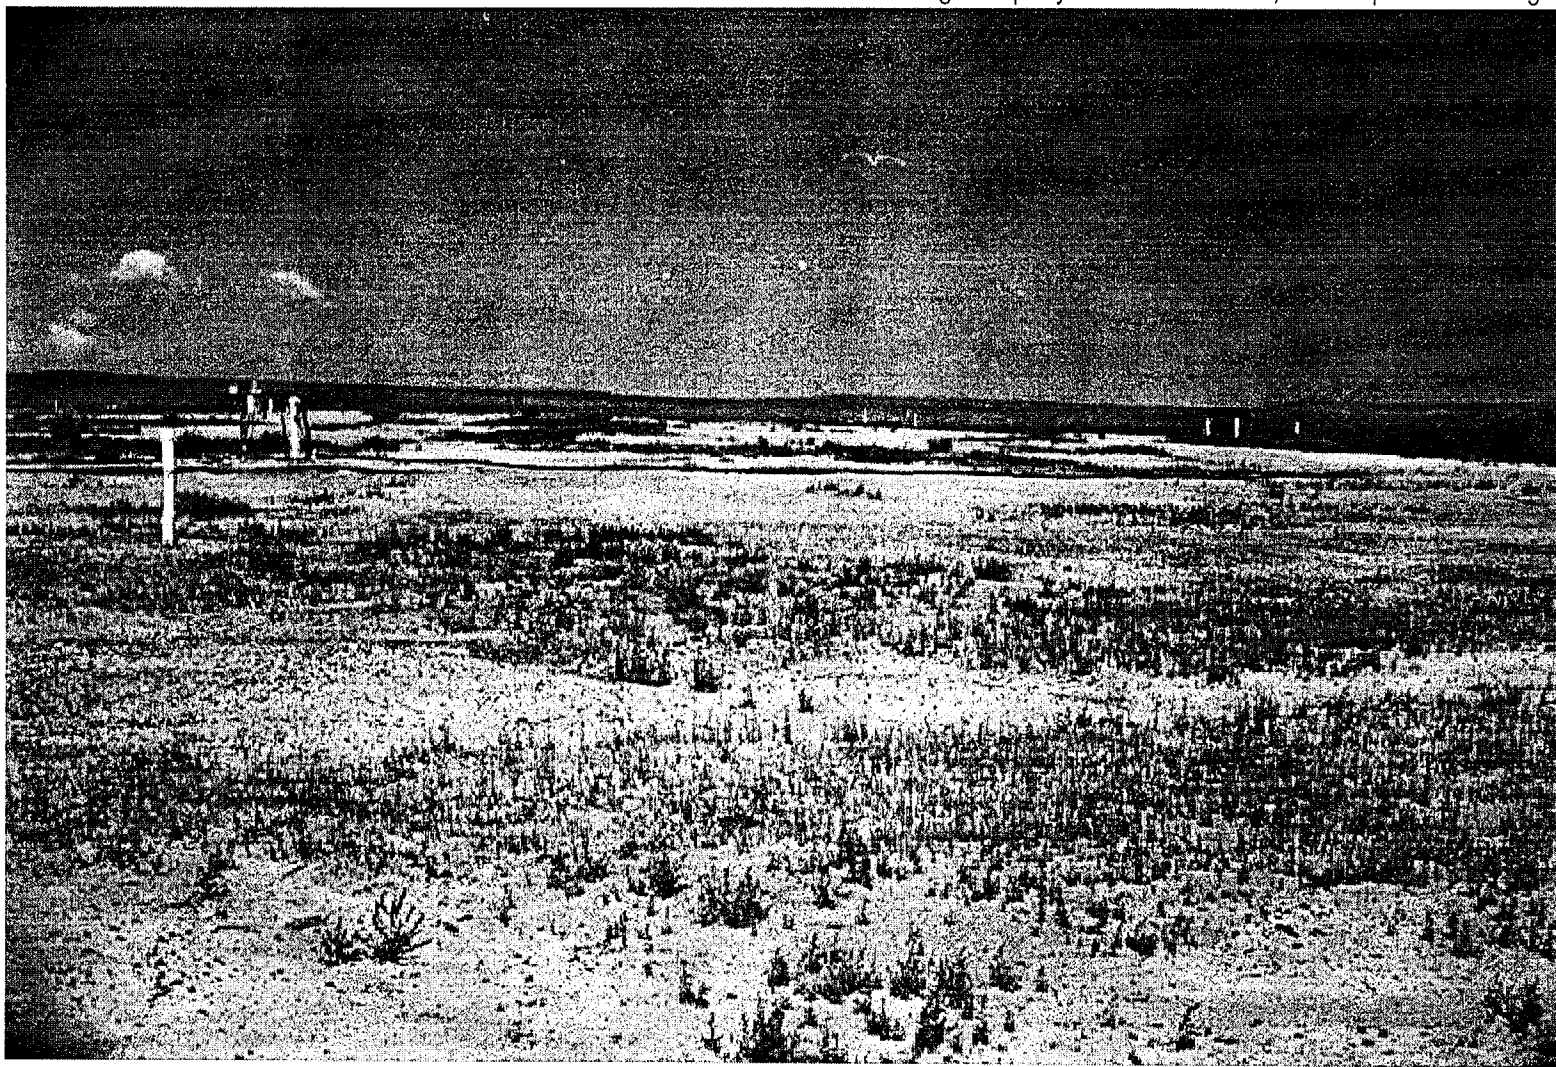
View across top of large tailing pile temporary cover, facing west.

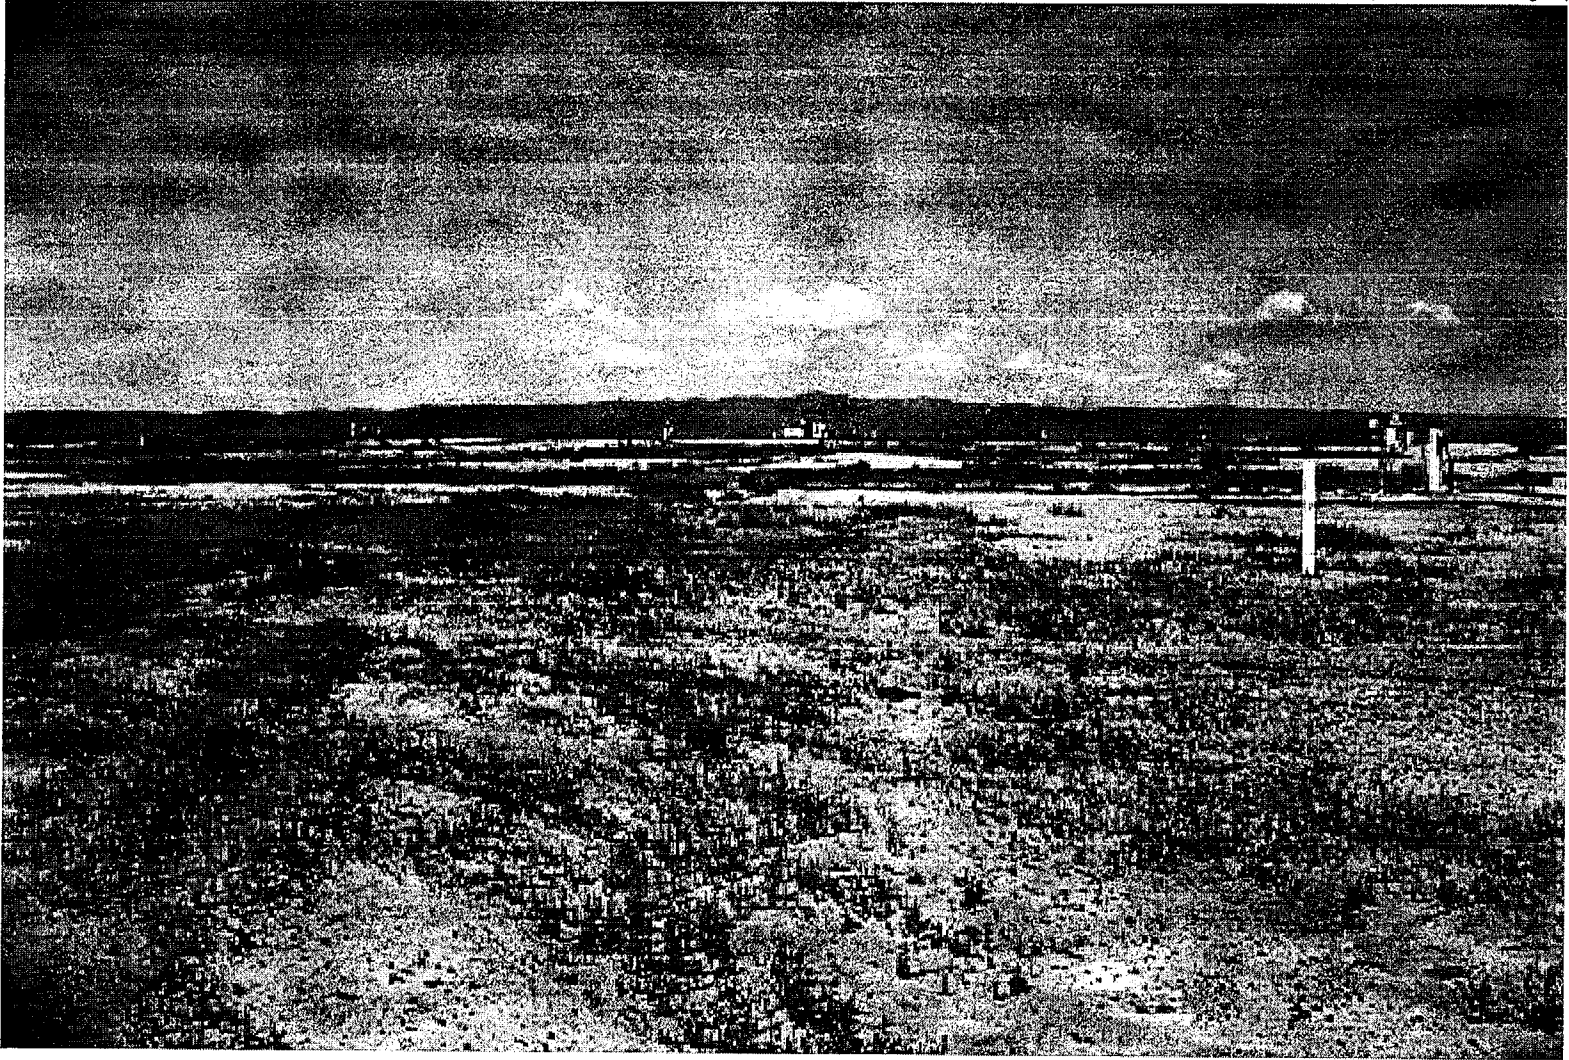
View across top of large tailing pile temporary cover, facing west-southwest (slightly left of view in previous photograph; wells at right are same wells at left in previous photograph).

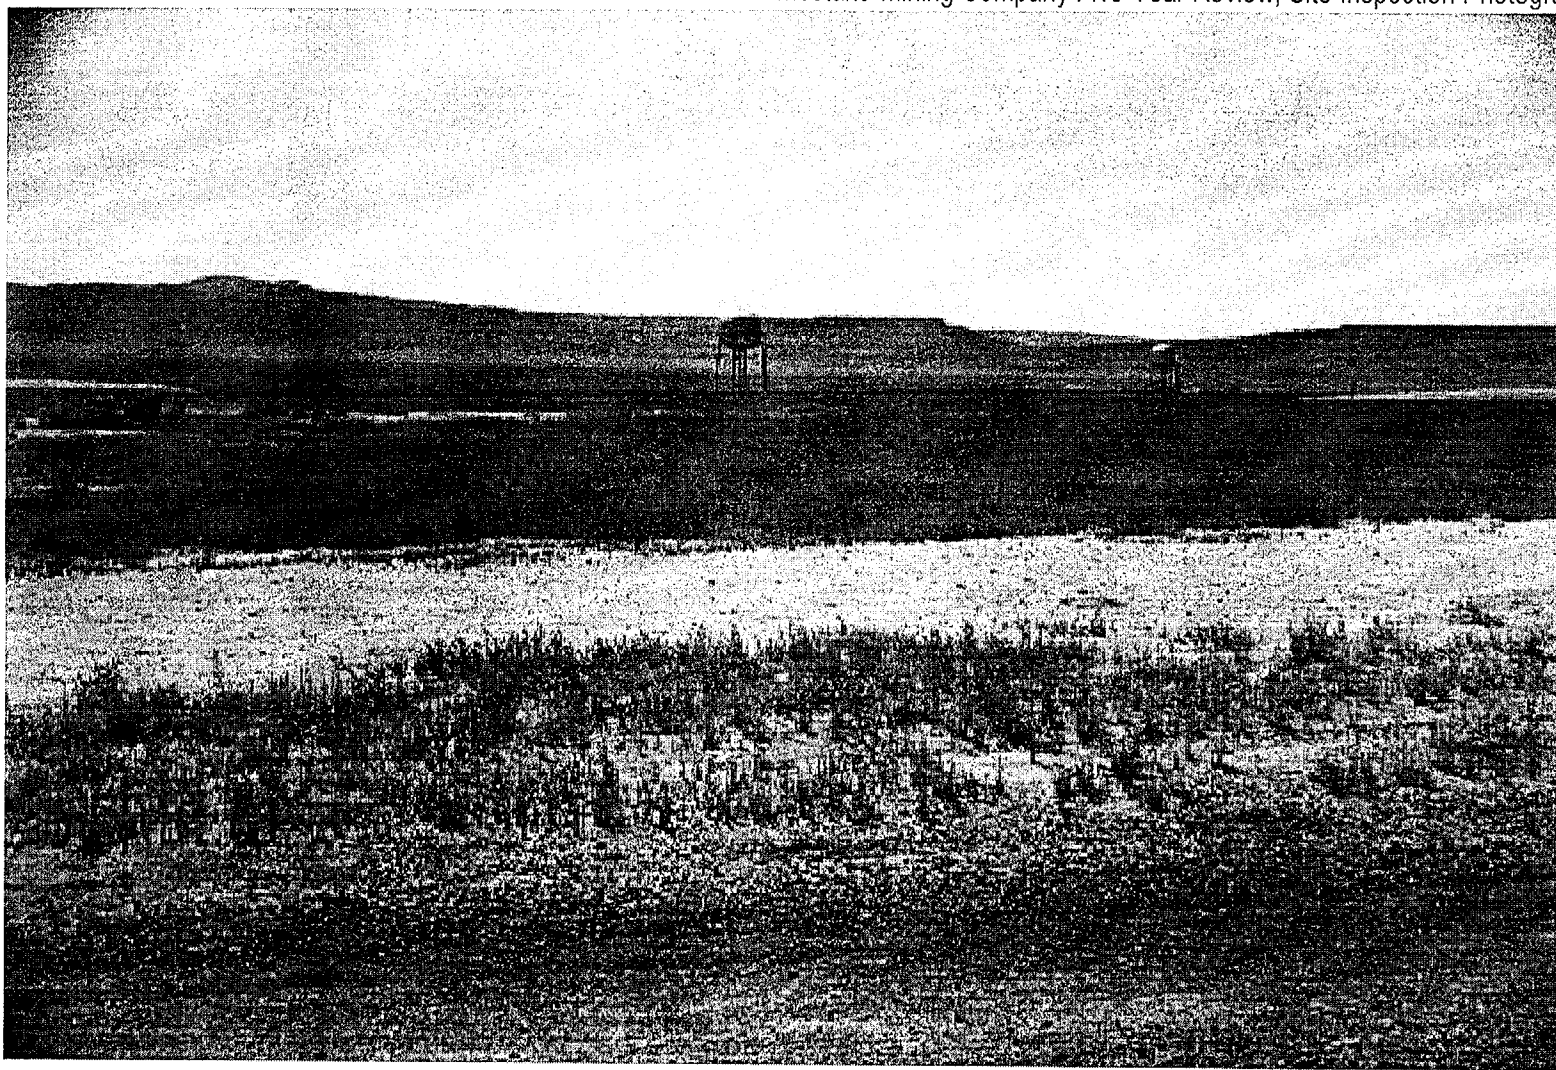
Facing east-southeast from top of large tailings pile toward fresh water supply towers.

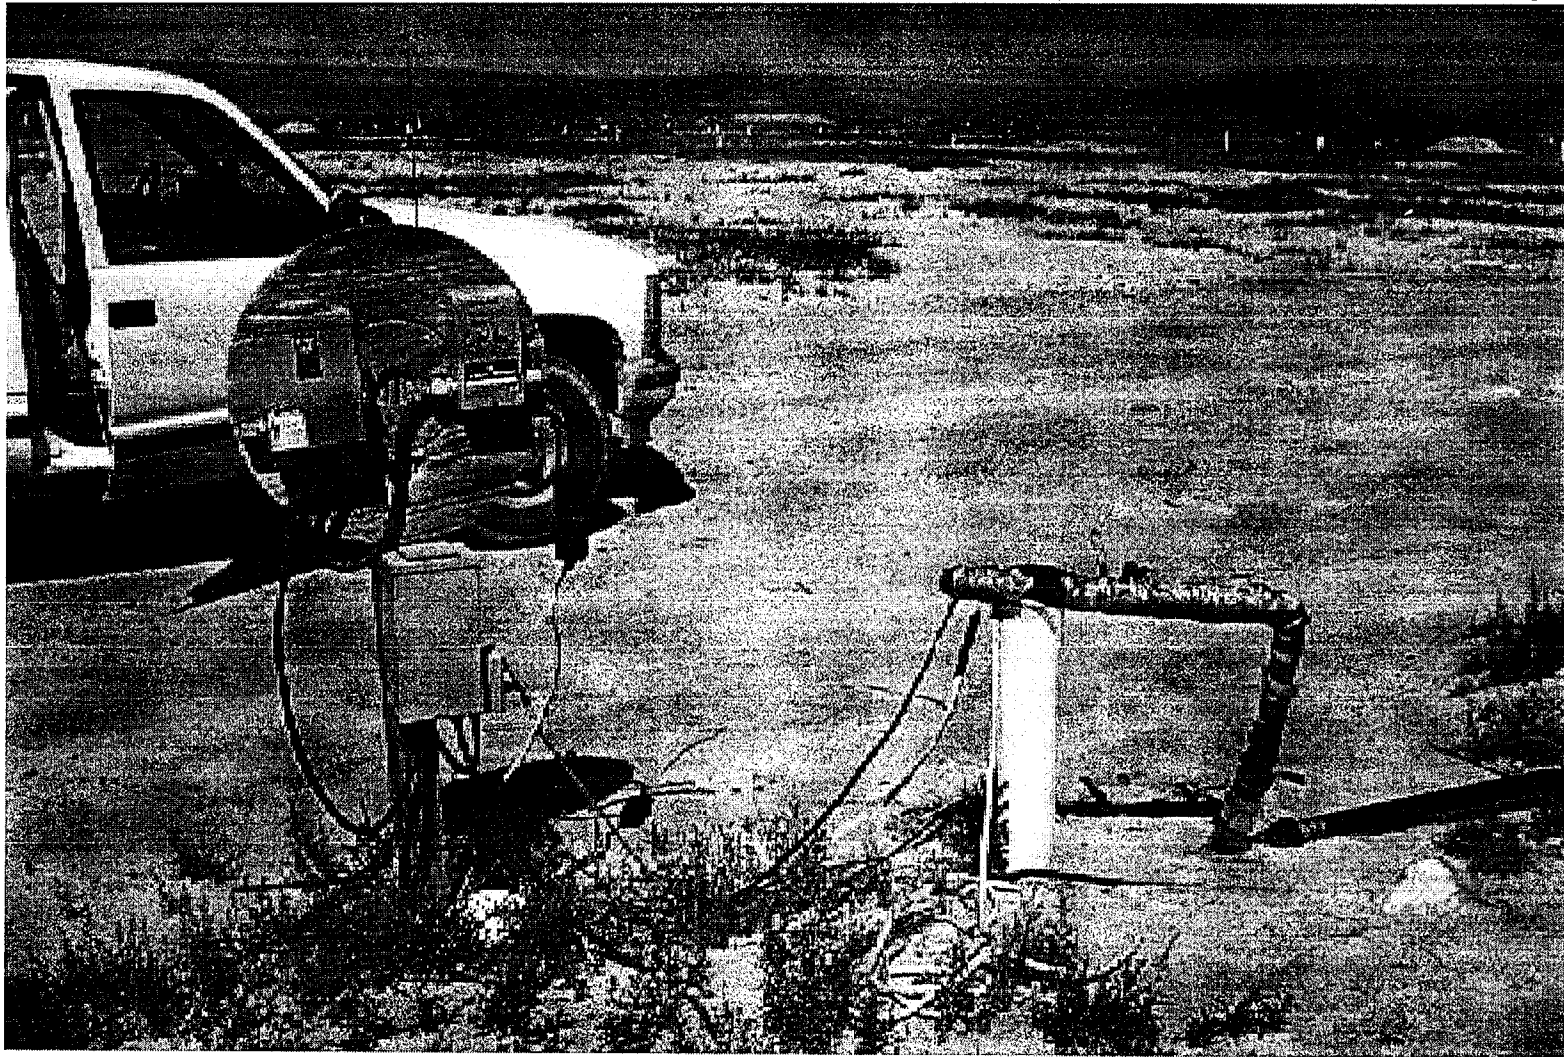
Facing west on top of large tailings pile, dewatering well CN6.

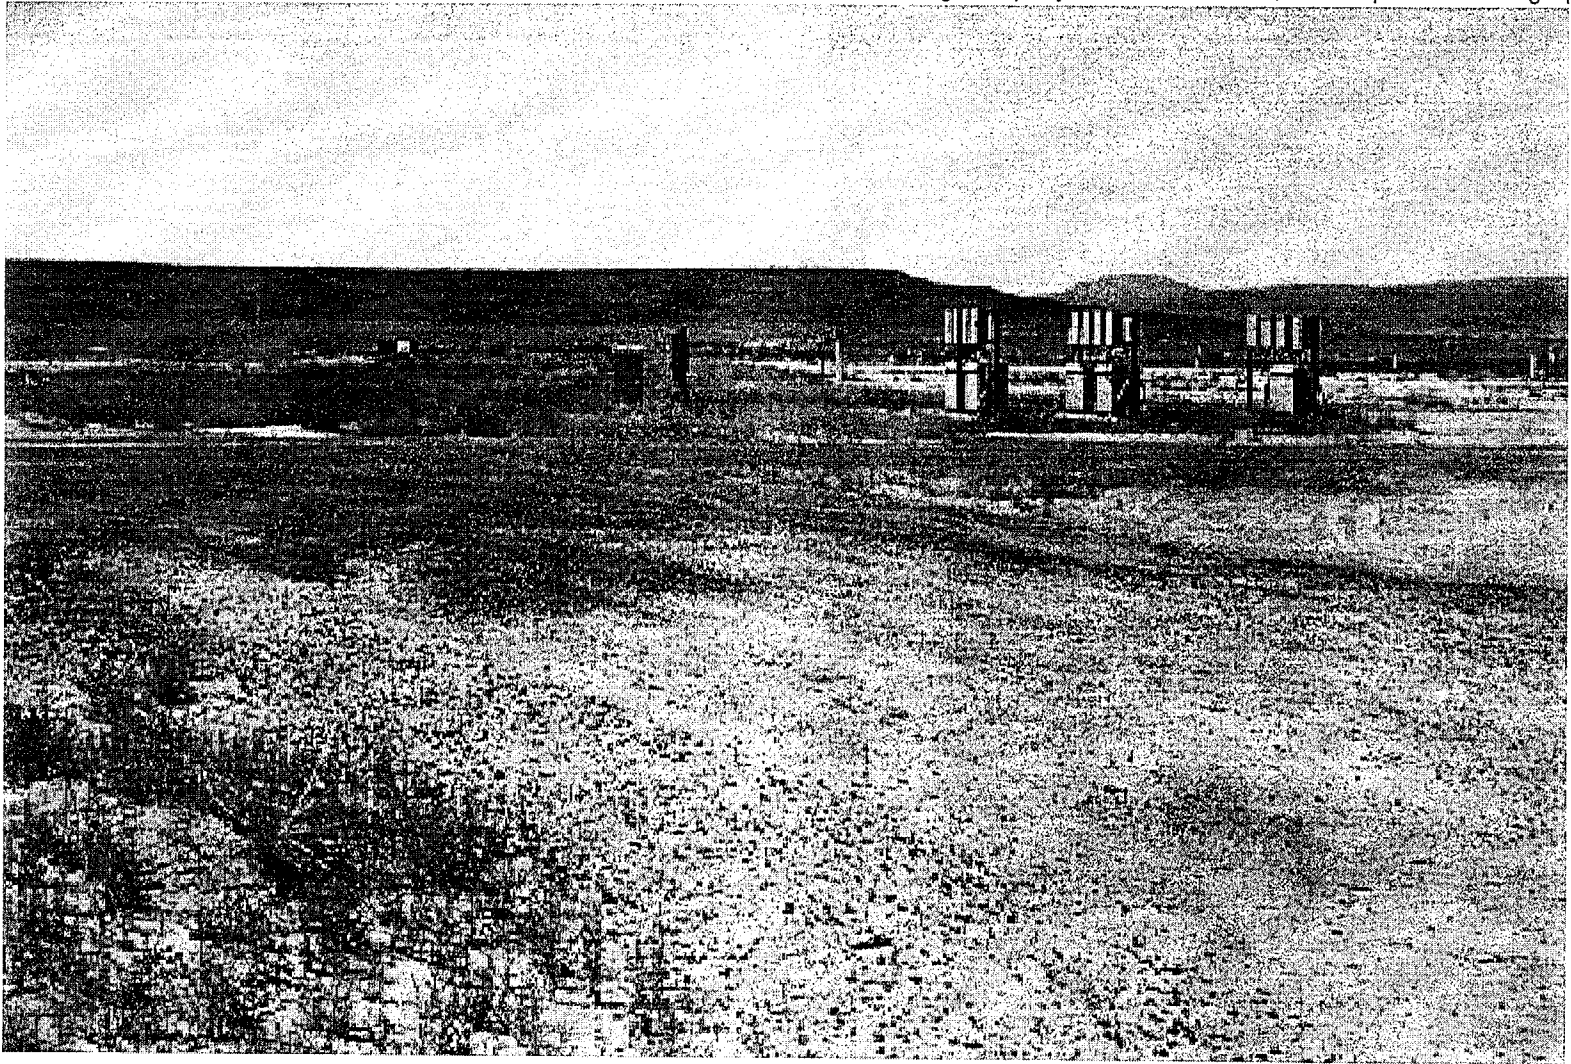
Facing south across large tailings pile temporary cover. Structures visible are the electrical boxes for the tailings pile dewatering well system.

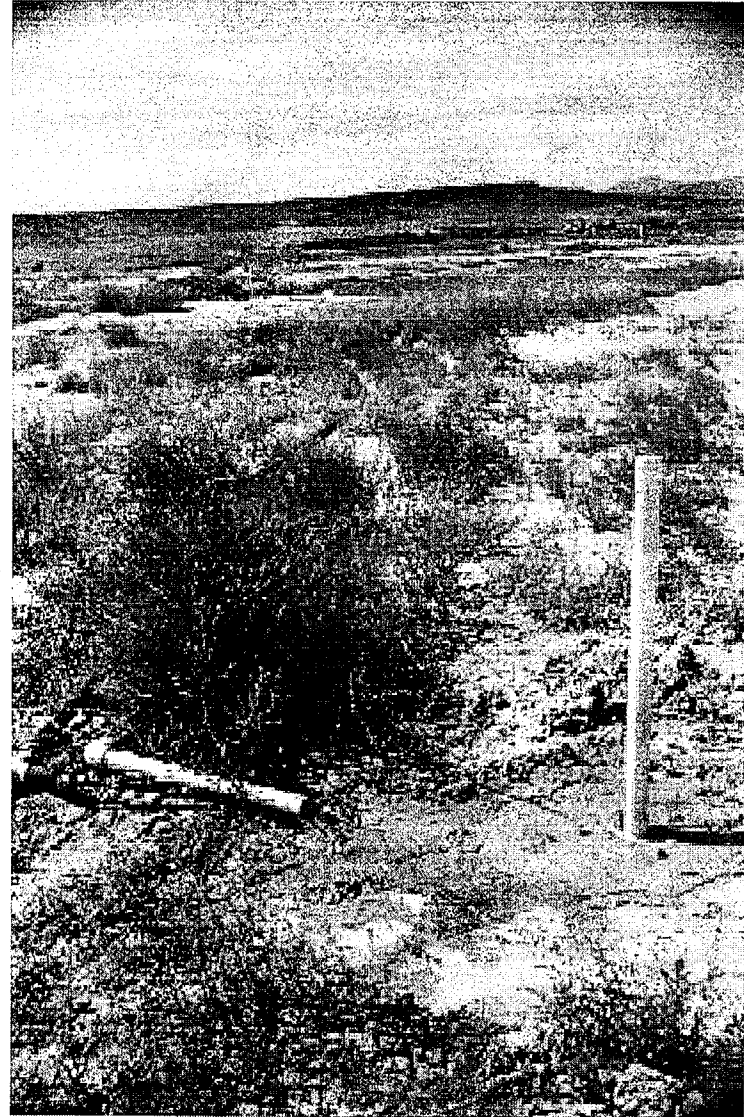
01_24_23A.JPG

Test injection well EK-7, on top of large tailing pile temporary cover. Using gravity drainage of fresh water.

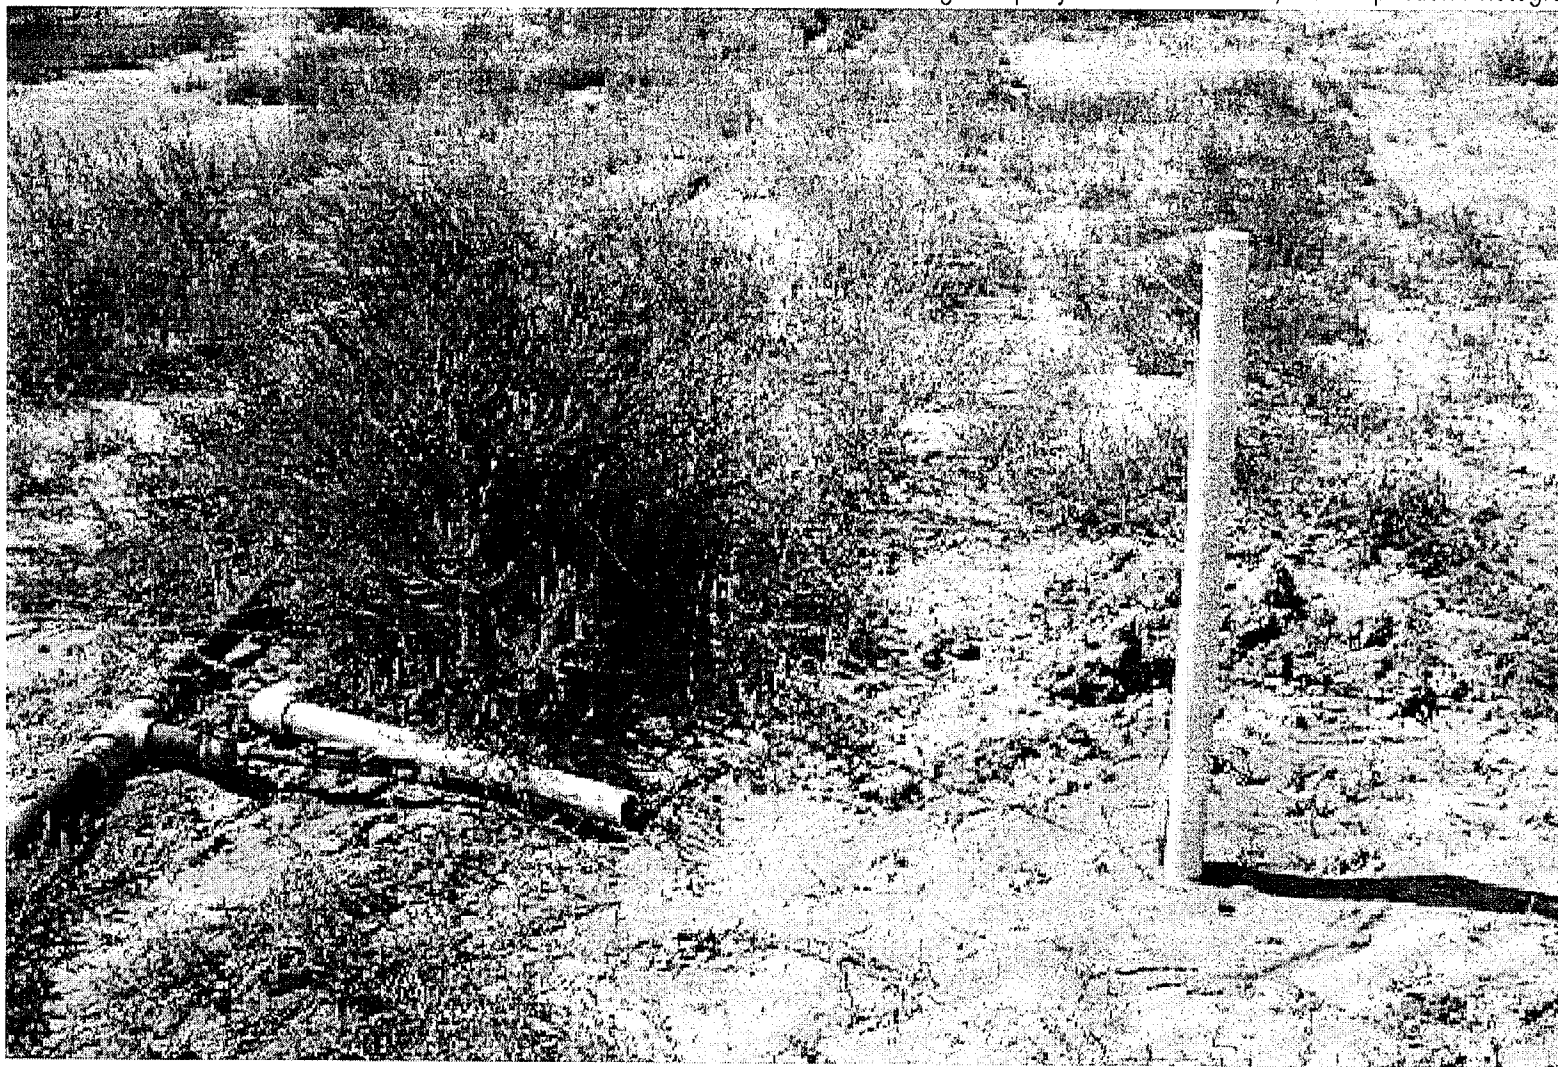
Closer view of injection well EK-7, seen in previous photograph.

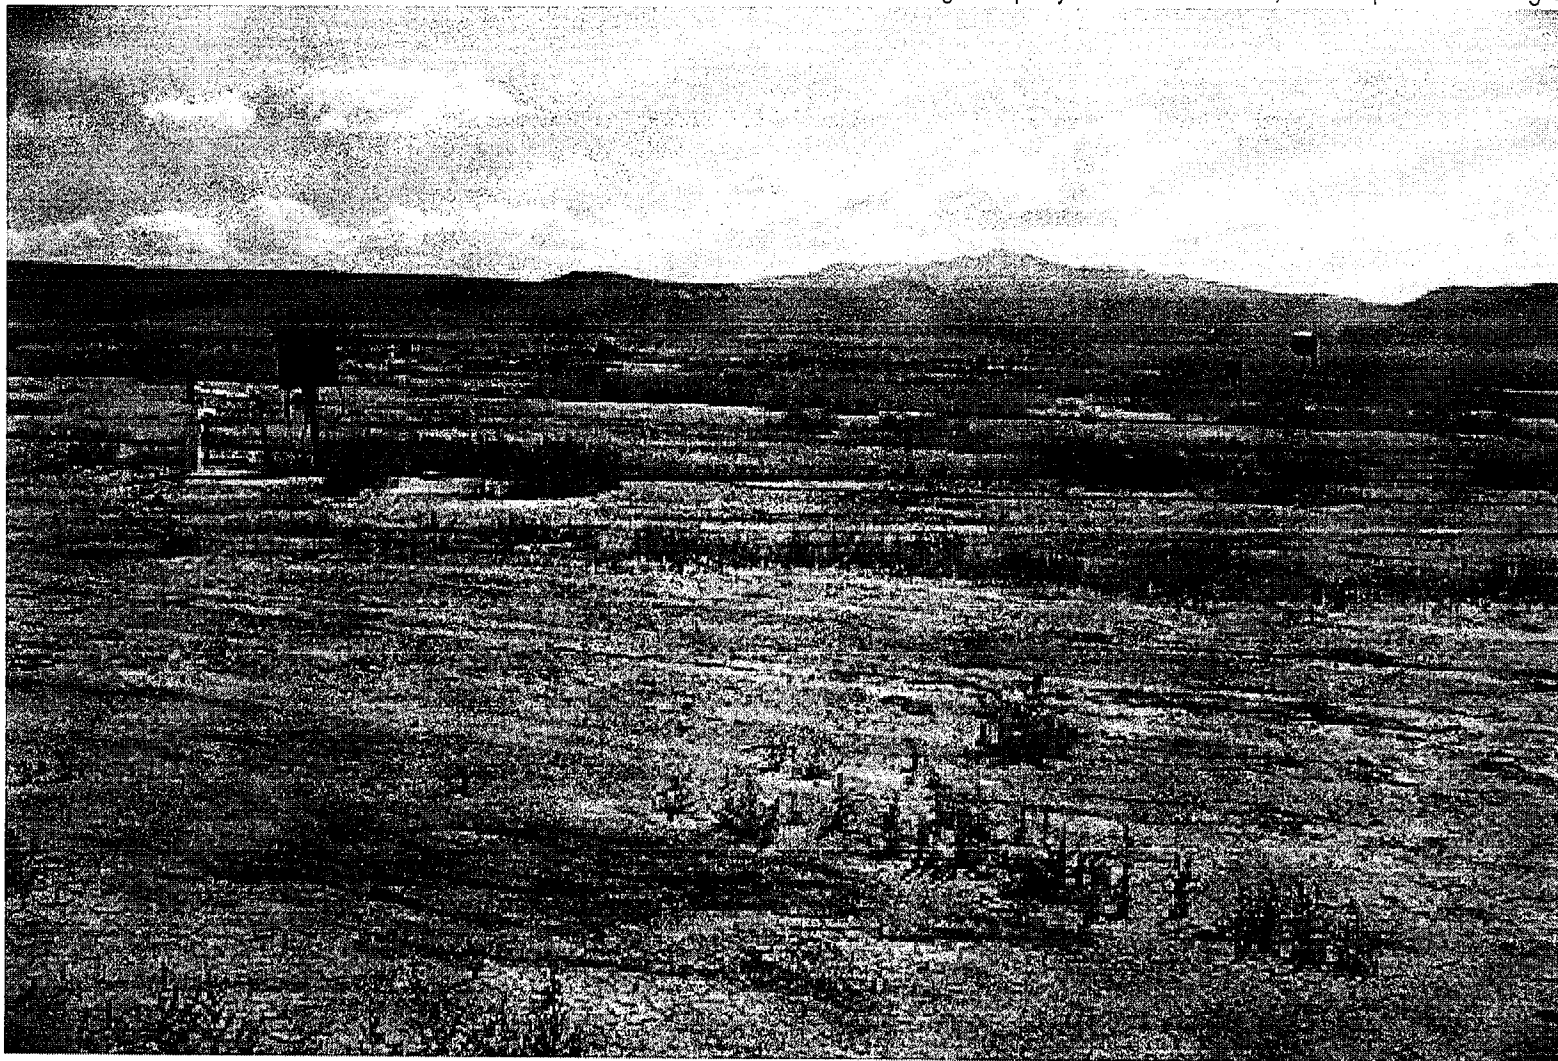
View southwest across top of large tailing pile temporary cover.

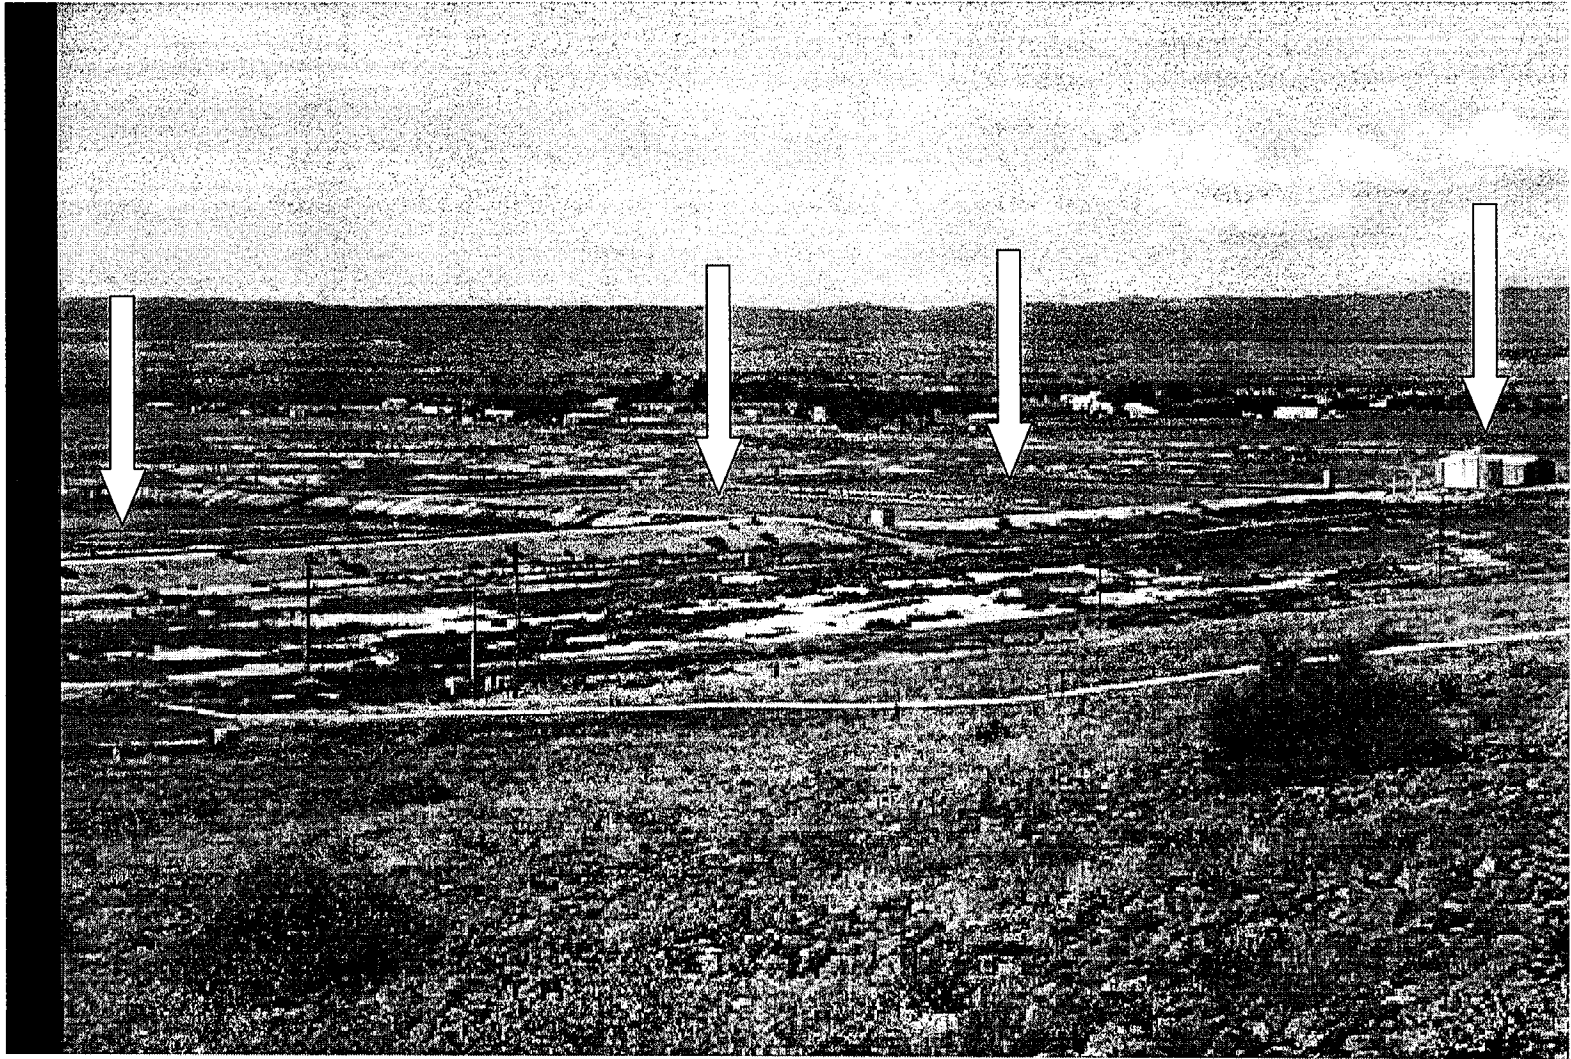
View south-southeast from southern edge of top of large tailing pile temporary cover, toward small lined evaporation pond (left white arrow), east-west collection ponds (two middle arrows) and reverse osmosis plant (right arrow). Residential community visible in background.

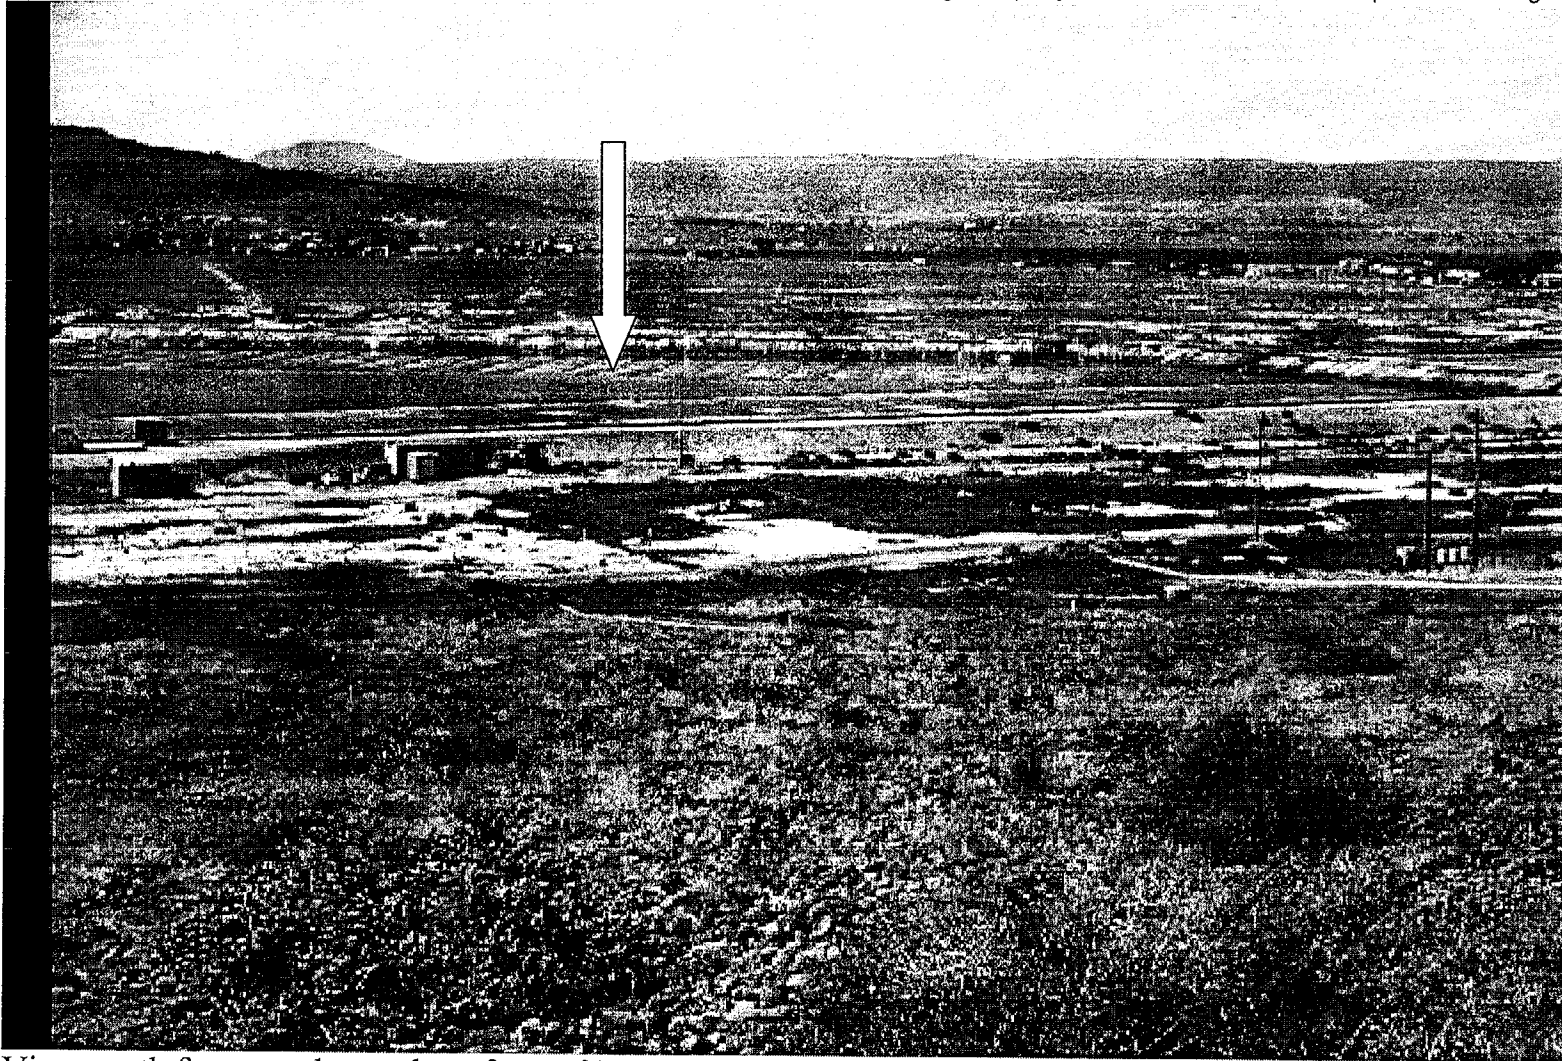
View south from southern edge of top of large tailing pile temporary cover, toward small lined evaporation pond (white arrow), Residential community visible in background; foreground is southern slope of large tailings pile.

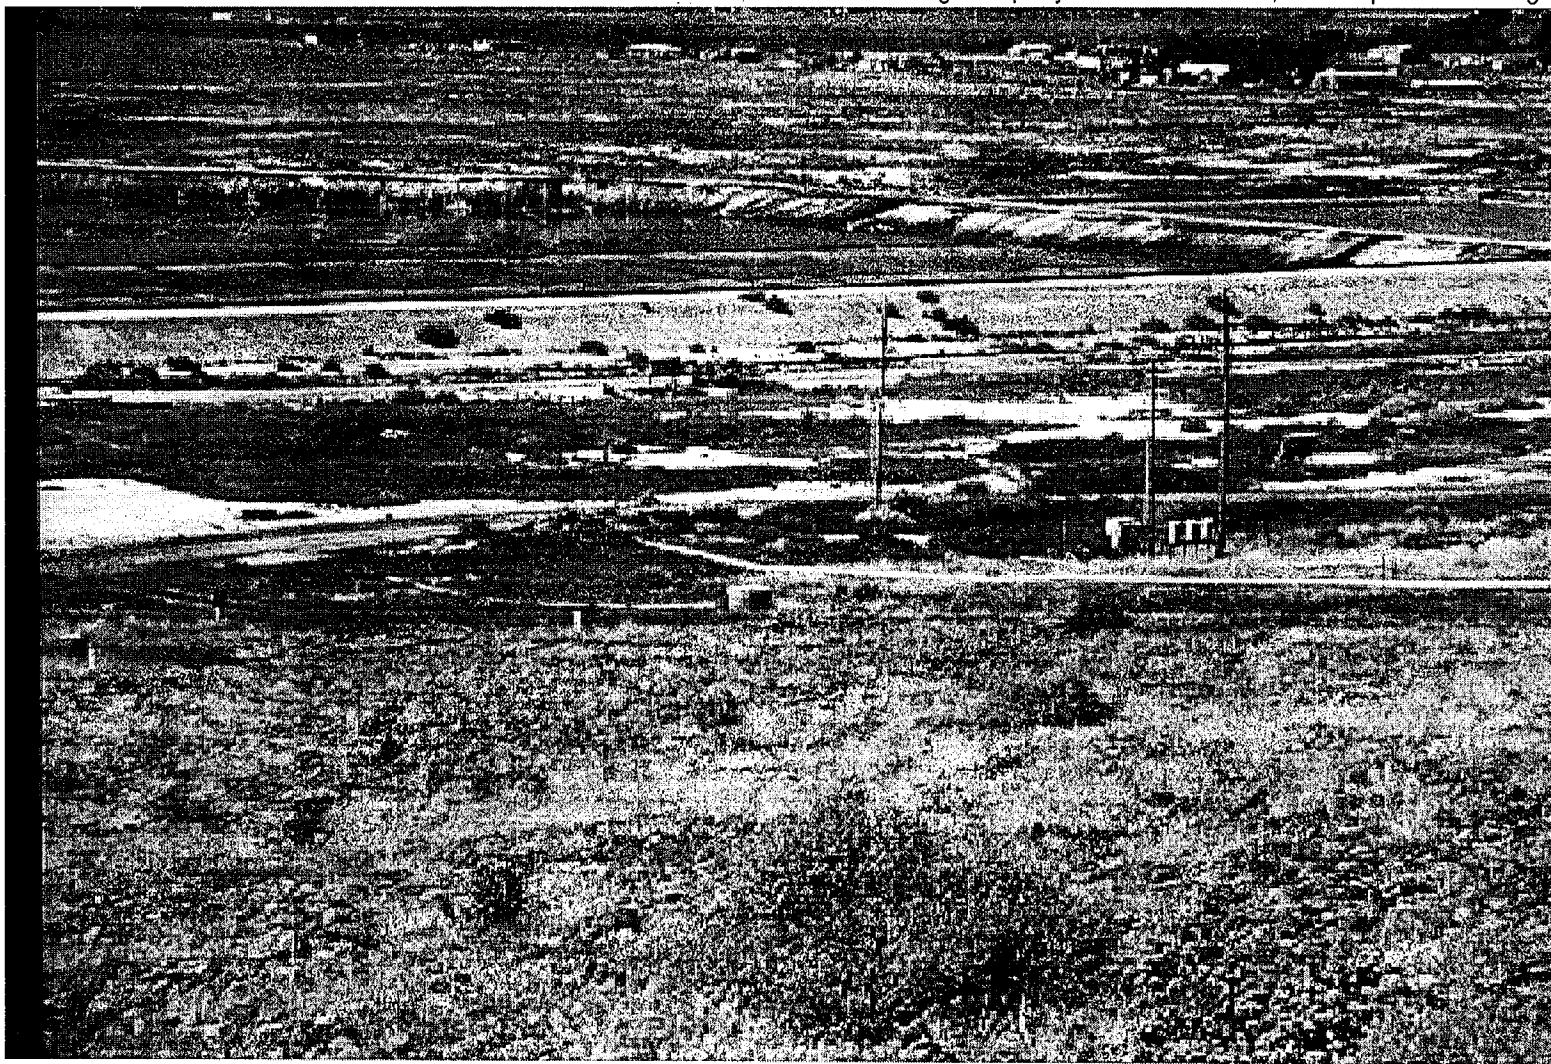
Closer view toward small lined evaporation pond (see previous photograph).

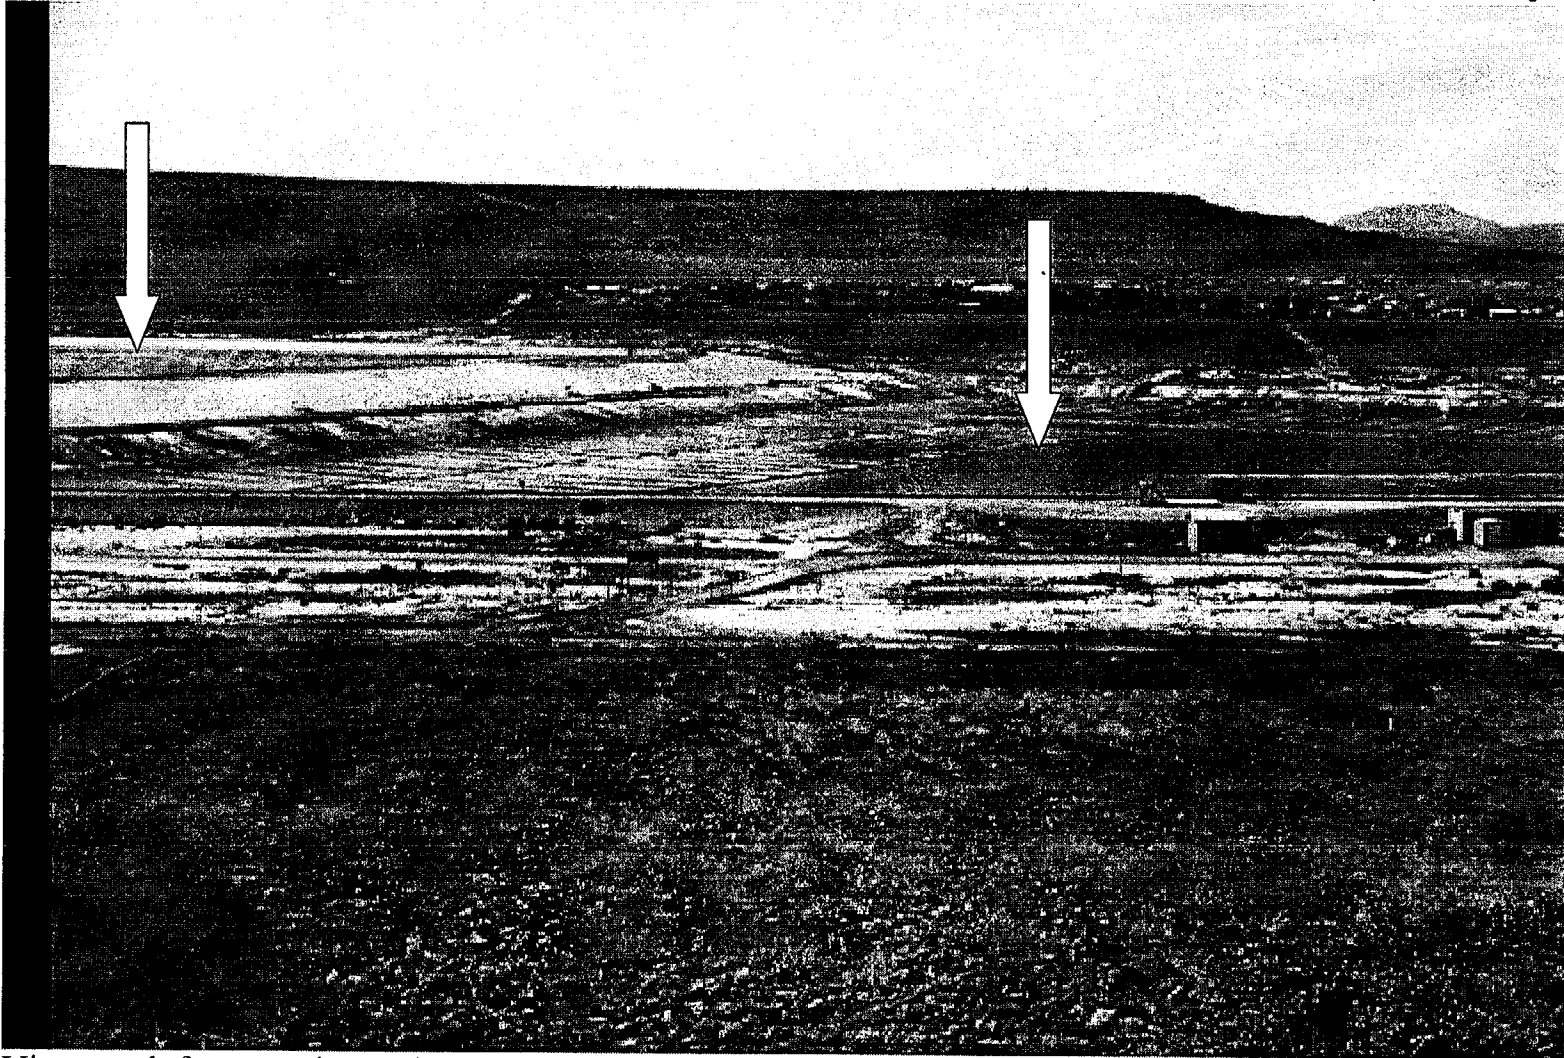
View south from southern edge of top of large tailing pile temporary cover, toward largelined evaporation pond (left arrow) and small lined evaporation pond (right arrow). Residential community visible in background; foreground is southern slope of largetailings pile.
