Table 1
Chronology of Site Events
Homestake Mining Company Site, New Mexico

Attachment 3**Site Inspection Roster for Site Inspection Conducted August 16, 2001****Homestake Mining Company Superfund Site**

Attachment 4
Site Inspection Photographs

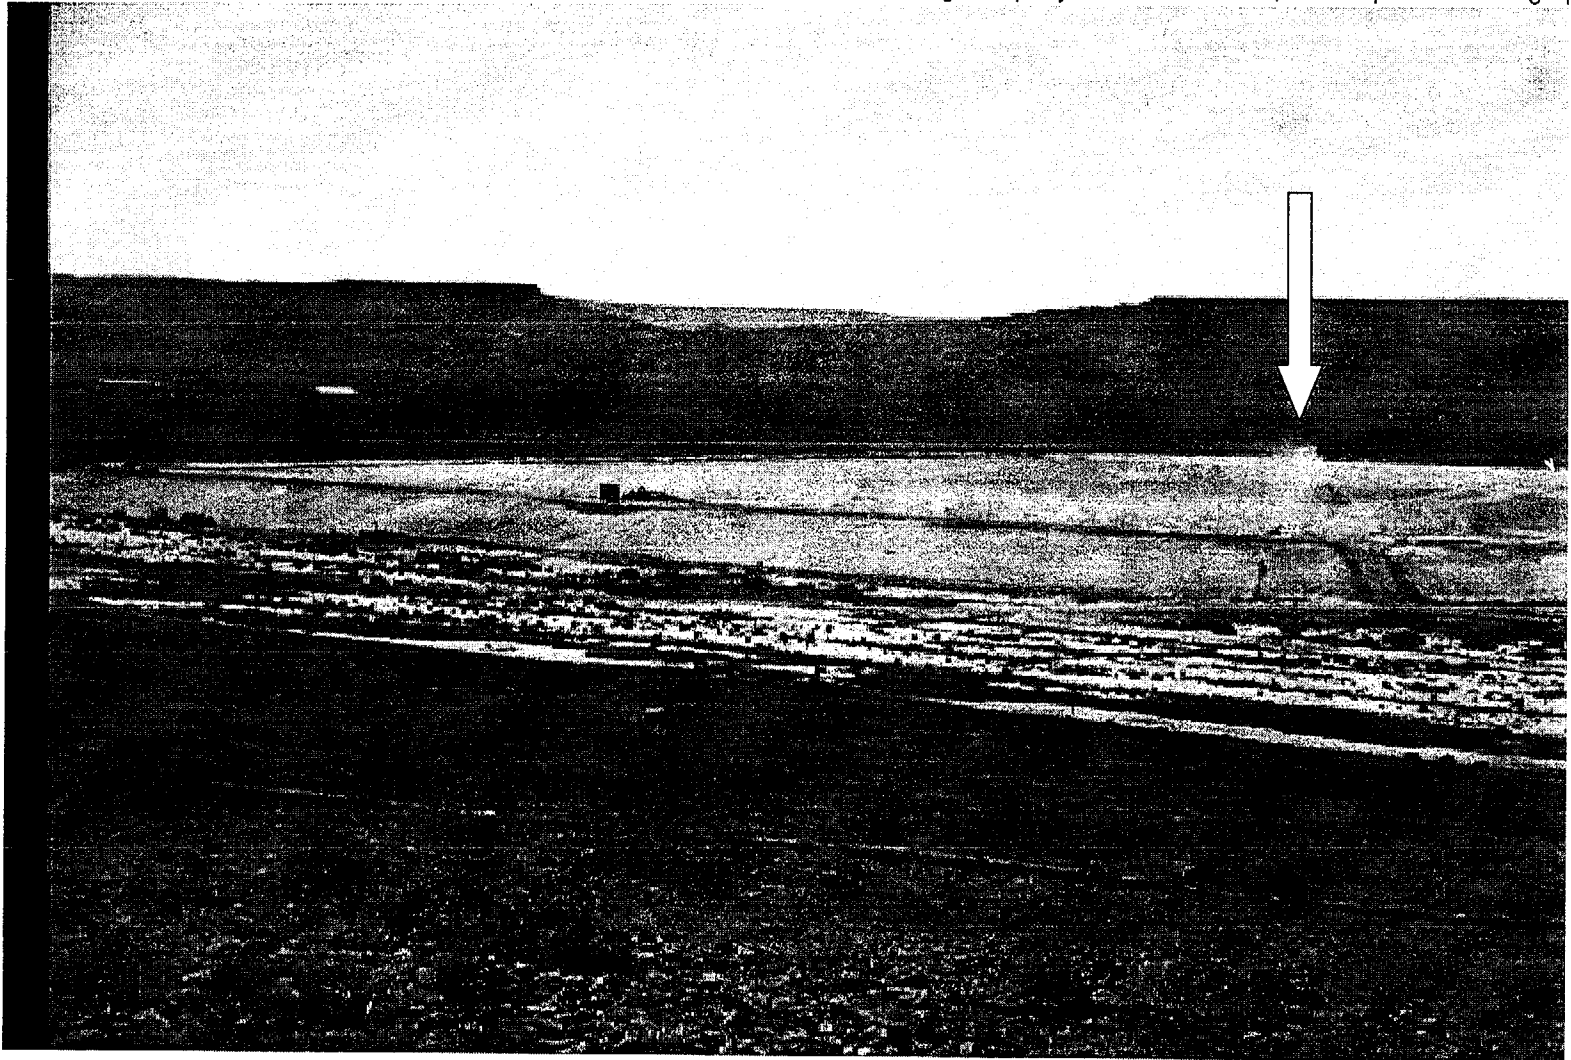
View south from southern edge of top of large tailing pile temporary cover, toward largelined evaporation pond. Foreground is southern slope of large tailings pile. Note spray blower in large pond (white arrow).

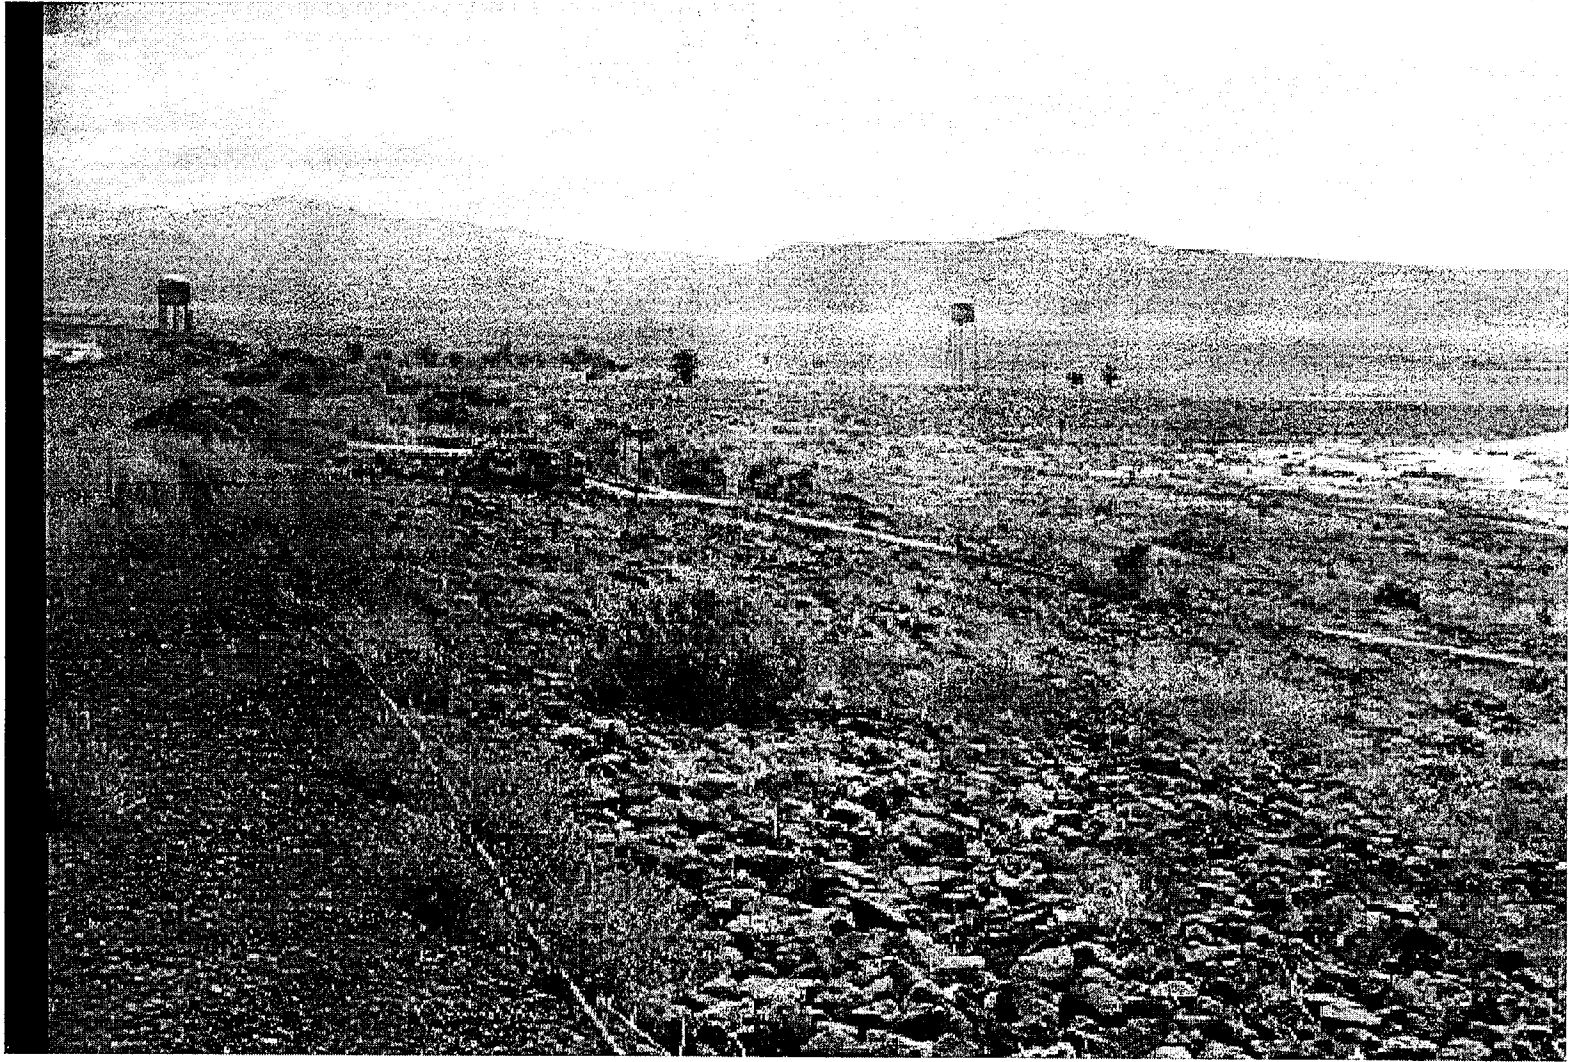
View east-southeast across southern slope of large tailings pile. Large lined evaporation pond is located to right of view.

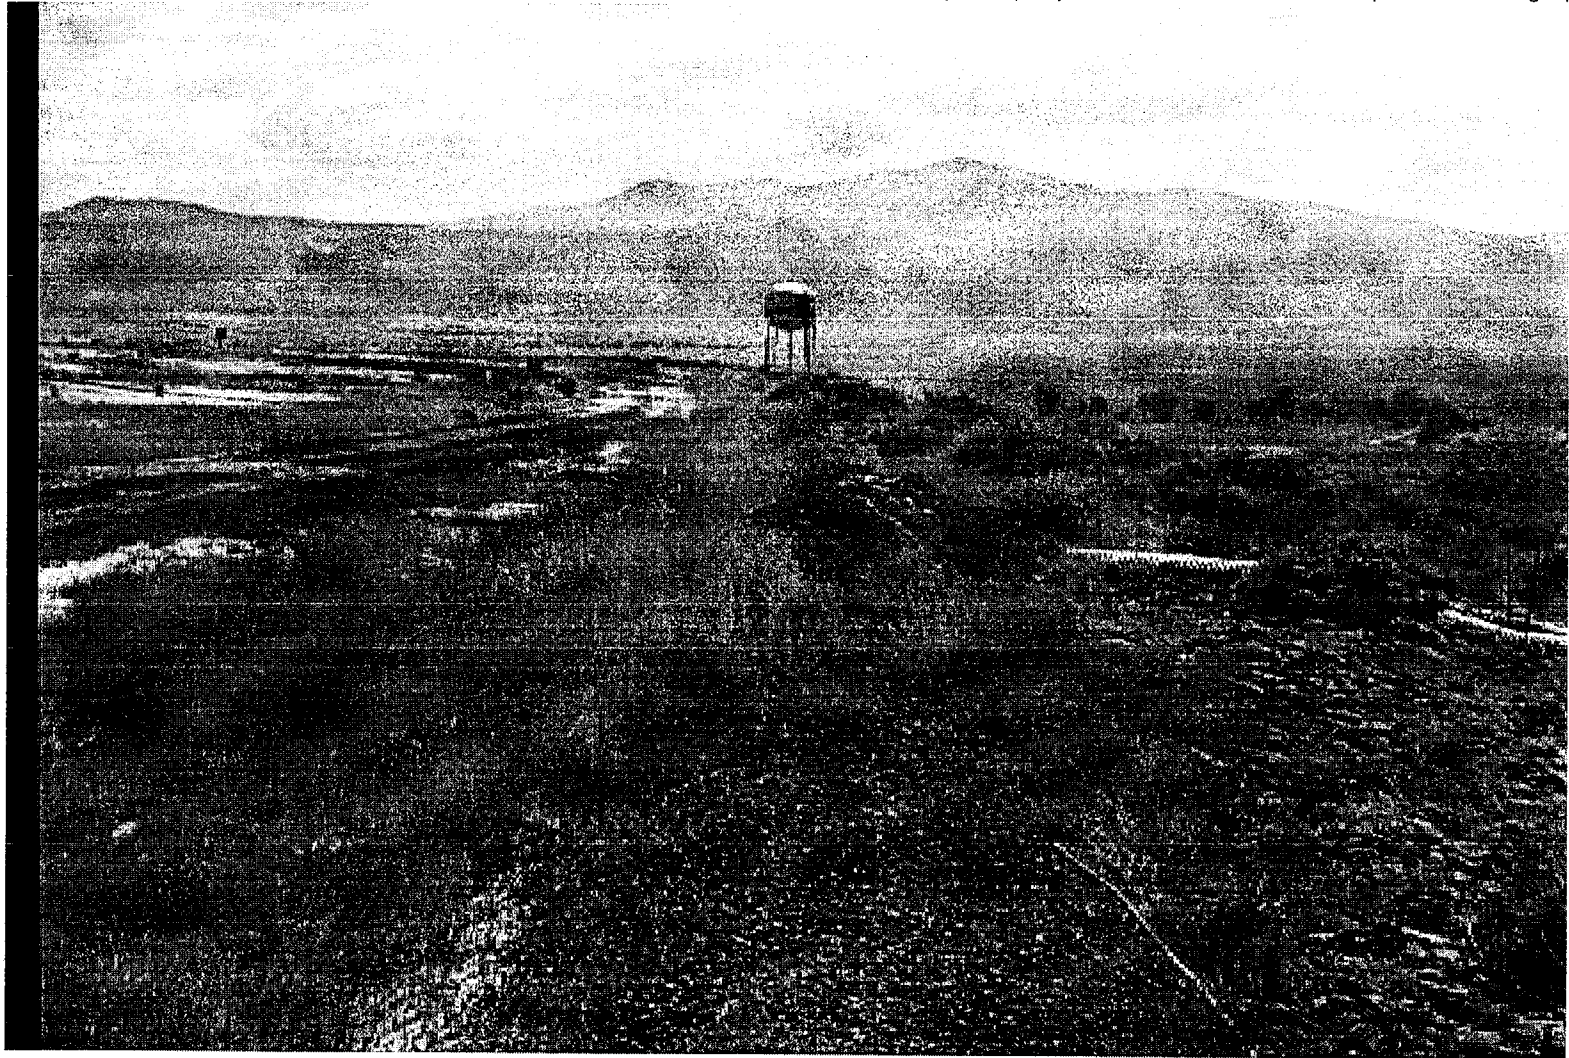
View east along top of south slope of large tailing pile.

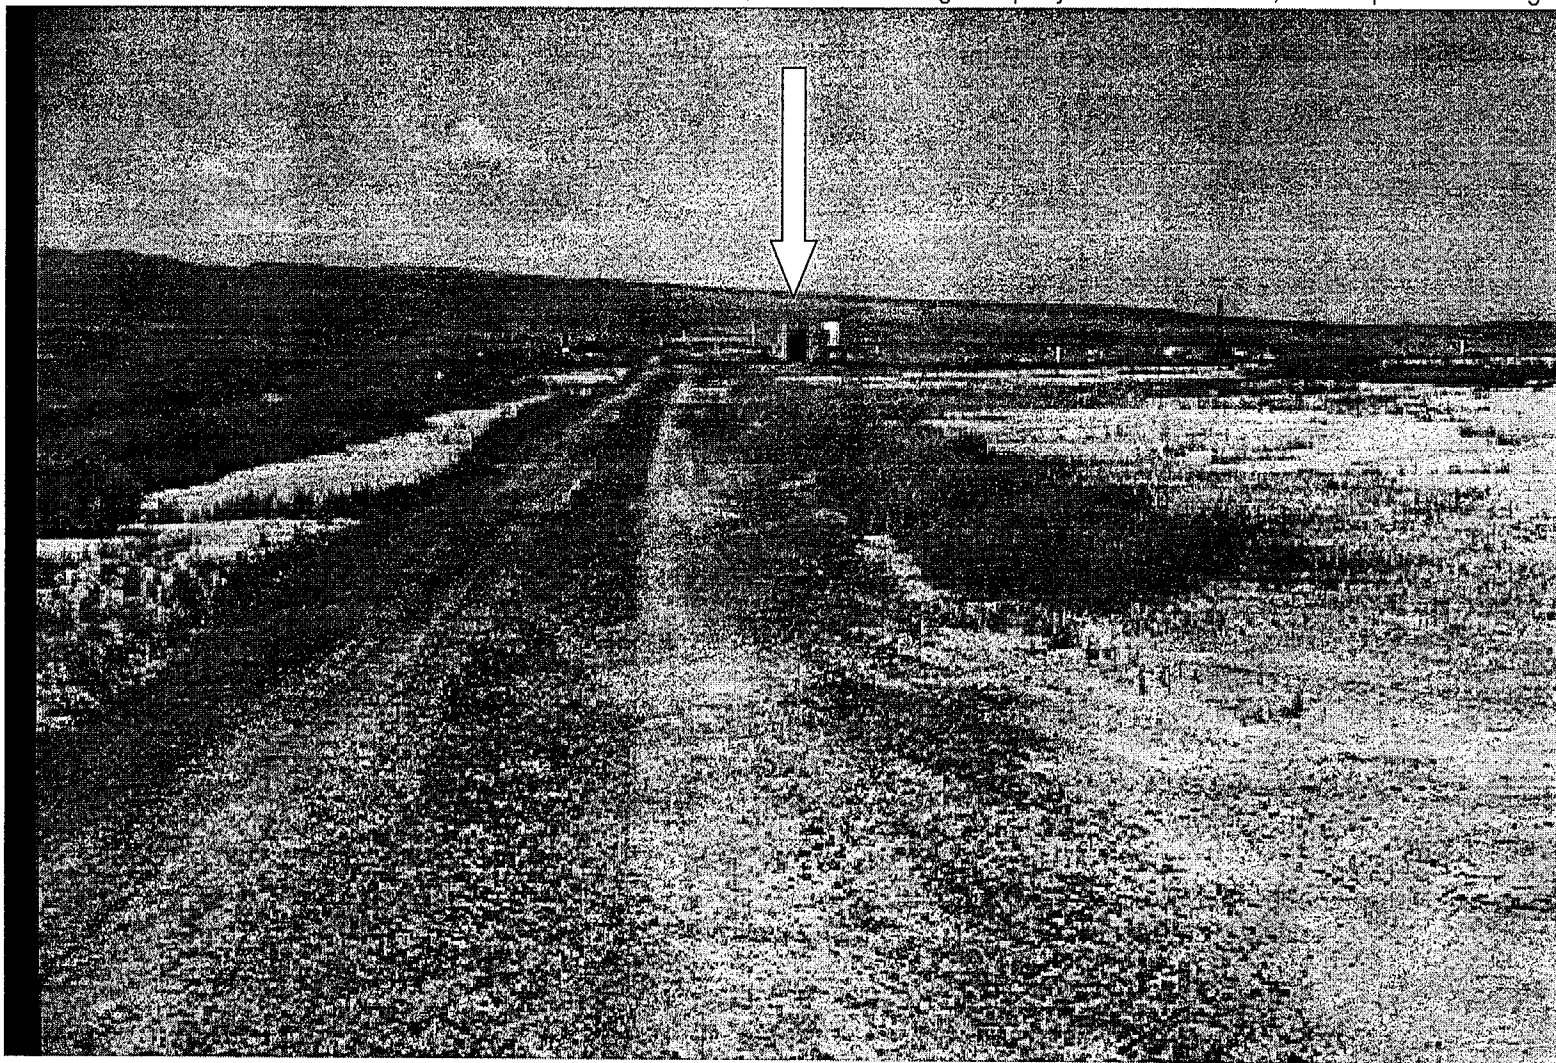
View west along top of south slope of large tailing pile (slope is to left). Bioremediation experiment station in background (white arrow).

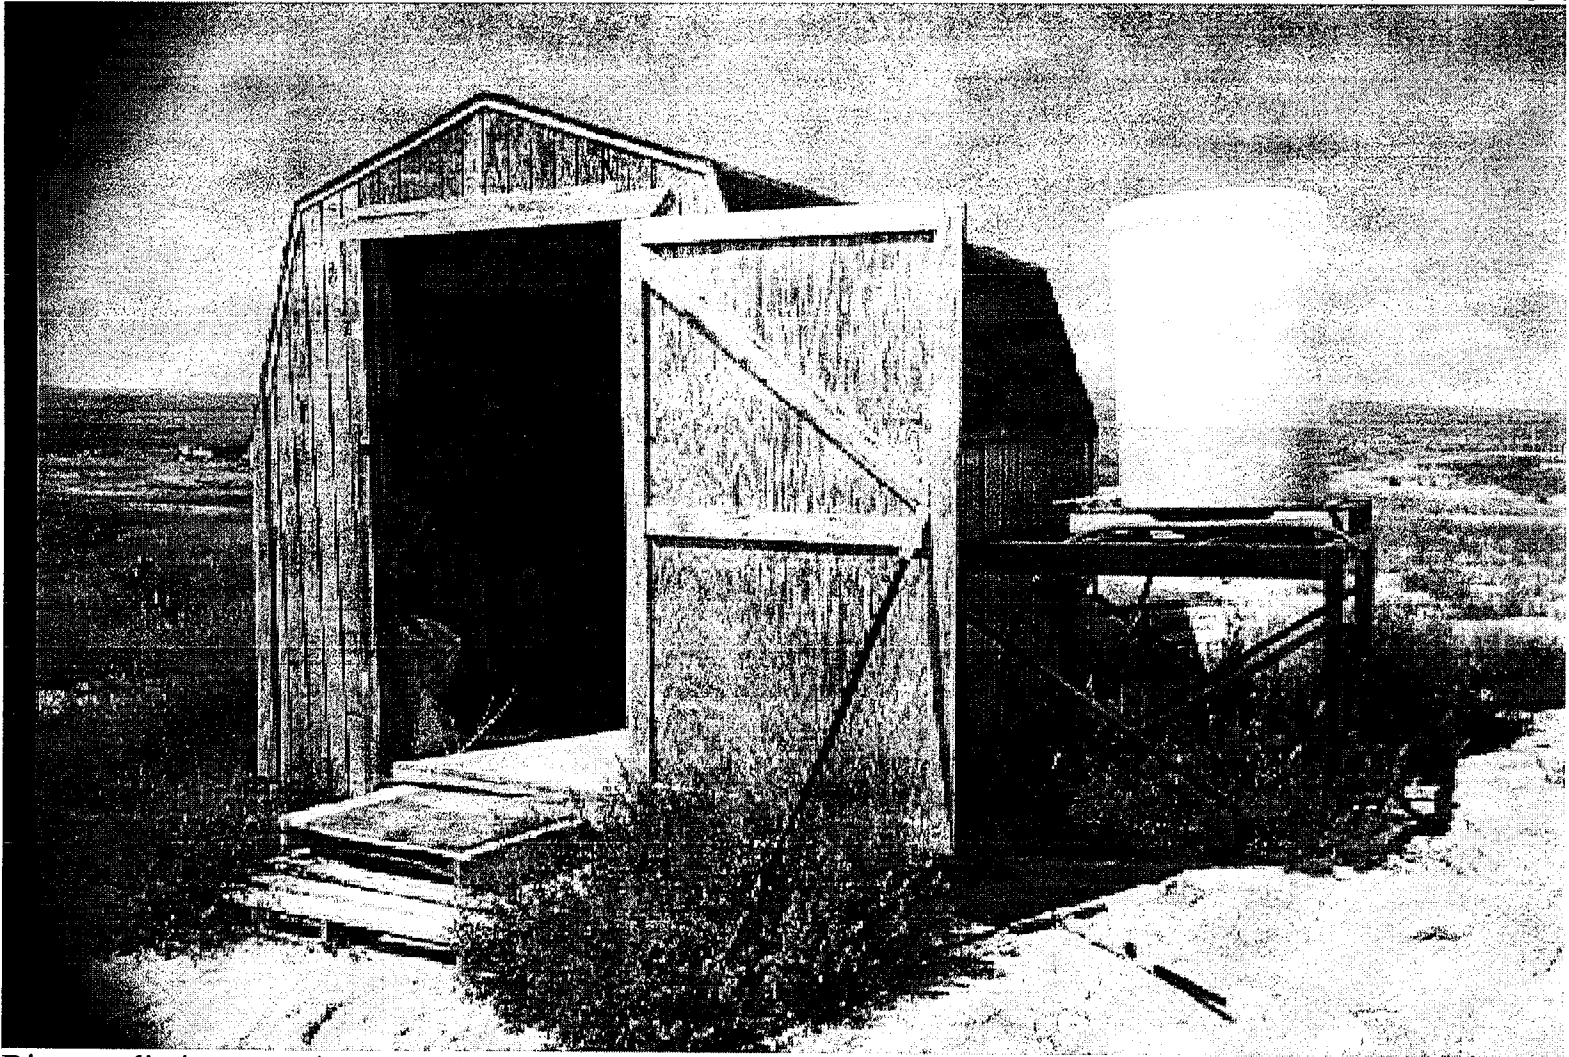
Bioremediation experiment station on top of large tailings pile (location visible in previous photograph). Injection well is located inside structure; molasses additive is in white tank. Associated monitoring wells are left of the structure.

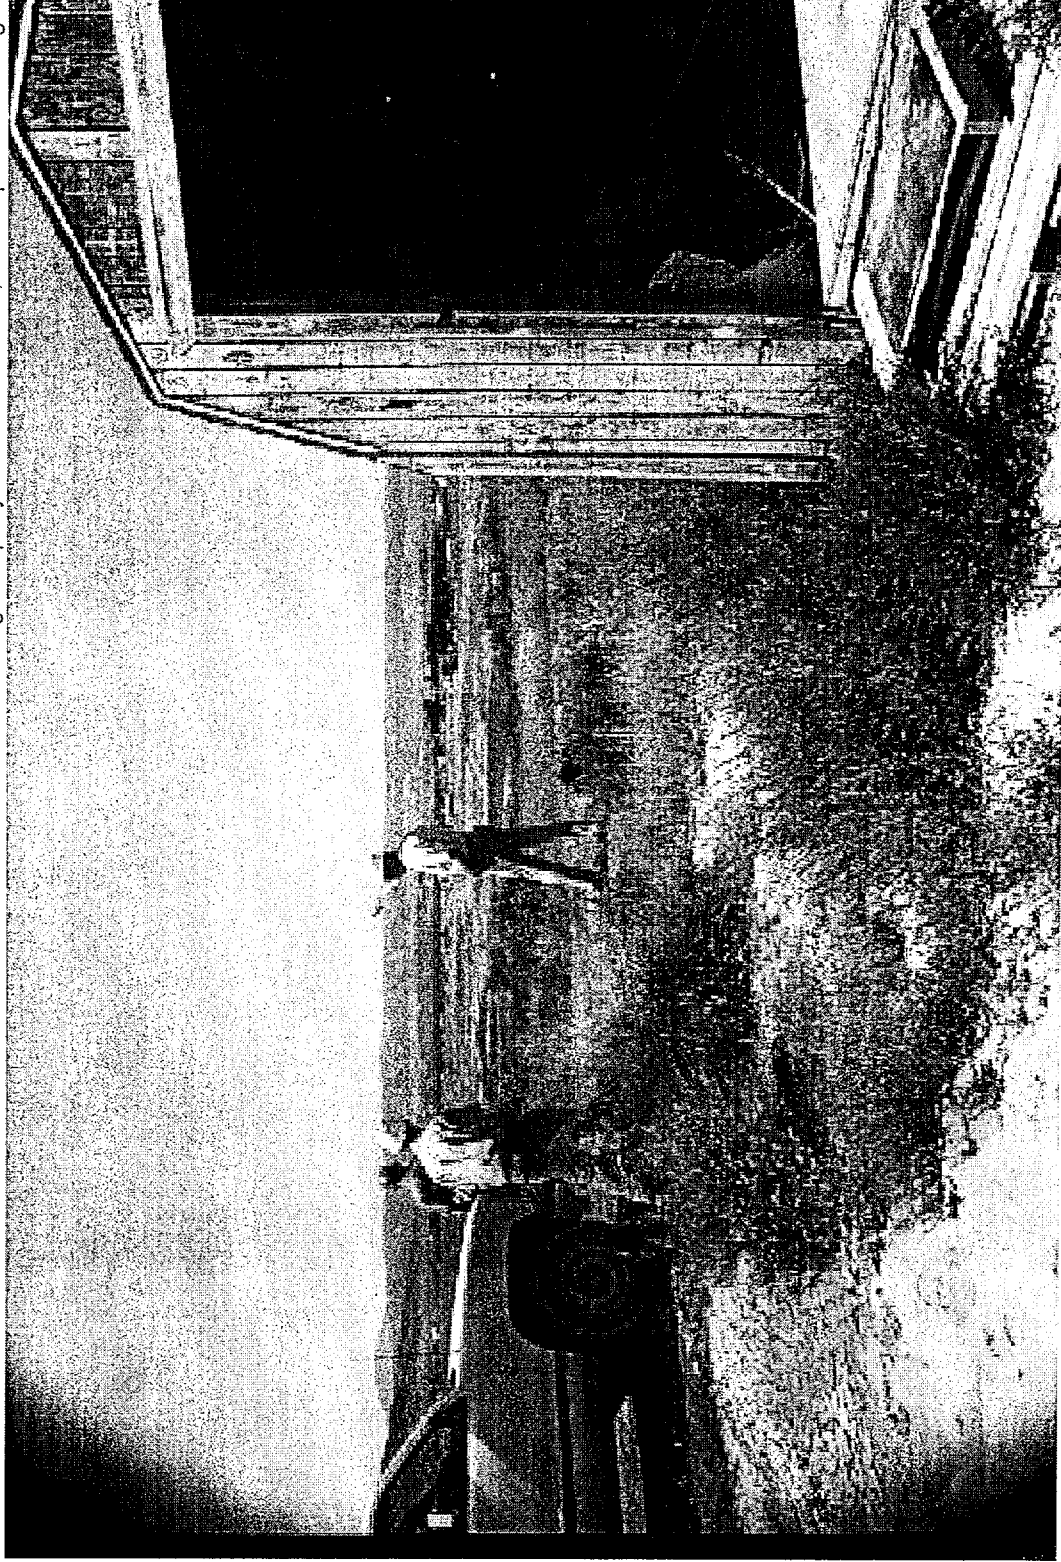
Photograph 21 of 55

Bioremediation experiment station on top of large tailings pile, slightly south of previous view. Note evaporation ponds and residential community visible in background.

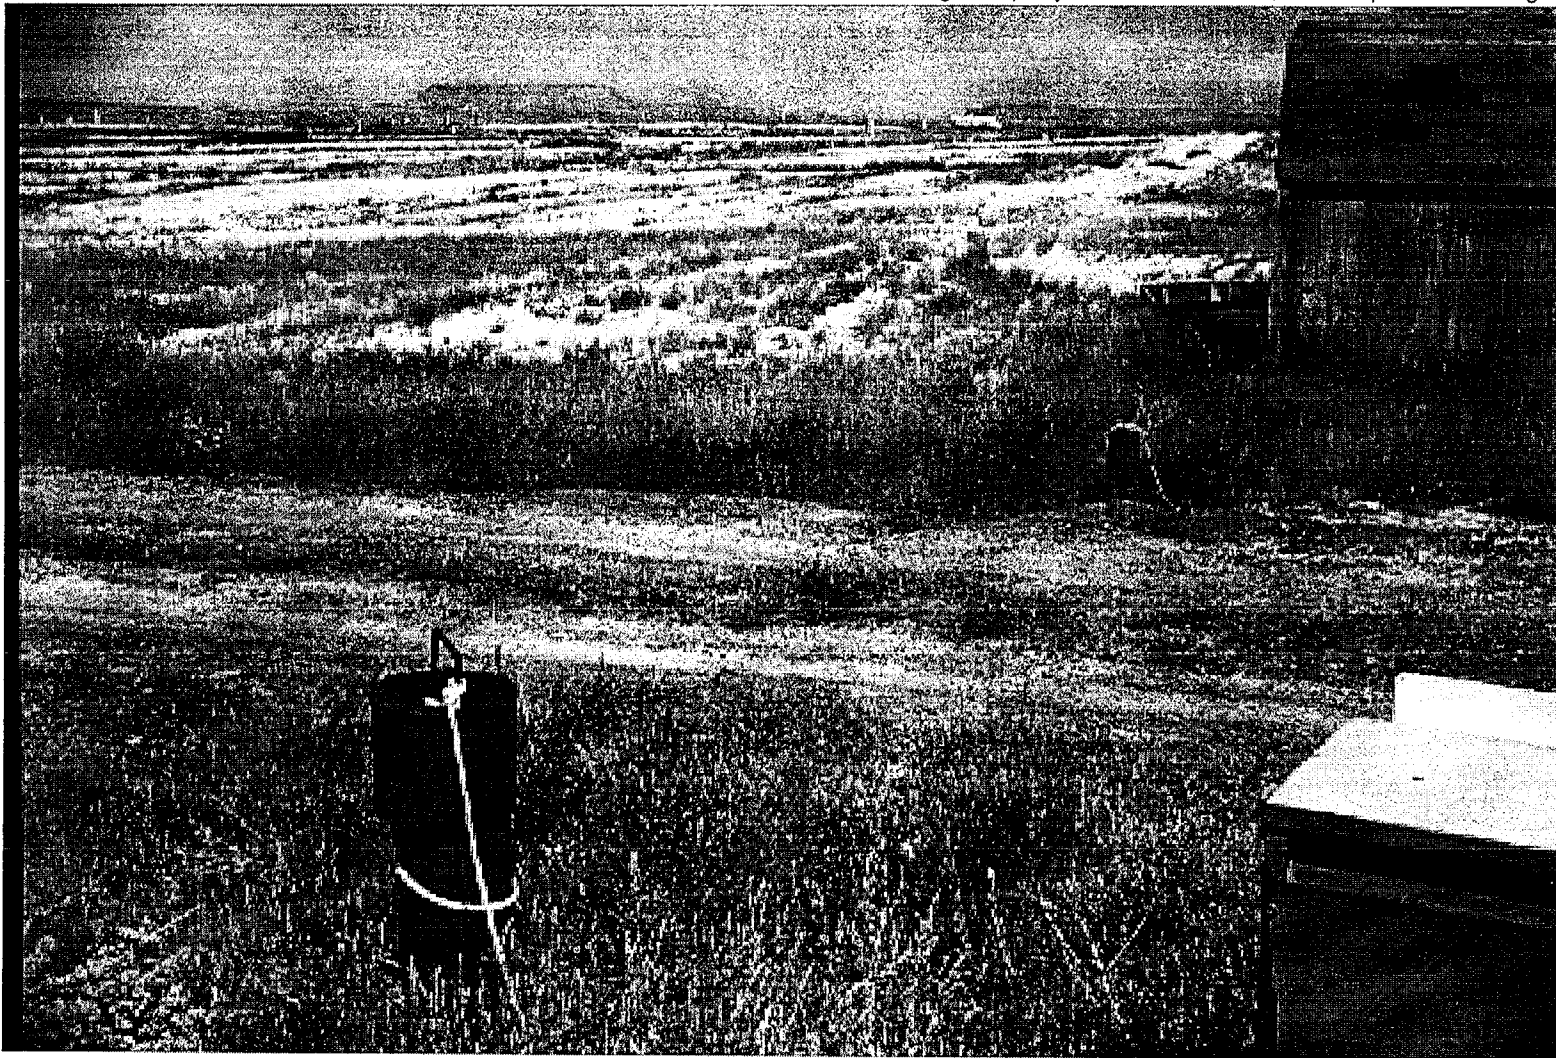
Monitoring wells associated with bioremediation experiment station, facing north-northwest.

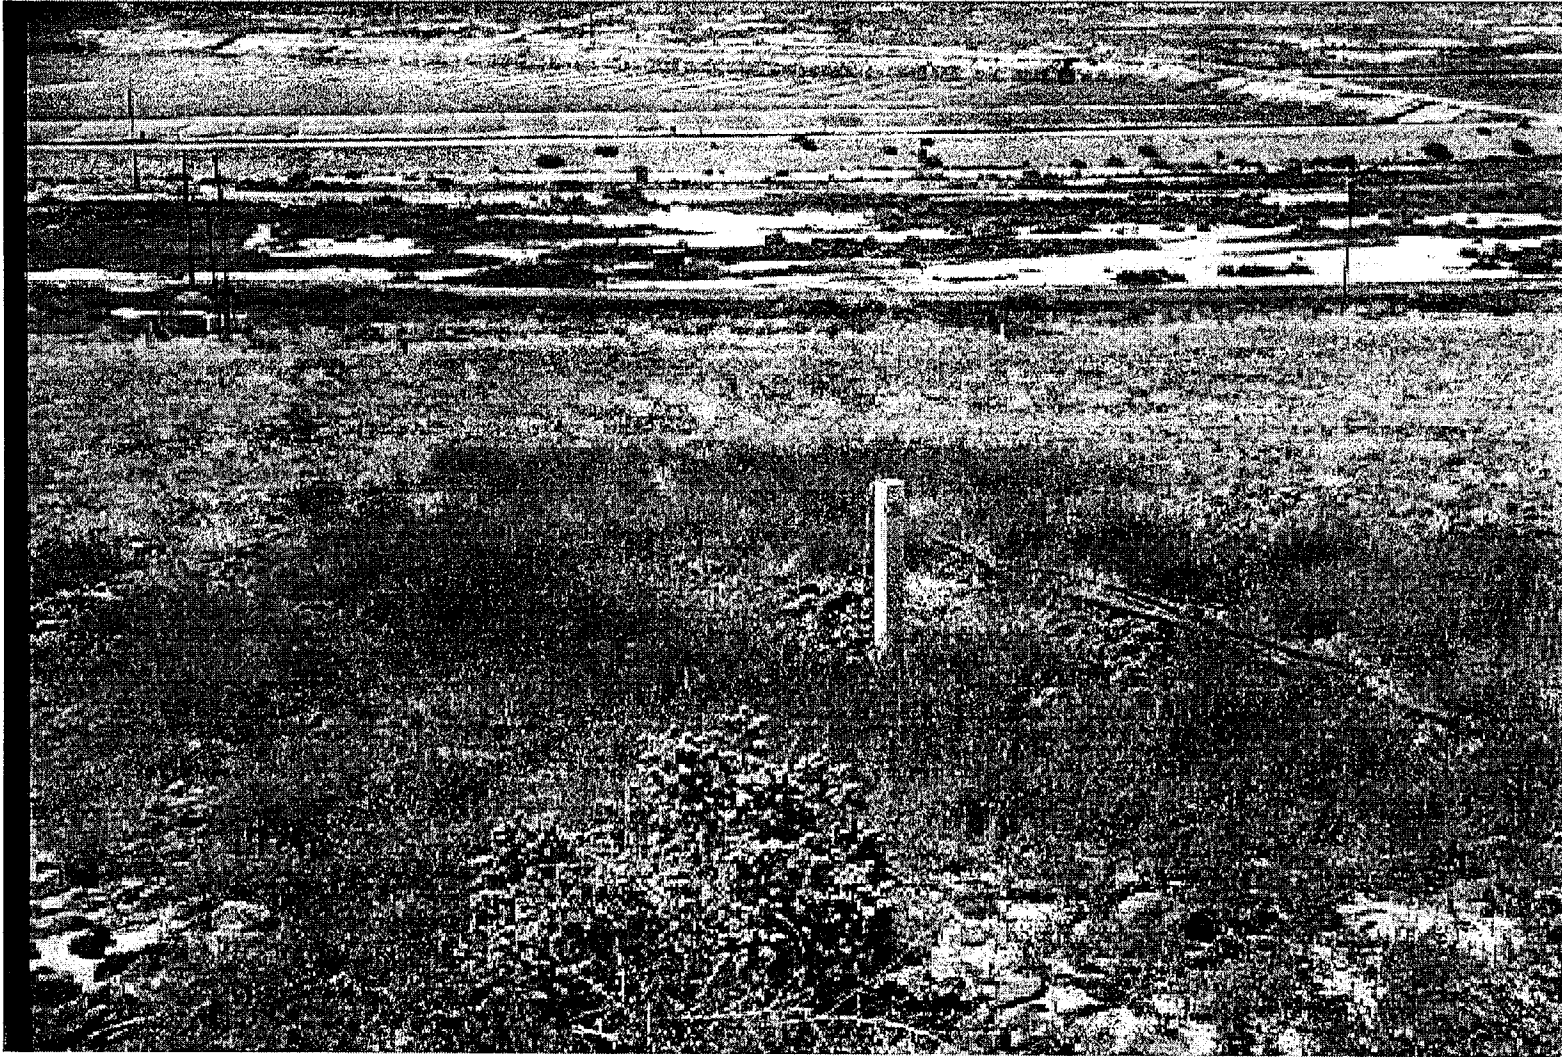
Facing opposite to previous view toward small lined evaporation pond.

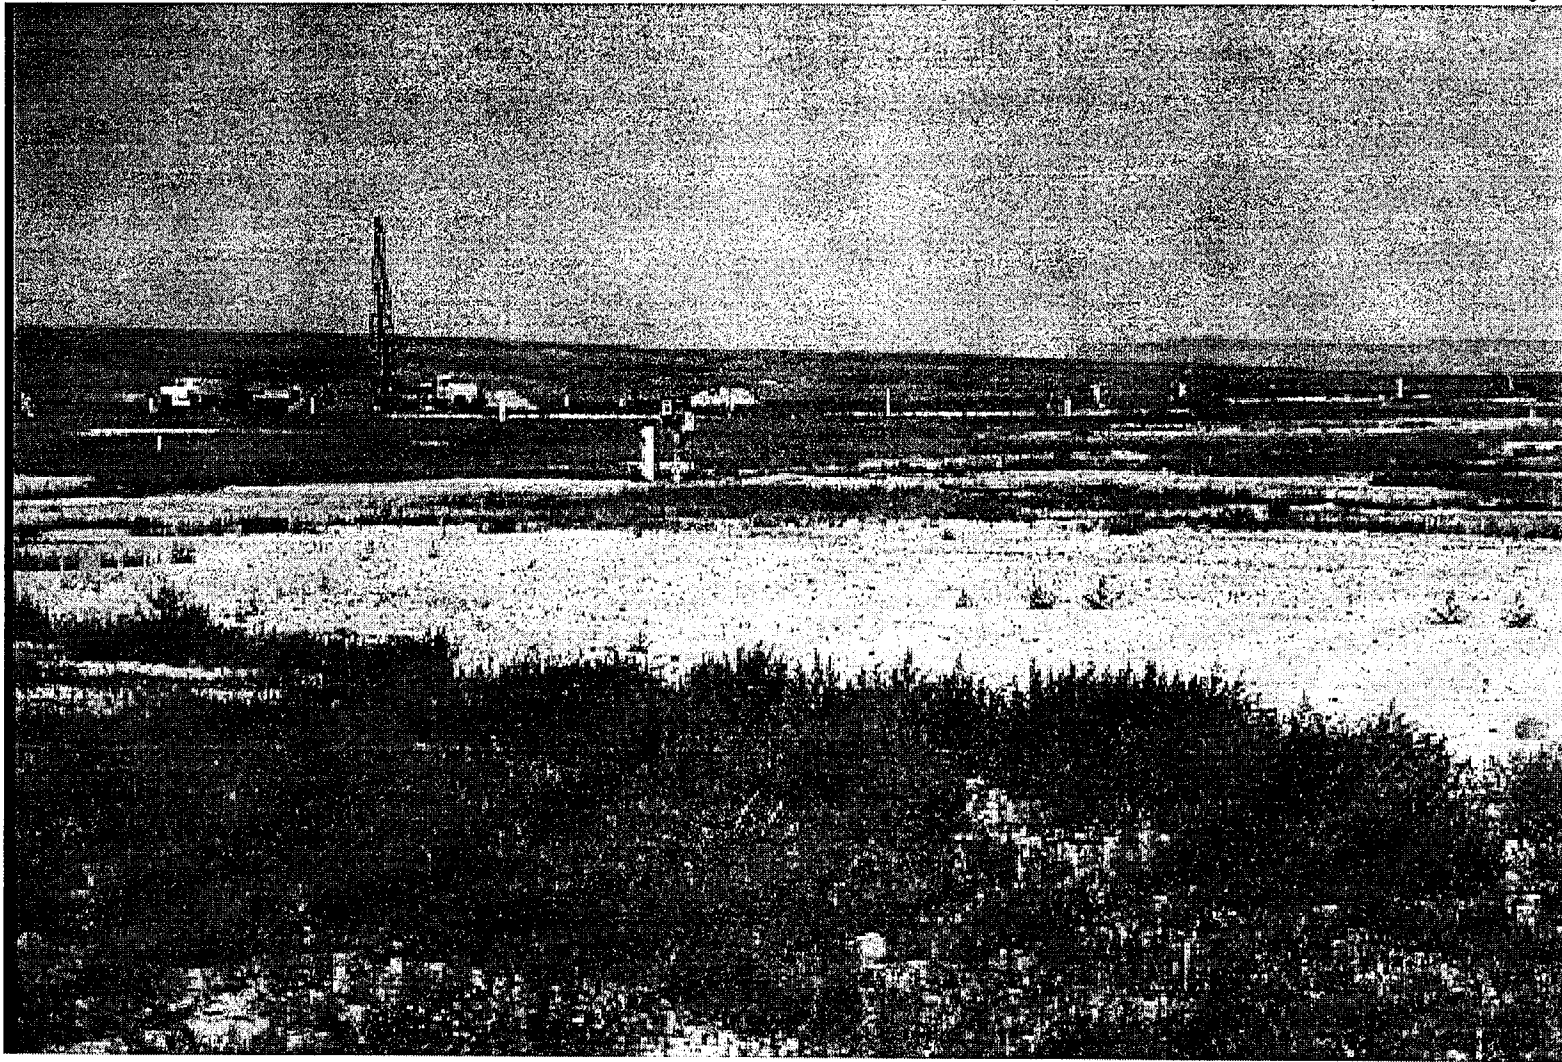
View west-northwest across top of large tailing pile temporary cover. Note drilling activity in background.

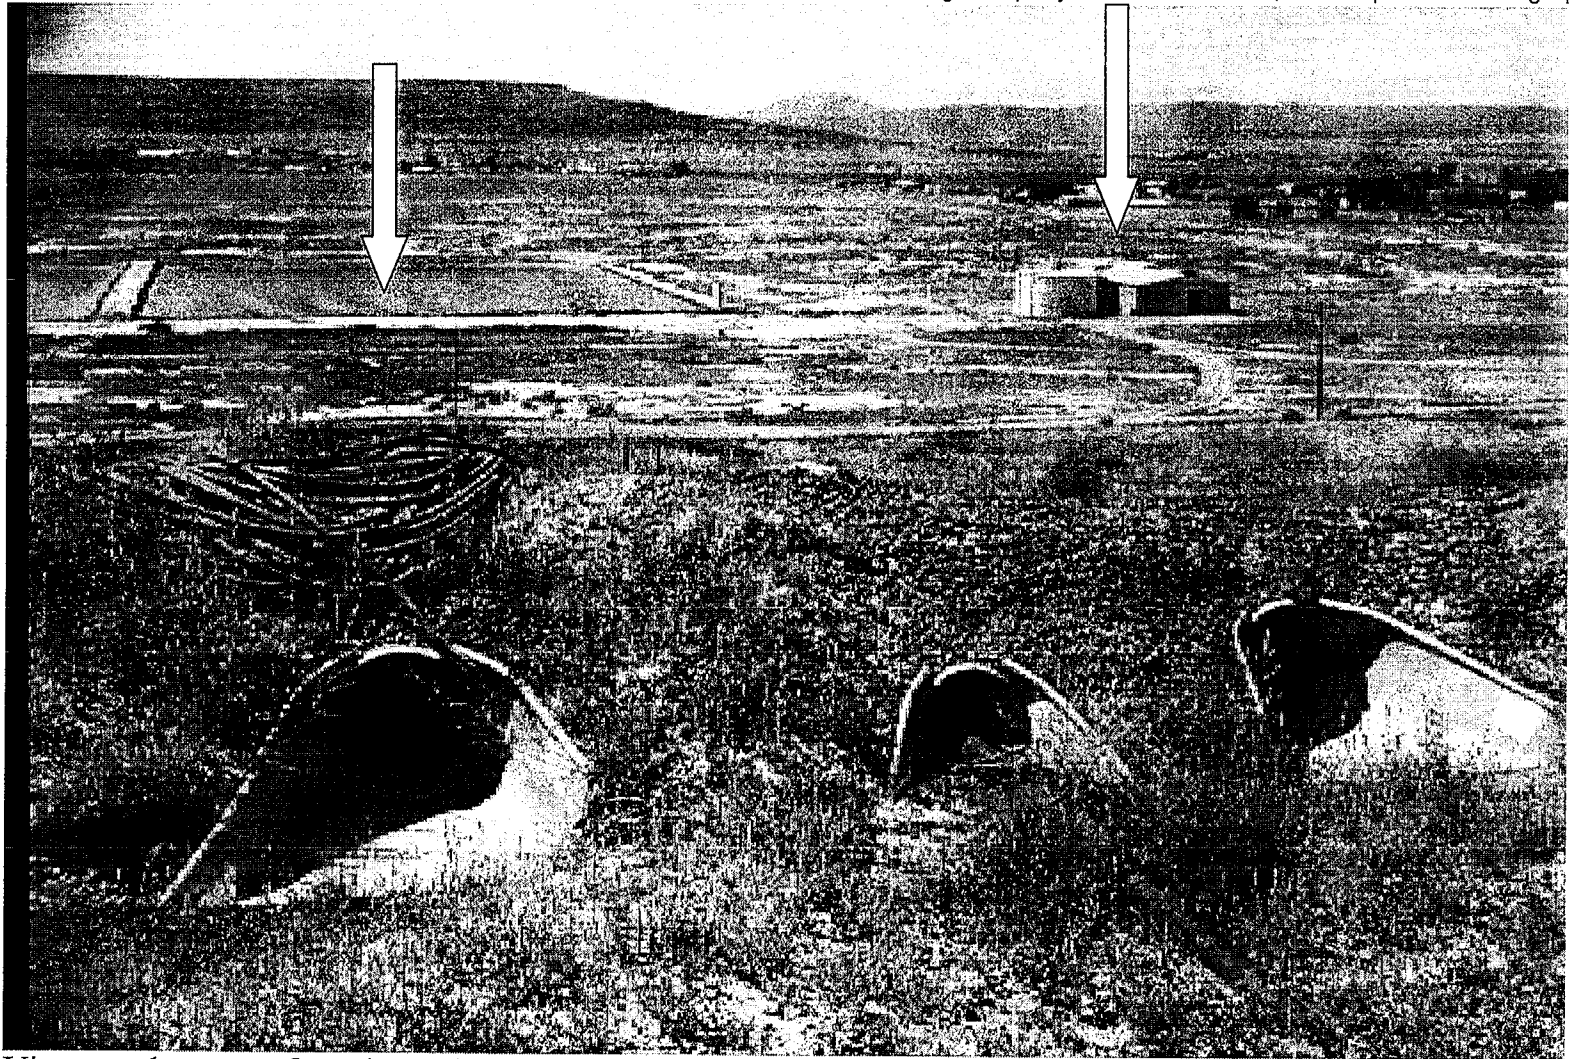
View south at top of southern slope of large tailings pile, showing runoff drainage pipes. Note west collection ponds and reverse osmosis plant (left and right arrows, respectively) Residential community is visible in background.

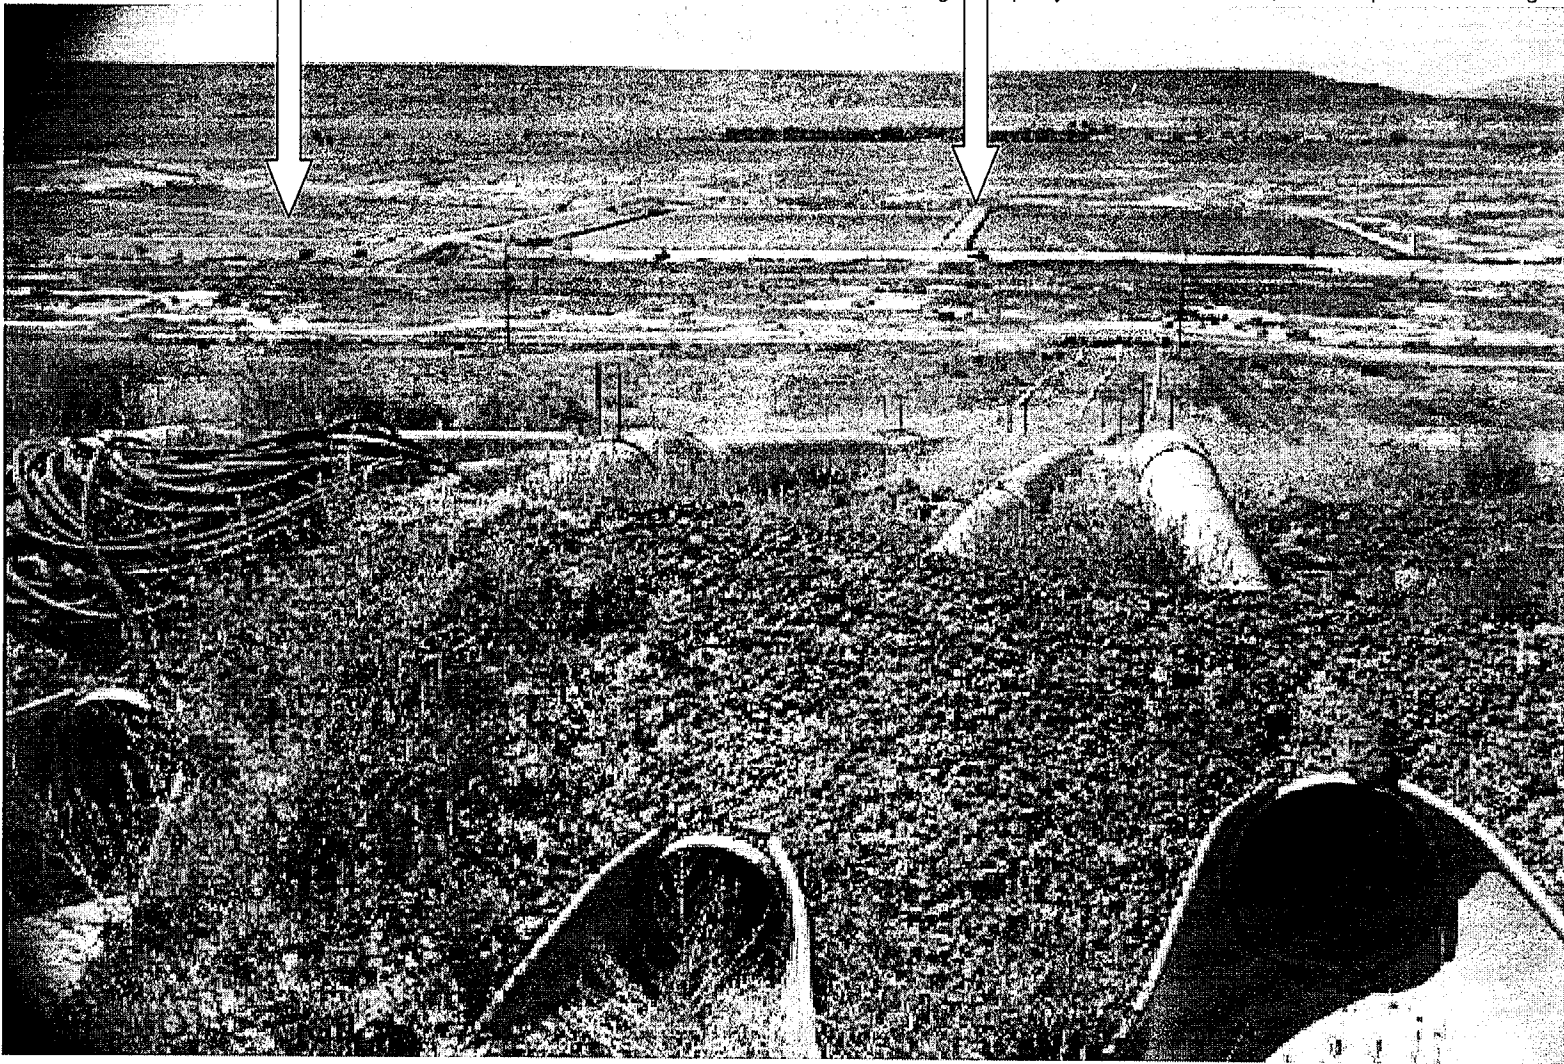
Slightly left (west) of previous view. Eastern end of small lined evaporation pond and collection ponds visible in background (left and right arrows, respectively).

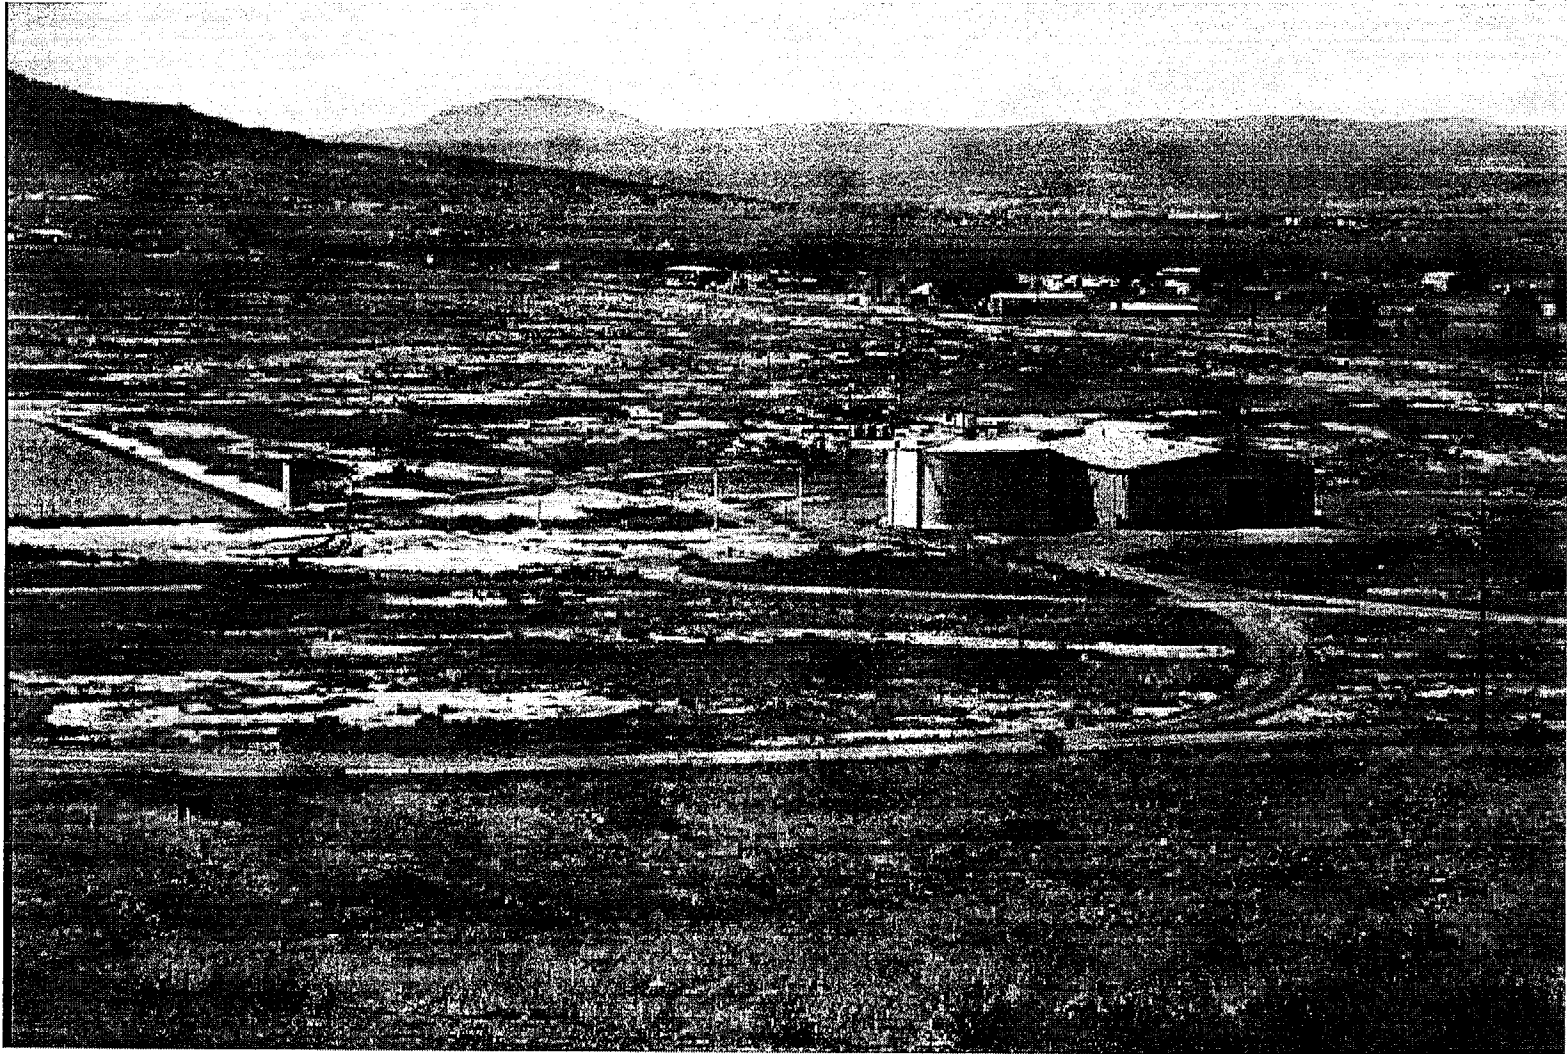
Closer view of reverse osmosis plant, as seen from top of southern slope of large tailings pile.

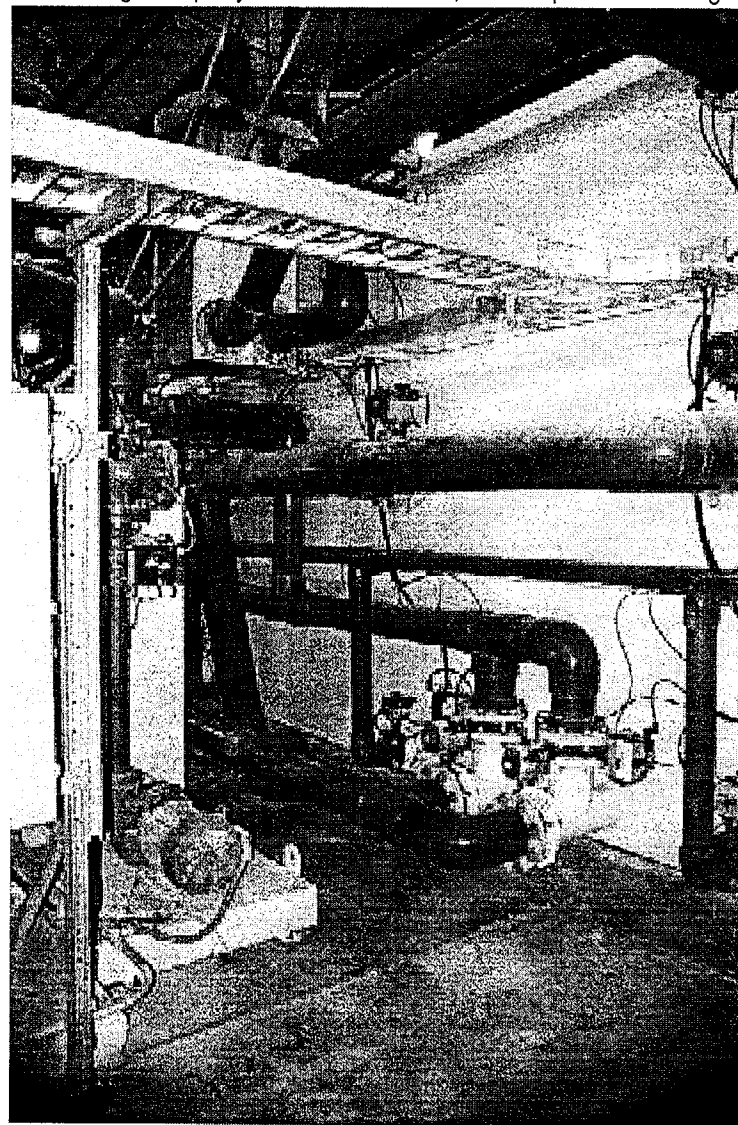
02_019_19.JPG

Inside reverse osmosis plant.

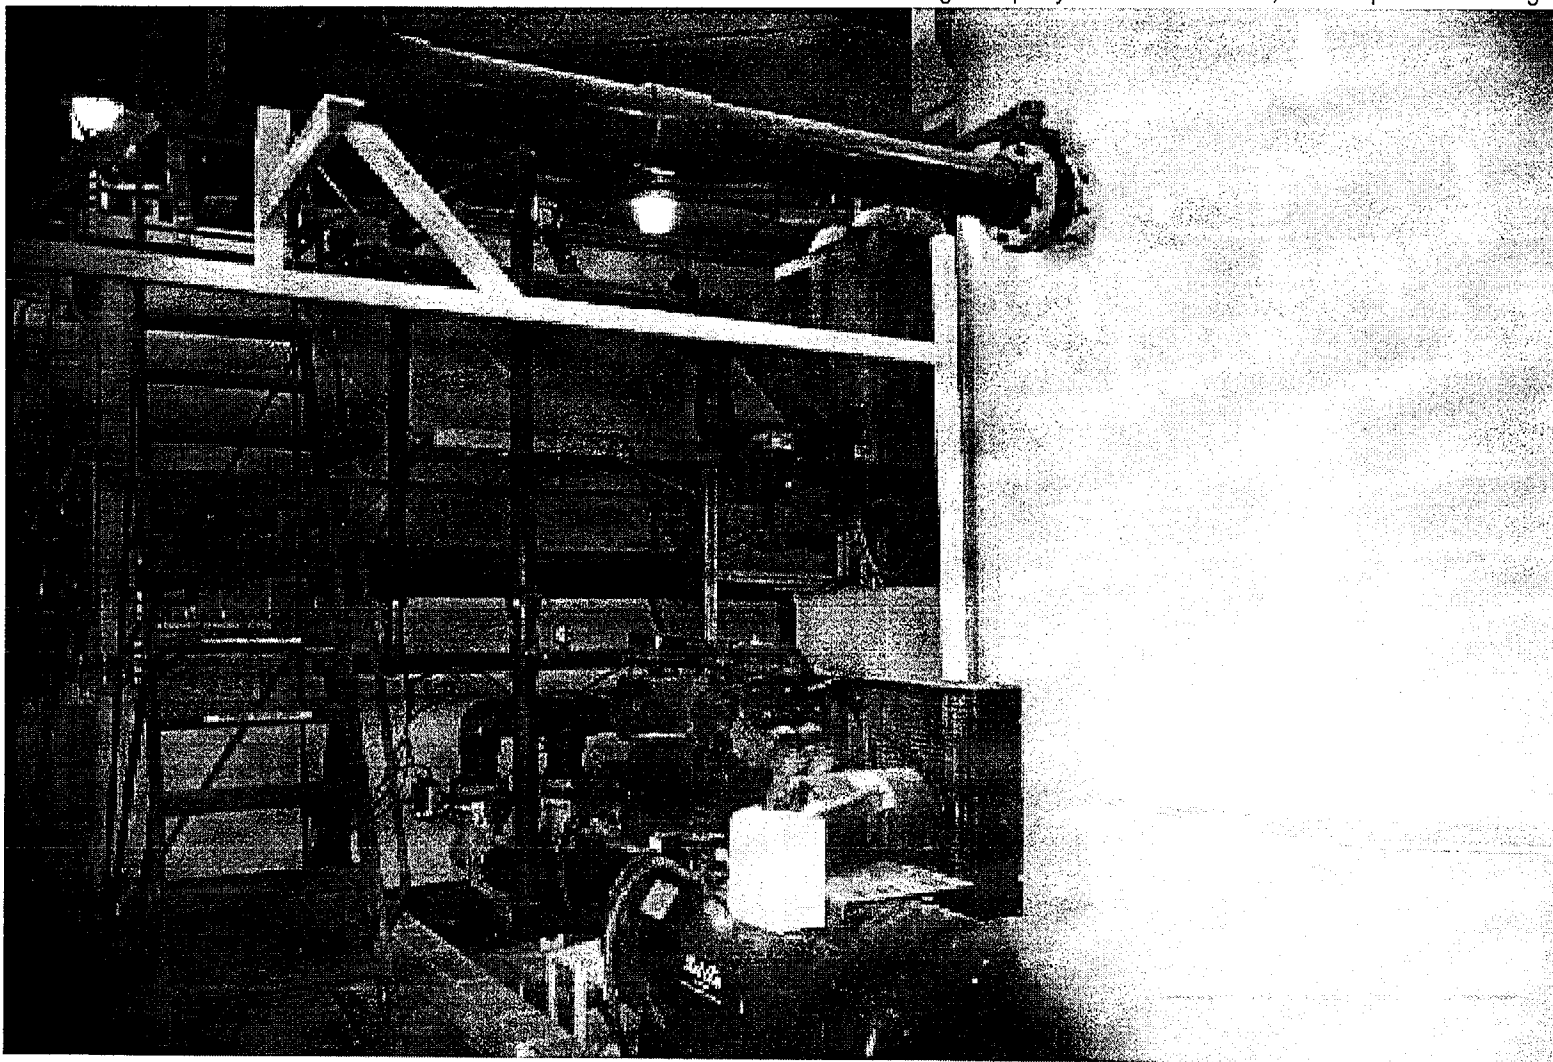
Inside reverse osmosis plant.
