Table 1
Chronology of Site Events
Homestake Mining Company Site, New Mexico

Attachment 3**Site Inspection Roster for Site Inspection Conducted August 16, 2001****Homestake Mining Company Superfund Site**

Attachment 4
Site Inspection Photographs

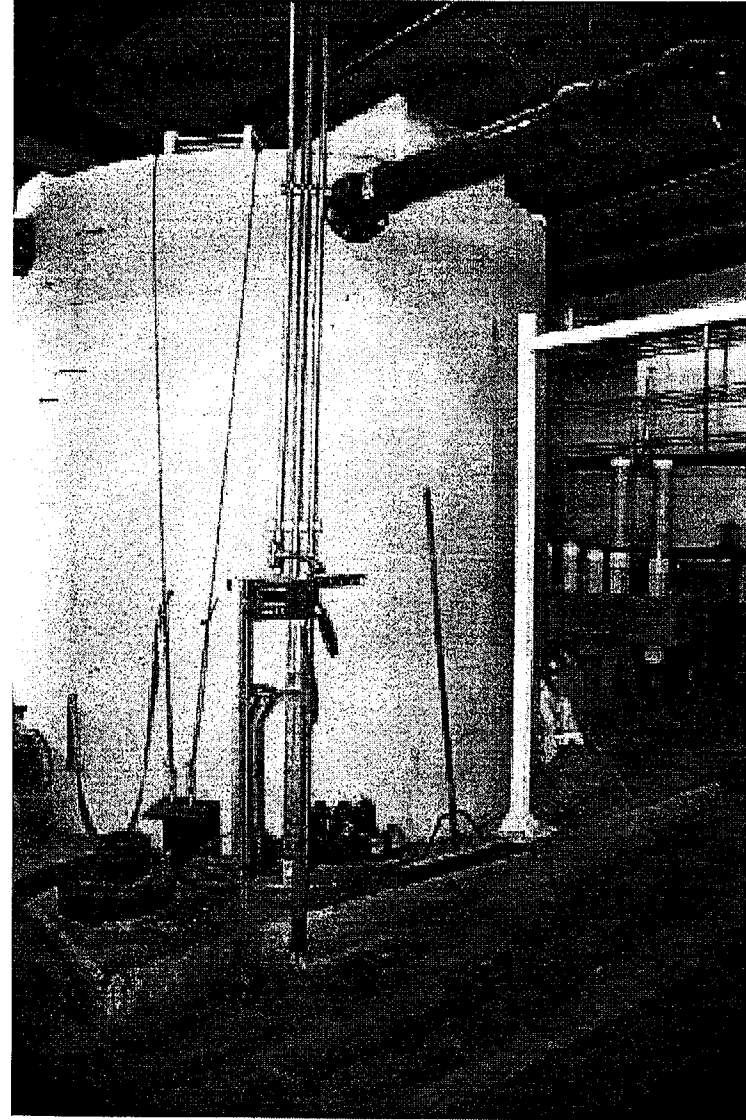
02_021_21.JPG

Inside reverse osmosis plant.

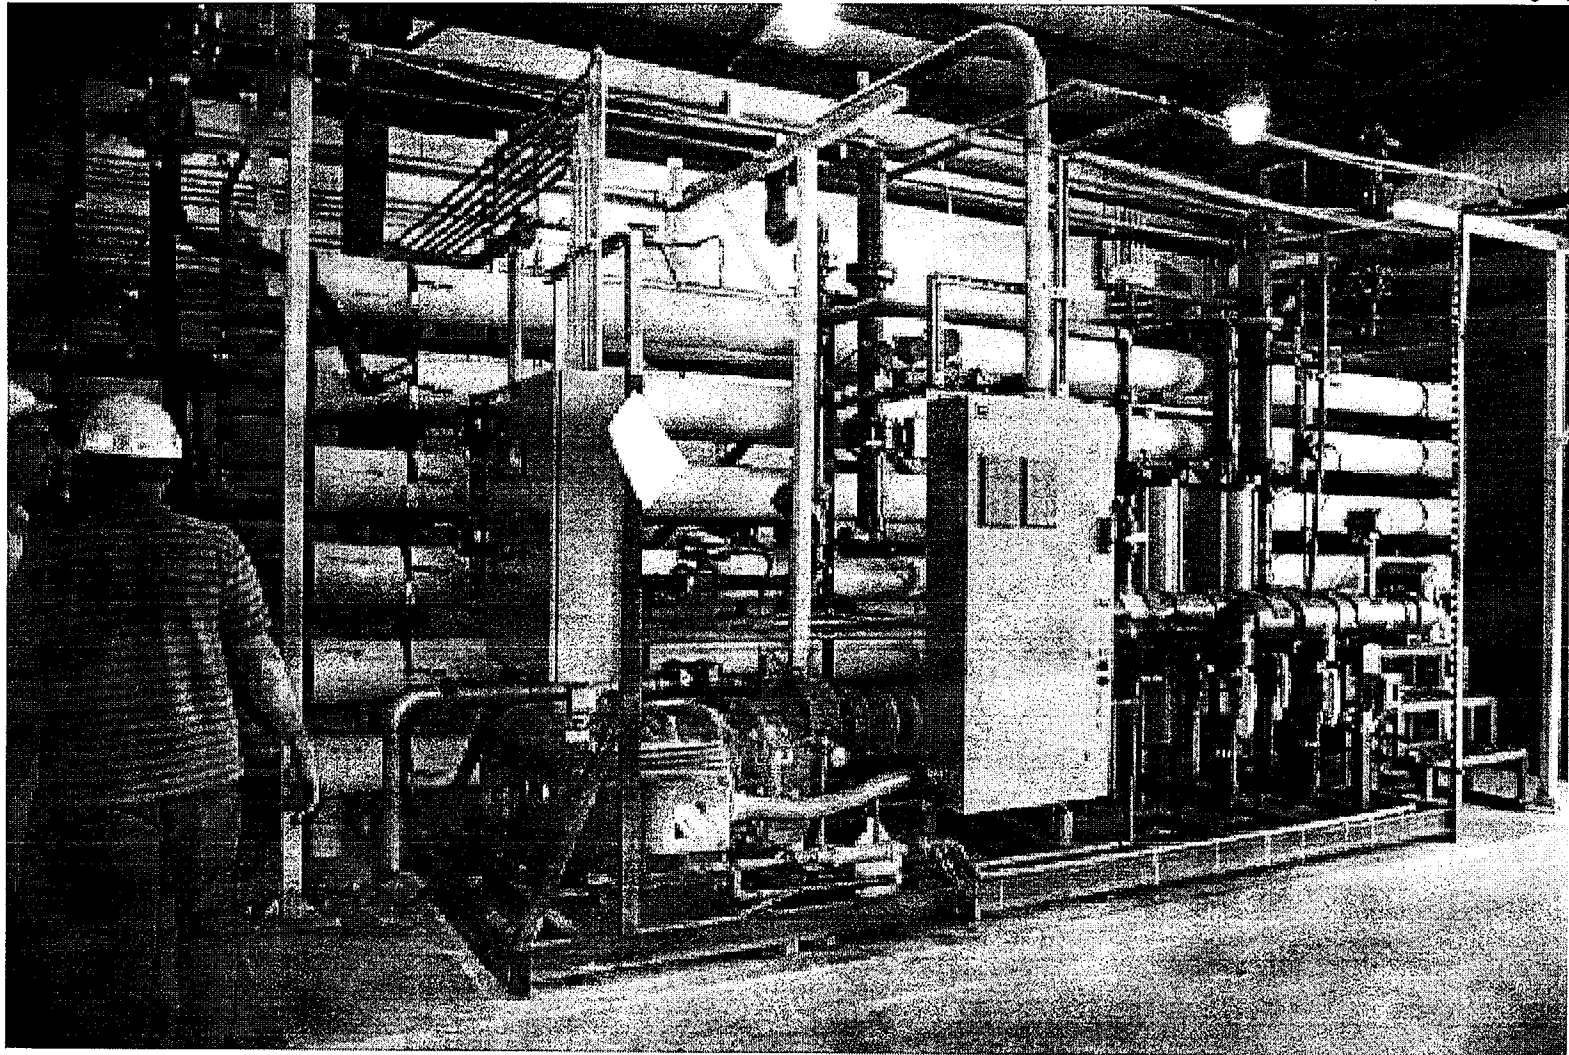
Inside reverse osmosis plant.

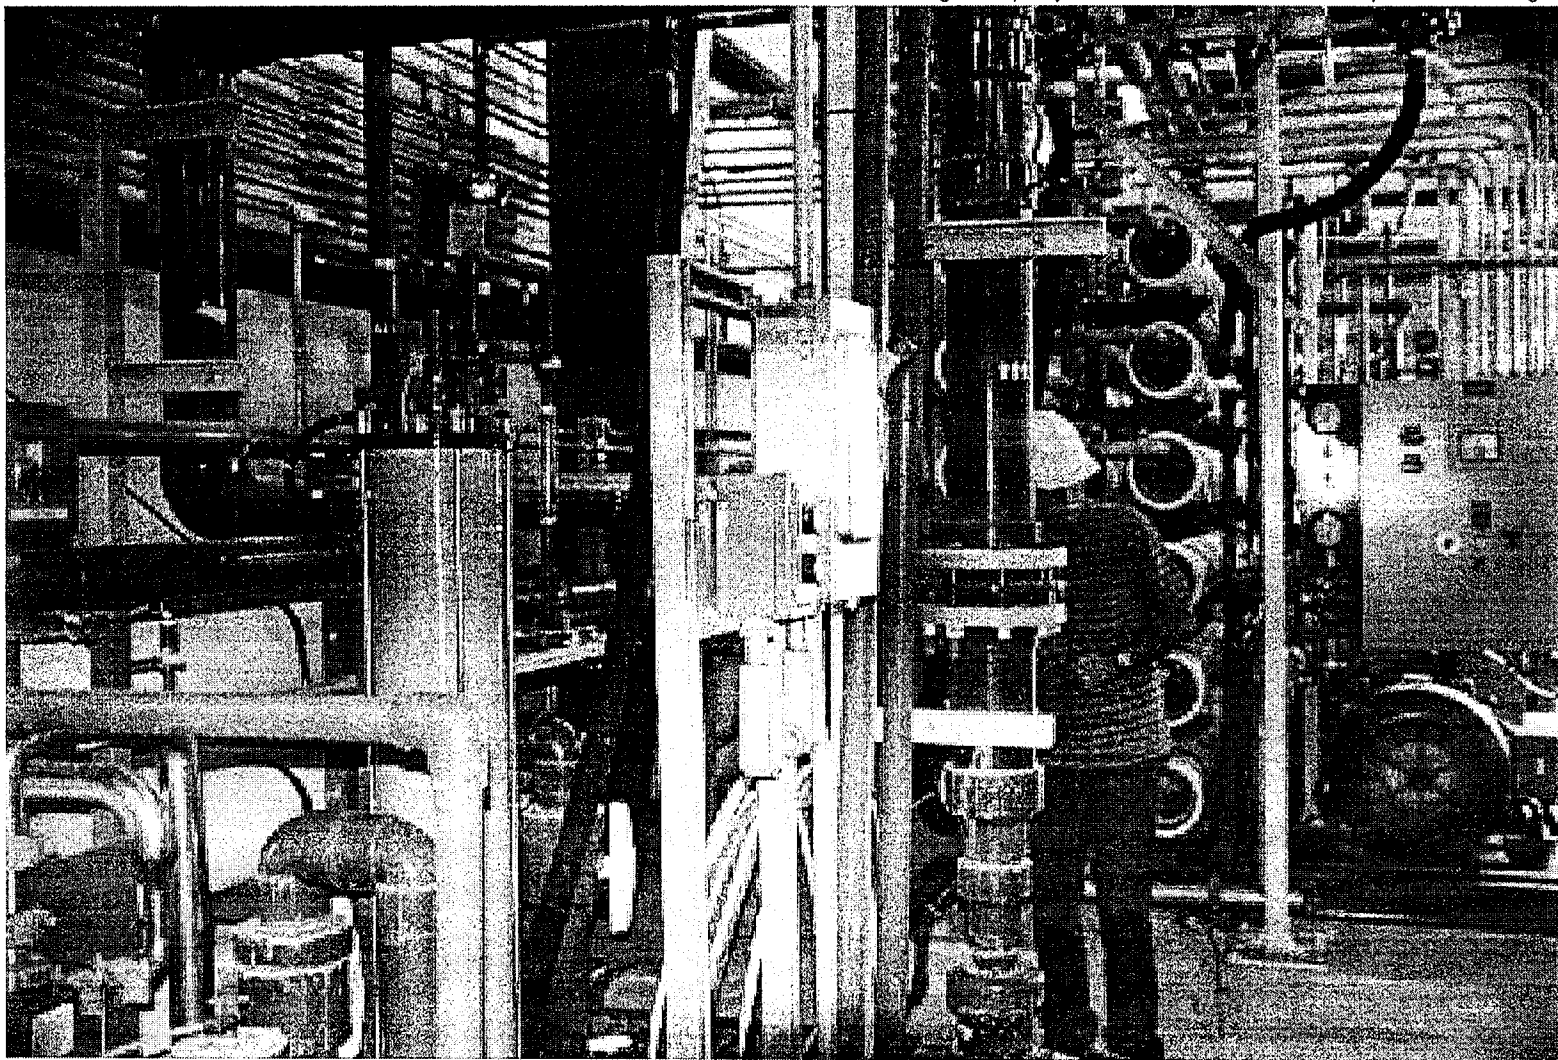
Inside reverse osmosis plant.

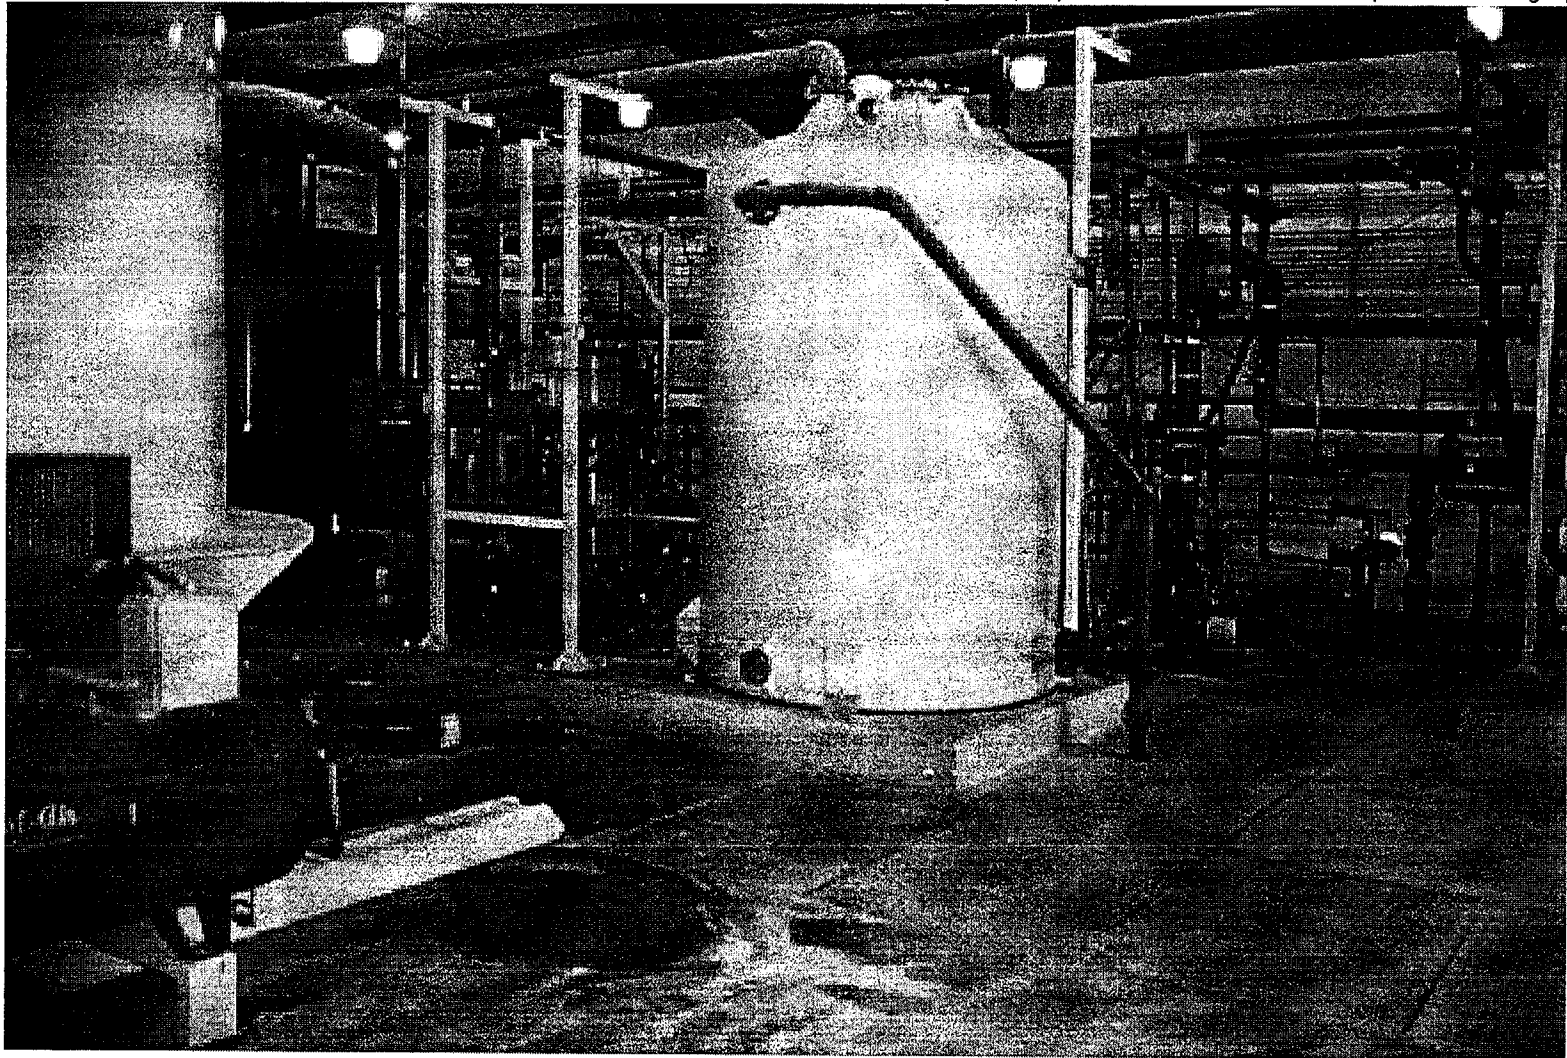
Inside reverse osmosis plant.

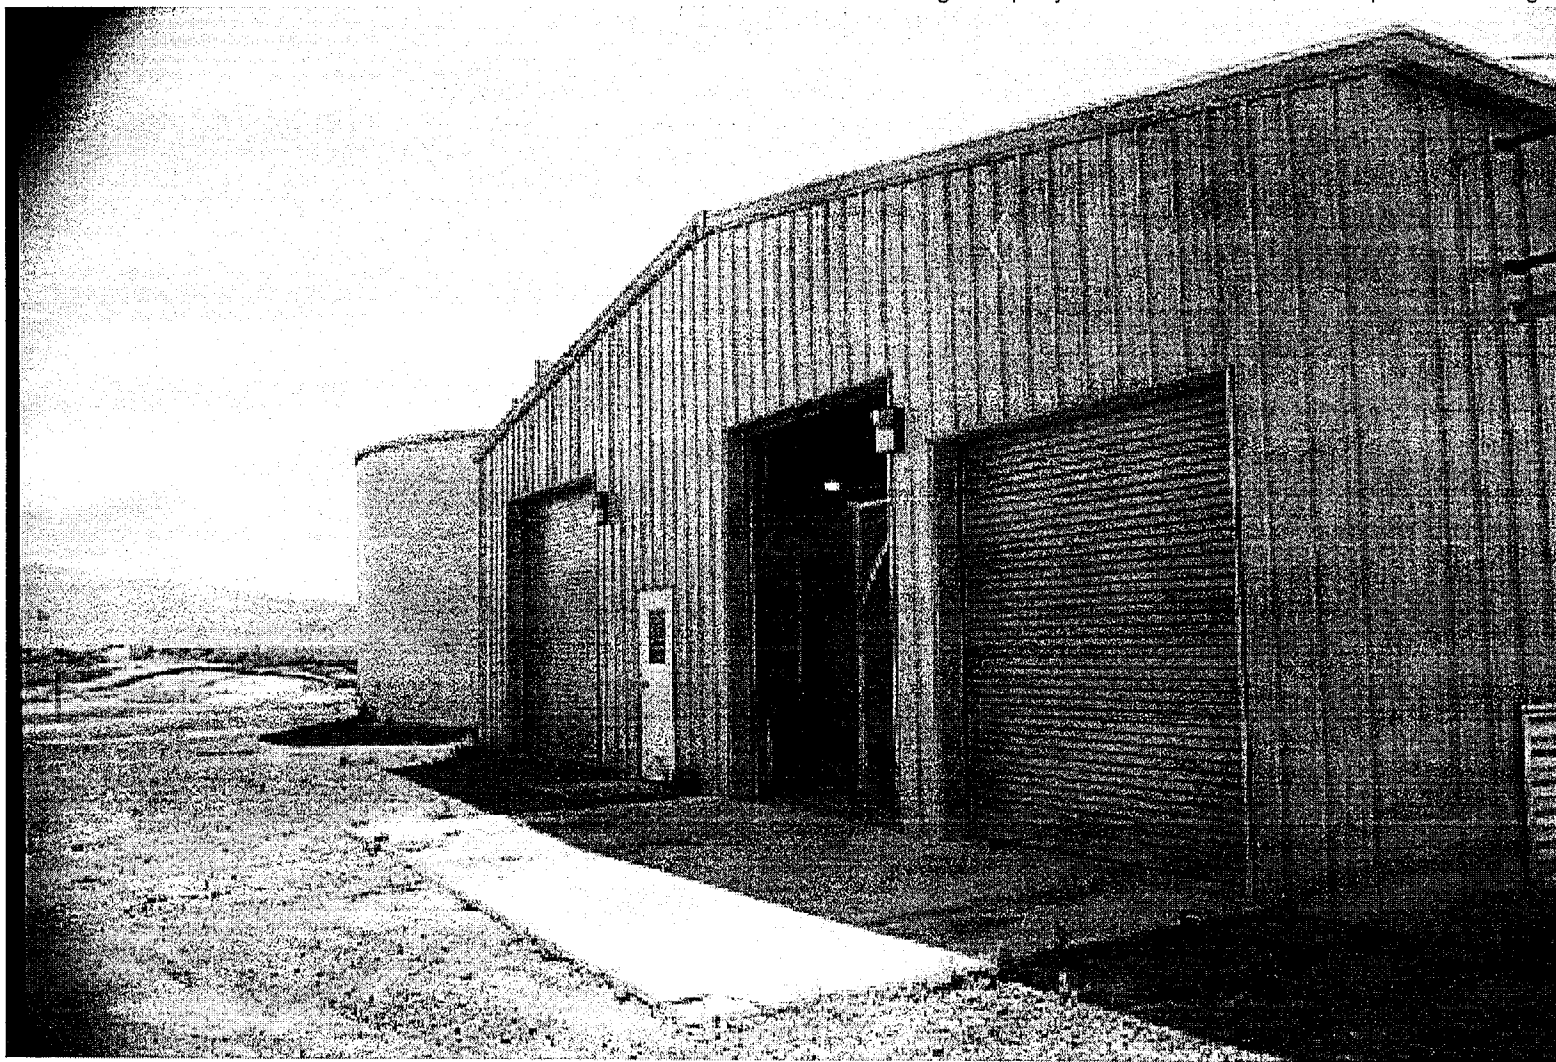
Exterior of reverse osmosis plant, facing east-southeast.

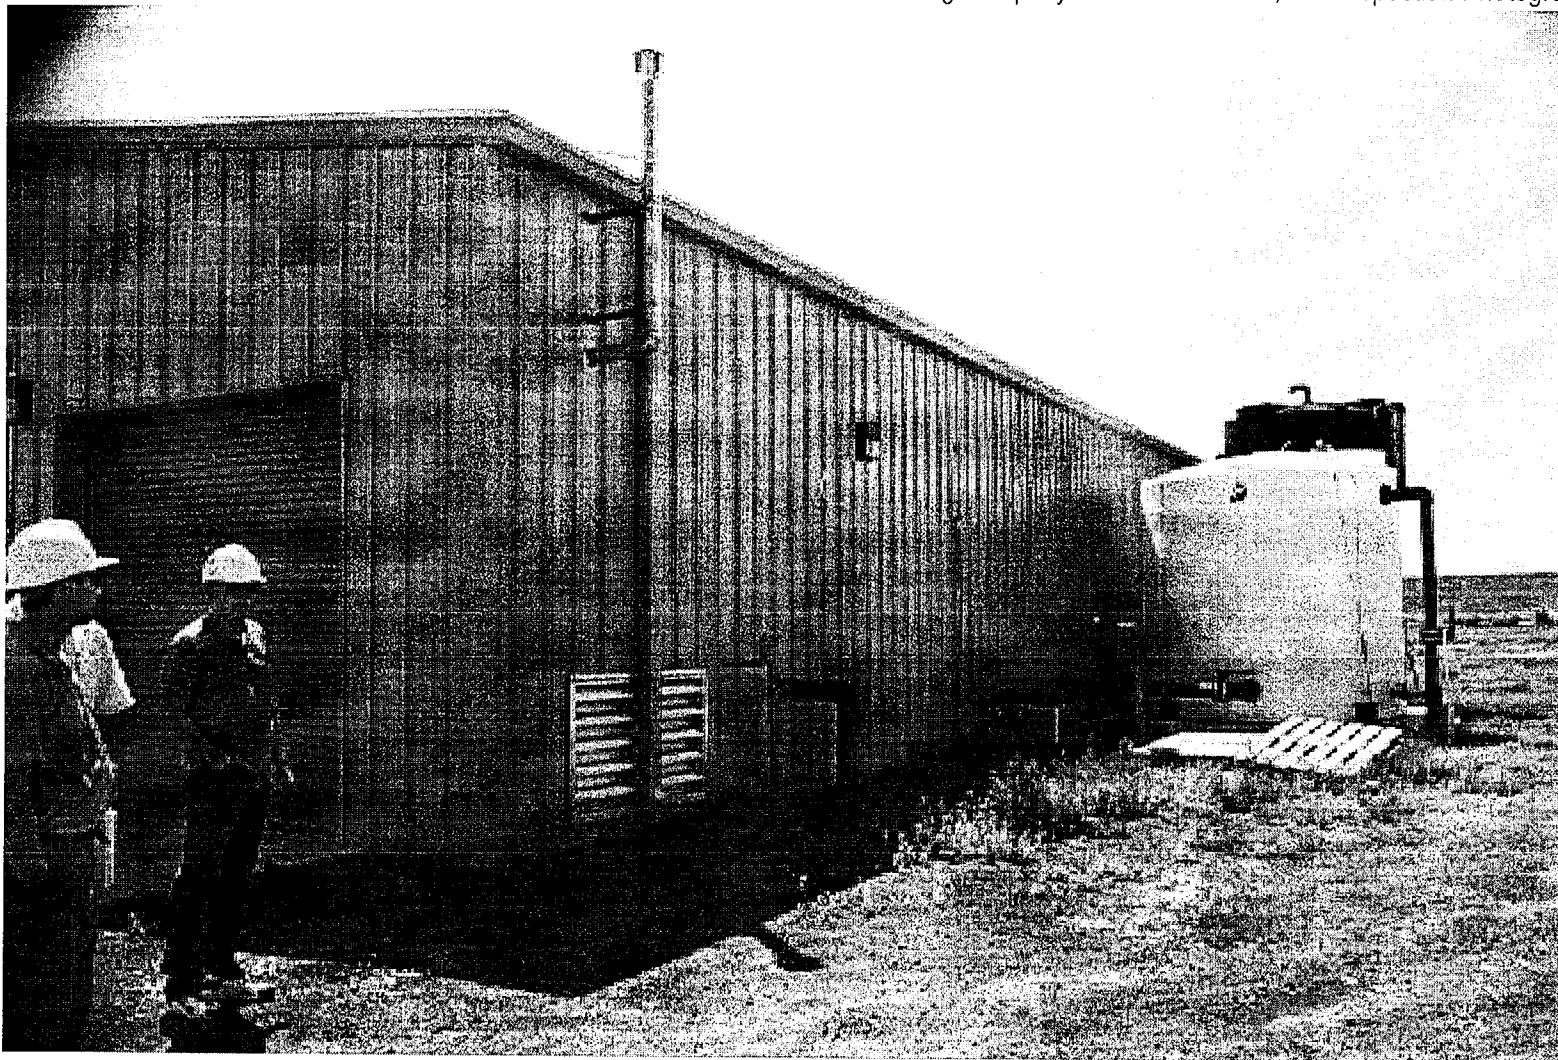
Exterior of reverse osmosis plant, facing south (to right of previous view).

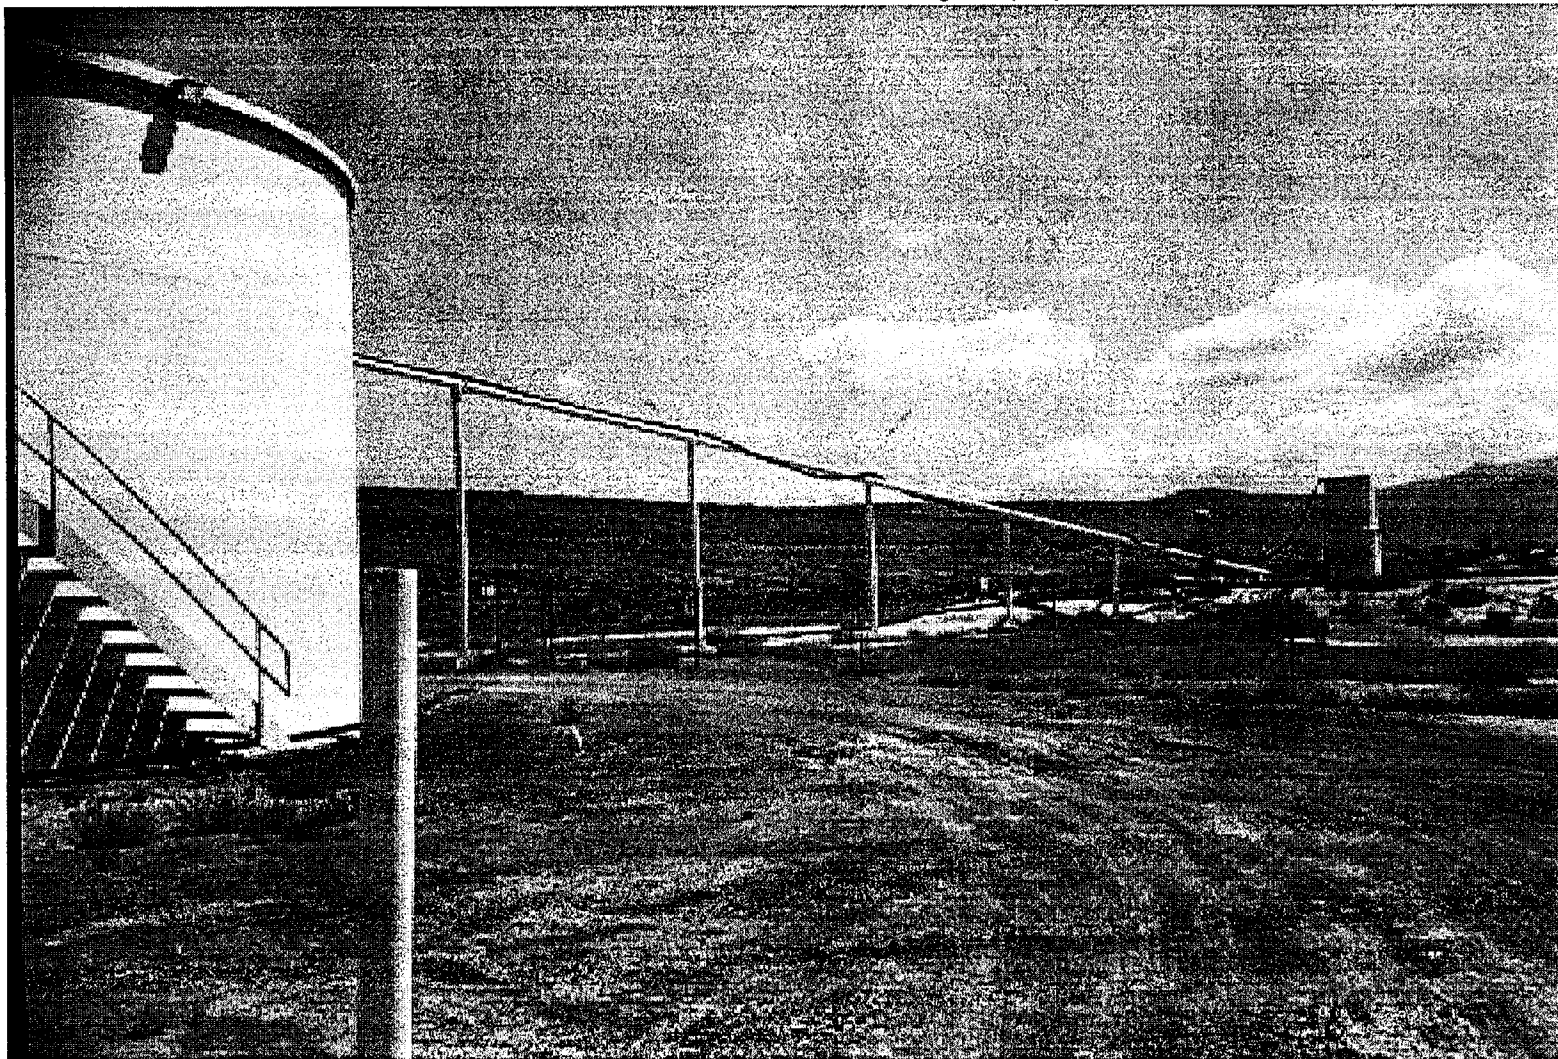
Exterior of reverse osmosis plant, showing conveyance between plant and evaporation ponds to right of view.
Facing north-northwest.

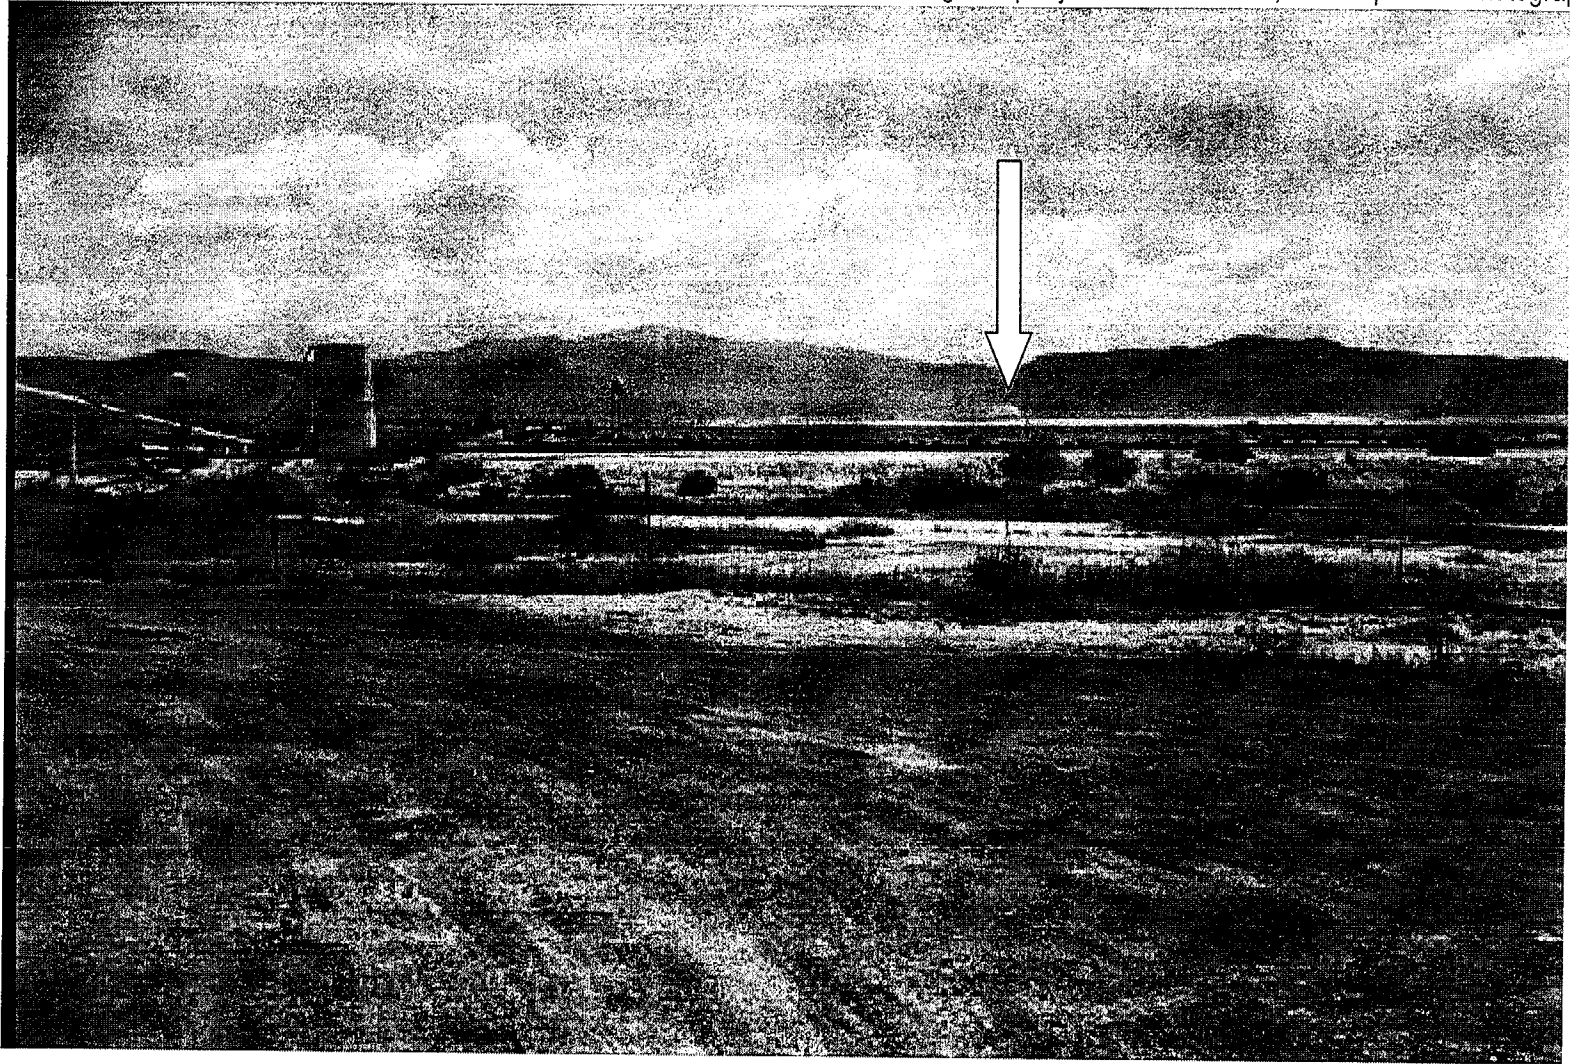
Facing east from south of reverse osmosis plant across evaporation ponds. Note spray blower in far pond at white arrow (the large lined evaporation pond).

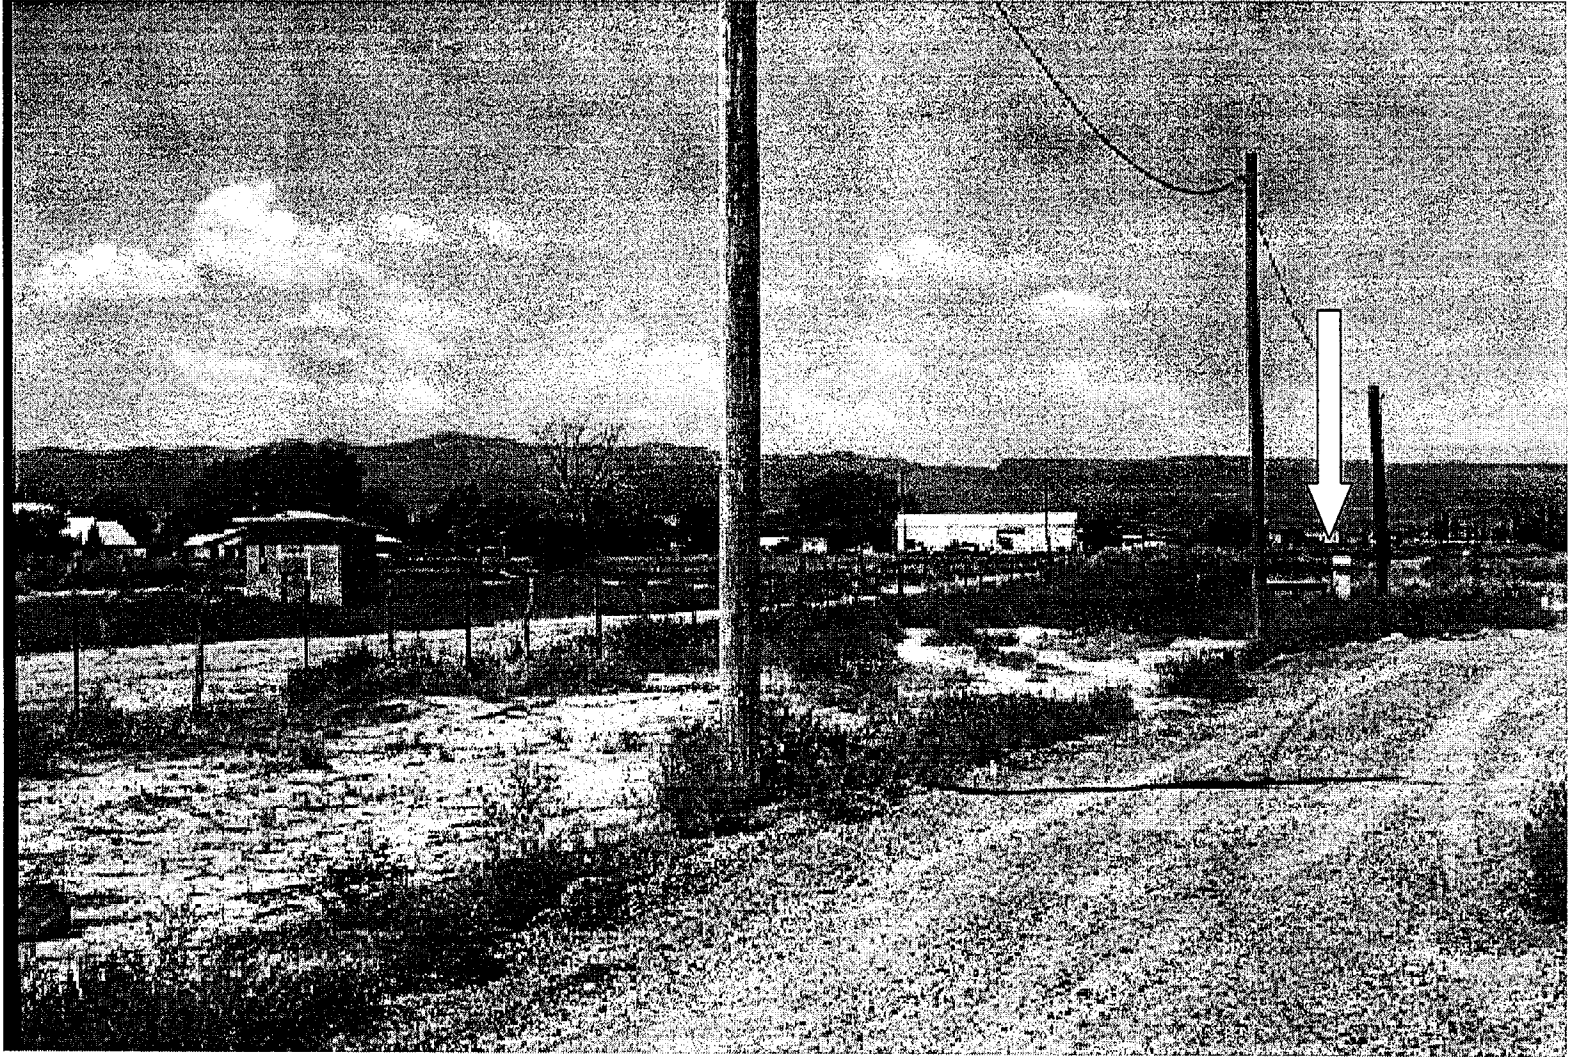
Facing west along site road at southern edge of property, at north end of Murray Acres subdivision.
Note air monitoring station at white arrow.

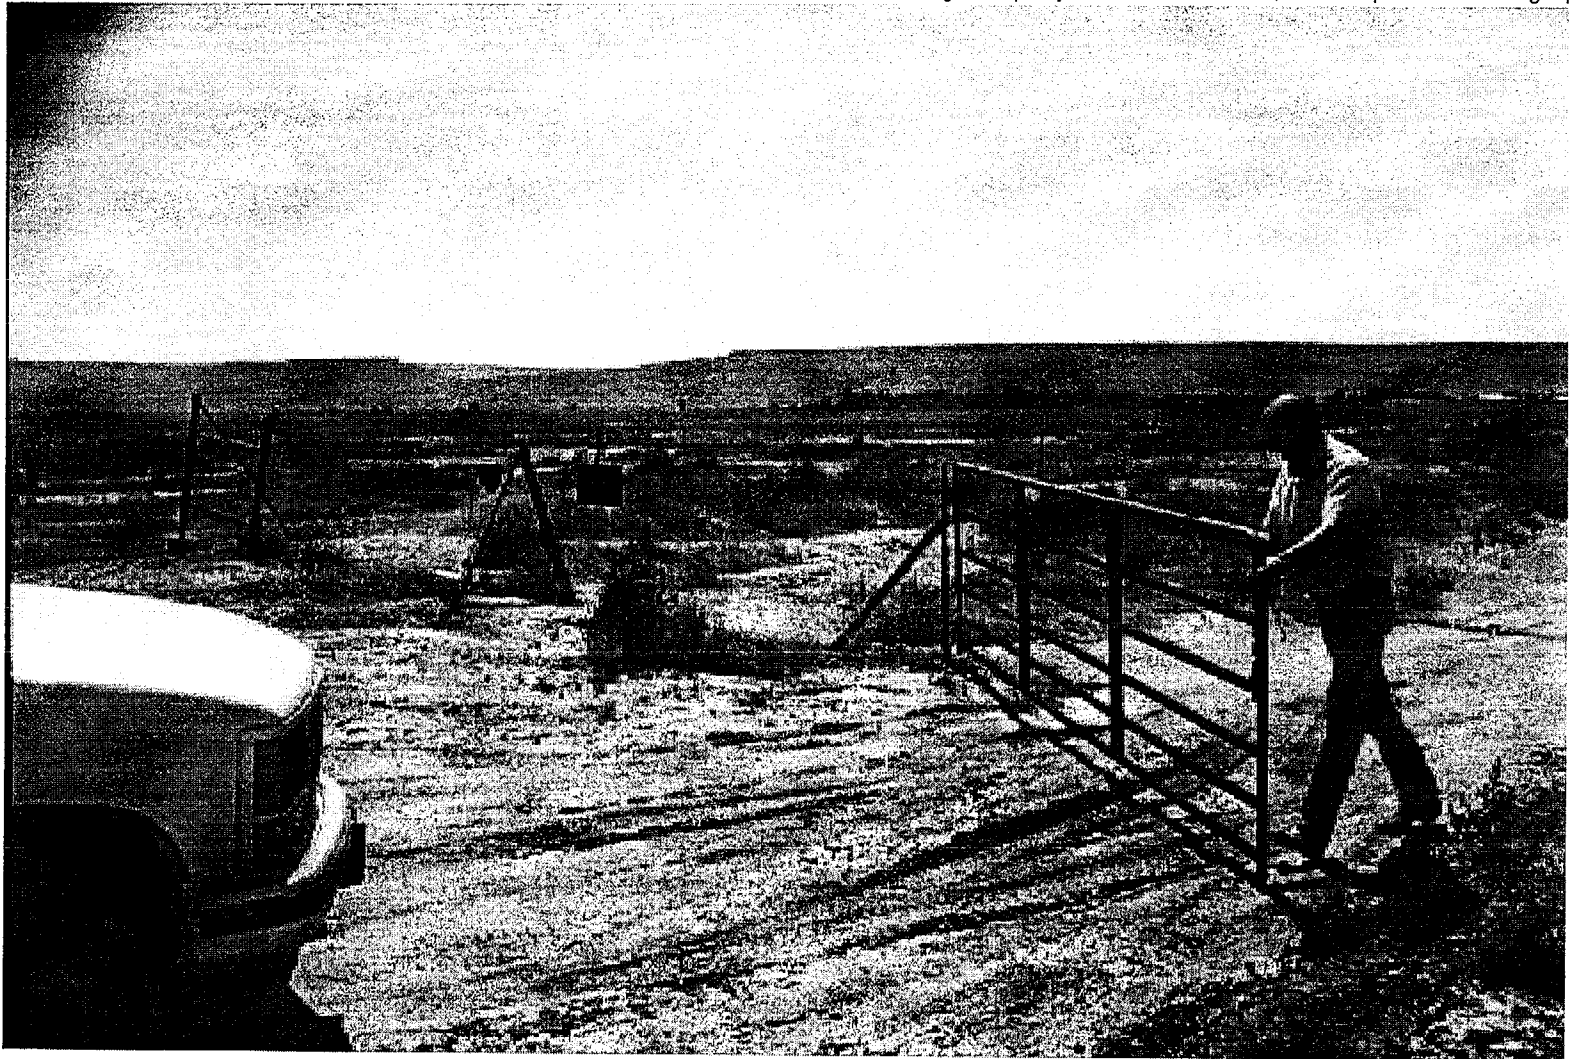
Facing east-southeast at site access gate near northeastern corner of Murray Acres subdivision.

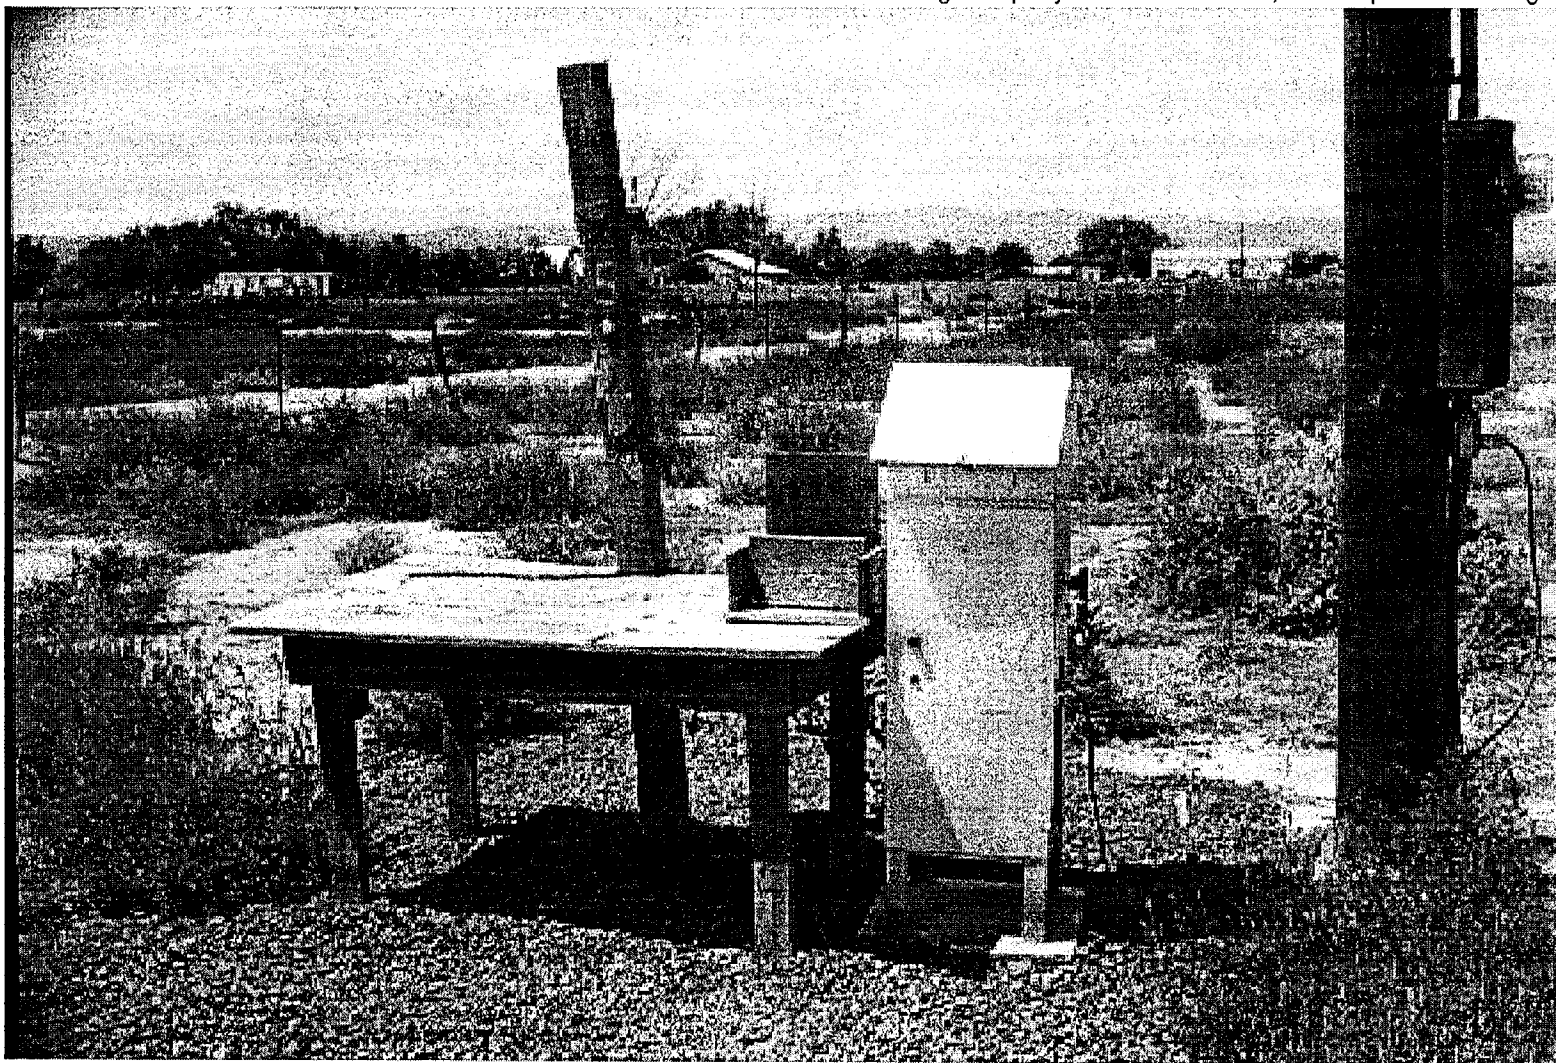
Facing west, air monitoring station near north end of Murray Acres subdivision.

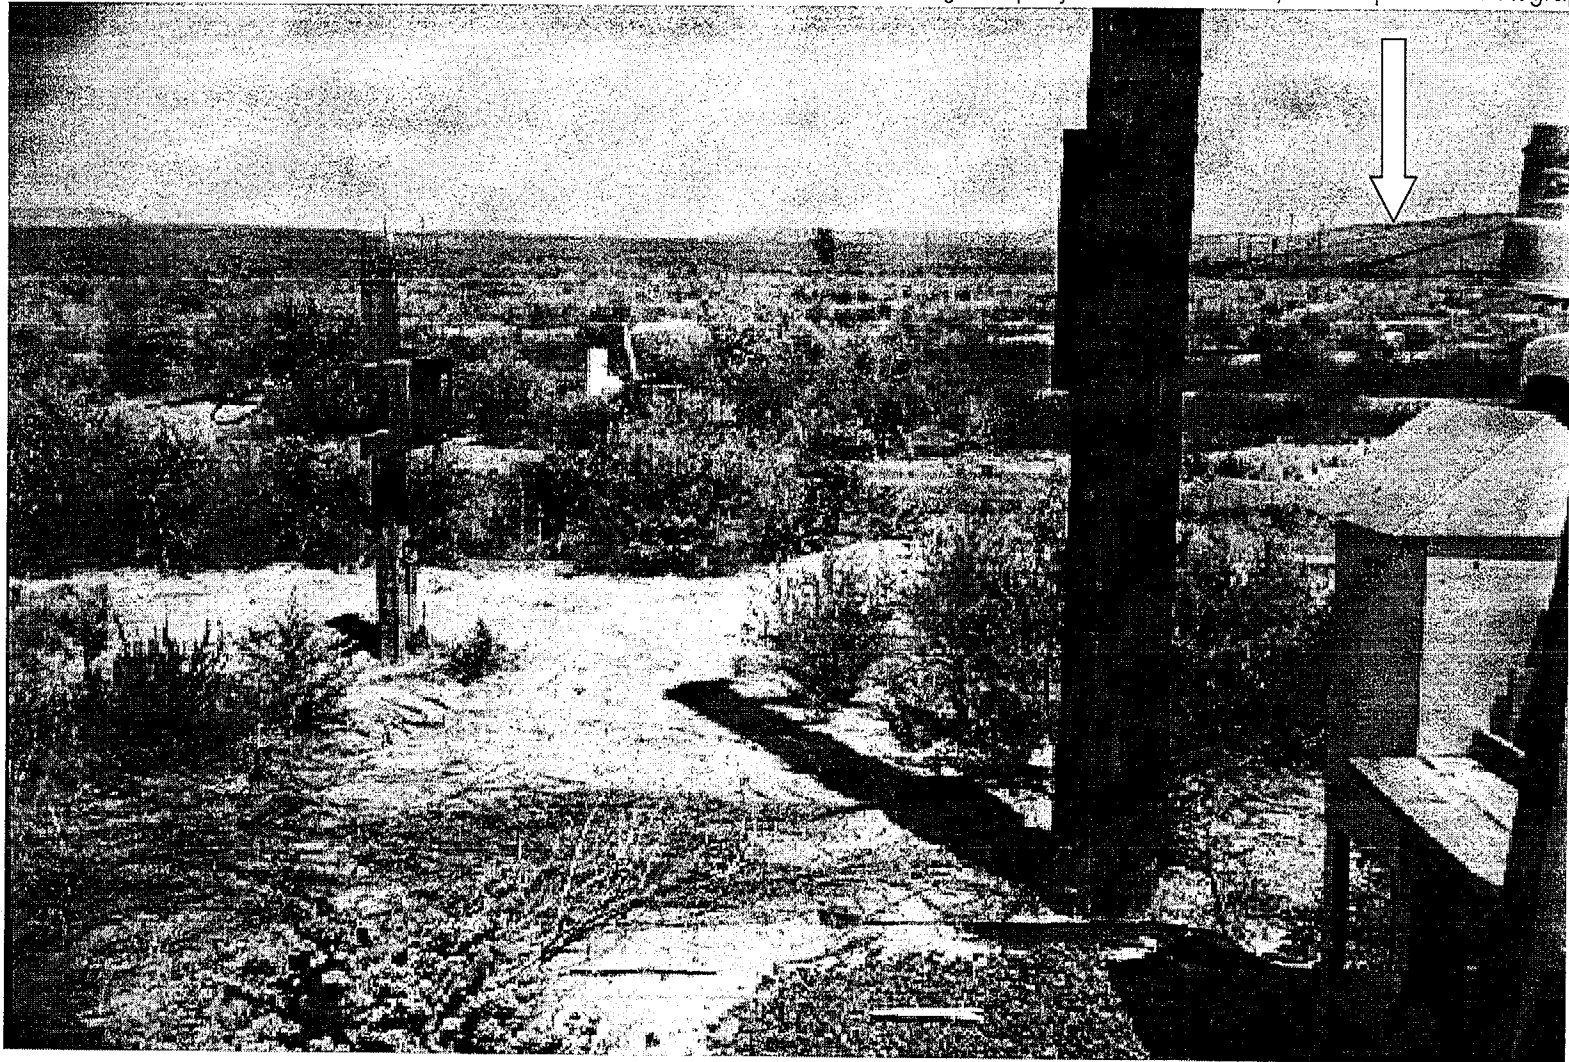
Facing north on west side of air monitoring station shown in previous photographs. Western slope of large tailings pile is visible at white arrow.

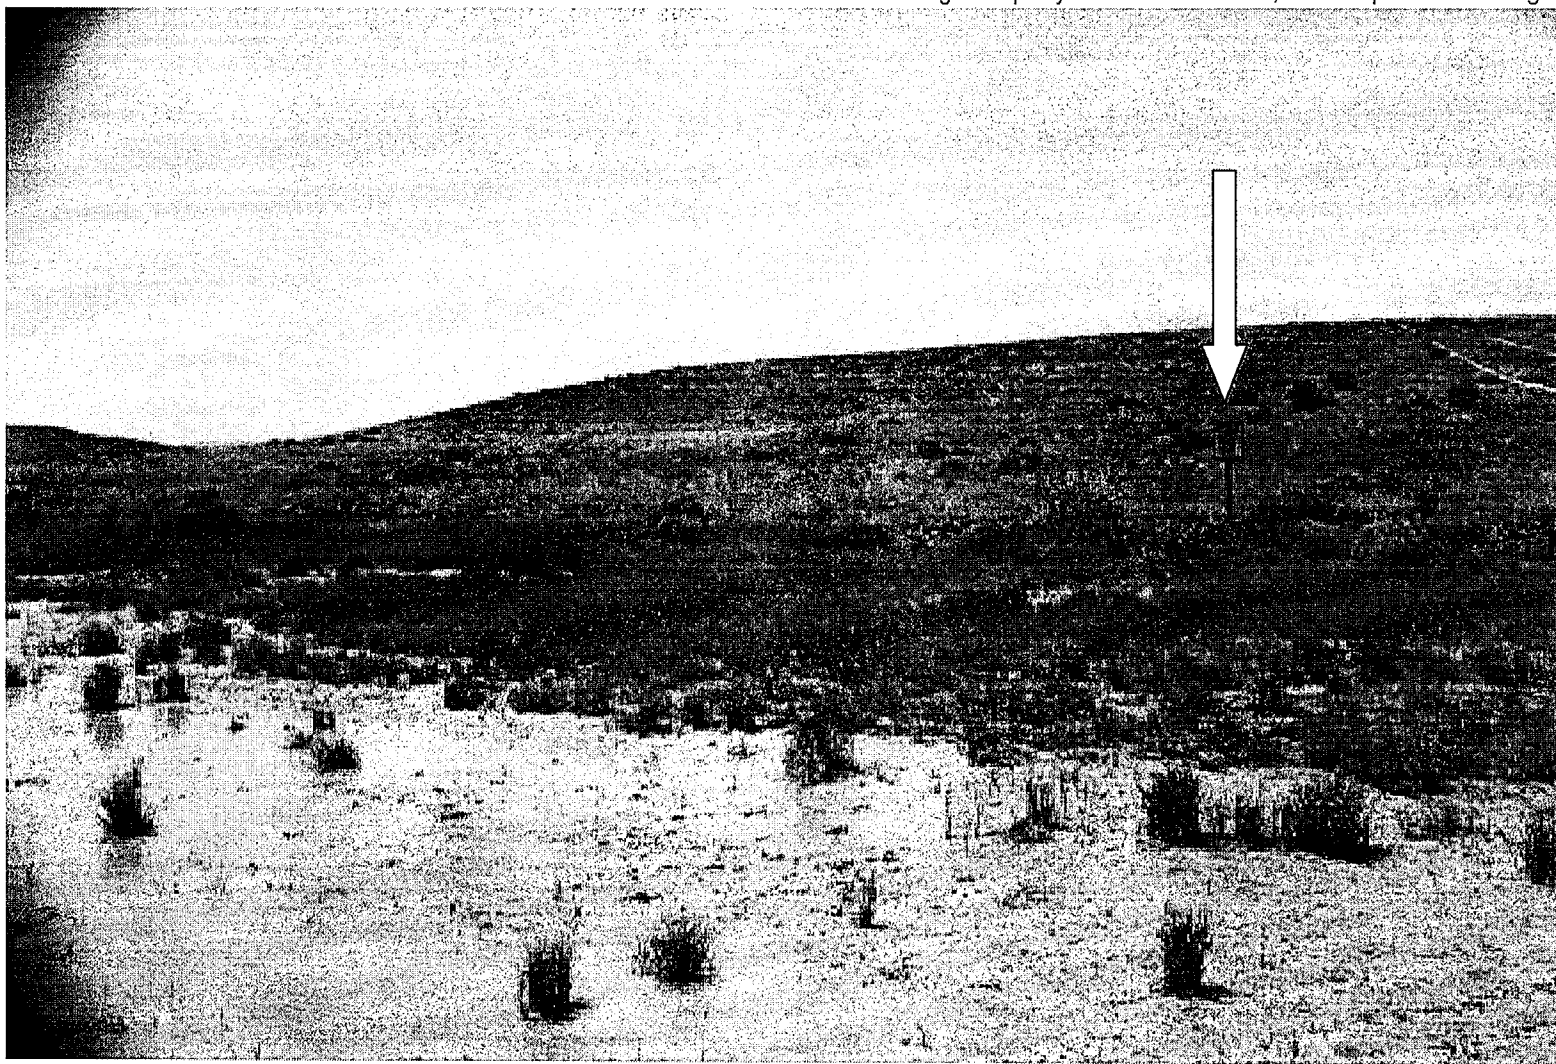
Facing south toward north-eastern slope of large tailings pile, at northeast corner. Note sign at white arrow; signifies presence of an asbestos disposal area.

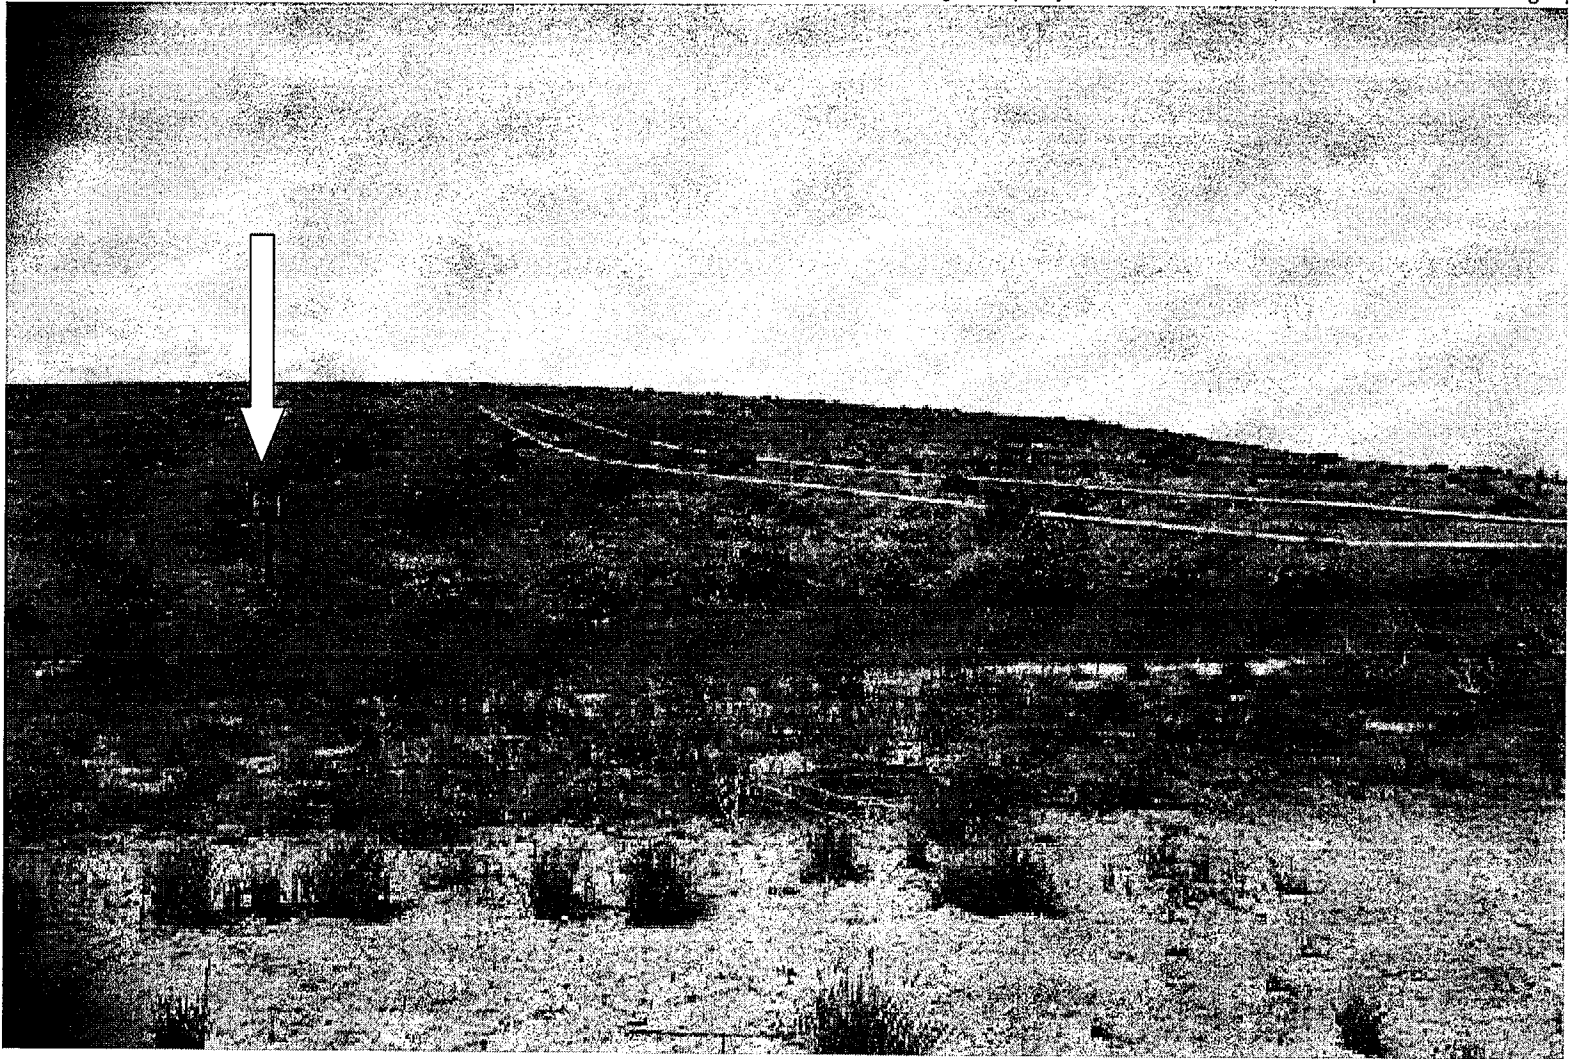
Facing south-southwest toward north-eastern slope of large tailings pile, at northeast corner. Note same sign as visible in previous photograph at white arrow; signifies presence of an asbestos disposal area.
