Table 1
Chronology of Site Events
Homestake Mining Company Site, New Mexico

Attachment 3**Site Inspection Roster for Site Inspection Conducted August 16, 2001****Homestake Mining Company Superfund Site**

Attachment 4
Site Inspection Photographs

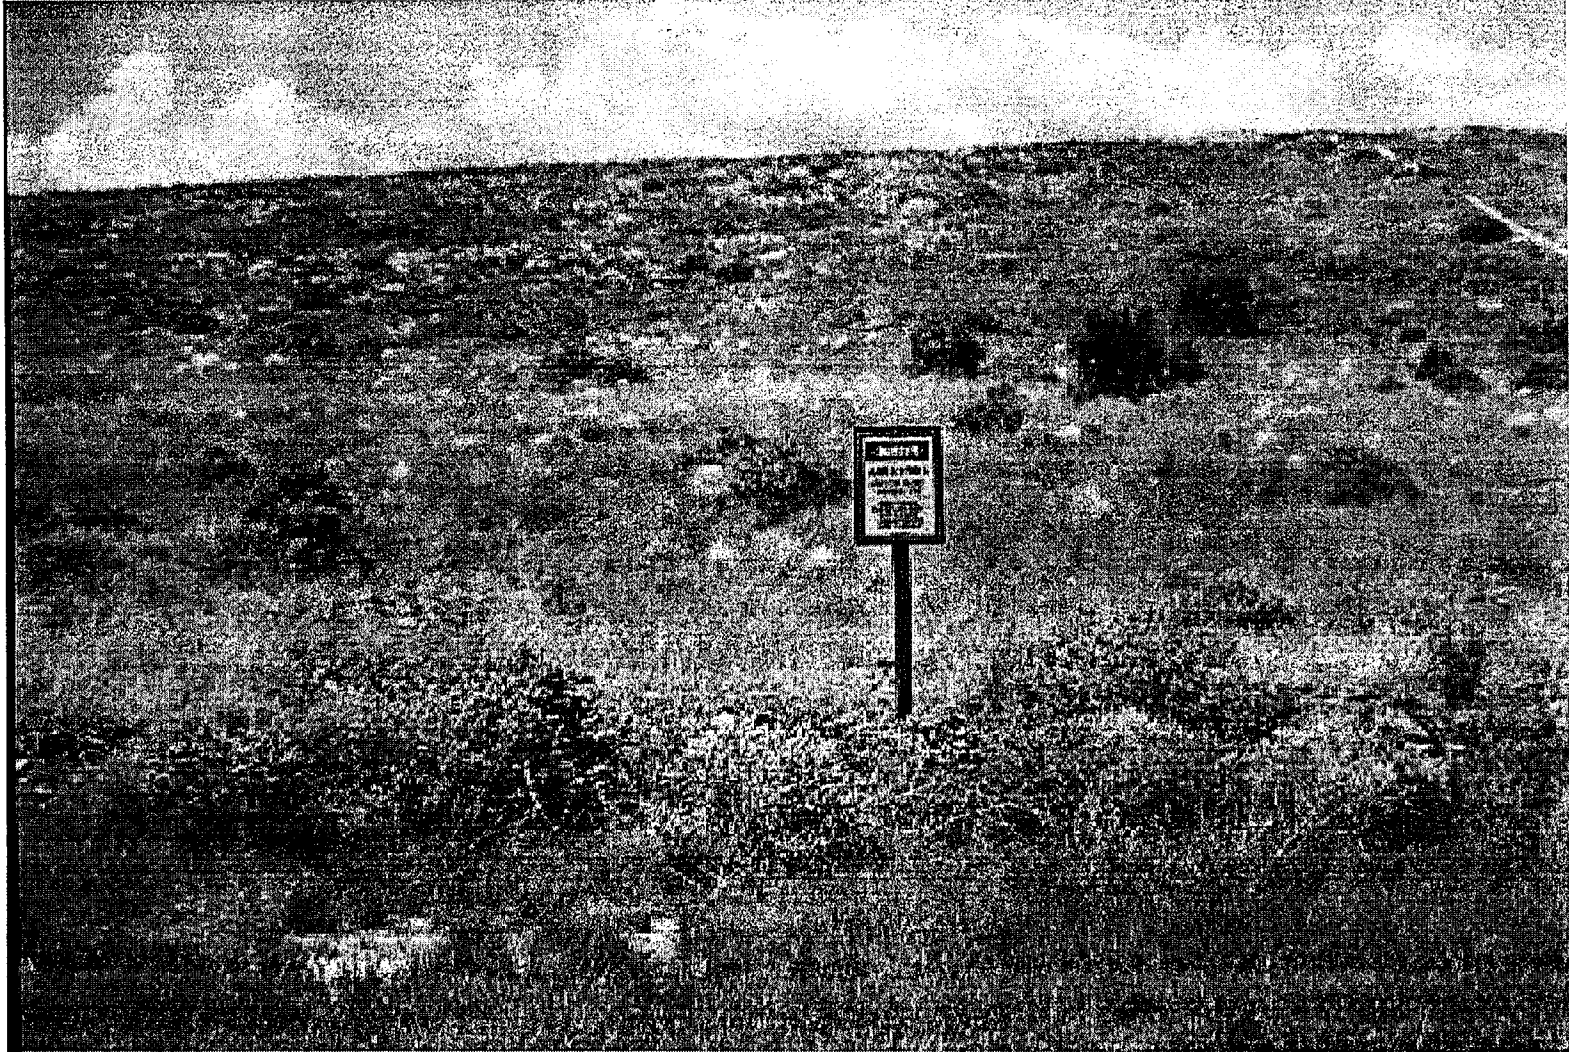
Facing south toward northern slope of large tailings pile, toward eastern end of the pile, closer view of asbestos disposal area seen in previous photographs. Sign states "Danger, Asbestos Waste Disposal Site, Breathing Asbestos Dust May Cause Lung Disease and Cancer".

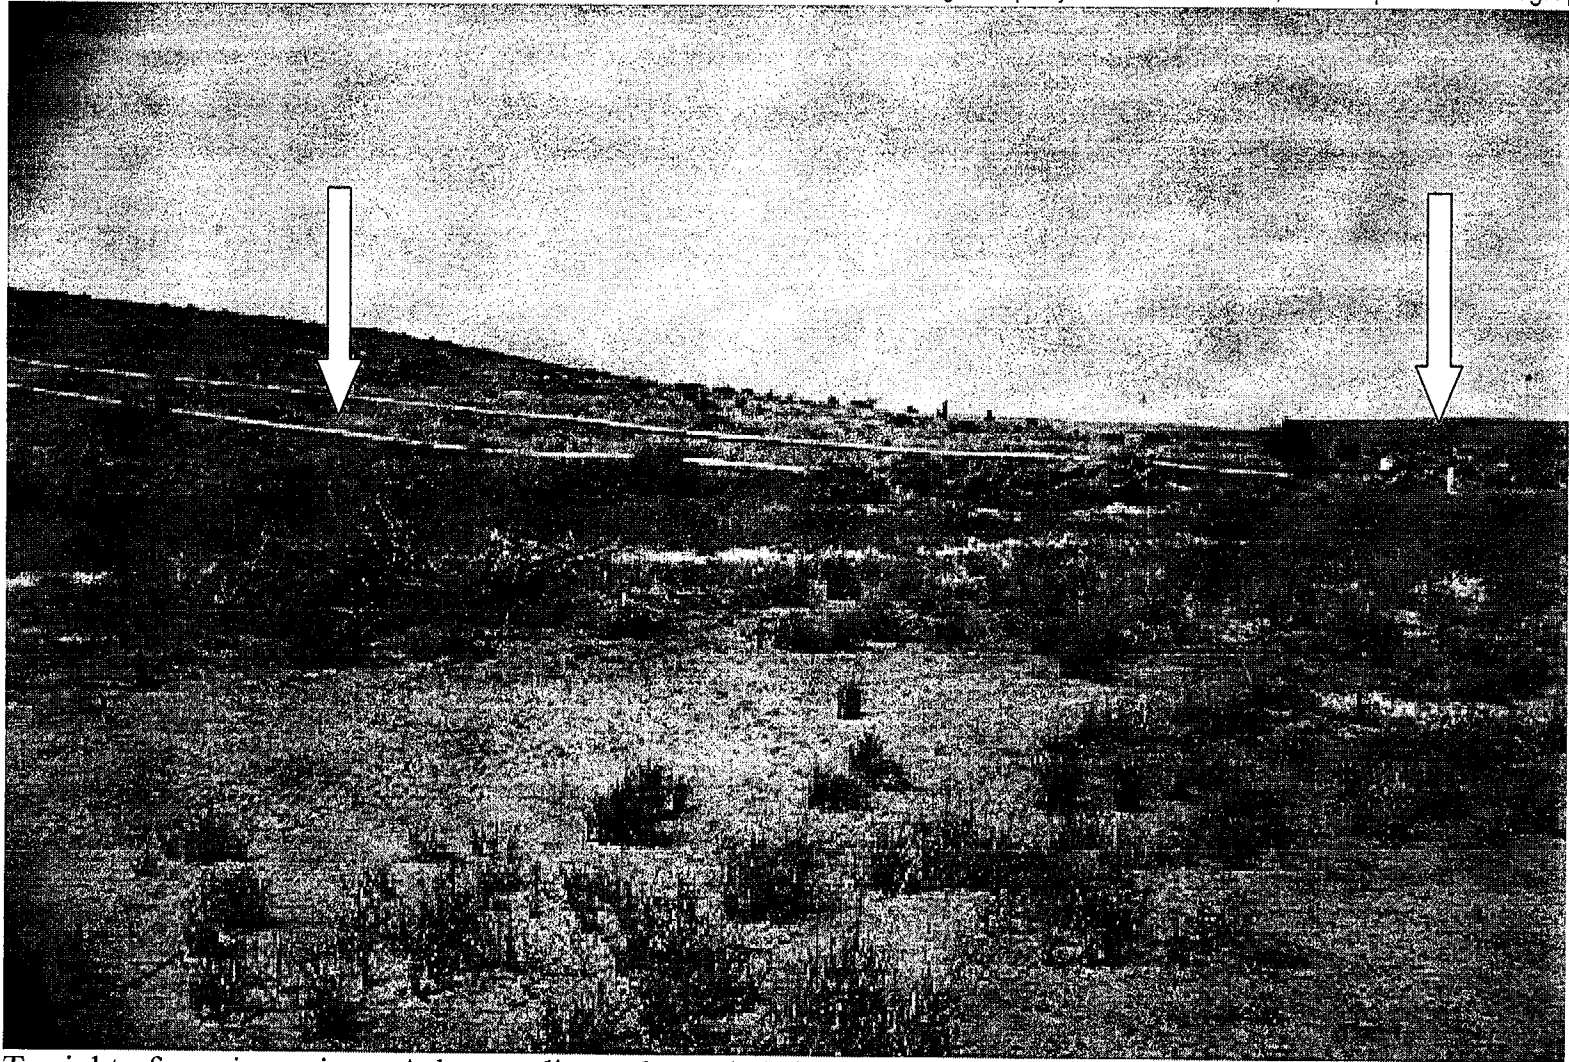
To right of previous view. Asbestos disposal area is left of view; runoff conveyance from top of large tailings pile is visible at left white arrow. Right white arrow shows runoff discharge point, which uses boulders to break flow.

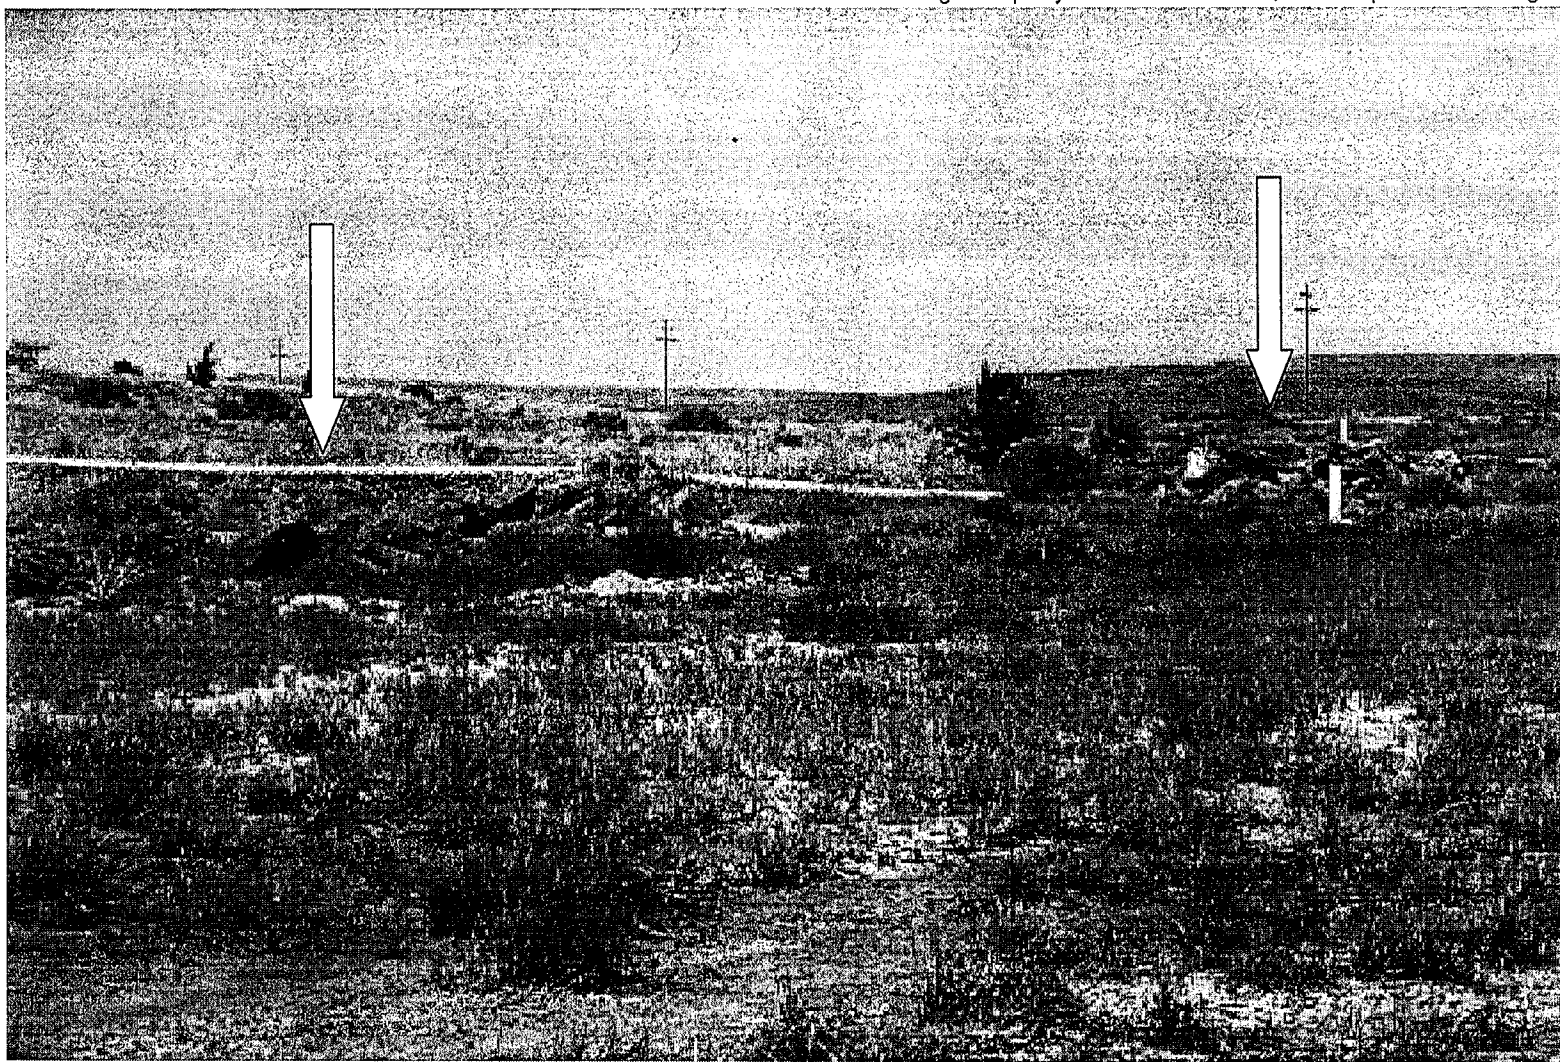
Closer view of previous photograph. Asbestos disposal area is left of view; runoff conveyance from top of large tailings pile is visible at left white arrow. Right white arrow shows runoff discharge point, which uses boulders to break flow.

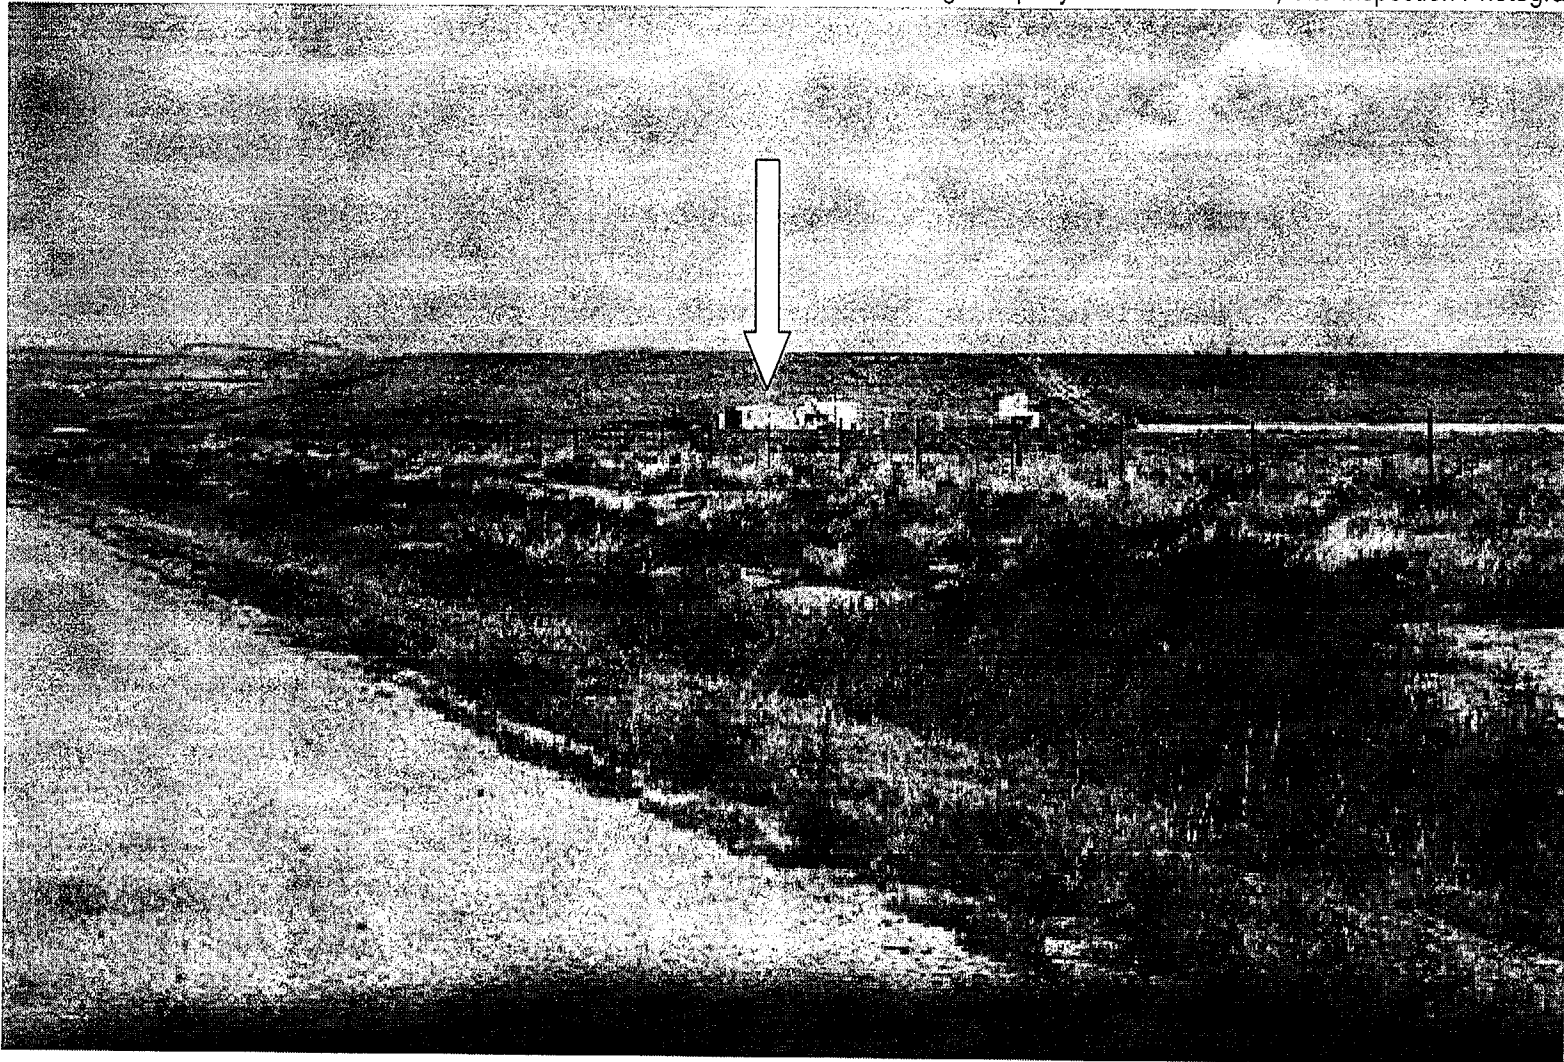
Facing north toward site from Thunderbird Lane east of Murray Acres. Note location of reverse osmosis plant at white arrow. Large tailings pile is visible in background.

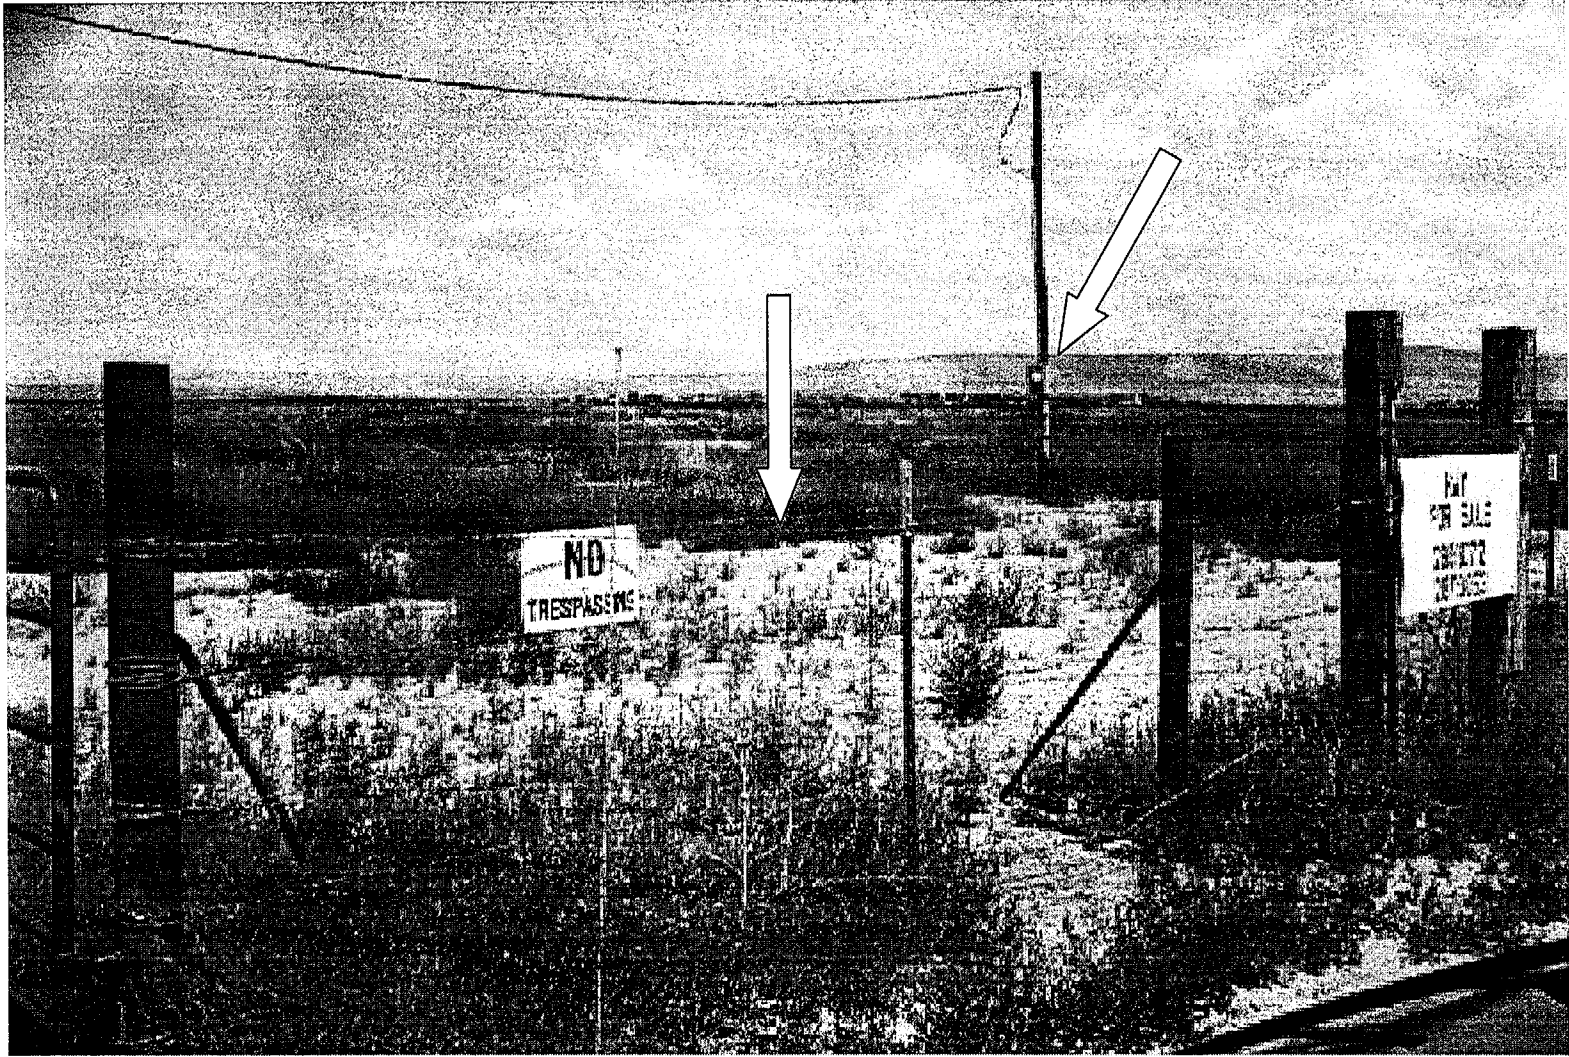
Facing north toward irrigation area west of Pleasant Valley Estates, at southwest corner of the irrigation area property. Note water conveyance pipe and power pole with electrical box (left and right arrows, respectively).
