DOCKET 50-255 - LICENSE DPR-20 - PALISADES NUCLEAR PLANT
WITHDRAWAL OF RELIEF REQUEST TO PERFORM WELD OVERLAY REPAIRS
ON CONTROL ROD DRIVE MECHANISM (CRDM) UPPER HOUSINGS; AND
RESTATEMENT OF RESPONSES CONCERNING WELD NO. 1 (TAC NO. MB3001)

**Response to Request for Additional Information Regarding Weld No. 1 (Reactor
Vessel Head Nozzle Pipe to Flange Weld) as provided November 6, 2001**

**Follow-up Questions Regarding Weld No. 1 (Reactor Vessel Head Nozzle Pipe to
Flange Weld) as provided November 17, 2001**

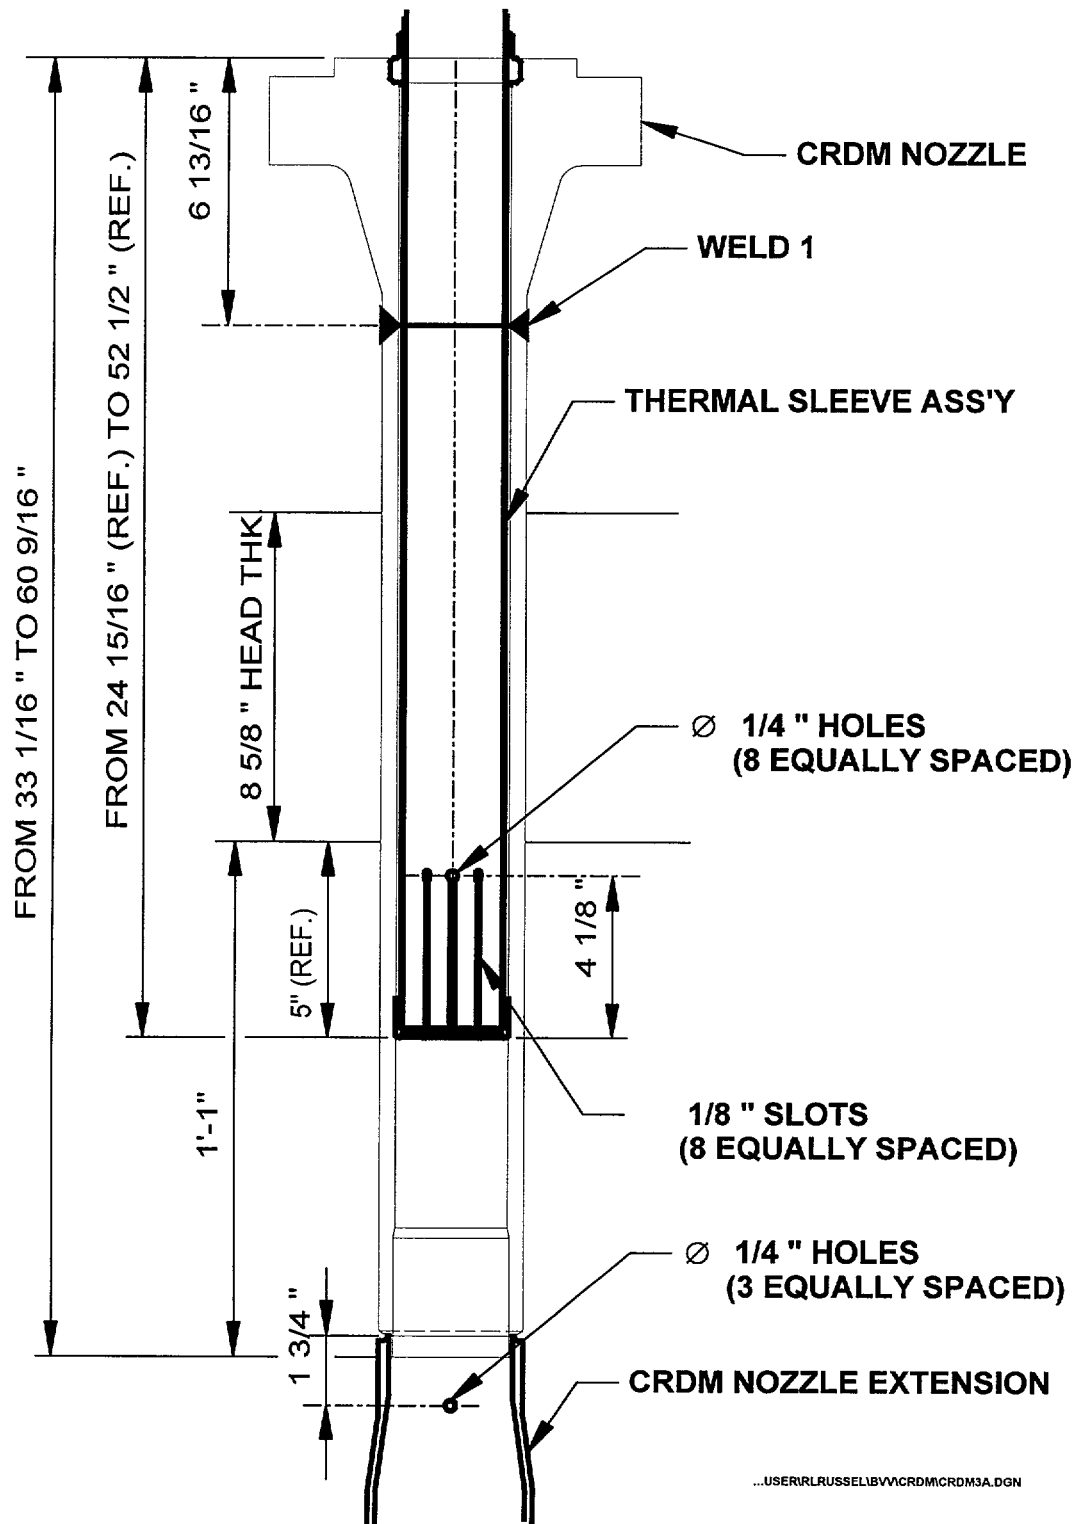
WELD 1/THERMAL SLEEVE:

The attached sketch shows the location of flow holes. The subject flow holes are not in the thermal sleeves themselves. The three ¼ inch diameter flow holes exist within each CRDM nozzle tube assembly. They are located about 13 inches from the inside of the reactor head. Due to the presence of the upper guide structure between the fuel and the nozzle tube ends, a portion of the reactor coolant flow proceeds upward into the nozzle tube assemblies and out of the three ¼ inch diameter flow holes. In addition to this, a temperature gradient exists between the inside of the thick vessel head and Weld No. 1. This temperature gradient will promote some convective flow within the annulus surrounding the thermal sleeve as would occur in any environment where a temperature gradient exists.

Three ¼ inch diameter flow holes exist within each CRDM nozzle tube assembly. They are located about 13 inches from the inside of the reactor head. Due to the presence of the upper guide structure between the fuel and the nozzle tube ends, a portion of the reactor coolant flow proceeds upward into the nozzle tube assemblies and out of the three ¼ inch diameter flow holes. In addition to this, a temperature gradient exists between the inside of the thick vessel head and Weld No. 1. This temperature gradient should promote some convective flow within the annulus surrounding the thermal sleeve as would occur in any environment where a temperature gradient exists.

Regarding the holes in the thermal sleeve, provide a sketch showing their location relative to Weld No. 1. It is not apparent why there would be flow in the thermal sleeve annulus in the vicinity of Weld No. 1.

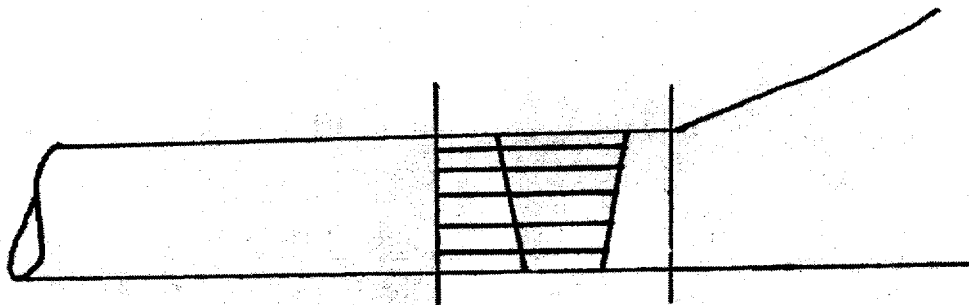
Area Examined

\ = Axial
— = Circumferential

The welds were examined with both surface and volumetric examination techniques. The volumetric exam was a manual ultrasonic (UT) examination using IGSCC qualified personnel. It was recognized that the UT exams would be limited and that not all of the Code required volume could be obtained due to the geometries involved with each weld. To supplement this examination a surface examination (dye penetrant) of five of the welds was also performed. The surface examination served two purposes, it allowed all of the required weld volume to be examined to satisfy the examination volume requirement and it provided a means to detect any flaws that might be generated from the outside diameter surface.

Provide a cross-section of the weld showing the volume that was inspected using qualified procedures and personnel. Show the volume that was inspected using a best effort UT procedure and personnel:
