**DATA REPORT D**  
**TRENCHES IN THE ISFSI STUDY AREA**  
**DIABLO CANYON ISFSI**

**DCPP ISFSI SAR**  
**Data Report D**  
**Trenches in the ISFSI Study Area**

Twenty-two shallow (1- to 8- feet-deep) trenches (designated T-1 to T-22) with cumulative length of about 1,510 feet, were excavated and logged at the Diablo Canyon ISFSI study area to obtain information on bedrock stratigraphy and rock mass properties (Figures D-1 and D-2). The trenches expose marine sedimentary rocks of unit Tof<sub>6</sub> of the Tertiary Obispo Formation and Holocene colluvium. Discontinuity surveys of joints, fractures and bedding (William Lettis & Associates, Inc., 2001, Diablo Canyon ISFSI Data Report F), as well as rock mass evaluations (William Lettis & Associates, Inc., 2001, Diablo Canyon ISFSI Data Report H) were performed in the trenches to obtain information to assess slope stability and in situ rock strength. The preparation of this data report was performed under the 2000 WLA Work Plan (William Lettis & Associates, Inc., Work Plan, 2000) using data collected under that Work Plan and the 2001 WLA Work Plan (William Lettis & Associates, Inc., Work Plan, 2001) .

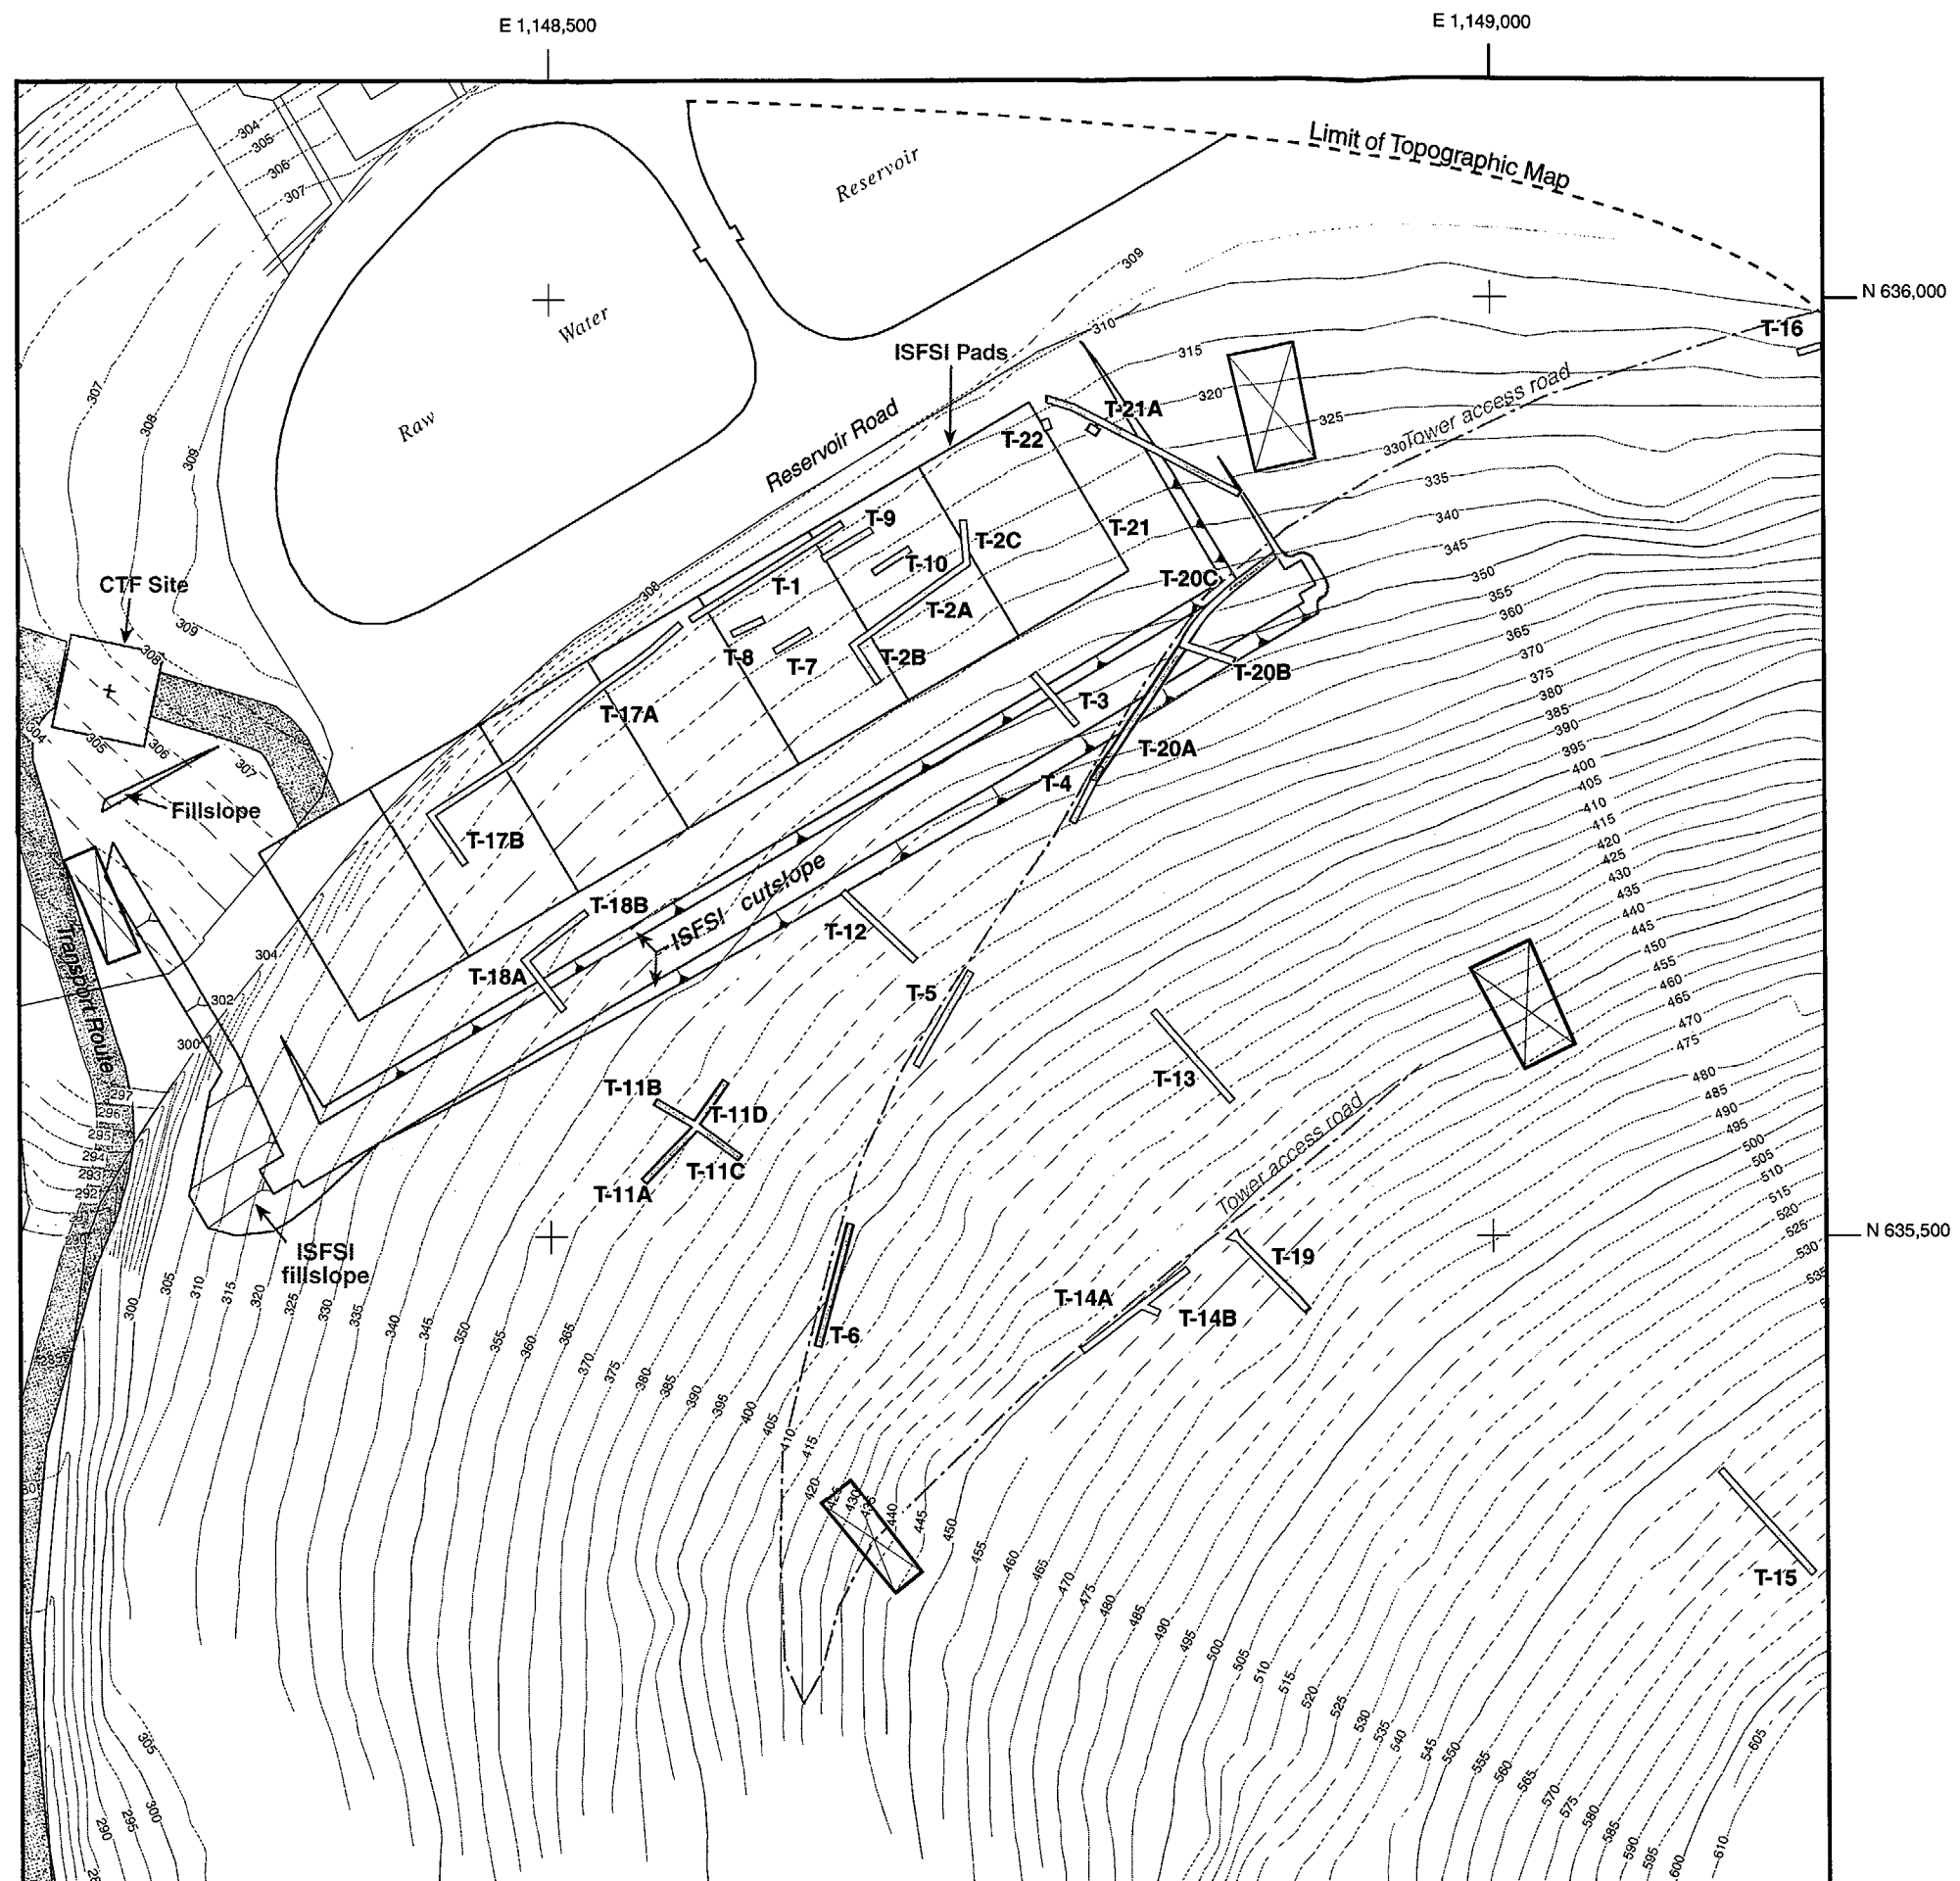
**FIGURE D-1**  
**LOCATION OF EXPLORATION TRENCHES**

- Explanation**
- T-3 Exploratory trench, number indicated
  - Footprint of 500 kV tower
  - Outline of ISFSI Pads
  - Cutslope above, and fill prism west of, ISFSI pads

Five minor bedrock faults were encountered in trenches along the northern (downhill) margin of the site (e.g., trenches T-1, T-17). The faults strike west-northwest, are steeply dipping to vertical, and juxtapose rocks of different lithologies (Figure D-1). The sense of vertical separation generally is down to the northeast. Slickensides generally are subhorizontal. Combined, the sense of vertical separation and slickensides data indicate primarily right lateral strike slip on the minor faults.

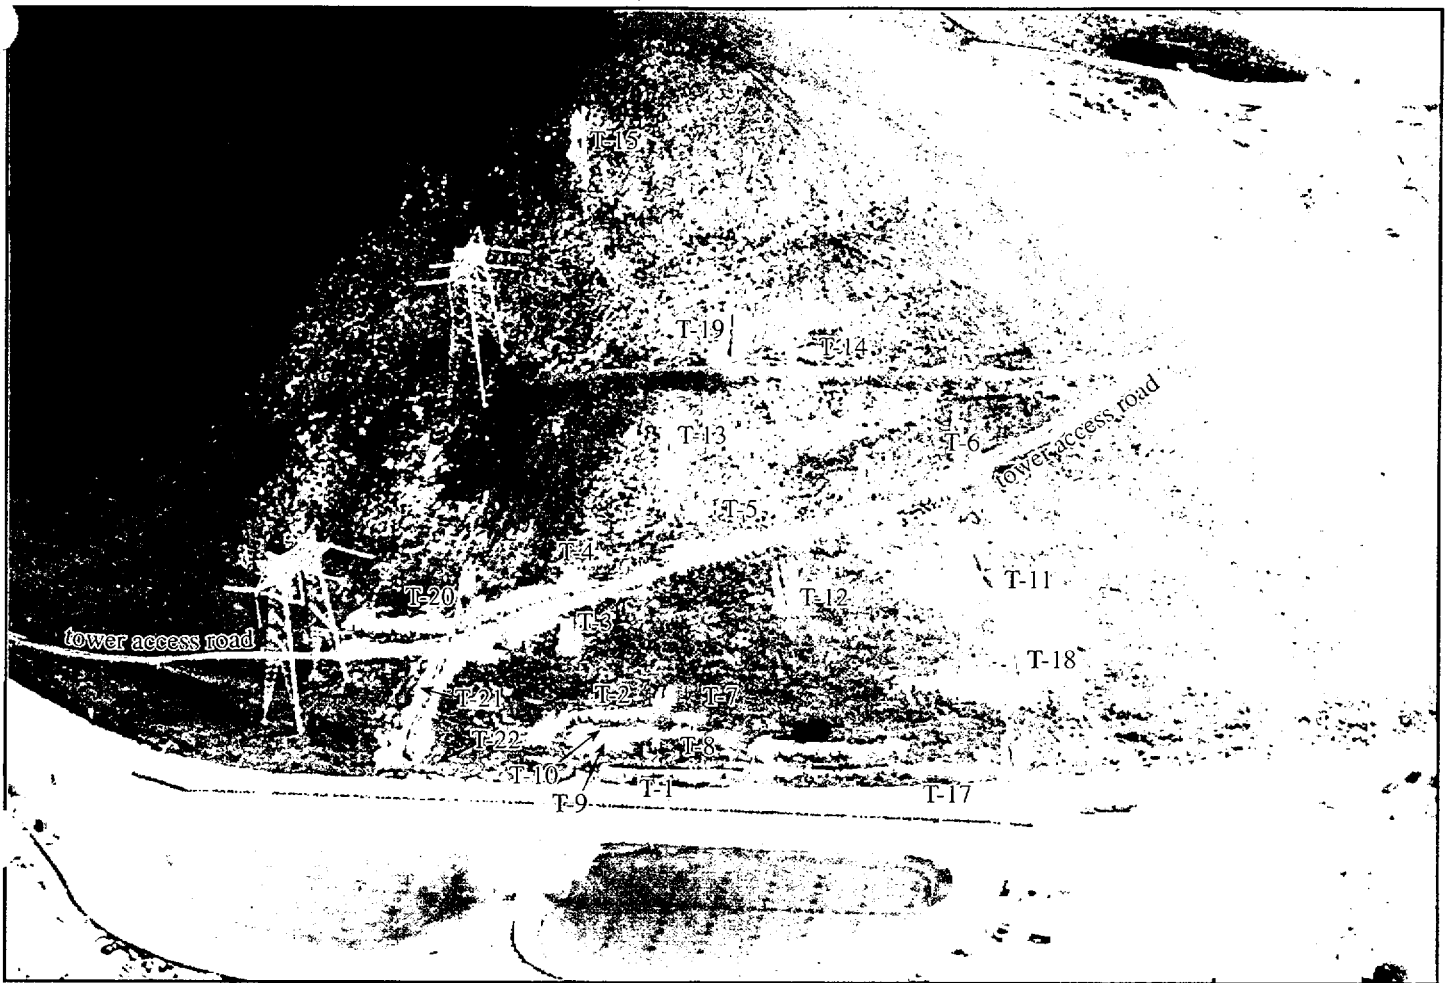
**FIGURE D-2  
SOUTHWARD VIEW OF ISFSI STUDY AREA**

Southward view of ISFSI study area in center of photo above raw water reservoir. Outcrops of dolomite mark the borrow area cutslope. Trenches excavated for the ISFSI Site investigation are shown. Trench T-16 is located to the left and off of the photo. Photo obtained prior to excavation of T-22 at approximate location marked on photo.

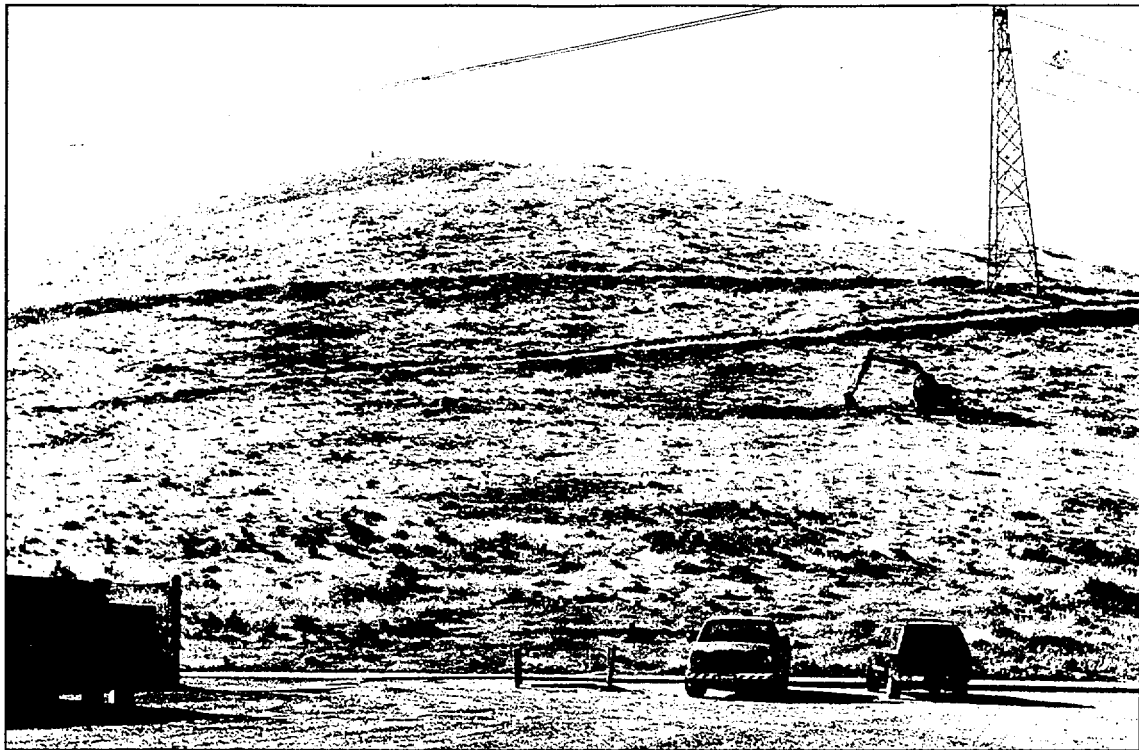
### FIGURE D-3 EXCAVATION OF TRENCH T-11, VIEW TO SOUTH

Excavation of trench T-11, view to the south.

Trenches were excavated with a rubber-tire backhoe or track-mounted excavator (Figure D-3), depending on the competence of the rock encountered. Excavation was easy and rapid in zones of friable, weathered, or closely jointed rock. In more massive rock, excavation was moderately difficult to difficult, and some trenches could not be extended more than 6 inches to 2 feet before meeting refusal. Site geologists supervised the trench excavations, cleaned the trench sidewalls with picks, shovels, and brooms, and logged the exposures. The geologists were Jeff Bachhuber, Charles Brankman, John Helms, John Baldwin and Rich Koehler of William Lettis & Associates, Inc. (WLA). Sedimentary beds and fault contacts, including structural features, were flagged with nails and colored plastic survey tape. Logs of the trench exposures were prepared at scales ranging from 1:40 to 1:160 to document rock lithology, structure, and lithologic contacts and are included in this Data Report. Measurements of bedding, joint, and fault orientations were made with a Brunton compass. Discontinuity surveys were performed in selected trenches by extending a fiberglass survey tape across the trench floor or sidewall, and

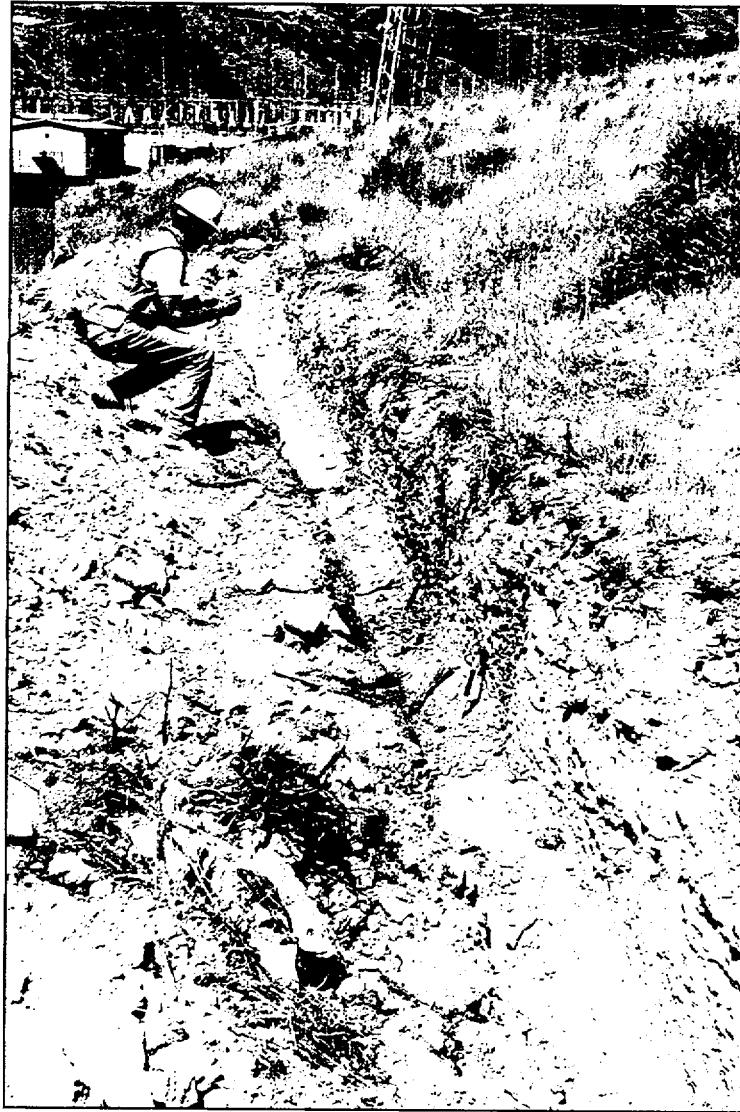
### FIGURE D-4 TRENCH T-1, VIEW TO NORTHEAST

Altered sandstone (blue-gray color) and dolomite (tan color at far end of trench) in trench T-1. Hammer and orange stake at top of trench across from geologist mark location of a small fault.

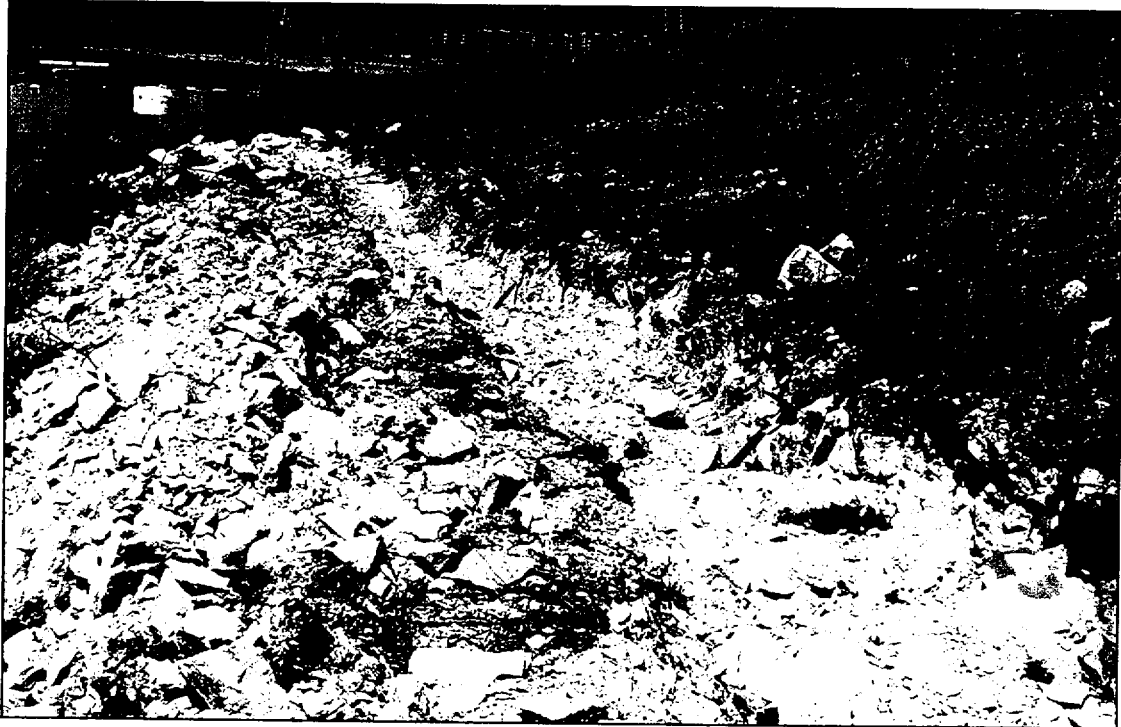
### FIGURE D-5 TRENCH T-2, VIEW TO NORTHEAST

Typical blocky dolomite exposed in trench T-2.

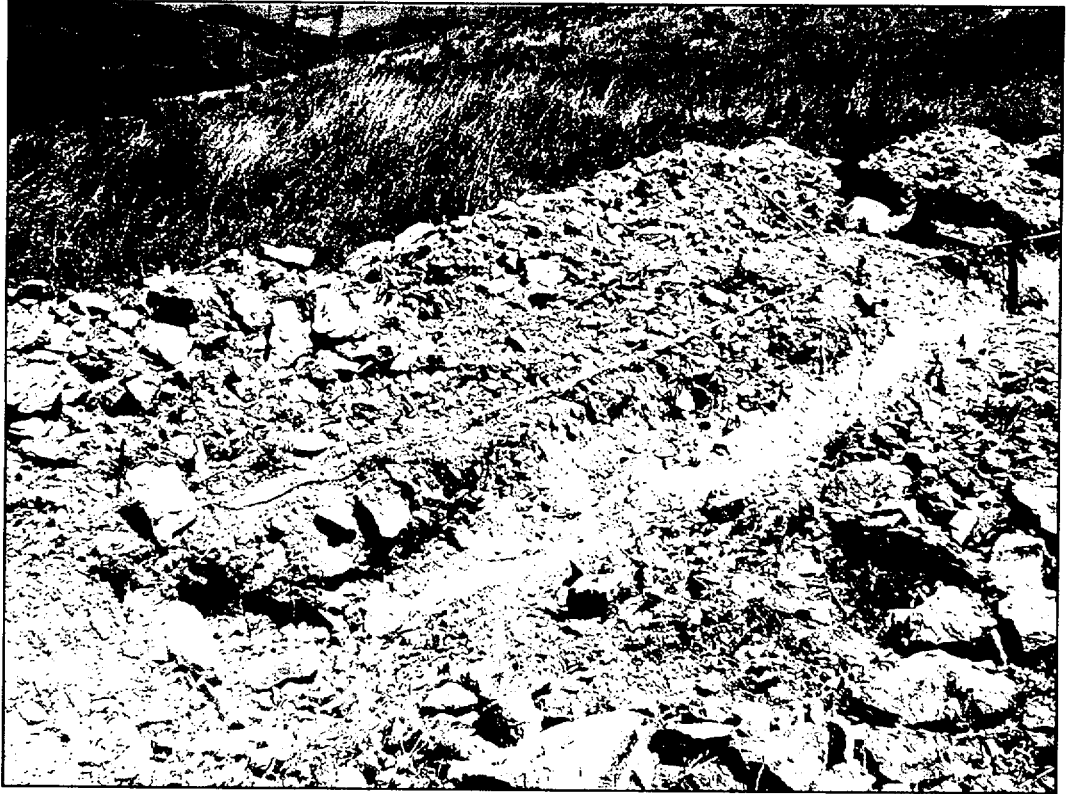
**FIGURE D-6  
TRENCH T-3, VIEW TO THE NORTHEAST**

Typical blocky dolomite in trench T-3. Excavator could not rip hard rock in trench bottom, and met practical refusal.

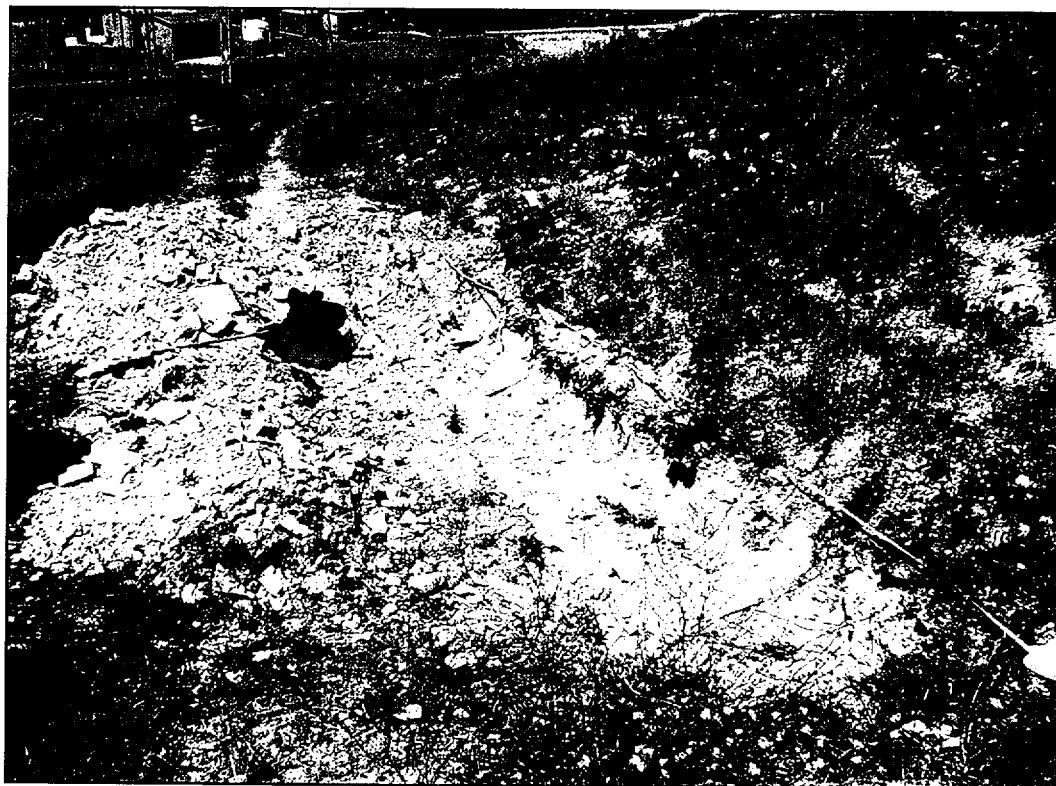
### FIGURE D-7 TRENCH T-4, VIEW TO THE NORTHEAST

Blocky dolomite in trench T-4 along tower across road.

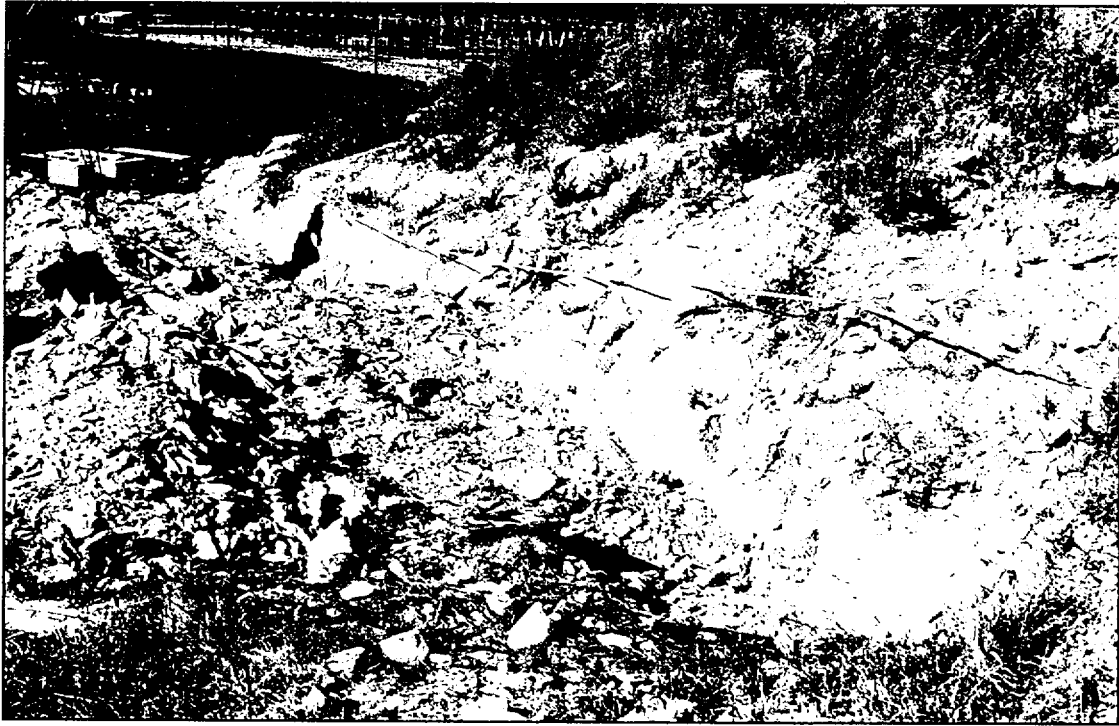
### FIGURE D-8 TRENCH T-5, VIEW TO NORTH

Blocky to massive dolomite in trench T-5.

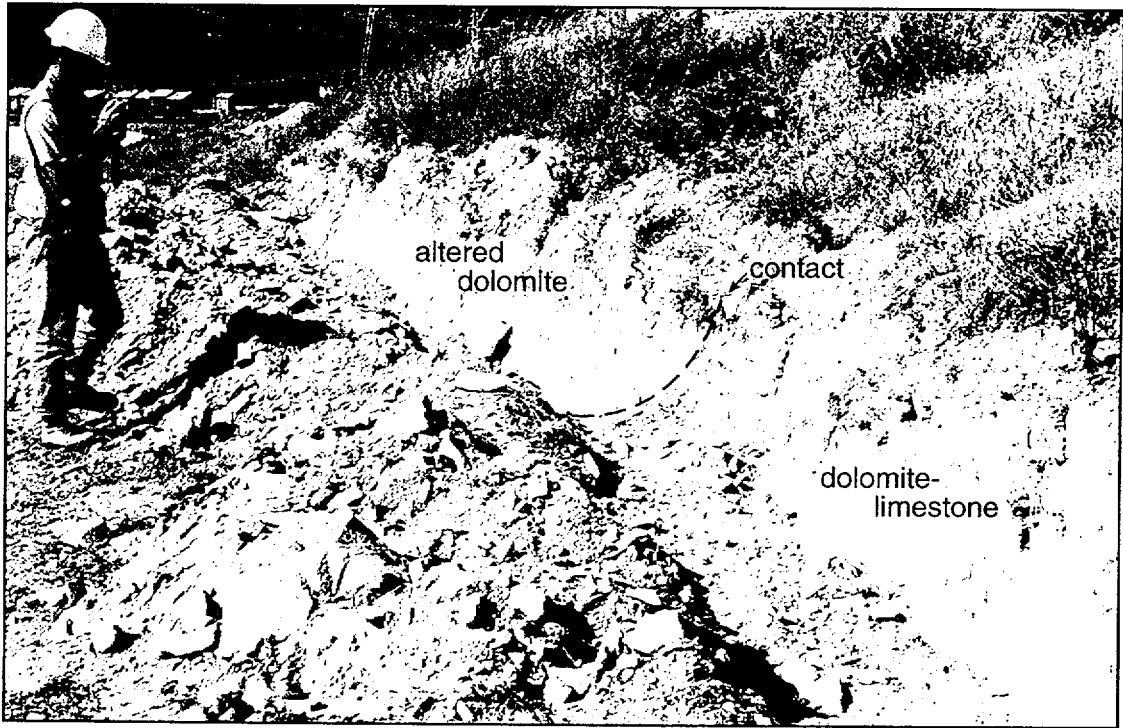
**FIGURE D-9**  
**TRENCH T-6, VIEW TO THE NORTH**

Massive altered dolomite and blocky dolomite-limestone in trench T-6.

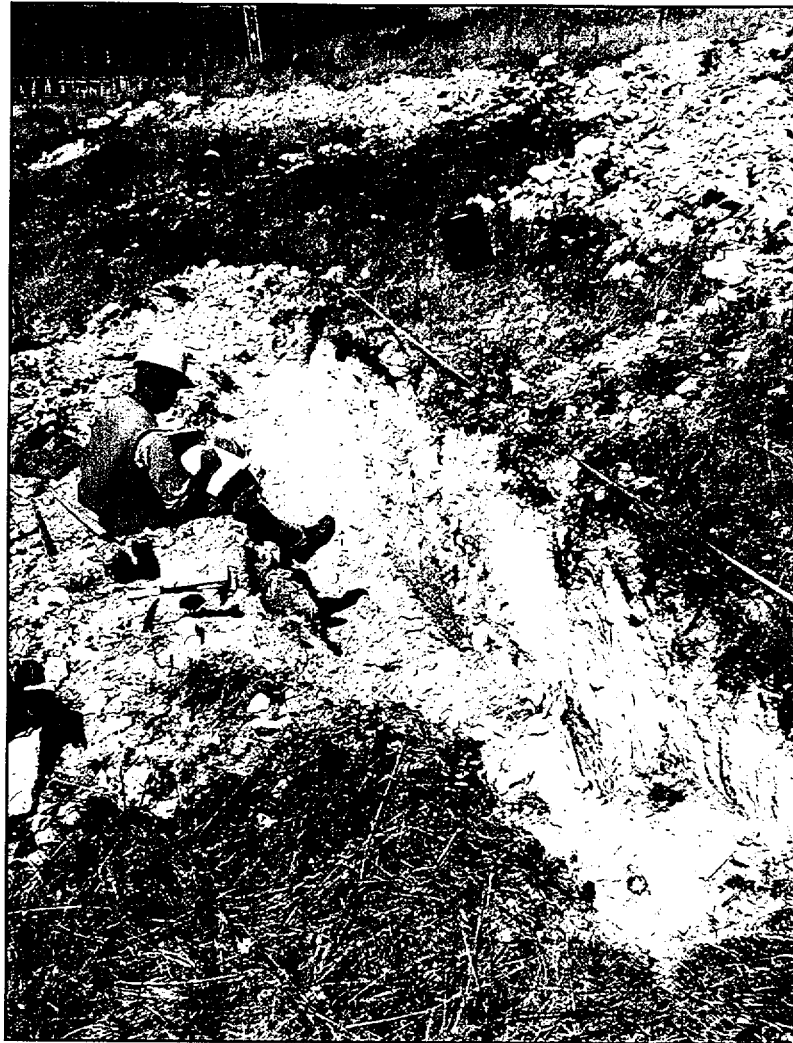
**FIGURE D-10**  
**TRENCH T-7, VIEW TO THE NORTHEAST**

Blocky dolomite (tan) and altered sandstone (blue-gray) in trench T-7.  
Several small secondary faults are marked by red survey flagging.

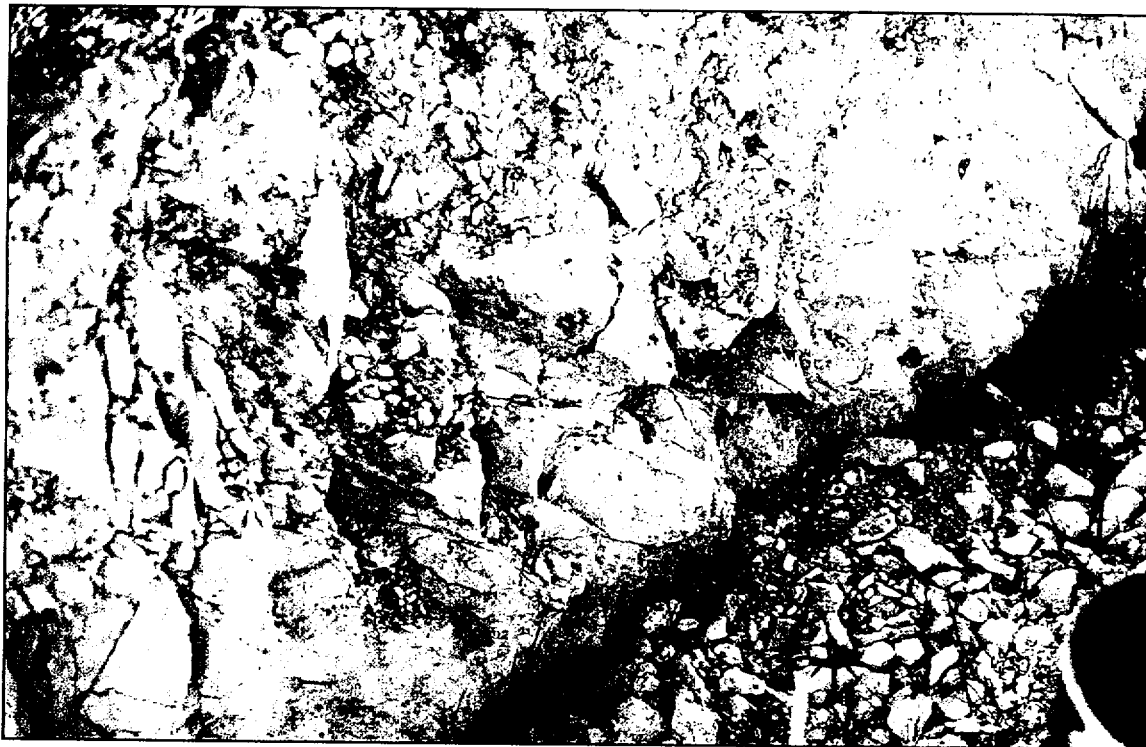
<b>DIABLO CANYON ISFSI</b>
<b>FIGURE D-12 TRENCH T-9</b>

Sandstone in trench T-9.

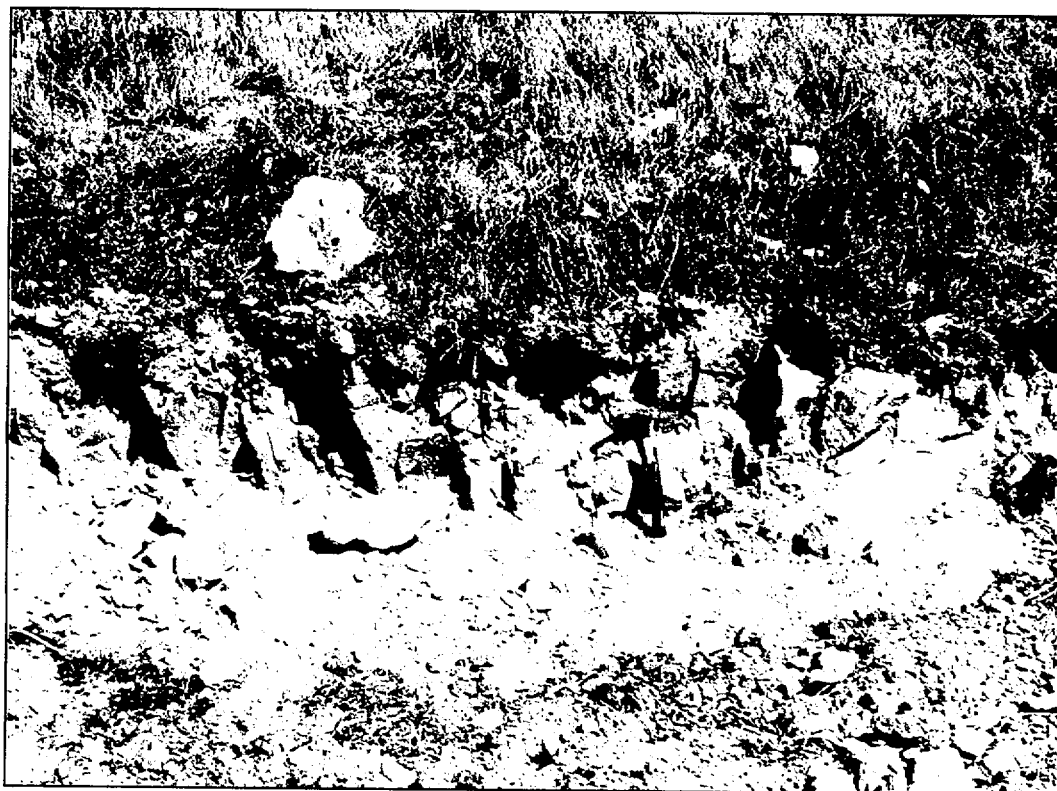
**FIGURE D-13**  
**TRENCH T-10, VIEW TO THE SOUTHEAST**

Blocky dolomite in trench T-10.

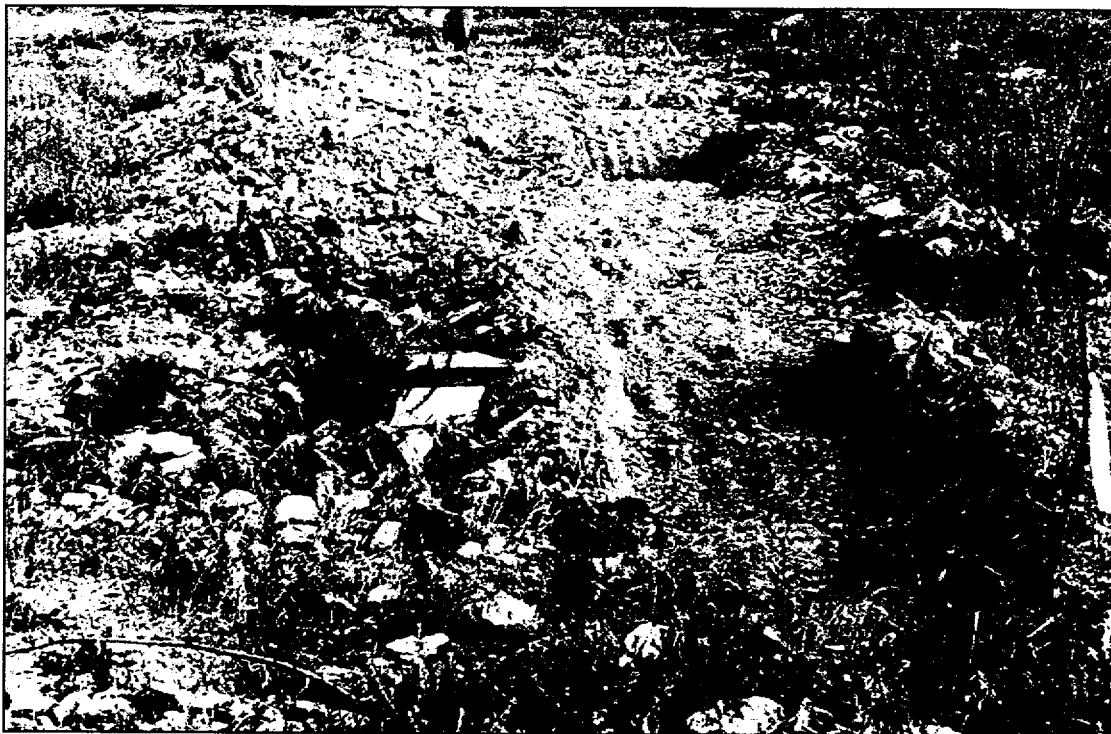
**FIGURE D-16**  
**TRENCH T-13, VIEW TO NORTHWEST**

Massive to blocky dolomite in trench T-13. Hard rock beds could not be ripped by excavator, limiting depth of trench.

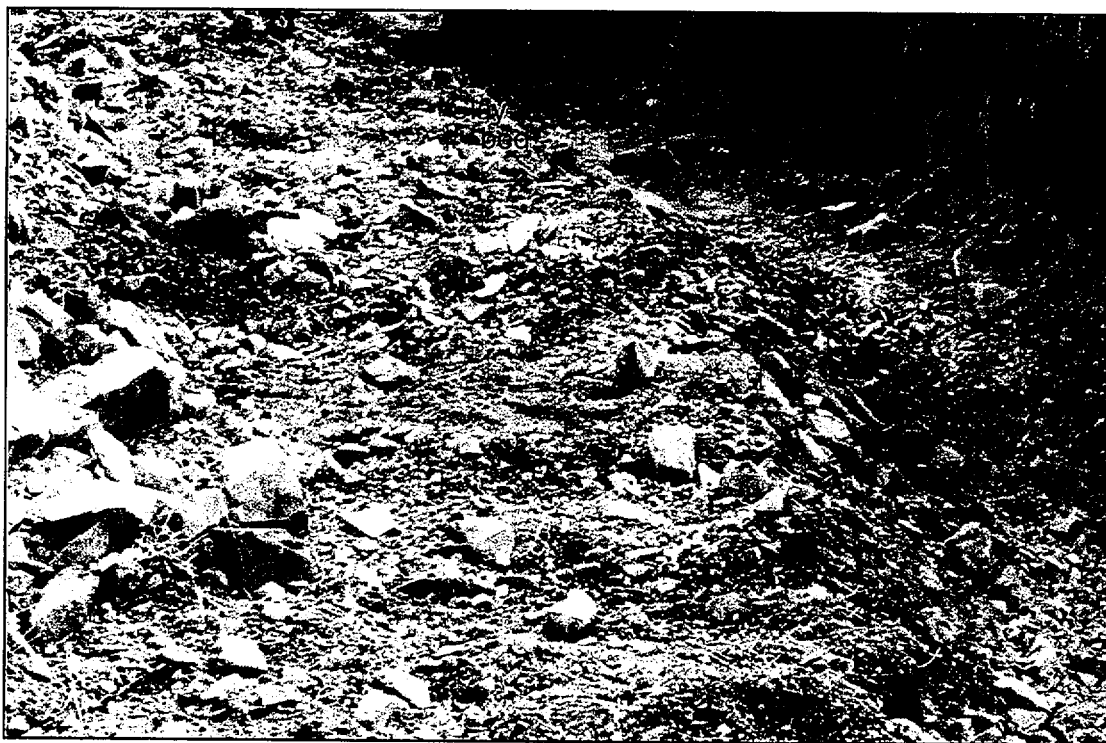
FIGURE D-17  
TRENCH T-14, VIEW TO NORTHEAST

Blocky dolomite and clay bed in trench T-14.

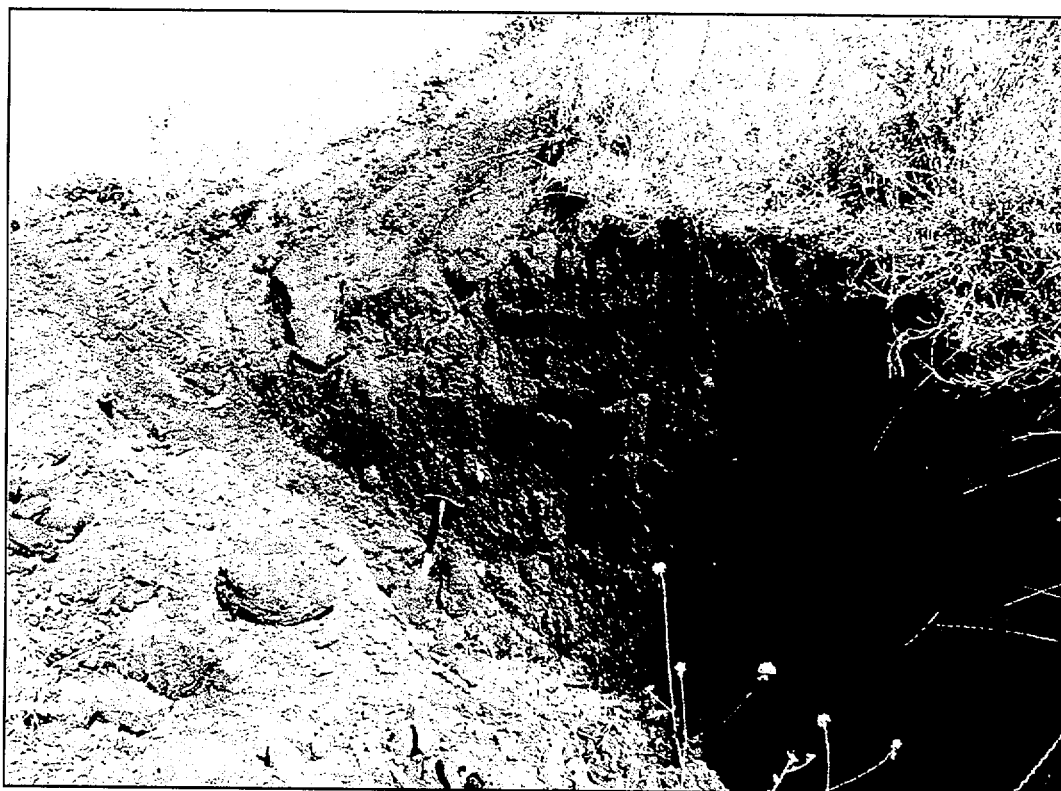
### FIGURE D-19 TRENCH T-16, VIEW TO THE SOUTH

Thick clay colluvium in trench T-16.

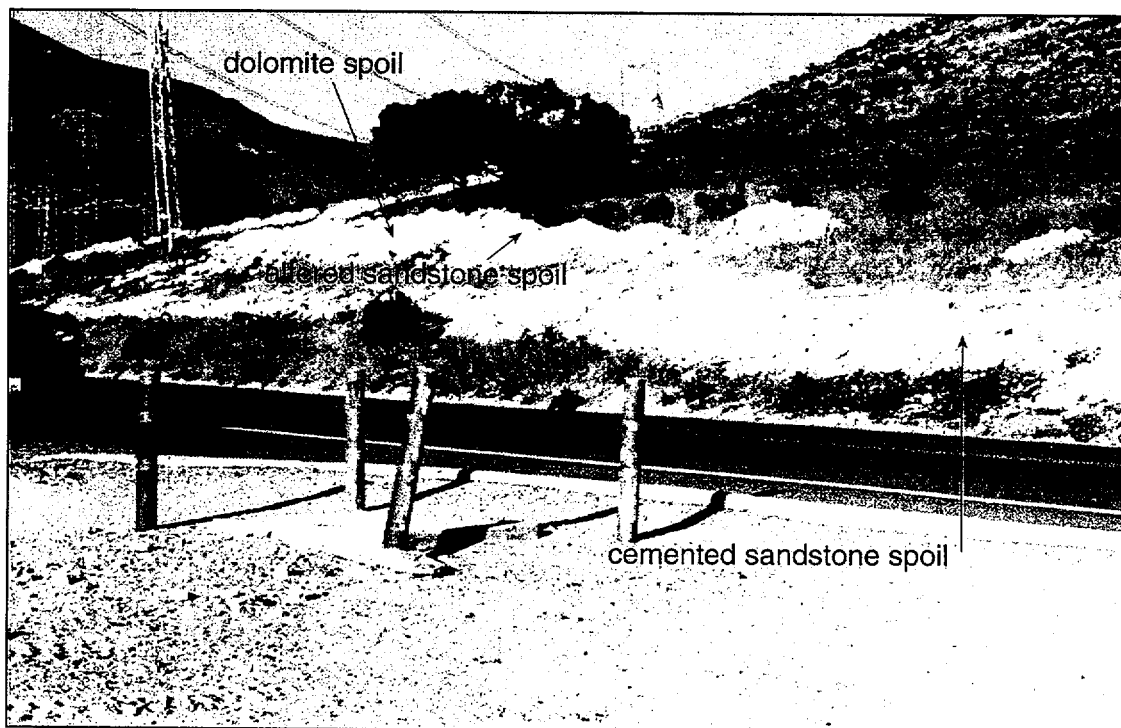
**FIGURE D-20**  
**TRENCH T-17 (FOREGROUND ALONG RESERVOIR**  
**ROAD) VIEW TO THE SOUTHEAST**

Distant view of trench T-17. Trench spoil piles show general locations of different rock types encountered at equivalent locations in the trench. Tan rock spoil along the right (near) part of the trench is derived from cemented sandstone. Blue-gray spoil in the middle and distant part of the trench is from altered sandstone. Tan spoil at the far end of the trench is from dolomite.

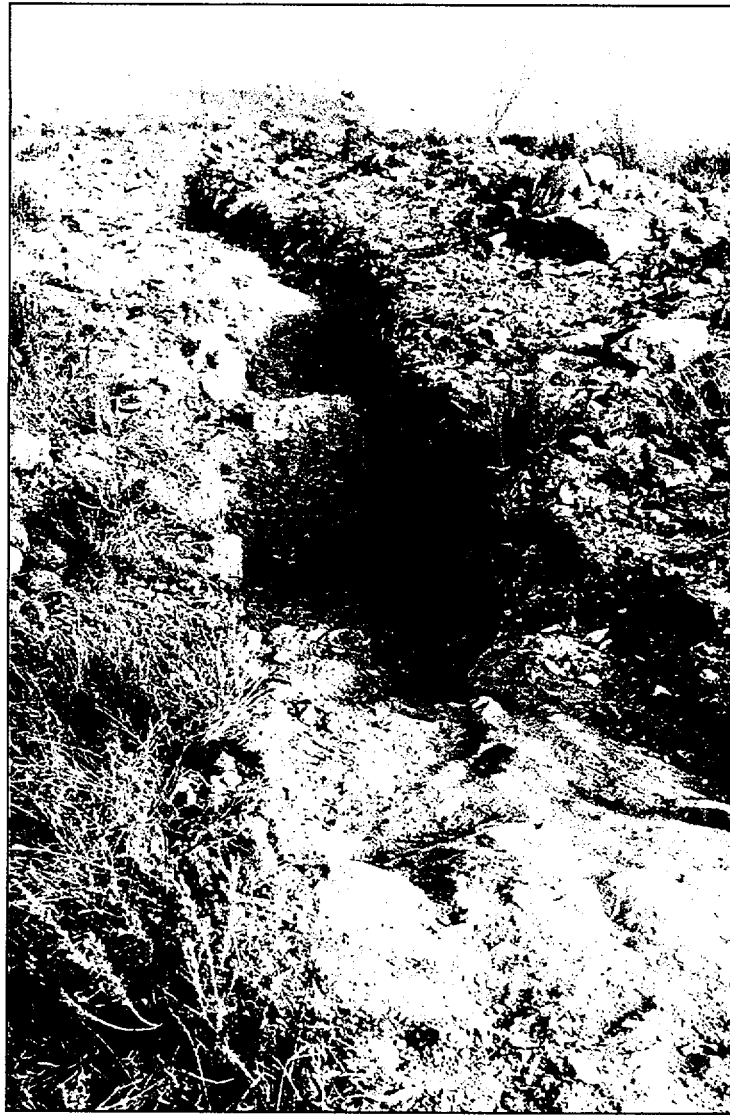
### FIGURE D-22 TRENCH T-19, VIEW TO NORTHWEST

Blocky to massive dolomite in trench T-19.

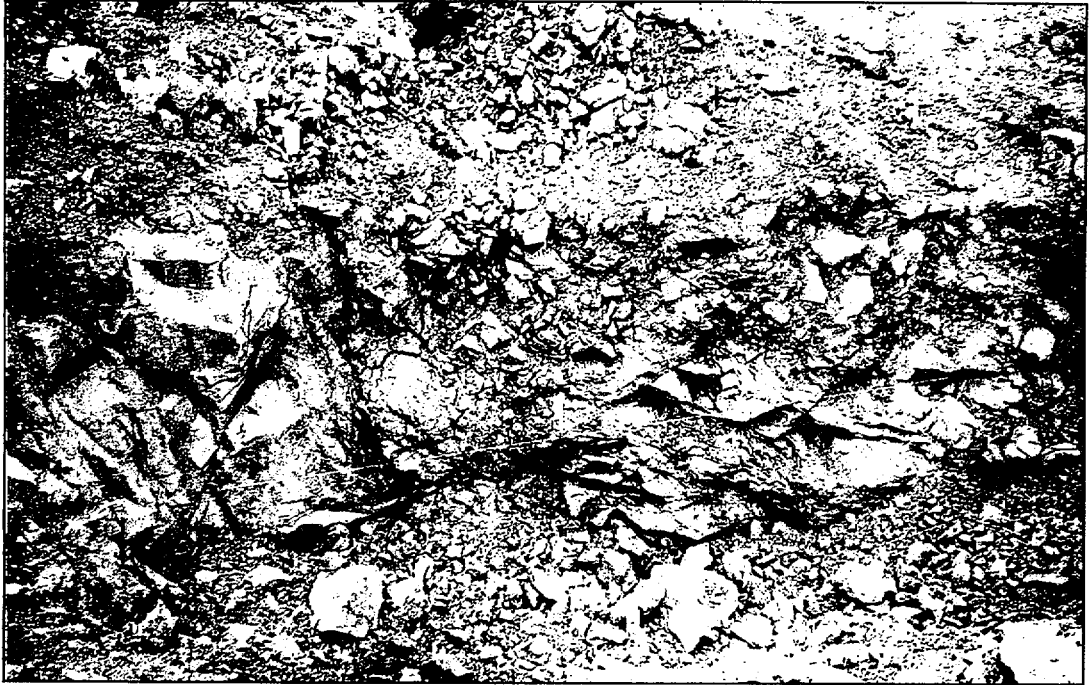
### FIGURE D-25 TRENCH T-22

Dolomite in trench T-22.

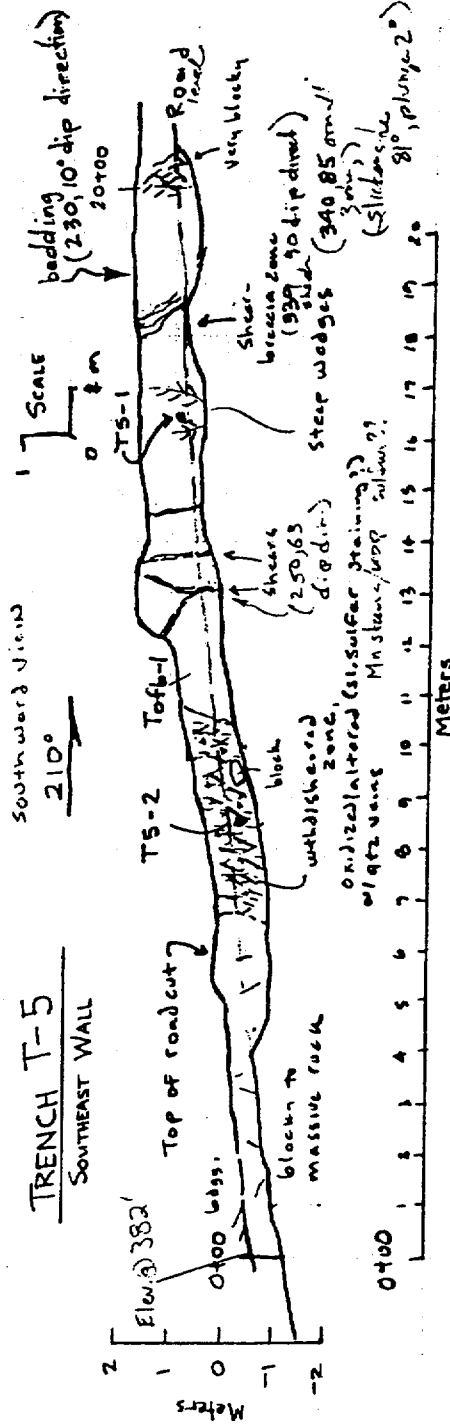
Trench 15FS1 T-5  
Tan dolomitic sandstone  
exposed throughout  
trench / road cut, (Tofb-1)  
Some zones of increased  
wtg. and faulting  
brecciation.  
Bedding laminations and  
surfaces.  
Bdg. is tightly-bounded  
w/ discontinuous beds plane  
Joints 0.25-0.5m long.  
Significant cohesion - bound  
along bedding surfaces
