SUBJECT: FORT CALHOUN STATION - MEETING TO DISCUSS CONTROL ELEMENT
DRIVE MECHANISM (CEDM) CRACKING ISSUES

Control Element Drive Mechanism Housing Reliability

A presentation to the NRC
by the Fort Calhoun
Station Staff

February 8, 2002,
Arlington, Texas

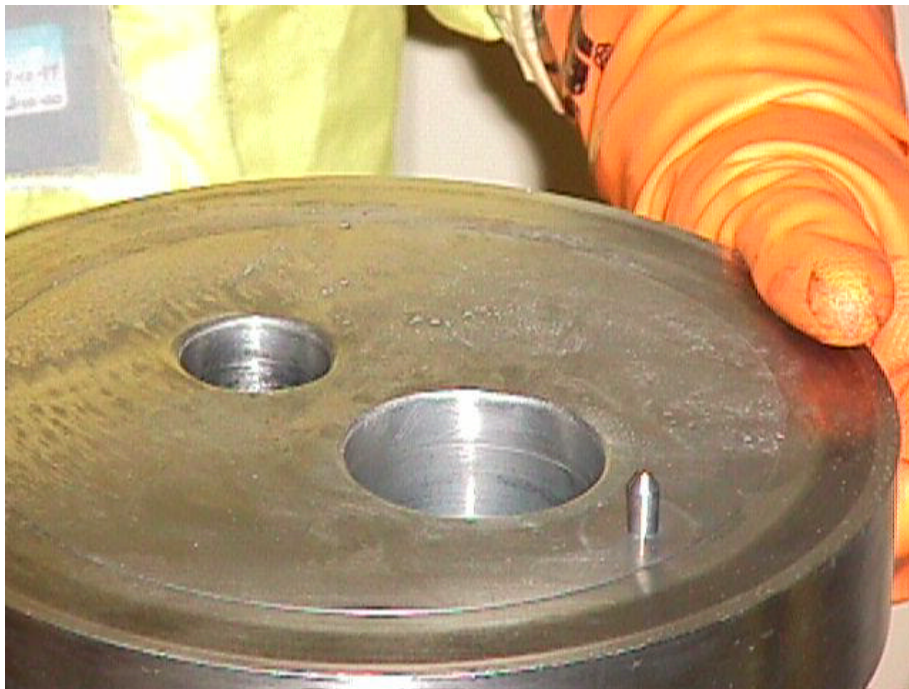
CEDM - Seal Housing Assembly

- Weld Induced Shrinkage
