South Texas Project Electric Generating Station P.O. Box 289 Wadsworth, Texas 77483

South Texas Project  
Units 1 & 2  
Docket Nos. STN 50-498, STN 50-499  
Responses to NRC Questions Regarding  
Bottom Mounted Instrumentation Penetration Indications

## Responses to NRC Questions

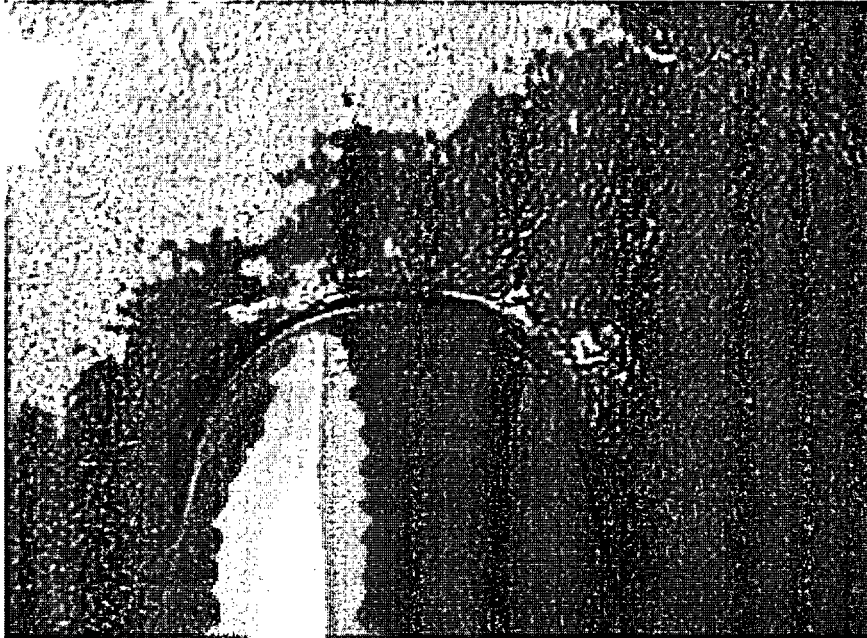
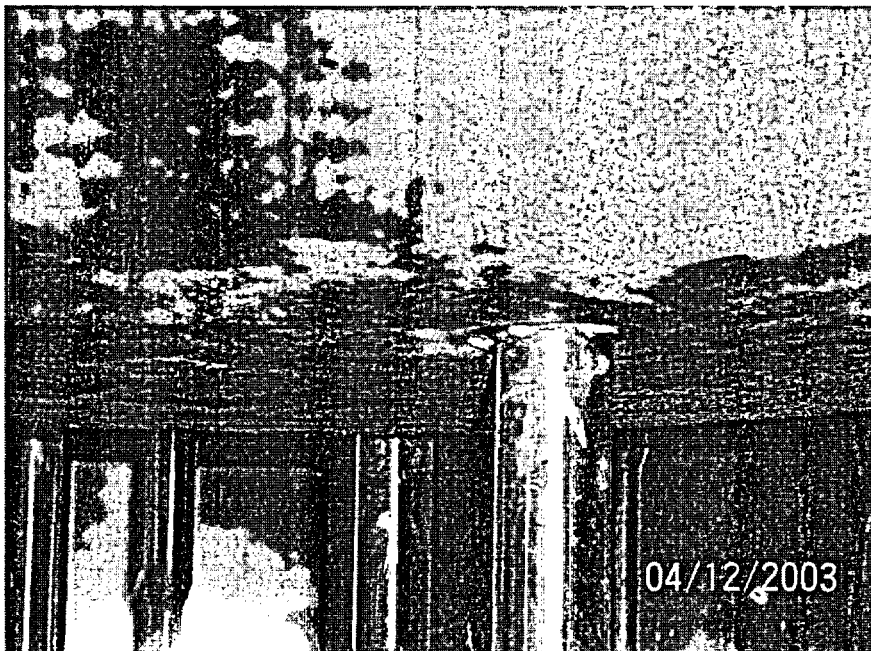
9. Please explain the apparent groove or gap in the photograph of Penetration 1.

There is no groove or gap. A closeup photo from a video taken after the residue was removed shows a better view of Penetration 1. The penetration openings are chamfered. This photograph shows that the chamfer is still clearly defined. A photograph of Penetration 1 prior to cleaning is provided for comparison.
