**TRANSMITTAL OF KEY TECHNICAL ISSUE (KTI) AGREEMENT ITEM PRECLOSURE
(PRE) 7.04**

TDR-EBS-ND-000007 REV 01

Weld Flaw Evaluation and Nondestructive Examination Process Comparison Results for High-Level Radioactive Waste Package Manufacturing Program

**Weld Flaw Evaluation and Nondestructive Examination Process Comparison Results for
High-Level Radioactive Waste Package Manufacturing Program**

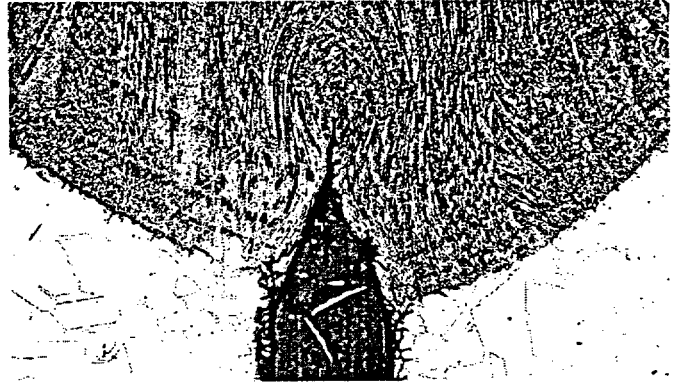
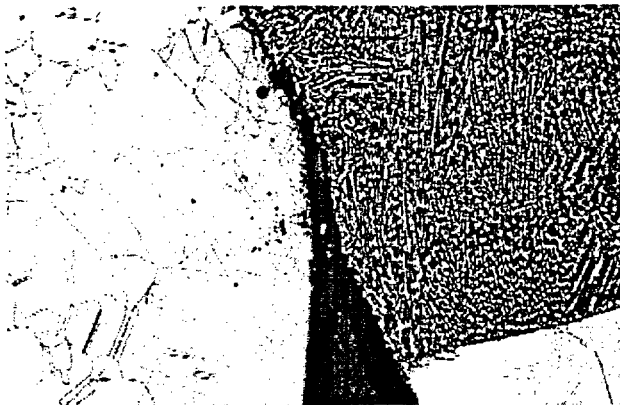
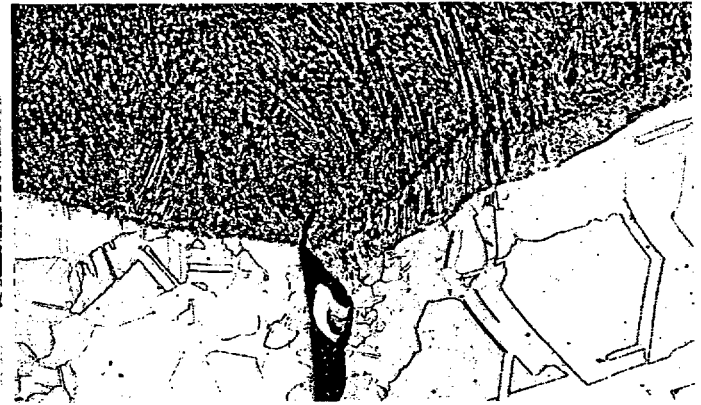
The examples in Figure 13 indicate the general condition of the root welds in this material during this test. The initial weld preparation gap design used by the contractor was too small (too tight) as described in Section 2.2.3.1. As a result, the walls of the nickel-based material "sucked back" during the early layers of the welding process. This prevented a quality weld from being produced. Subsequently, the weld preparation was modified to ensure that the weld could be successfully produced. This condition is not serious because welding with appropriate weld preparations is easily achieved. Current work will be evaluated to assure that proper root weld performance is achieved.

Root of Specimen K8 Magnification 95X

Root of Specimen K5 Magnification 95X

Root of Specimen L1 Magnification 95X

Root of Specimen M5 Magnification 95X

Root of Specimen M2 Magnification 95X

Root of Specimen N1 Magnification 95X

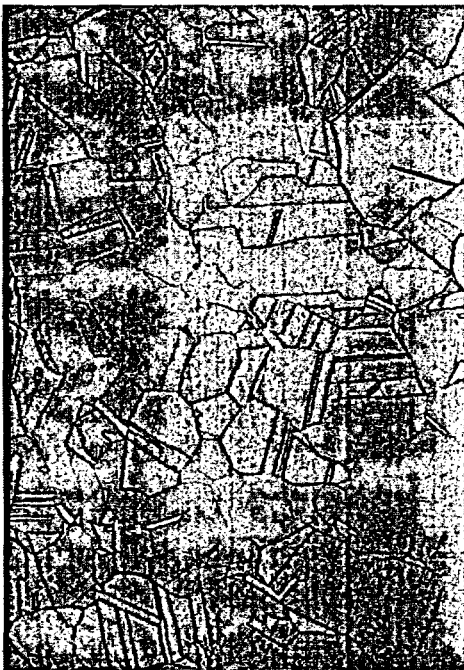
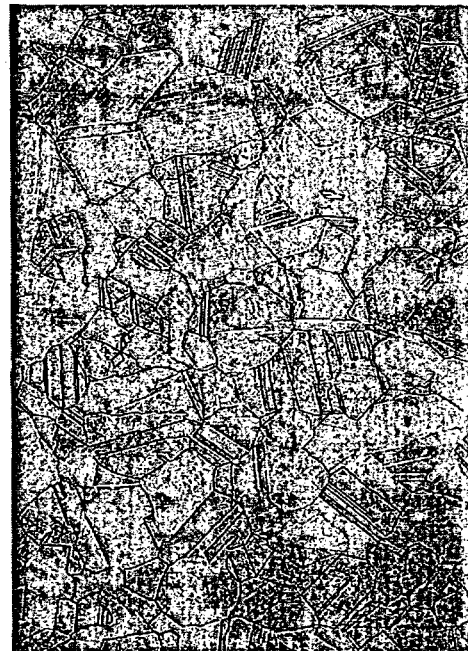
Figure 14. Base Metal Microstructures

As discussed previously, there were no flaws identified with NDE in the base material before or after forming, heat treatment, or welding; however, it is considered prudent to provide representative photomicrographs. The following represent the general microstructures. The microstructure of the base metal was typical equiaxial structures. Normal twins were present and no precipitation of other phases was observed. The following micrographs in Figure 14 are typical. It should be noted that all specimens were etched as indicated previously in this document. It should be noted that all the rings were solution heat treated prior to machining. The four micrographs presented in Figure 14 are a random selection of base metal microstructures and are only a few of several hundred produced during this test (Senior Flexonics Pathway 2002a, Appendices 10.1 through 10.16).

Specimen K7 Magnification 95X

Specimen O1 95X

Specimen Z1 380X

Specimen M4 380X
