Bottom Mounted Instrument Guide Tube Condition

April 12 - residue found
on two of the 58 Bottom
Mounted Instrumentation
(BMI) penetrations.

MEETING PARTICIPANTS
FOR
MEETING BETWEEN STPNOC AND NRC
ON MAY 1, 2003

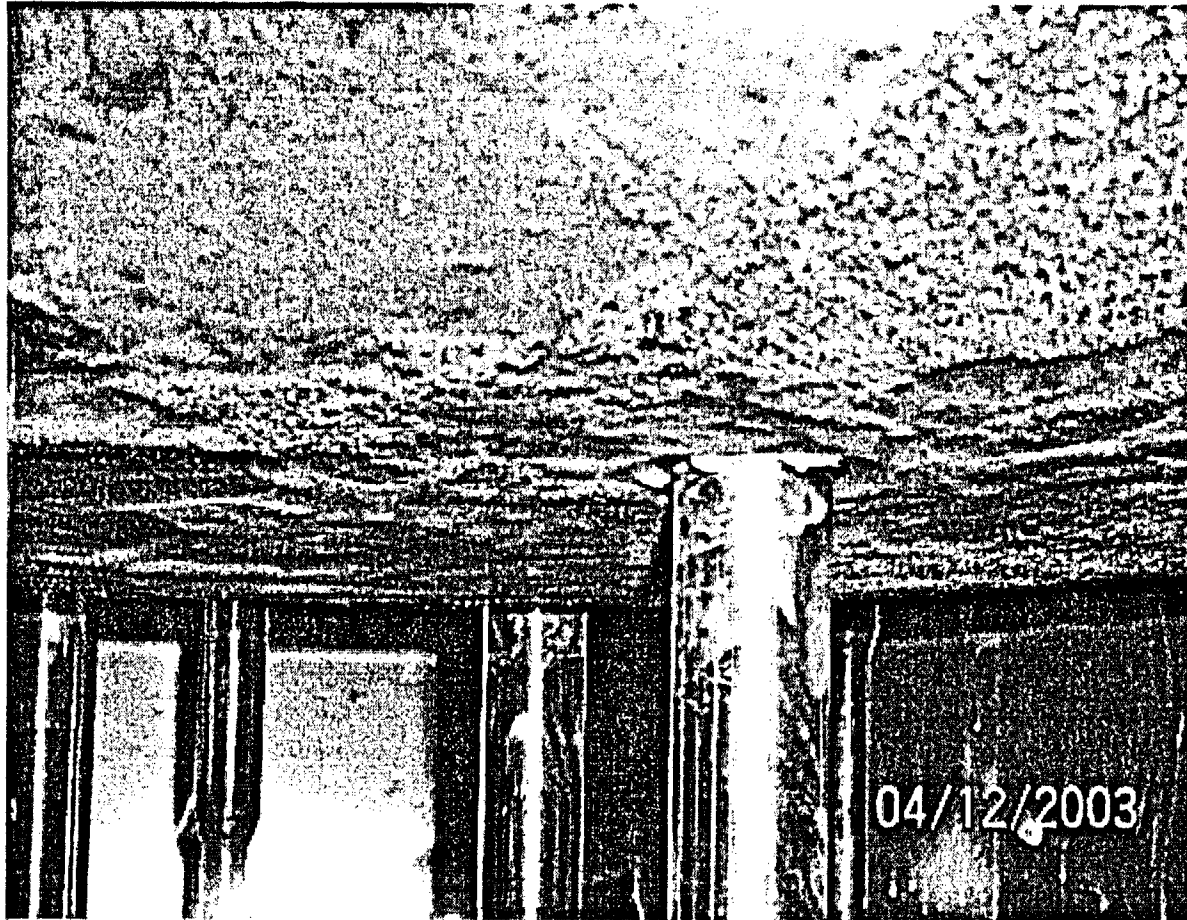
A small amount of residue had accumulated approximately 90 degrees around the guide tubes at vessel Penetrations #1 and #46.

The quantity of residue found on Penetration #1 is equivalent to about half of an aspirin (approximately 150 mg).
