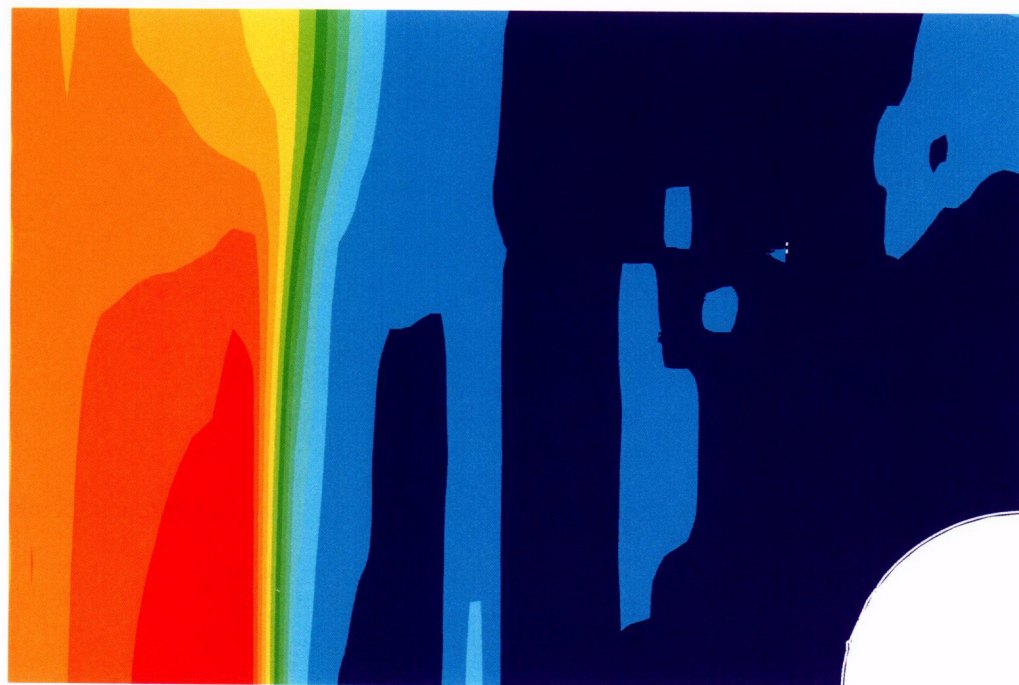
P = 3.5 Pd

P = 3.6 Pd

Figure 7-34. Liner Hoop Strains, Posttest Analysis Case D, at 3.5 Pd and 3.6 Pd
