Overpressurization Test of a 1:4-Scale Prestressed Concrete Containment Vessel Model

Sandia National Laboratories

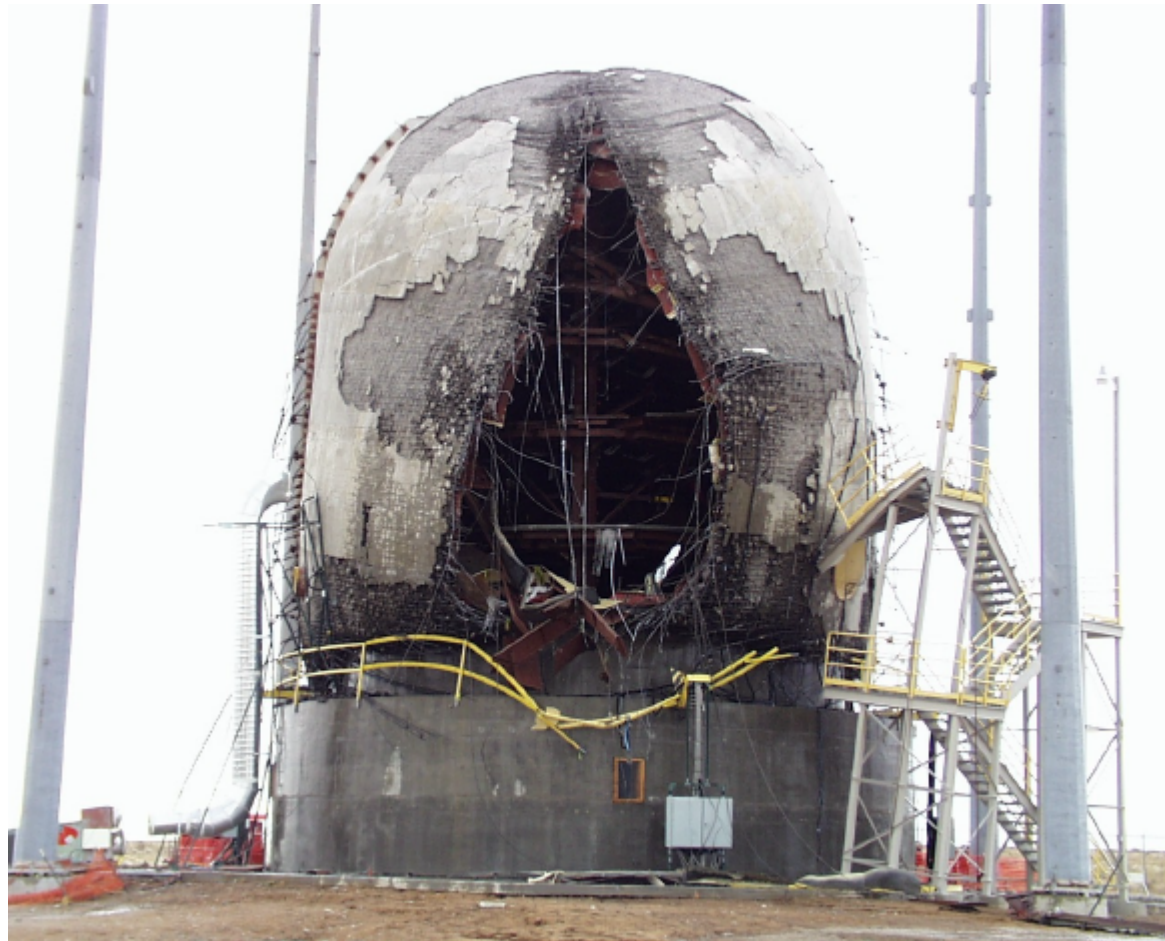
Figure 5.35 PCCV Model after the SFMT

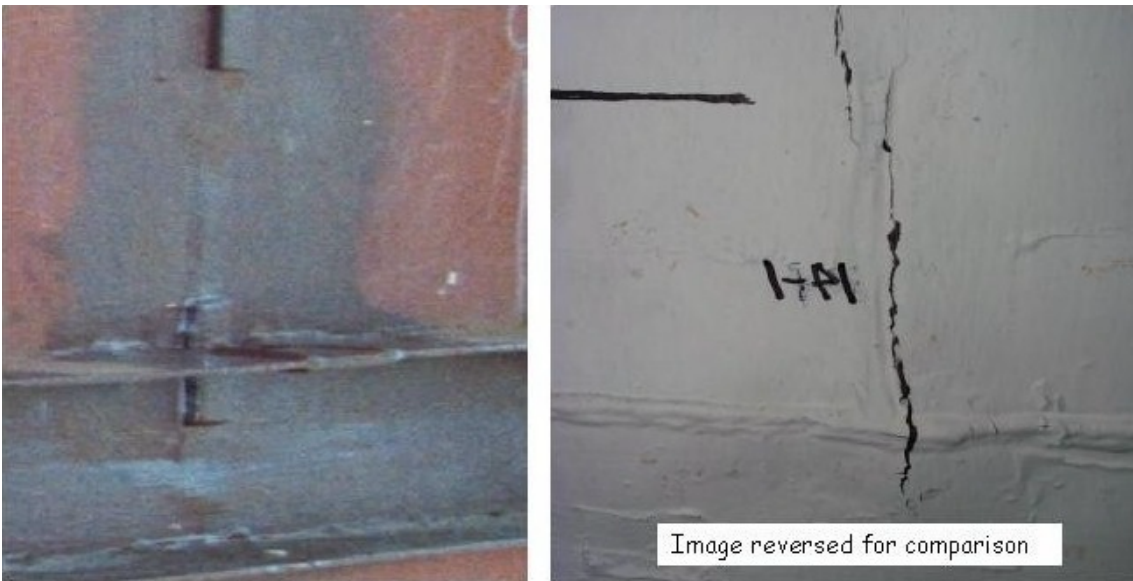
Figure 10. Photographs showing region of tear #14-1 from outside of liner (left) (prior to concrete placement) and inside of liner (right) (prior to removal of paint). Note missing segments of back-up bar in vicinity of repair weld and tear.

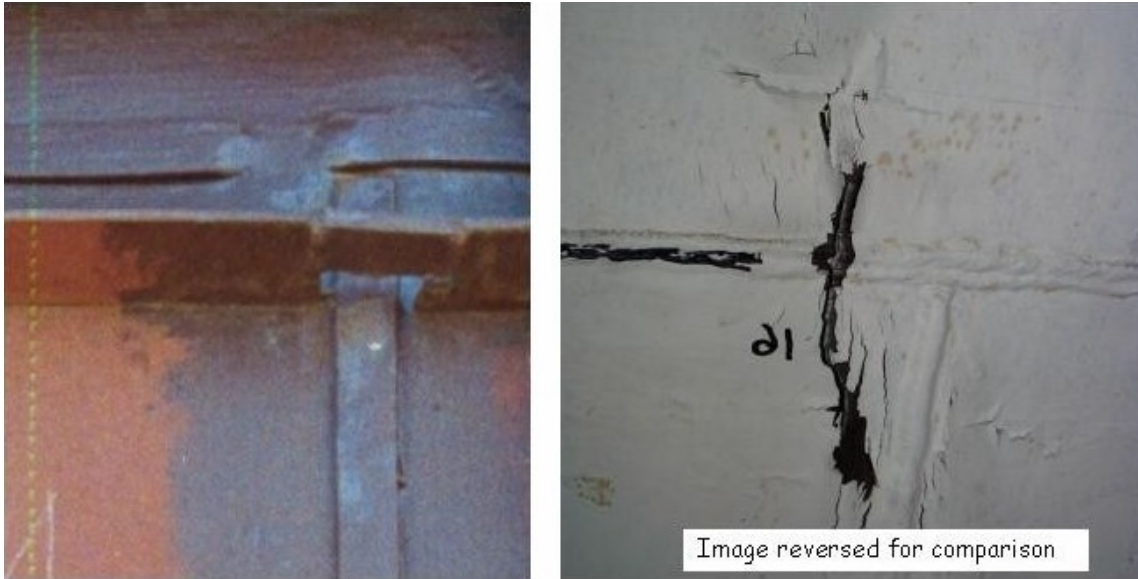
Figure 11. Photographs showing region of tear #16 from outside of liner (left) (prior to concrete placement) and inside of liner (right) (prior to removal of paint). Note missing segment of back-up bar on horizontal weld in vicinity tear.
