Overpressurization Test of a 1:4-Scale Prestressed Concrete Containment Vessel Model

Sandia National Laboratories

**U.S. Nuclear Regulatory Commission
Office of Nuclear Regulatory Research
Washington, DC 20555-0001**

**Nuclear Power Engineering Corporation
Tokyo 105, Japan**

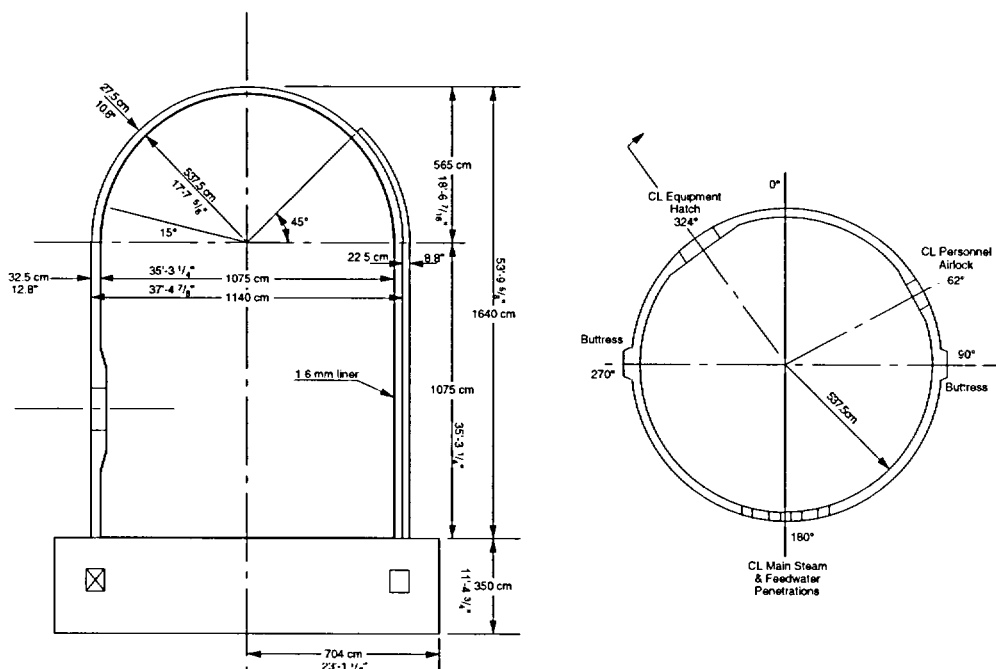
Figure 1.2 PCCV Model Elevation and Cross-Section

Details of the design and fabrication of the PCCV model are described in Chapters 2 and 3.

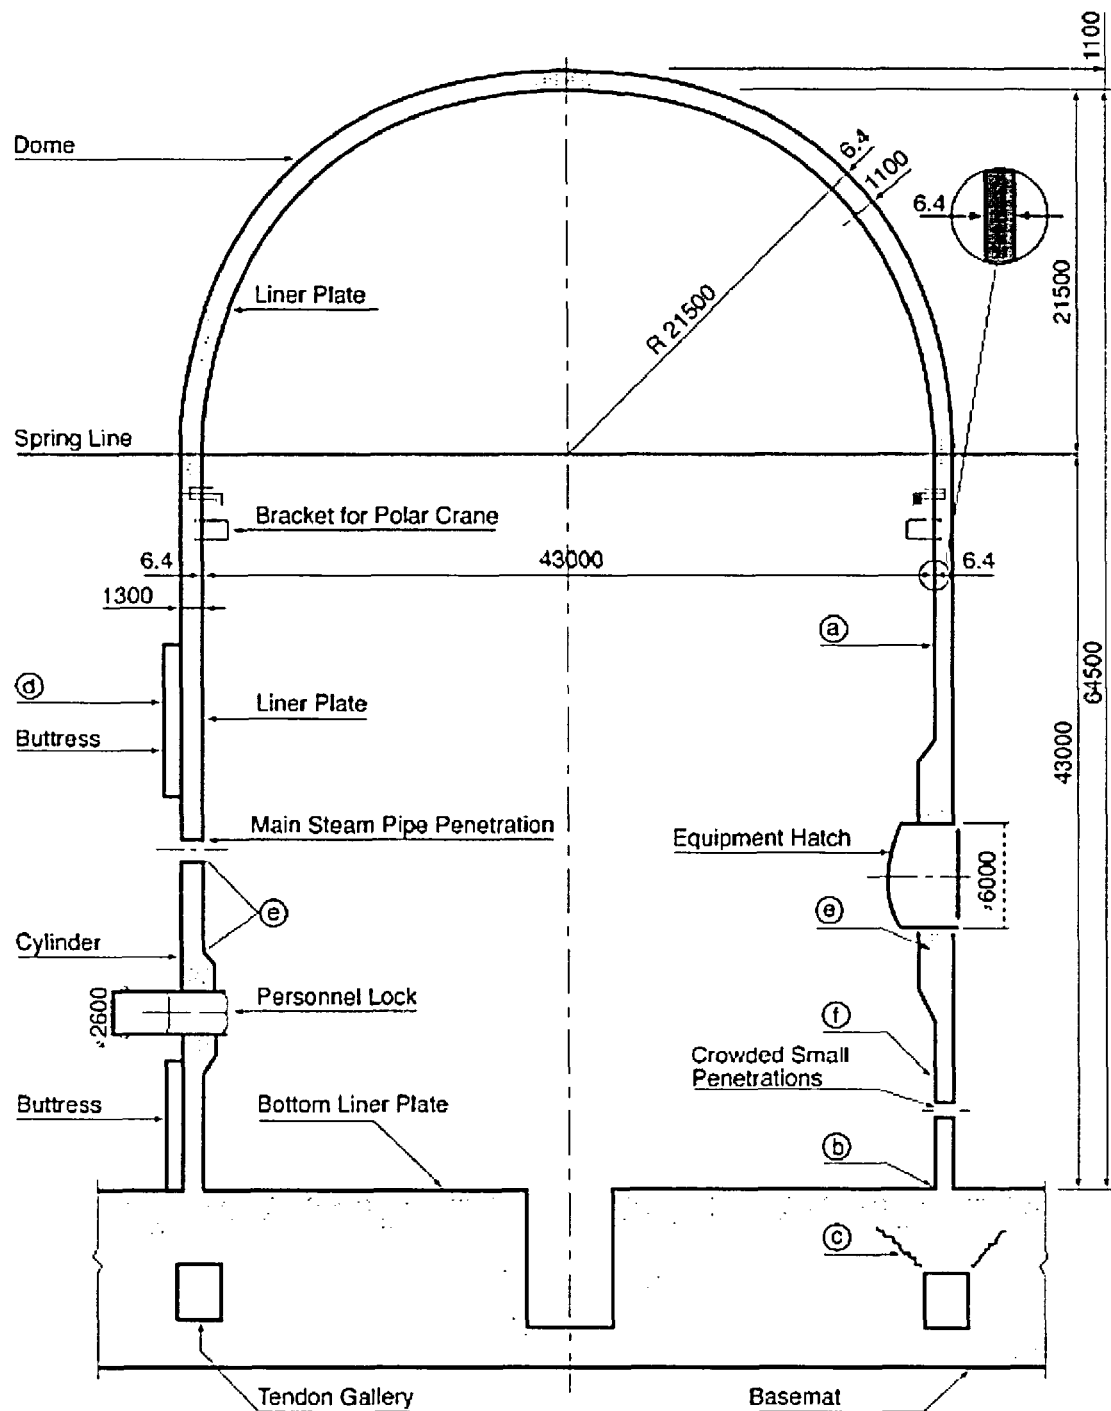
Figure 2.1. Elevation of PCCV Prototype and Potential Failure Locations

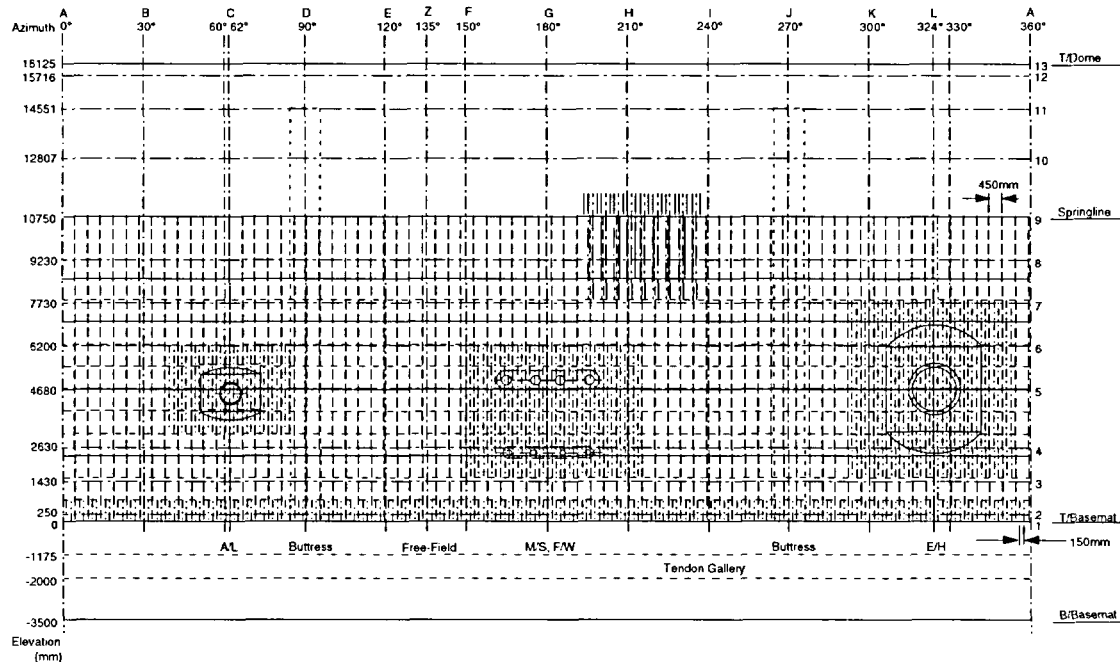
Figure 2.2 Liner Anchor Layout

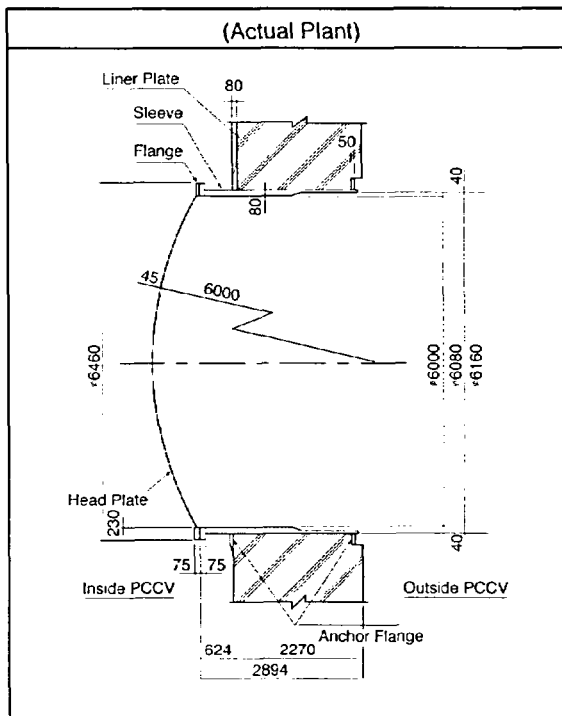
Figure 2.3 PCCV Prototype Equipment Hatch Arrangement

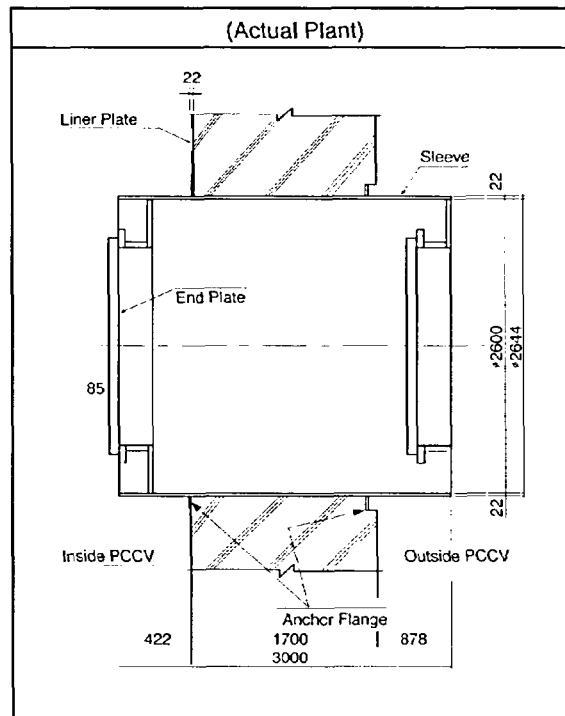
Figure 2.4 PCCV Prototype Personnel Airlock Arrangement

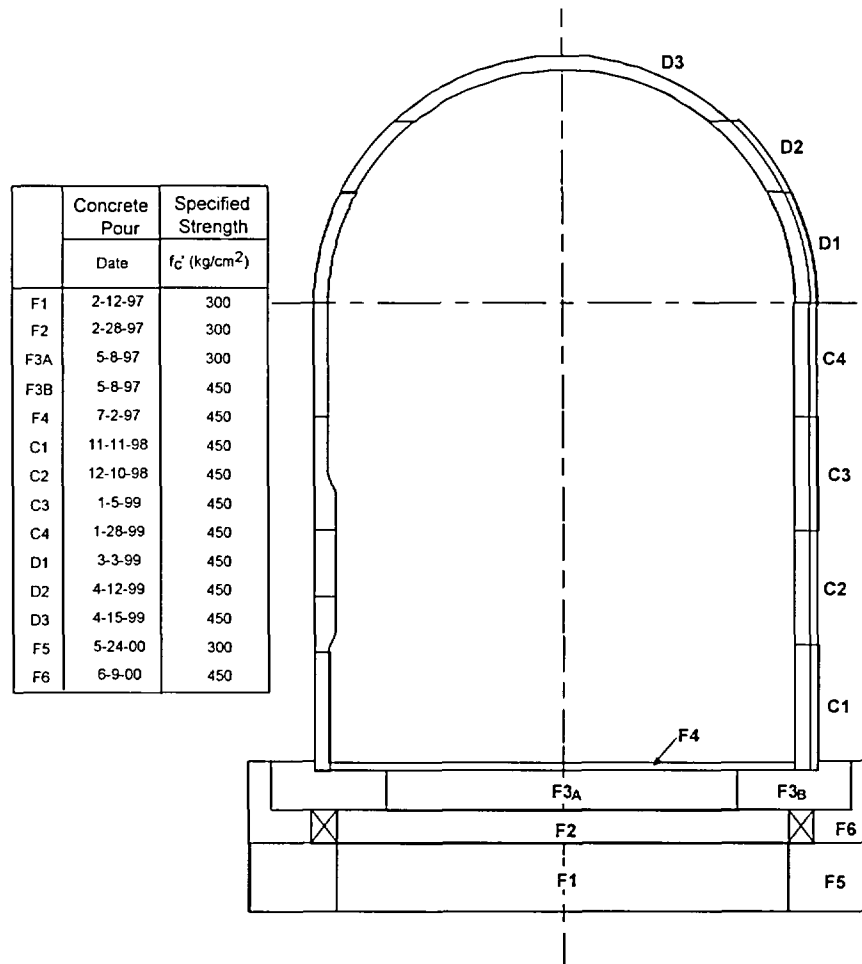
Figure 2.7 PCCV Concrete Lifts and Strengths

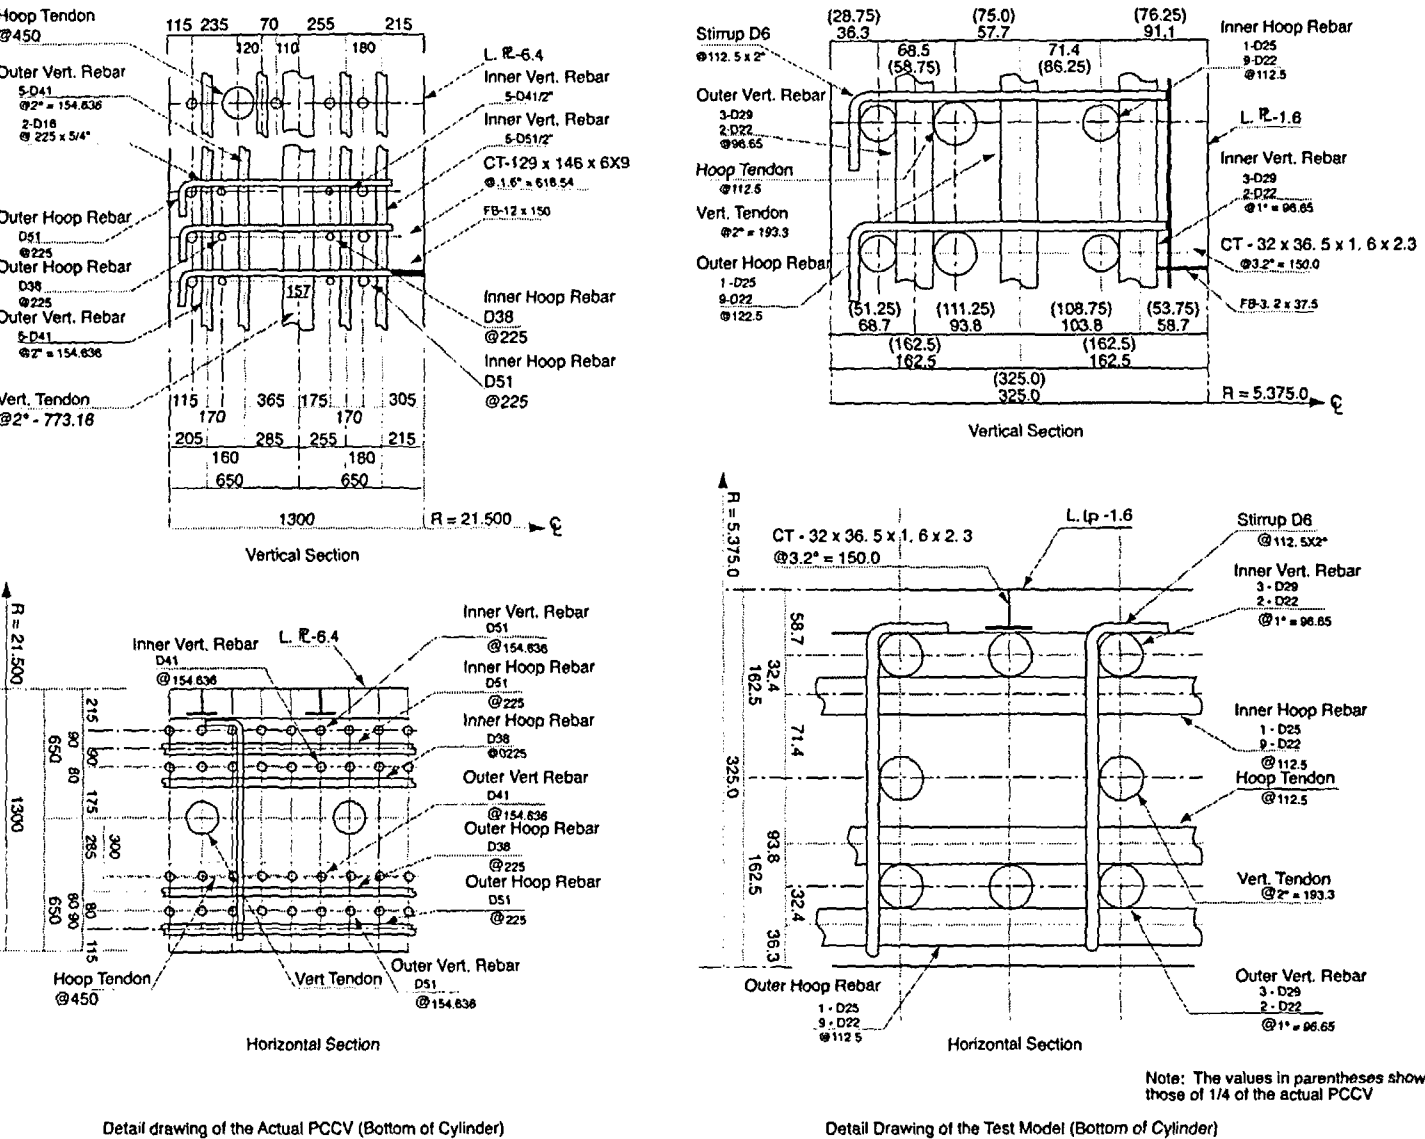
Figure 2.8 Arrangement of Reinforcing in the PCCV Prototype and Model at the Wall-Base Junction

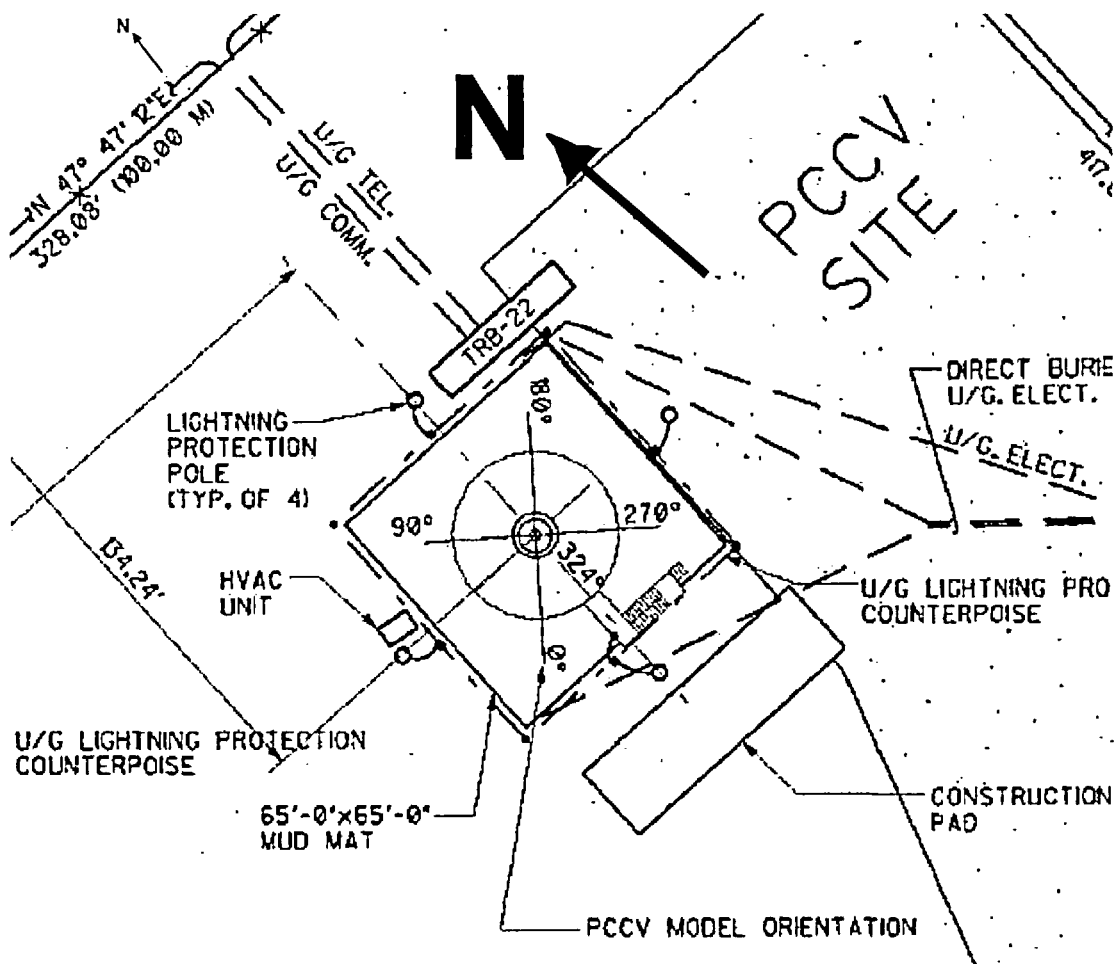
Figure 2.10 PCCV Model Layout

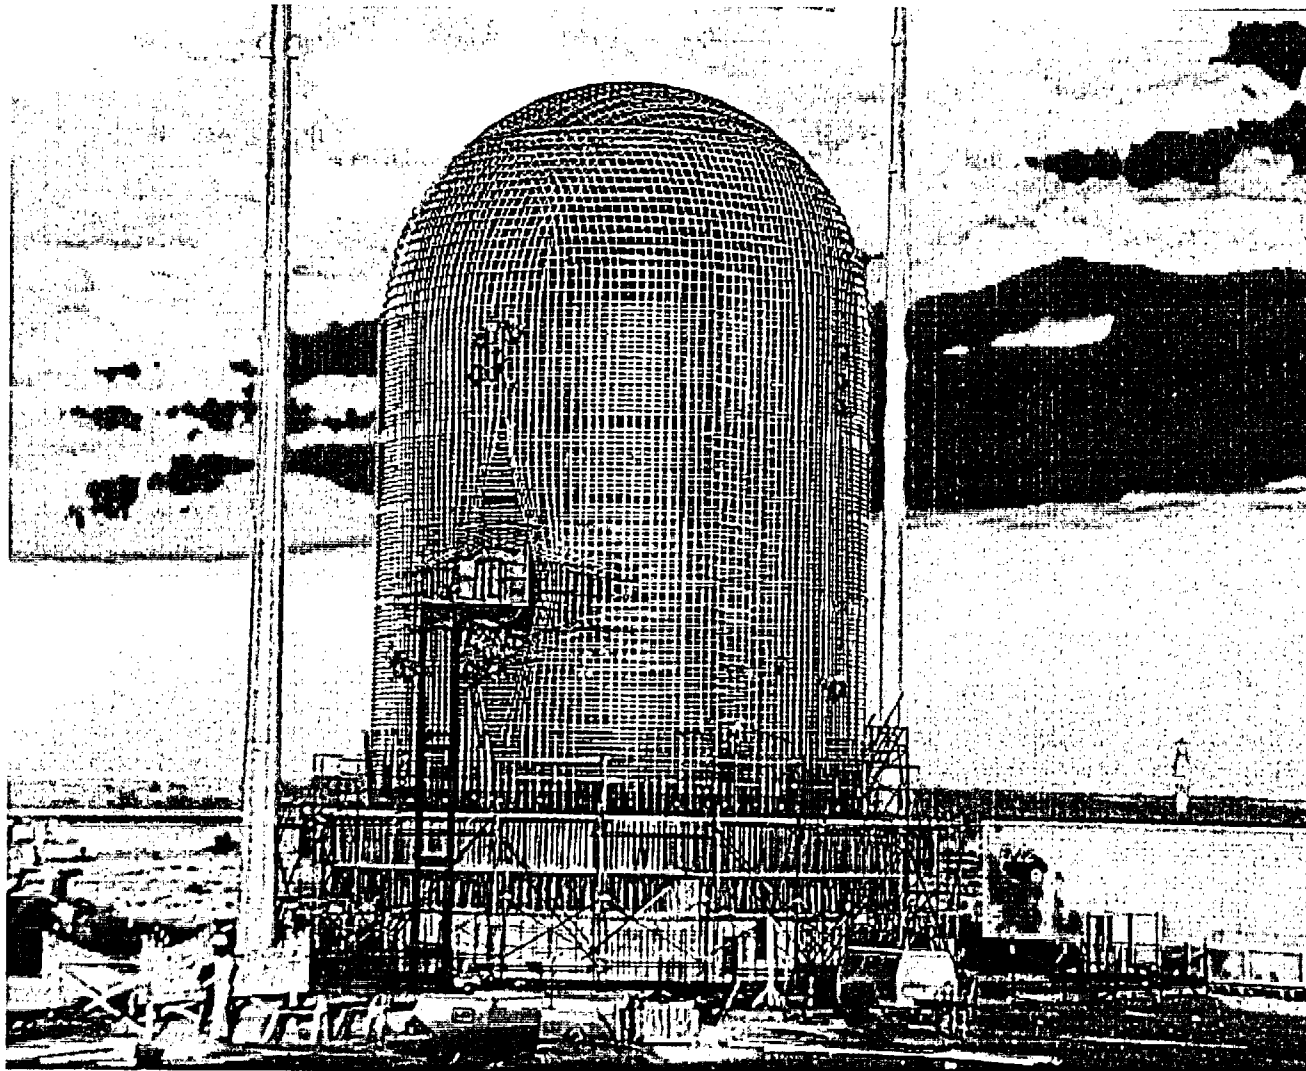
Figure 2.44 PCCV Model Tendon Sheaths

Model prestressing began on March 10, 2000. The arrangement of the model tendons is shown in Appendix A. The nomenclature for identifying individual tendons consisted of an alpha designator 'H' for hoop tendons and 'V' for vertical tendons, followed by a numerical designator (1 through 98 for the hoop tendons and 1 through 90 for the vertical tendons). The hoop tendons were numbered consecutively from 1, the lowest tendon in the cylinder wall, to 98, at the midpoint of the dome. Even-numbered hoop tendons (H2, H4, H6,..., H98) were anchored at the 90 degree buttress and odd-numbered hoop tendons (H1, H3,..., H97) were anchored at the 270 degree buttress. Vertical tendons were numbered consecutively from V1 at 45 degrees, clockwise to V90 at 223 degrees. The vertical tendons were arranged in two orthogonal groups, with V1 through V45 spanning the dome in a plane (nearly) parallel to the 90 to 270 degree axis and V46 through V90 in an orthogonal plane approximately 0 to 180 degrees. This arrangement is illustrated more clearly in the design drawings and shown in Figure 2.44.

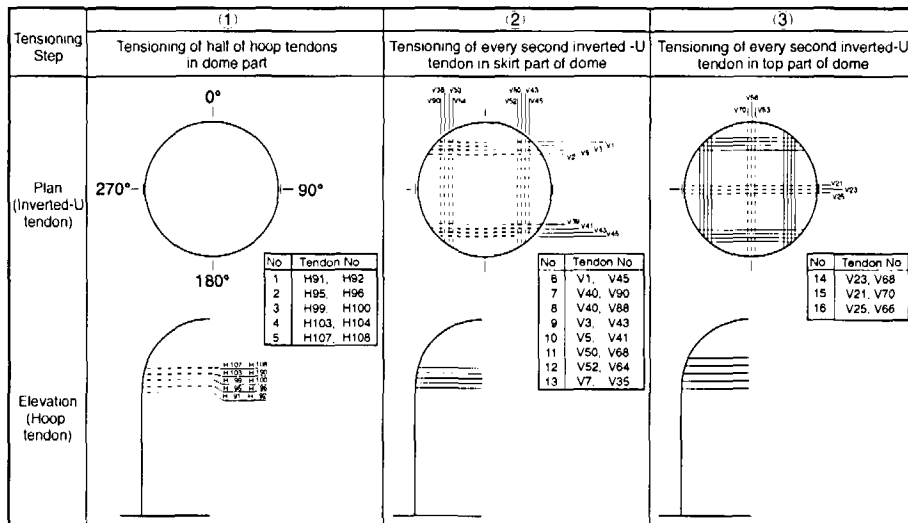
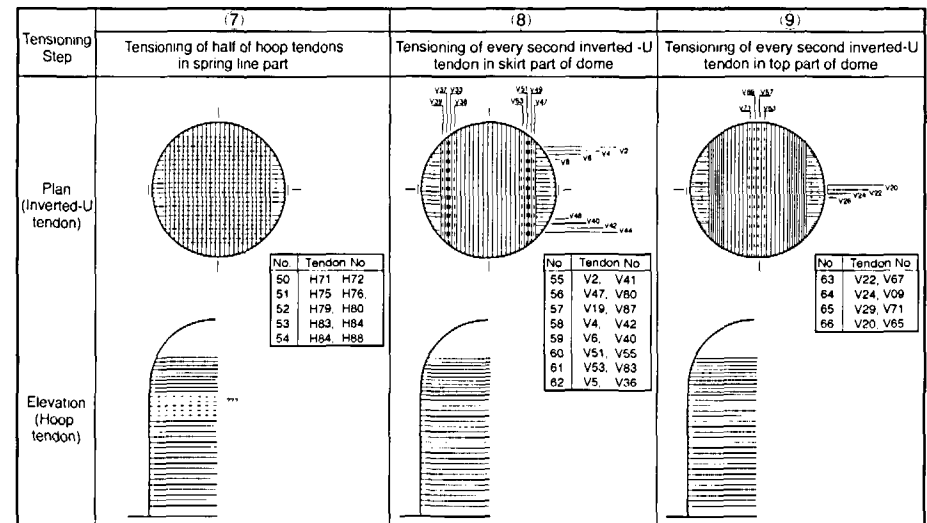
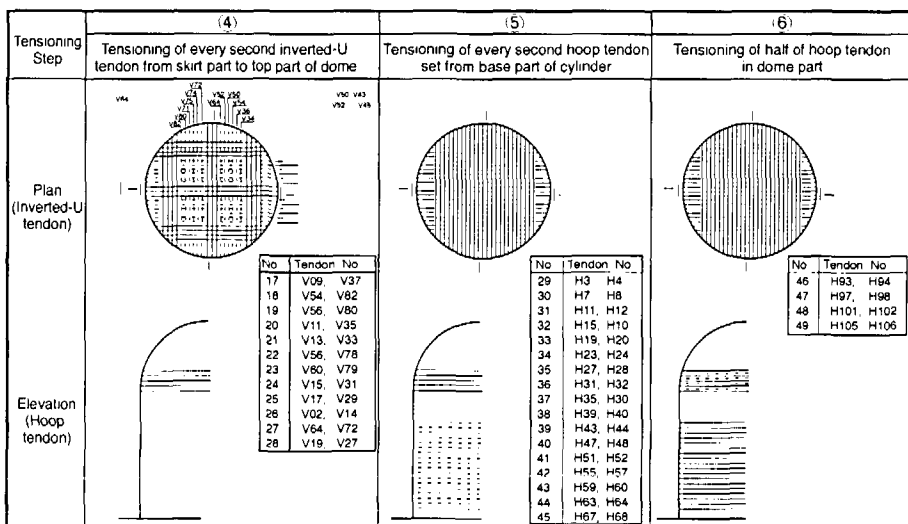
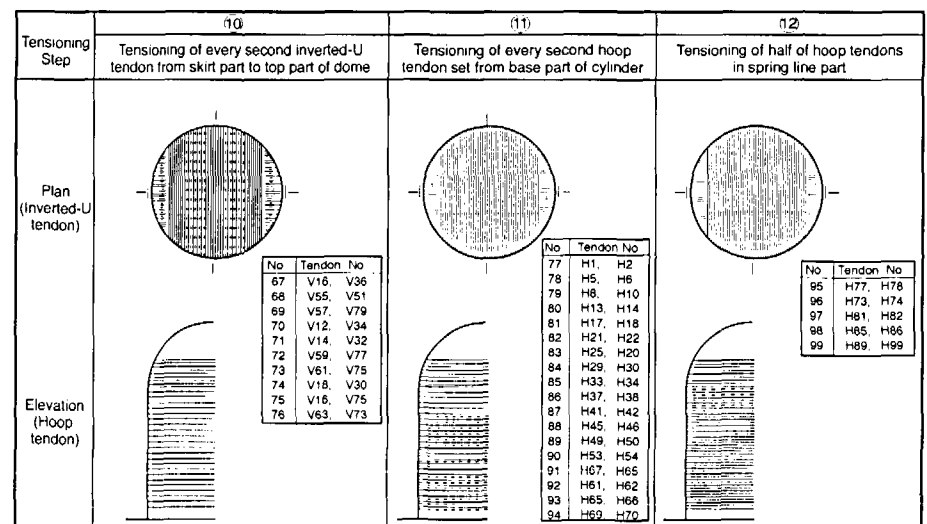
Tensioning Sequence (1/4)

Note: 1. Solid line shows tendon tensioned fully in the previous step.
2. Broken line shows tendon to be tensioned in this step.

Tensioning Sequence (3/4)

Tensioning Sequence (2/4)

Tensioning Sequence (4/4)

Prestressing operations were defined by MHI in the project construction specifications¹⁷. The overall sequence of tensioning is illustrated in Figure 2.56. This sequence is identical to that used for the prototype and is intended to apply balanced prestressing forces to the model to prevent excessive local deformation or damage. The actual tensioning schedule is shown in Table 2.7. Prestressing operations were completed on May 3, 2000.

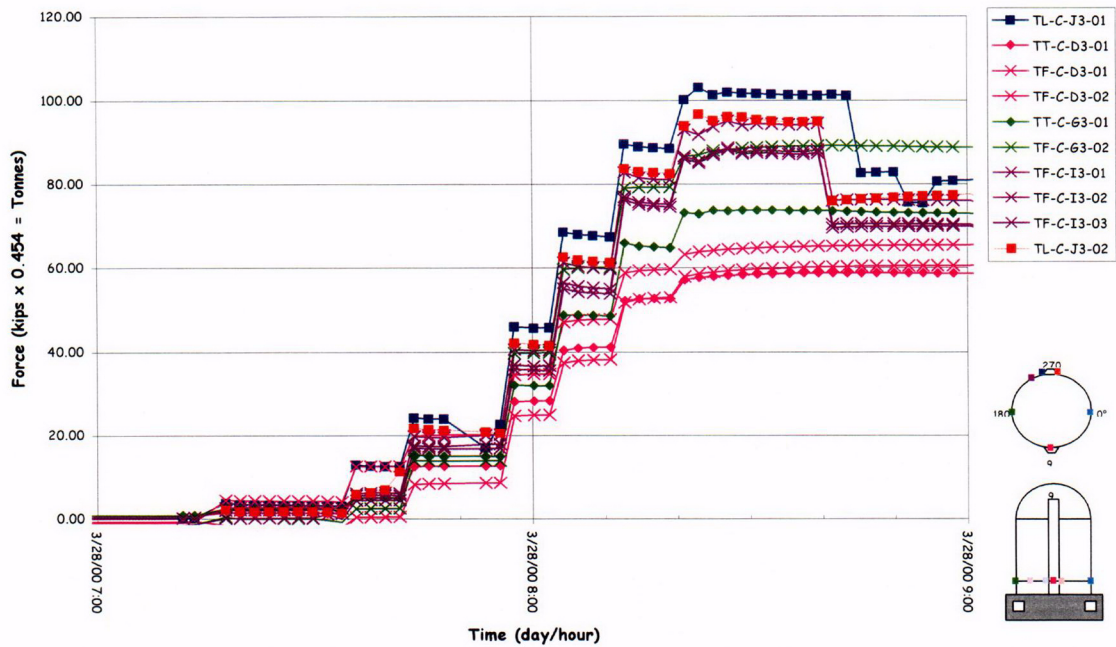
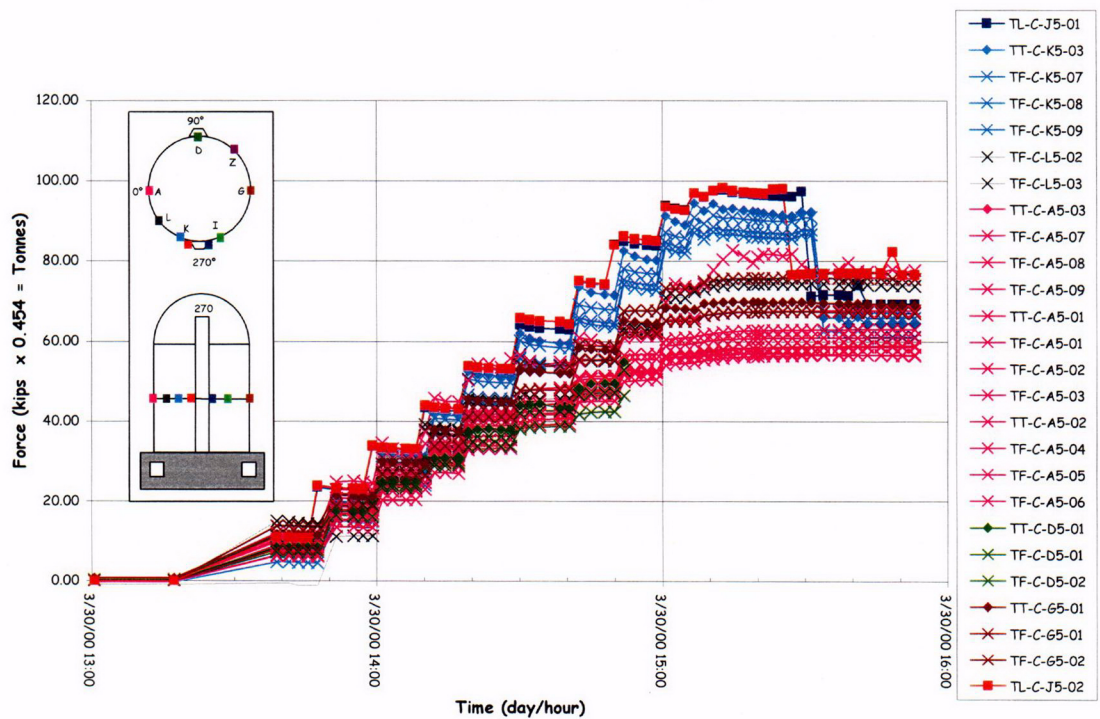
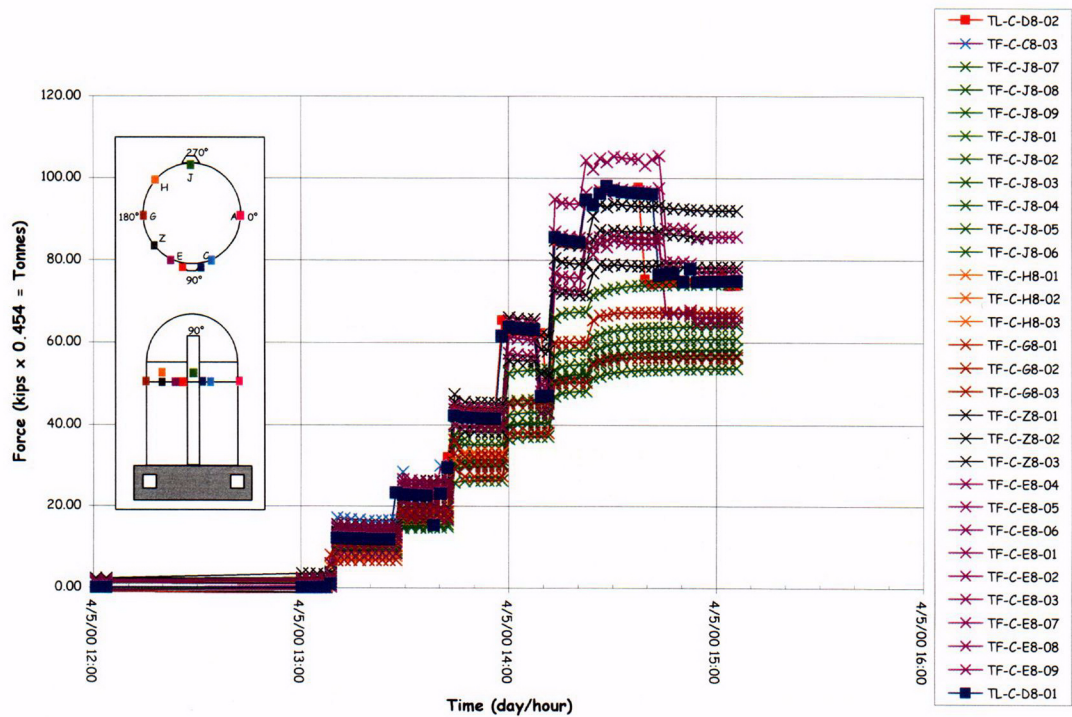
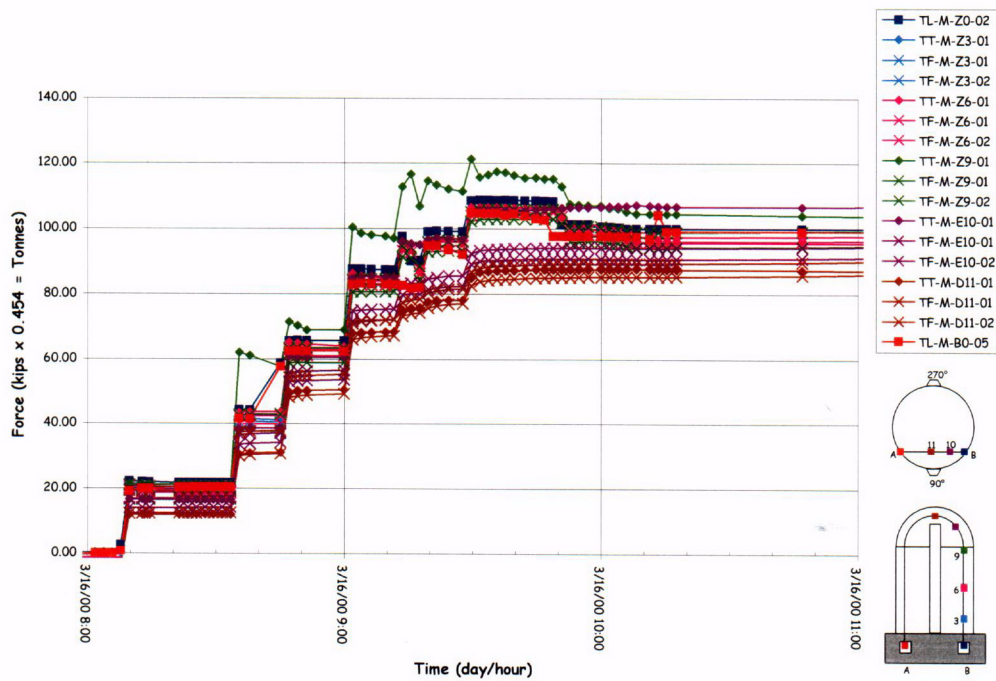
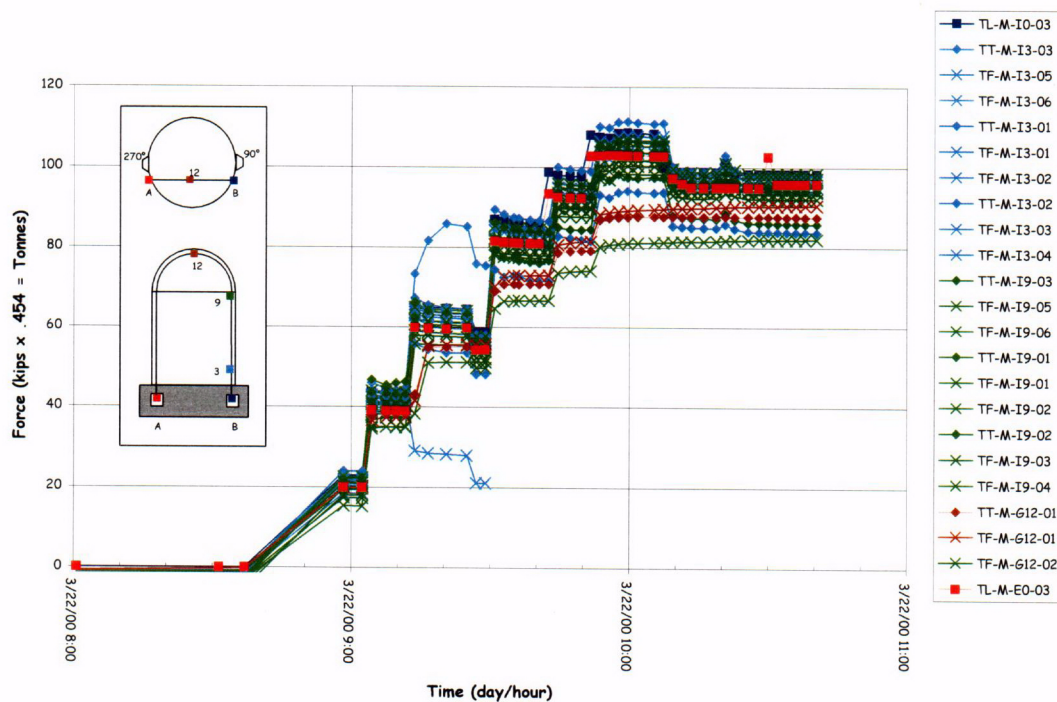
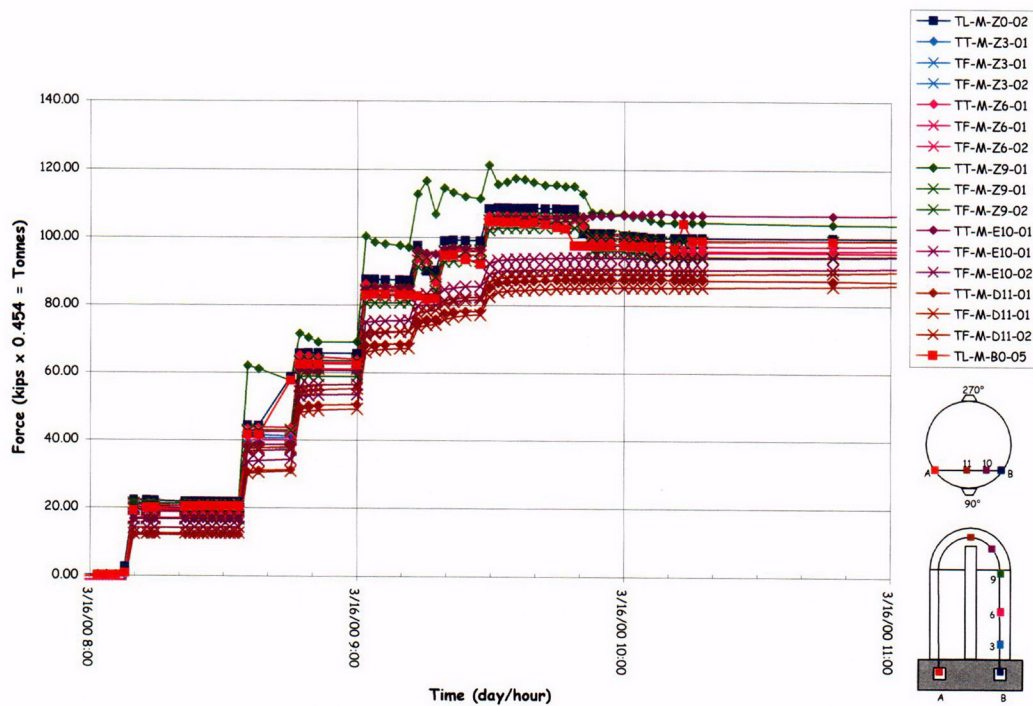
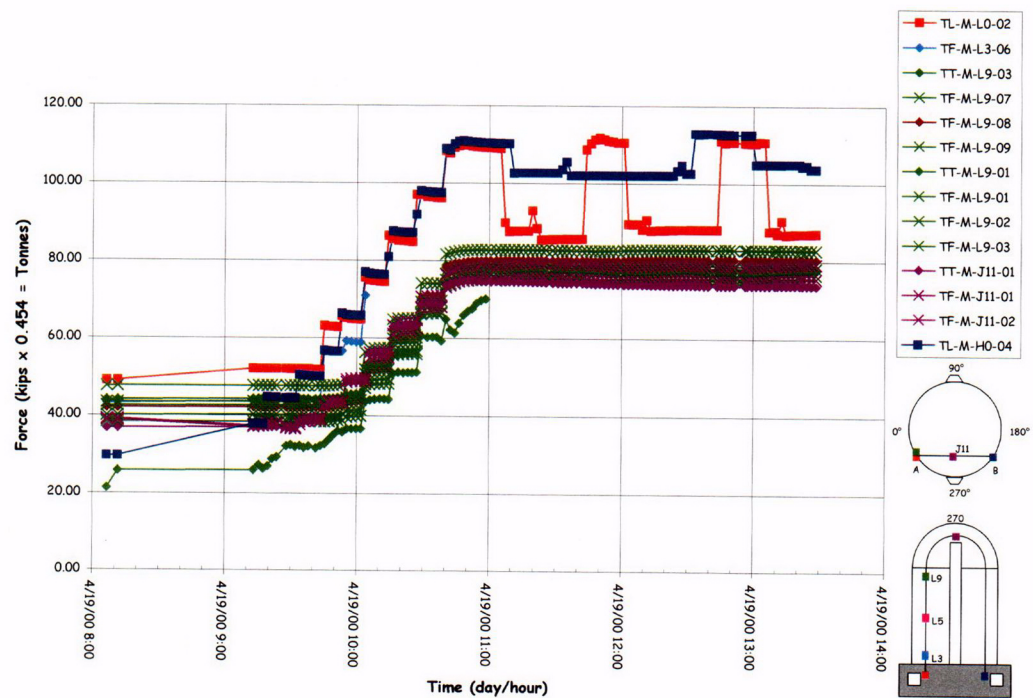
Figure 2.59 Tendon H11 Tensioning Force Time History

Figure 2.60 Tendon H35 Tensioning Force Time History

Figure 2.61 Tendon H53 Tensioning Force Time History

Figure 2.63 Tendon H68 Tensioning Force Time History

Figure 2.64 Tendon V37 Tensioning Force Time History

Figure 2.65 Tendon V46 Tensioning Force Time History

Figure 2.66 Tendon V85 Tensioning Force Time History

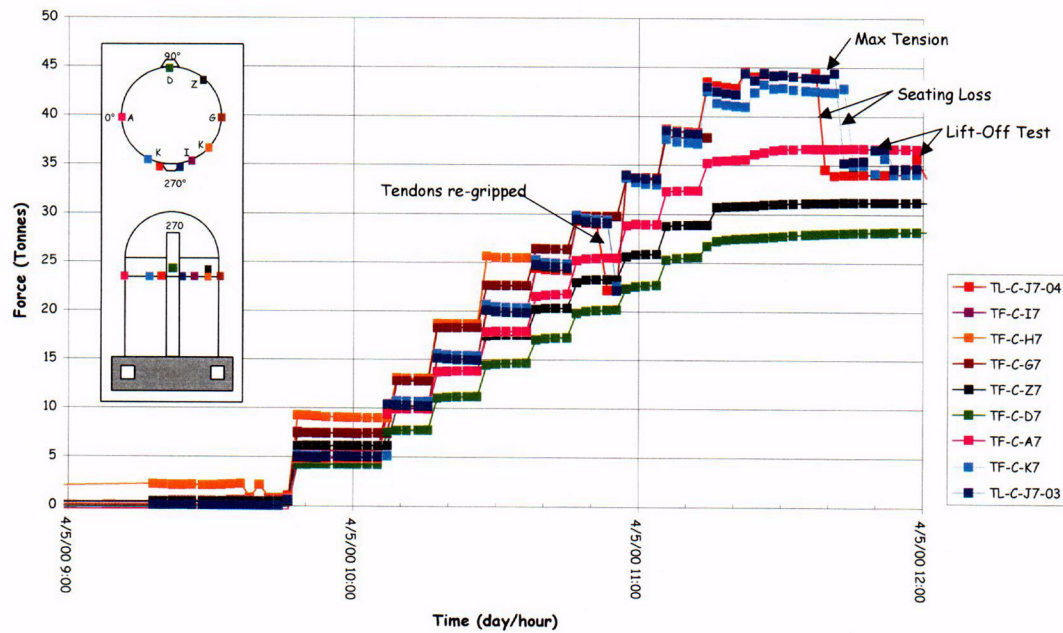
Figure 2.62 Tendon H67 Tensioning Force Time History

Considering Figure 2.62, it can be seen that the general force distribution along the length of the tendons is consistent with the design assumption, i.e., the highest tendon force is near the anchor and the lowest force is at the mid-point of the tendon. Figures 2.67 through 2.74 compare the measured force distribution in the tendons during and after tensioning with the design assumptions shown in Figure 2.9. The data for the horizontal tendons generally confirms the assumed design force distribution. The surviving gages do not provide enough data points to fully define the shape of the force distribution curve, notably where the effect of the anchor set loss disappears. Due to the discontinuities in the hoop tendon force distribution, only the data points are shown and no attempt was made to interpolate the hoop tendon force between measurement locations. In general, the data is consistent with the design assumptions and does not appear to contradict the predicted response.

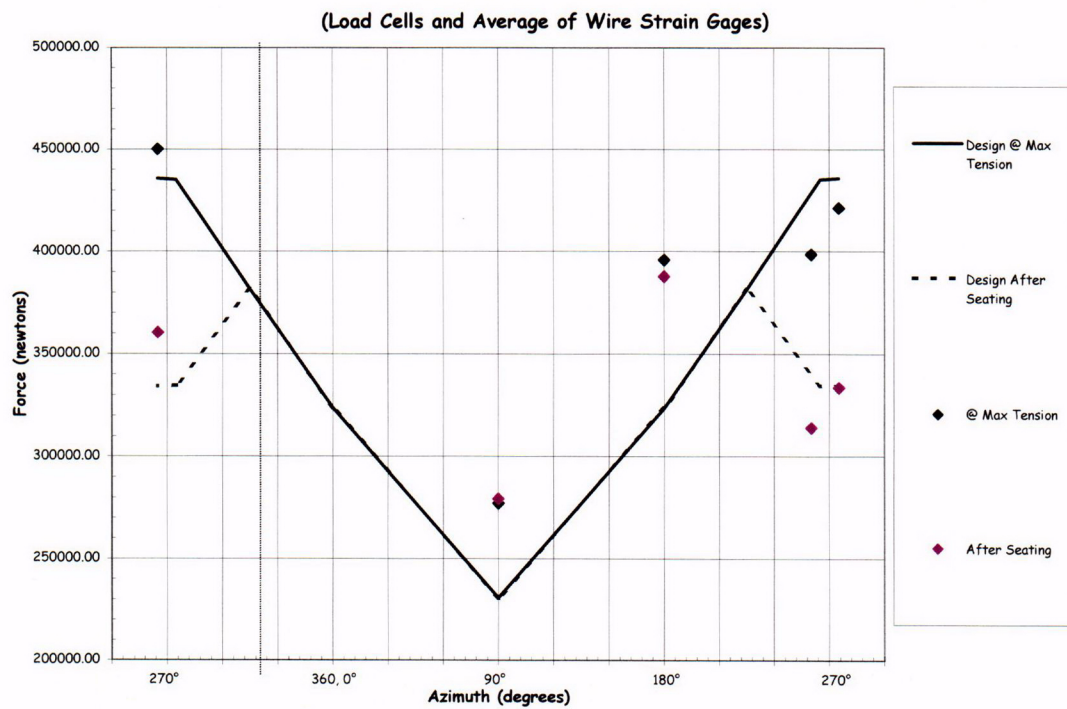
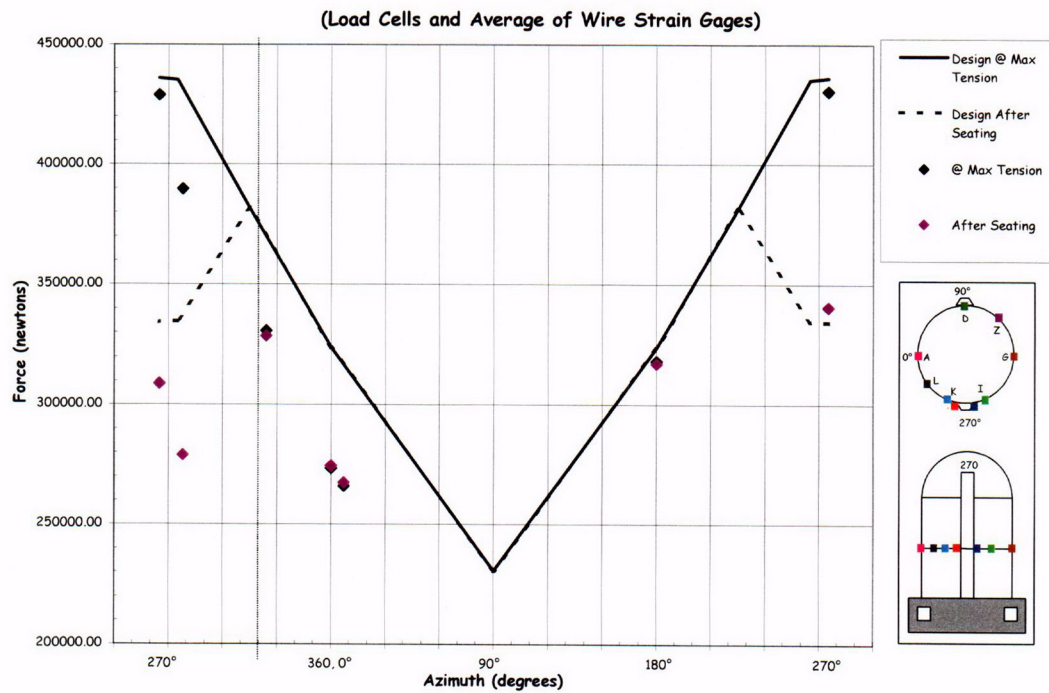
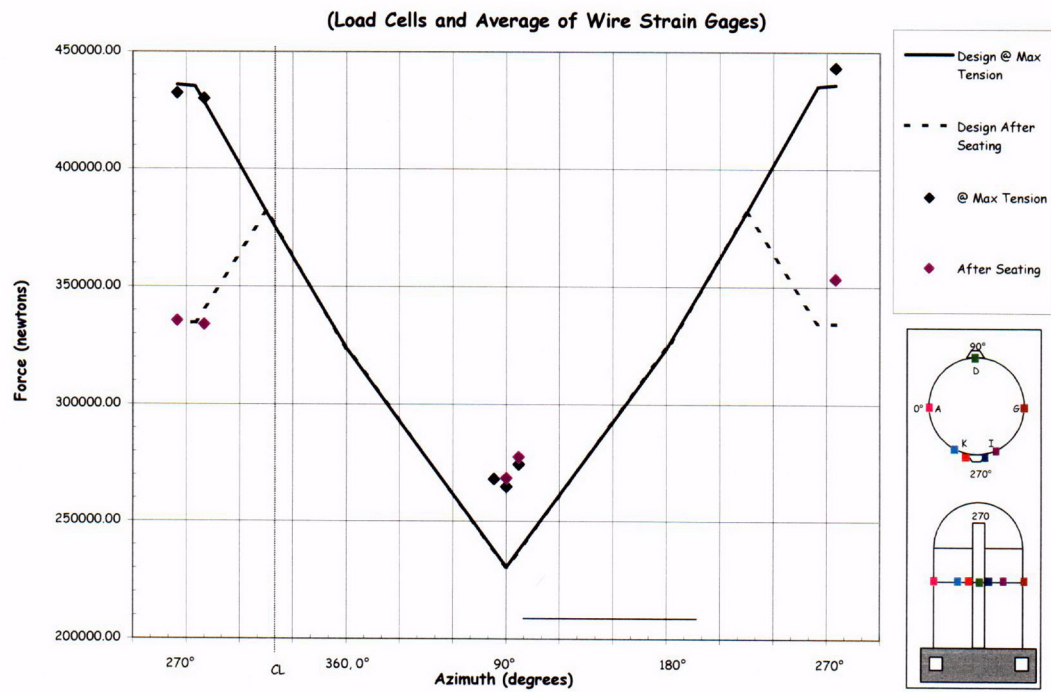
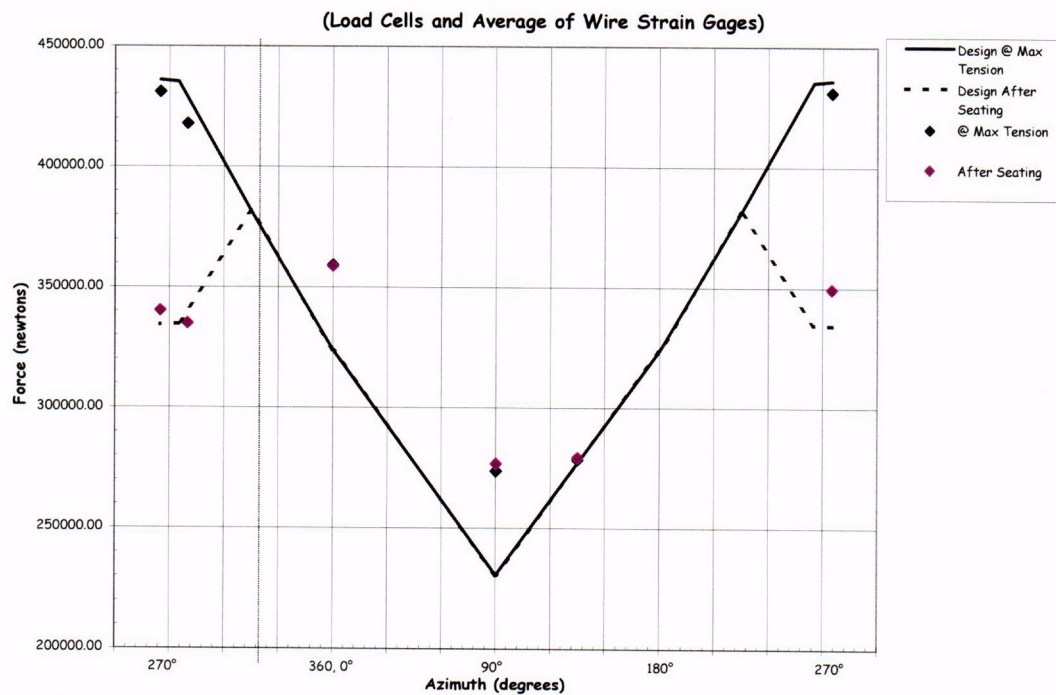
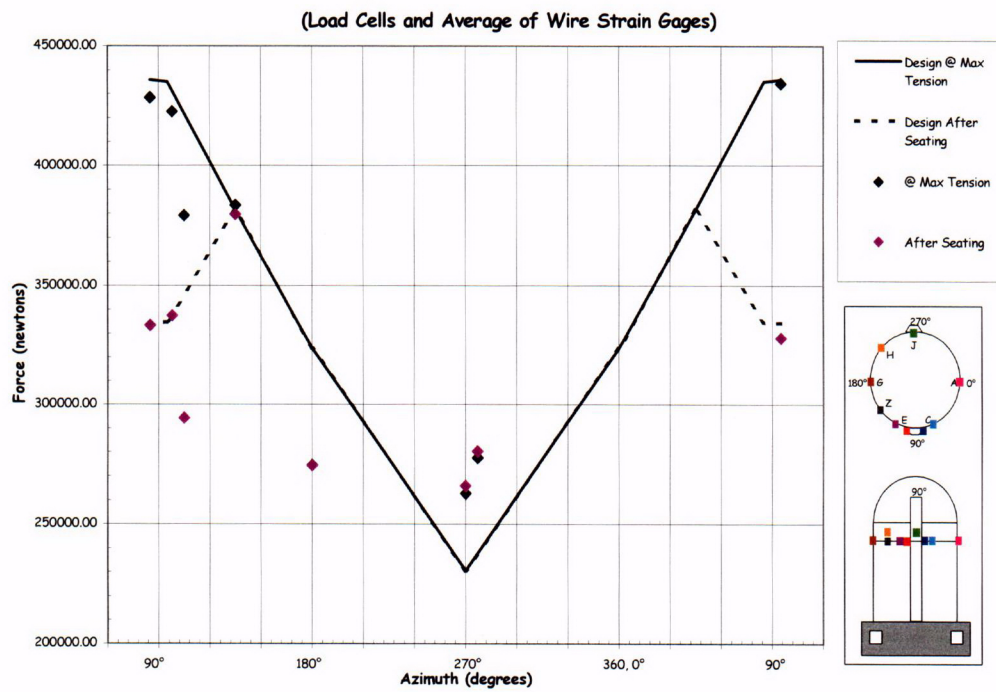
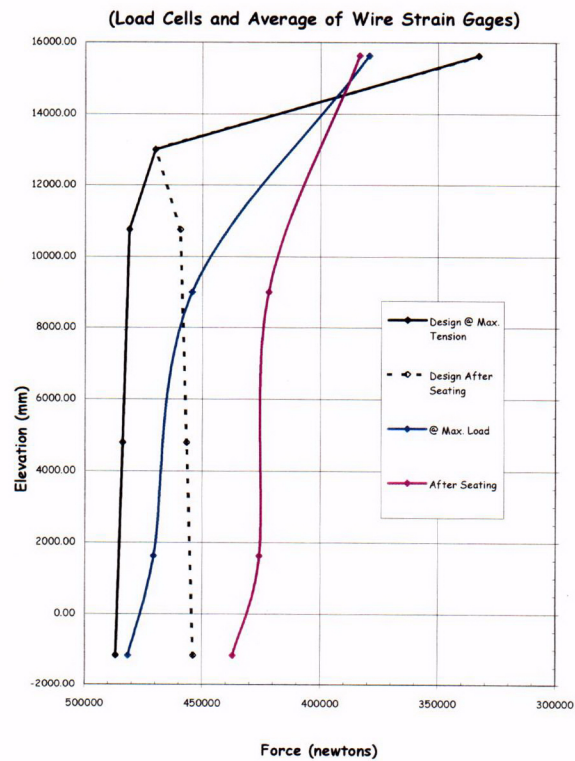
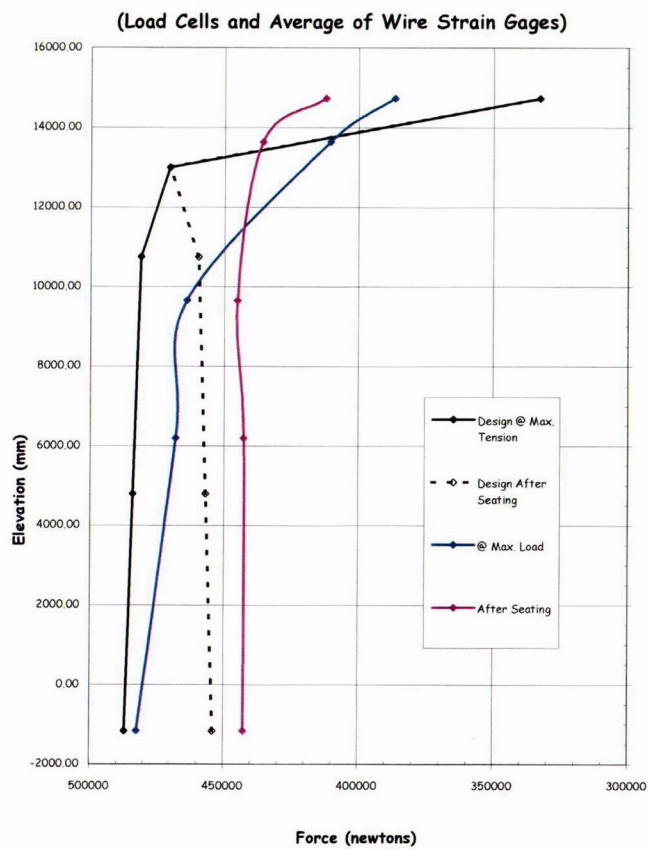
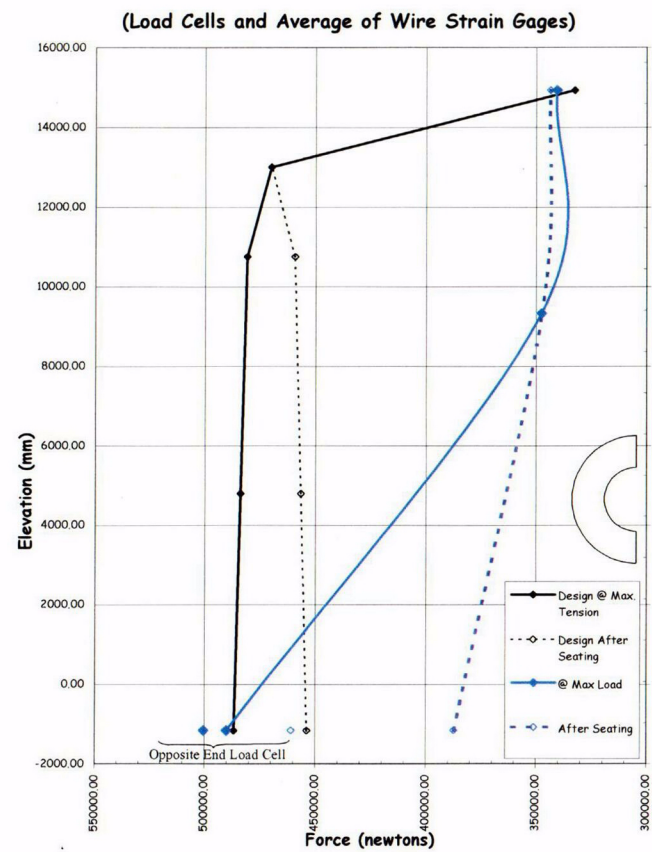
Figure 2.67 H11 Tendon Force Distribution, Elev. 1854

Figure 2.68 H35 Tendon Force Distribution, Elev. 4572

Figure 2.69 H53 Tendon Force Distribution, Elev. 6579

Figure 2.70 H67 Tendon Force Distribution, Elev. 8153

Figure 2.71 H68 Tendon Force Distribution, Elev. 8280

Figure 2.72 V37 Tendon Force Distribution, Azimuth 240 Degrees

Figure 2.73 V46 Tendon Force Distribution, Azimuth 135 Degrees

Figure 2.74 V85 Tendon Force Distribution, Azimuth 325 Degrees
