Overpressurization Test of a 1:4-Scale Prestressed Concrete Containment Vessel Model

Sandia National Laboratories

**U.S. Nuclear Regulatory Commission
Office of Nuclear Regulatory Research
Washington, DC 20555-0001**

**Nuclear Power Engineering Corporation
Tokyo 105, Japan**

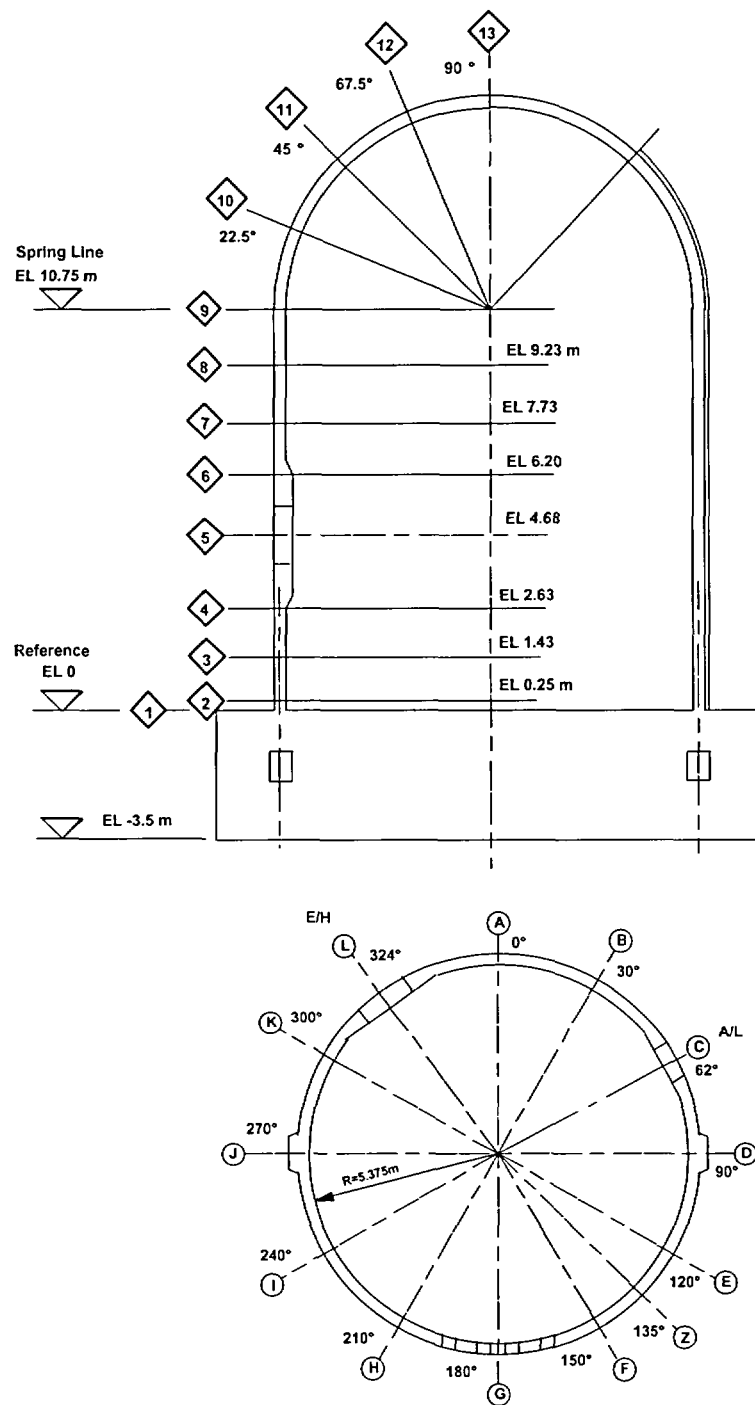
Figure 3.1 Cardinal Instrumentation Layout Lines

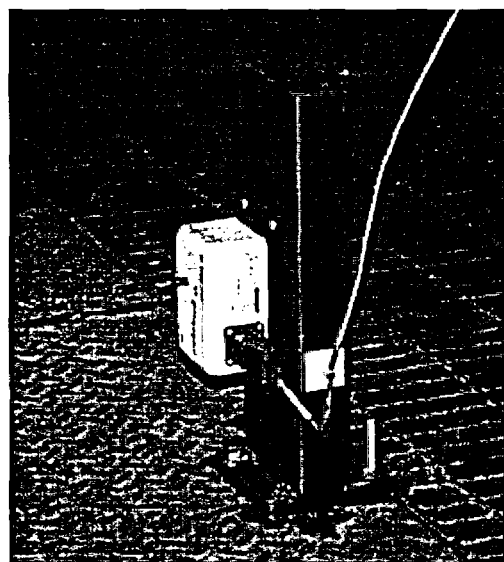
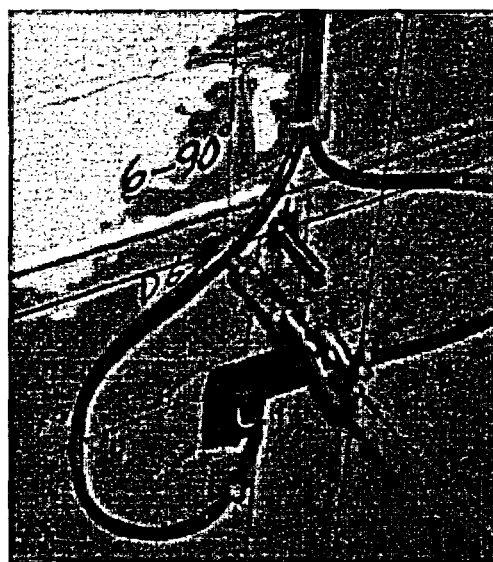
Figure 3.2 CPOT Mounted on Instrumentation Frame and Attachment to PCCV Liner

Specification Item	Data
Type of measurement required	Radial or vertical displacement of internal surface of the PCCV model
Anticipated exposure conditions	Nitrogen, from ambient to 2.1 MPa-g (300 psig)
Operational range	5 cm, 12.5 cm, 25 cm, and 38 cm (2", 5", 10" and 15")
Desired accuracy (linearity and repeatability)	0.15 to 0.25% full scale
Logistics (electrical connection, cabling requirements, etc.)	Power supply required (not included on VXI card), multi-pin cable connector needed

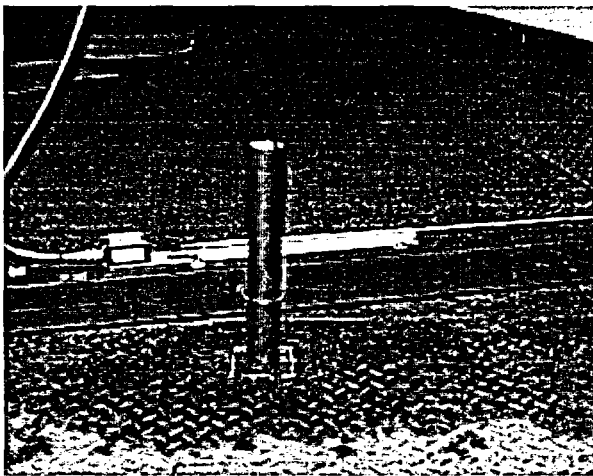
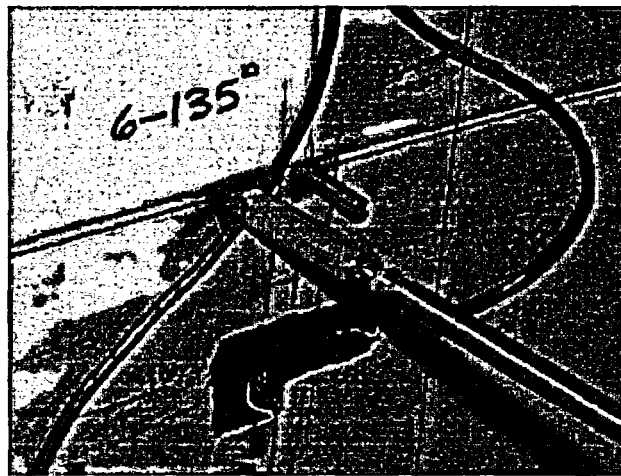
Figure 3.4 TLDT Mounted on Instrumentation Frame and Attachment to PCCV Liner

Specification Item	Data
Type of measurement required	Accurate and high range measurements of linear displacement of internal surface of PCCV model
Anticipated exposure conditions	Nitrogen, from ambient to approx. 2.1 MPa-g (300 psig)
Operational range	38 cm (15")
Desired sensitivity	< 1% total input range
Deviation from linearity	0.02% full scale (min 13 mm)
Logistics (electrical connection, cabling requirements, etc.)	Same as CPOT requirements

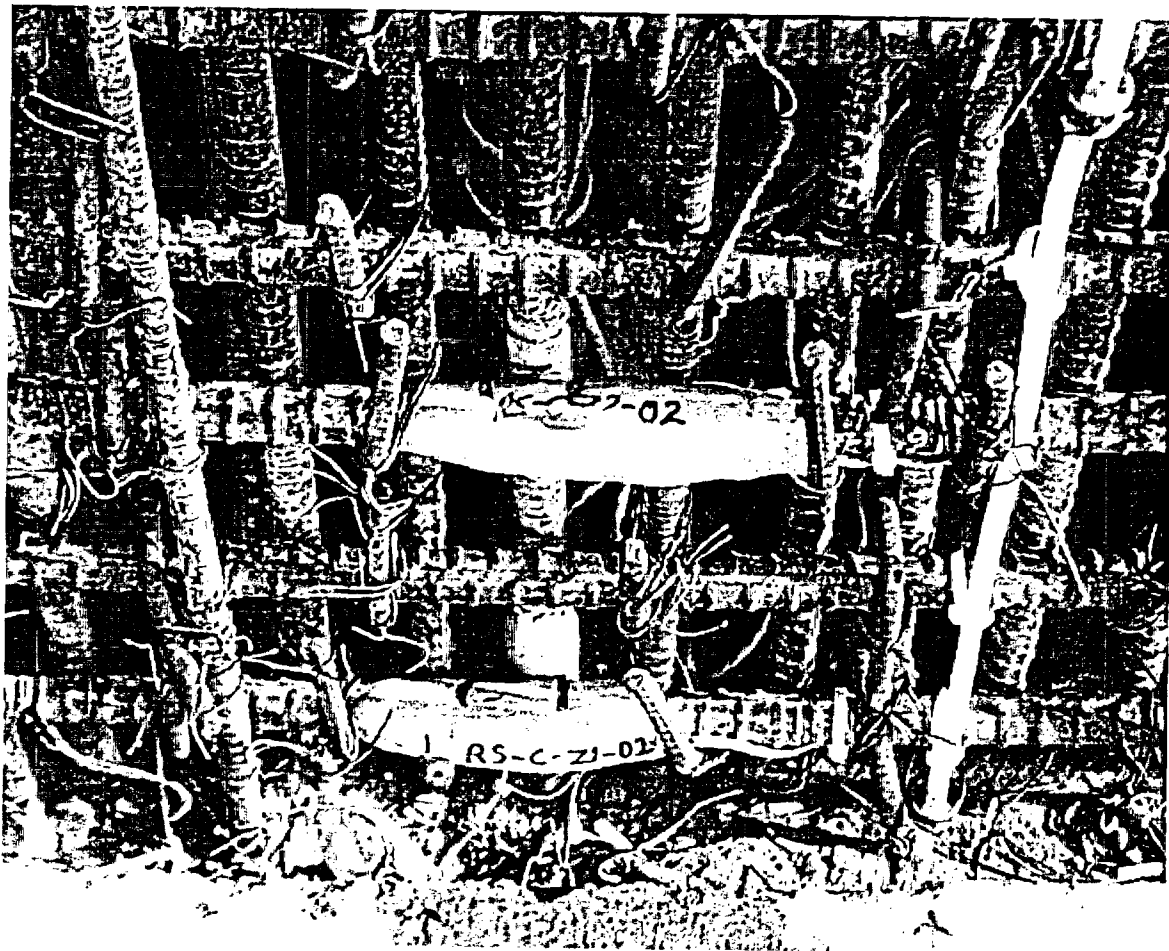
Figure 3.7 Rebar Strain Gages Installed in PCCV Model
(Note SOFO Fiber Optic Concrete Strain Gage at right)

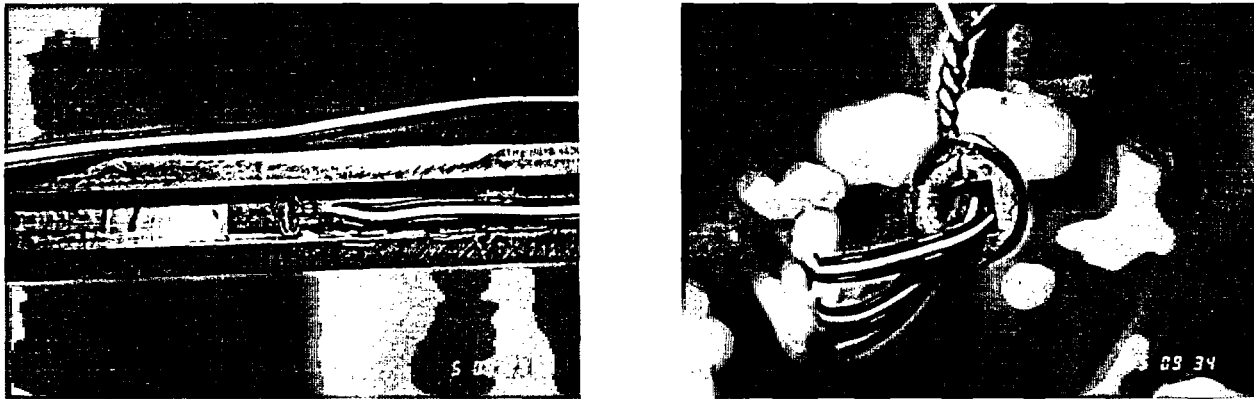
Figure 3.8 Concrete Strain Gage Bars

Specifications for the gage bar strain gages are summarized in Tables 3.9. The configuration of the gage bars is illustrated in Figure 3.8. Sample rebar and gage bar strain gages are compared in Figure 3.9.

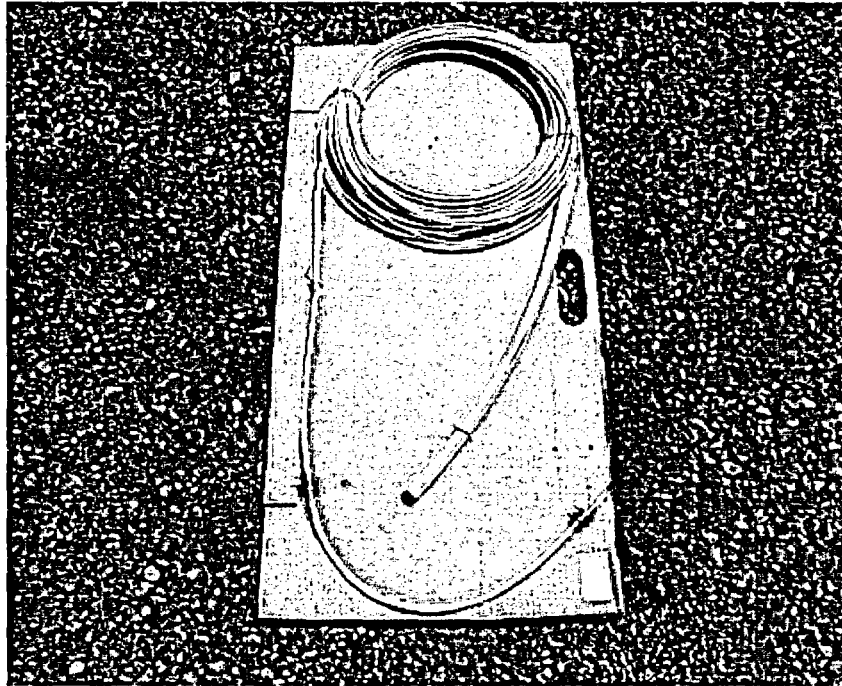
Figure 3.10 SOFO Fiber Optic Strain Gage

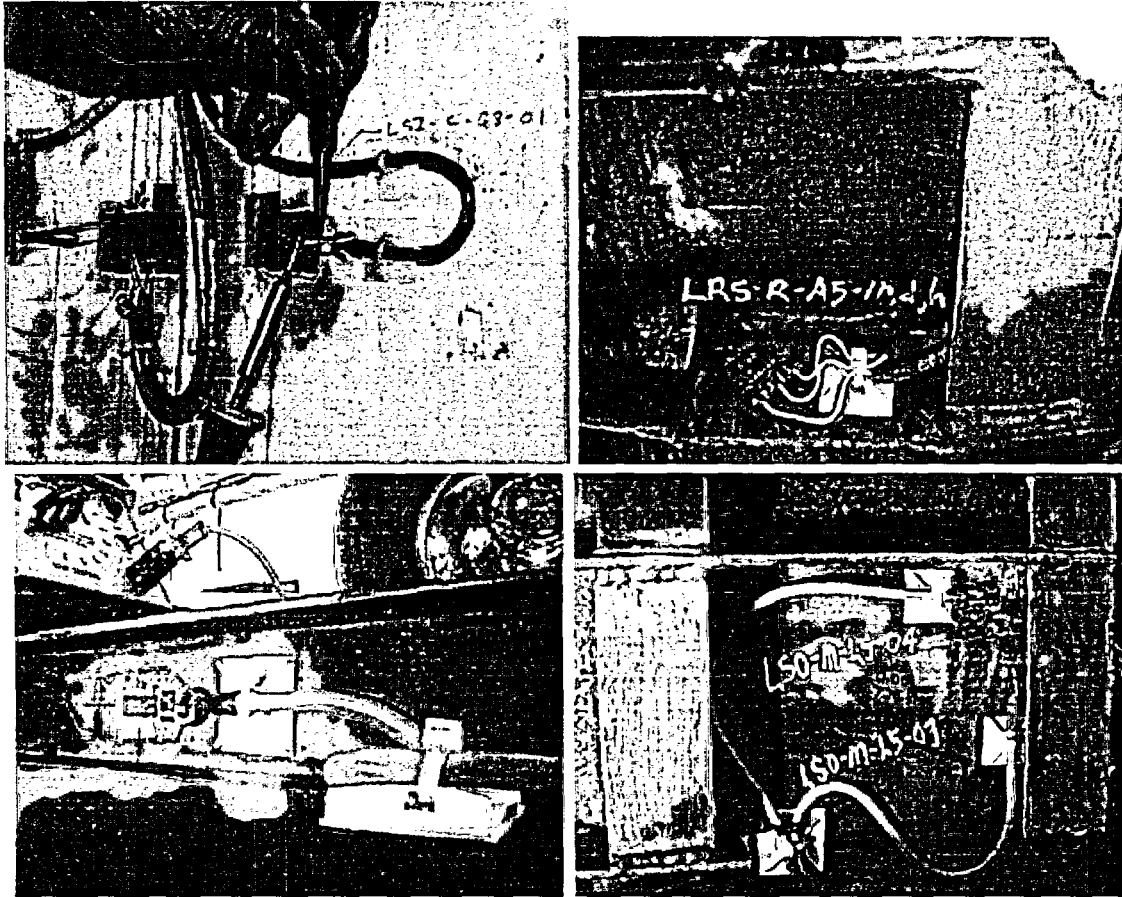
Figure 3.11 Liner and Liner Anchor Strain Gages

Specification Item	Data
Type of measurement required	Point strain (approx.) in the "hoop," "meridional," and "radial" directions, both internal and external on the liner, liner anchors, and stiffeners embedded in the concrete.
Anticipated exposure conditions	Internal: non-purified nitrogen gas at pressures from ambient to approx. 2.1 MPa-g (300 psig), duration of elevated pressures not more than 20 days (500 hours), temperatures from -5 to 50°C. External: concrete placement, curing, and long term exposure
Operational range	Strip gages (2-10 elements): 20% 0-45-90 rosettes (3 elements): 20% single gages: 10 - 20%
Desired strain sensitivity (gage factor, k)	$1 < k < 2$ (all gages)
Transverse sensitivity, k_t	$k_t < 2\%$ (all gages)
Mounting configuration	Carrier matrix material bonded to surface of liner (both internal and external), model liner material is carbon steel, painted internally
Logistics (installation, electrical connection, cabling requirements, etc.)	Three wire twisted, insulated cable, junctions to pin-type pressure feedthroughs

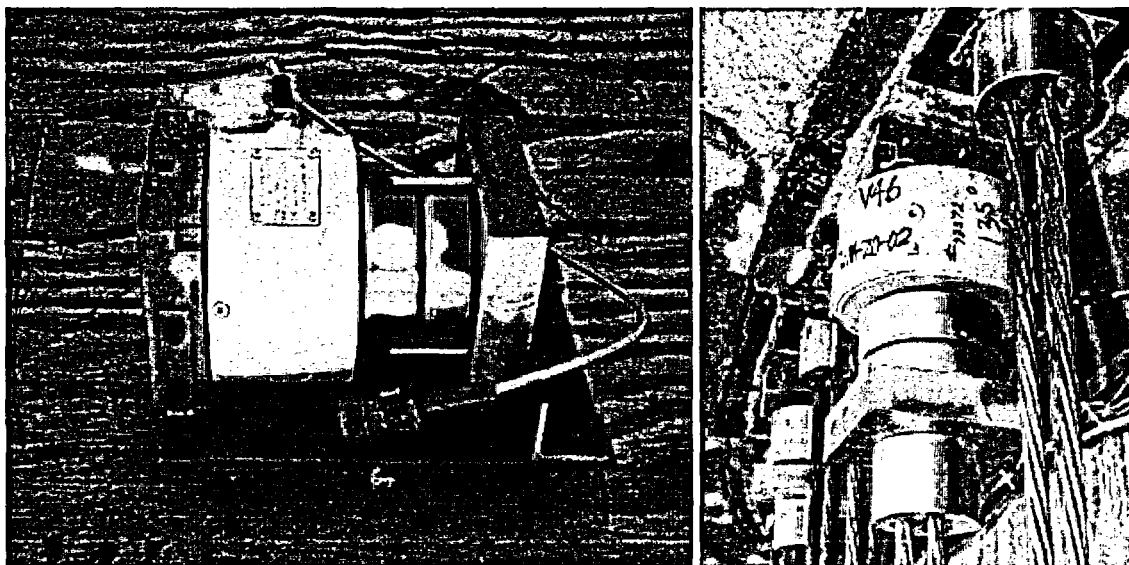
Figure 3.13 HBM Load Cell (a) Installation Jig, (b) In-Place

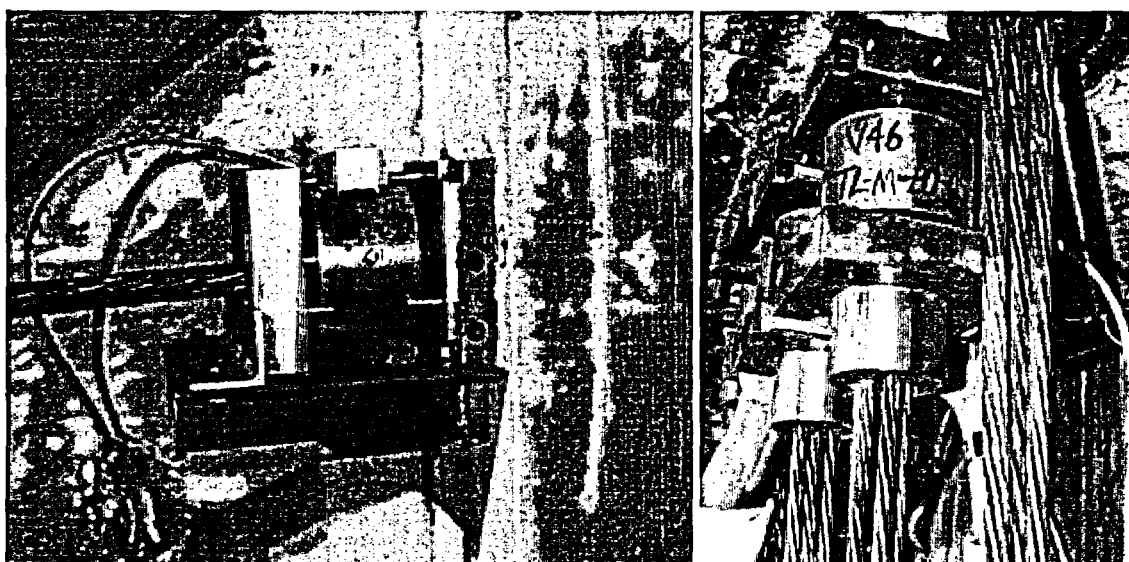
Figure 3.14 Geokon Load Cell (a) Installation Jig, (b) In-Place

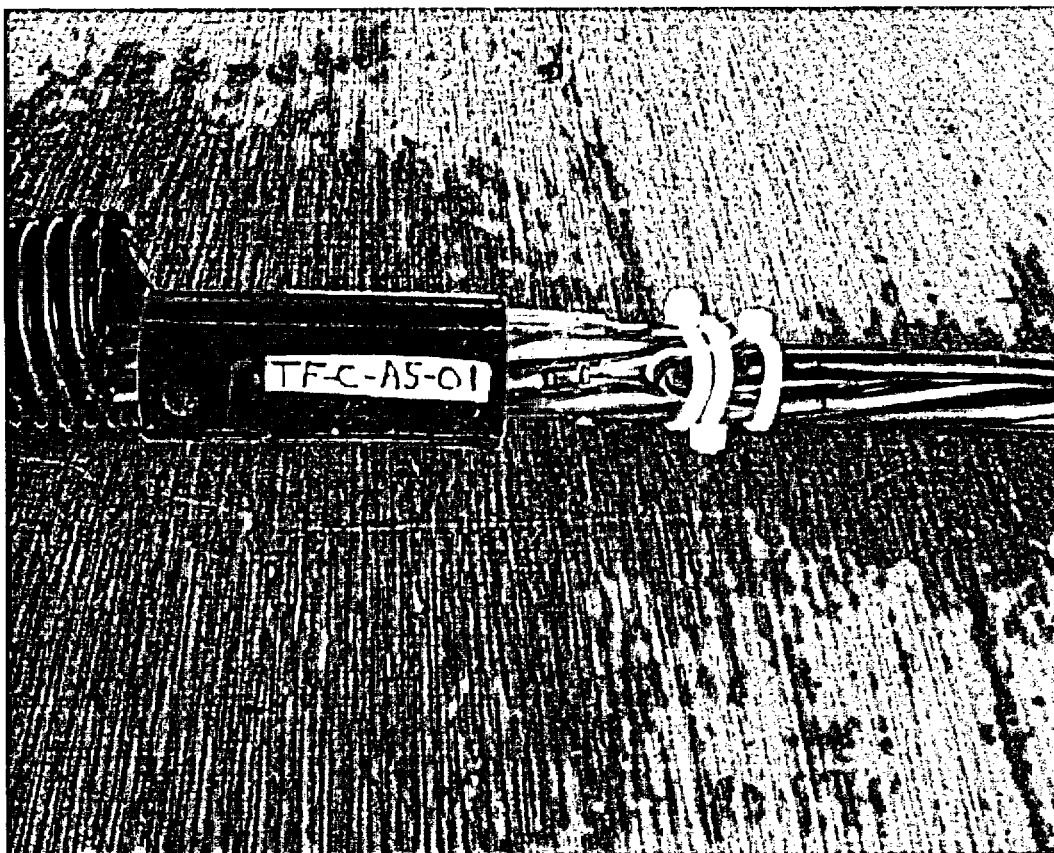
(c) Tensmeg End Block and Wire Strain Gage

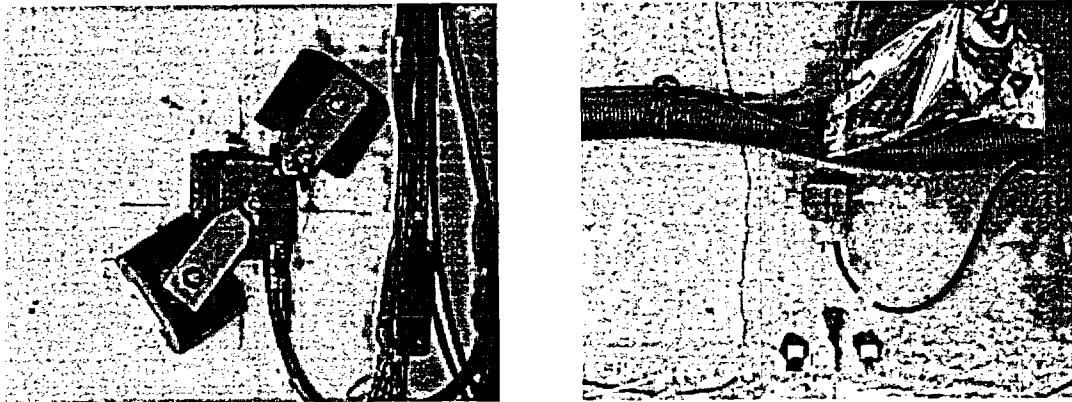
Figure 3.17 Interior and Exterior Acoustic Sensor (clamps during installation only)

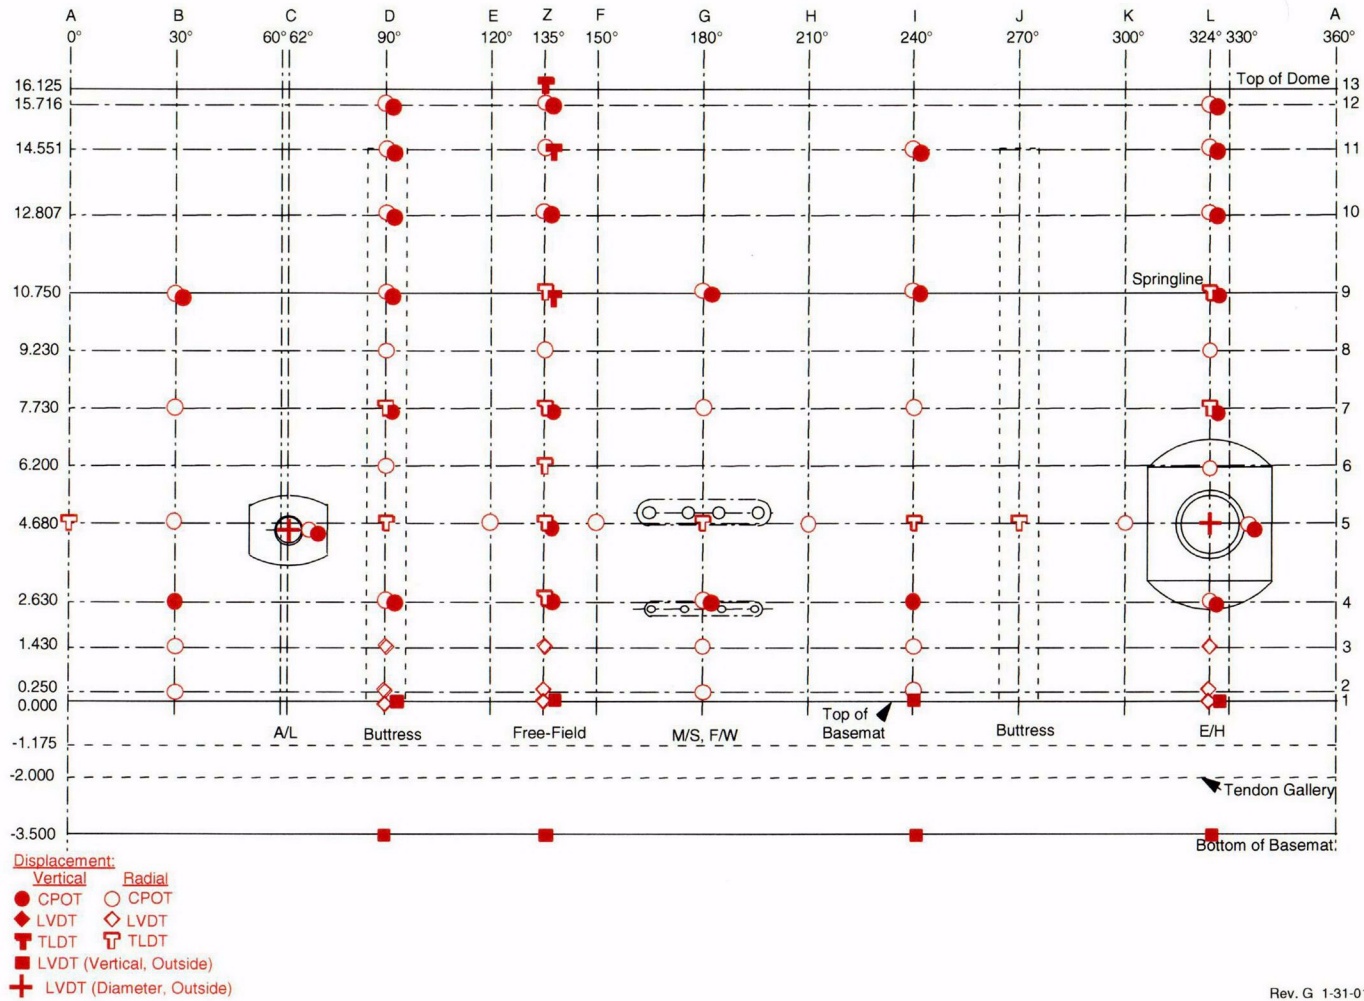
Figure 3.18. Displacement Instrumentation Locations

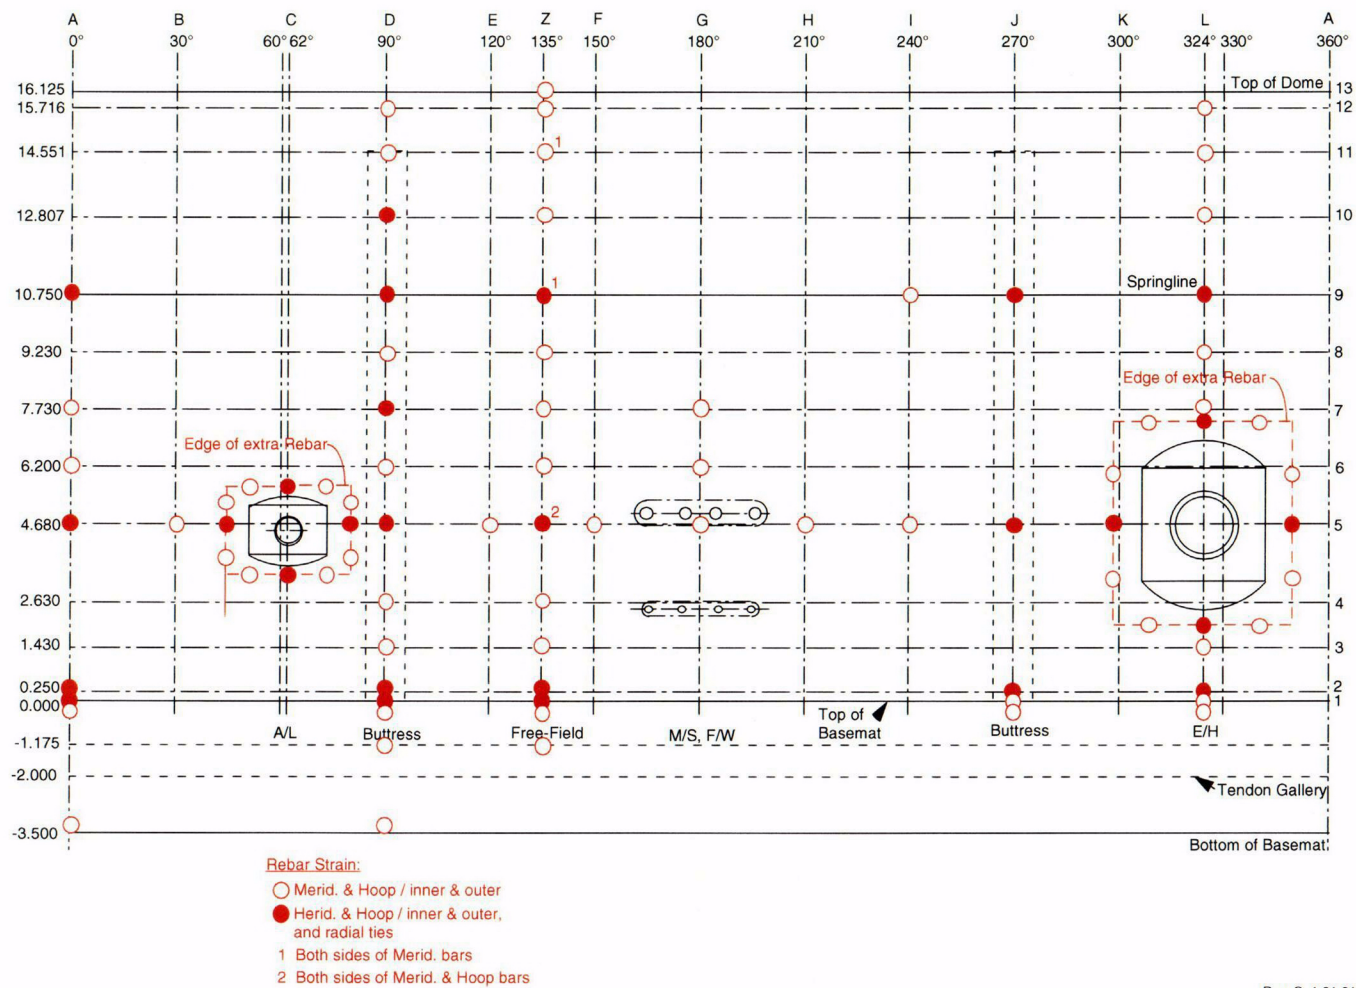
Figure 3.19. Rebar Instrumentation Locations

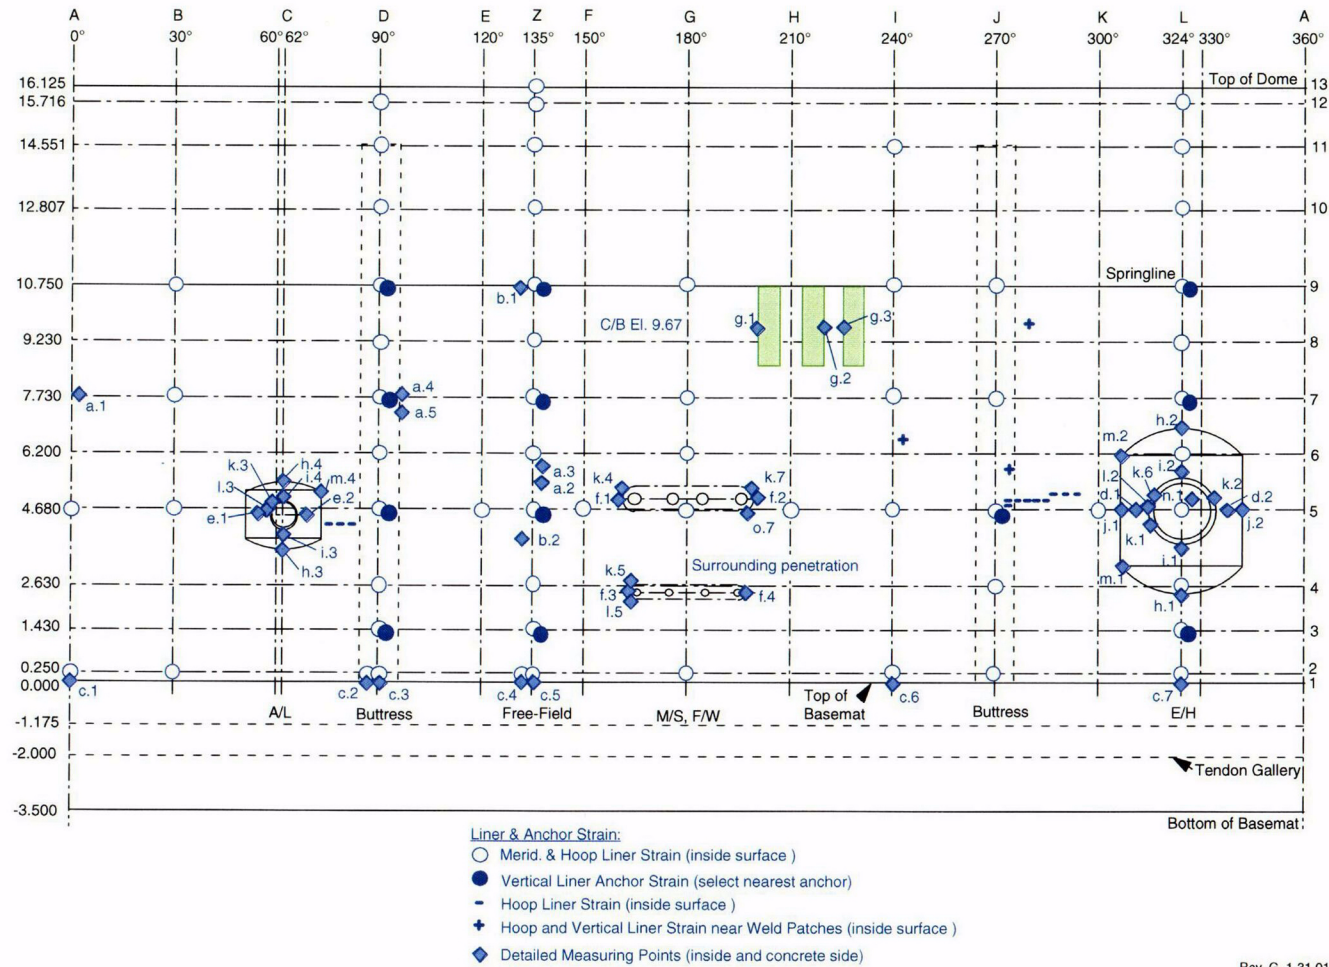
Figure 3.20. Liner and Liner Anchor Instrumentation Locations

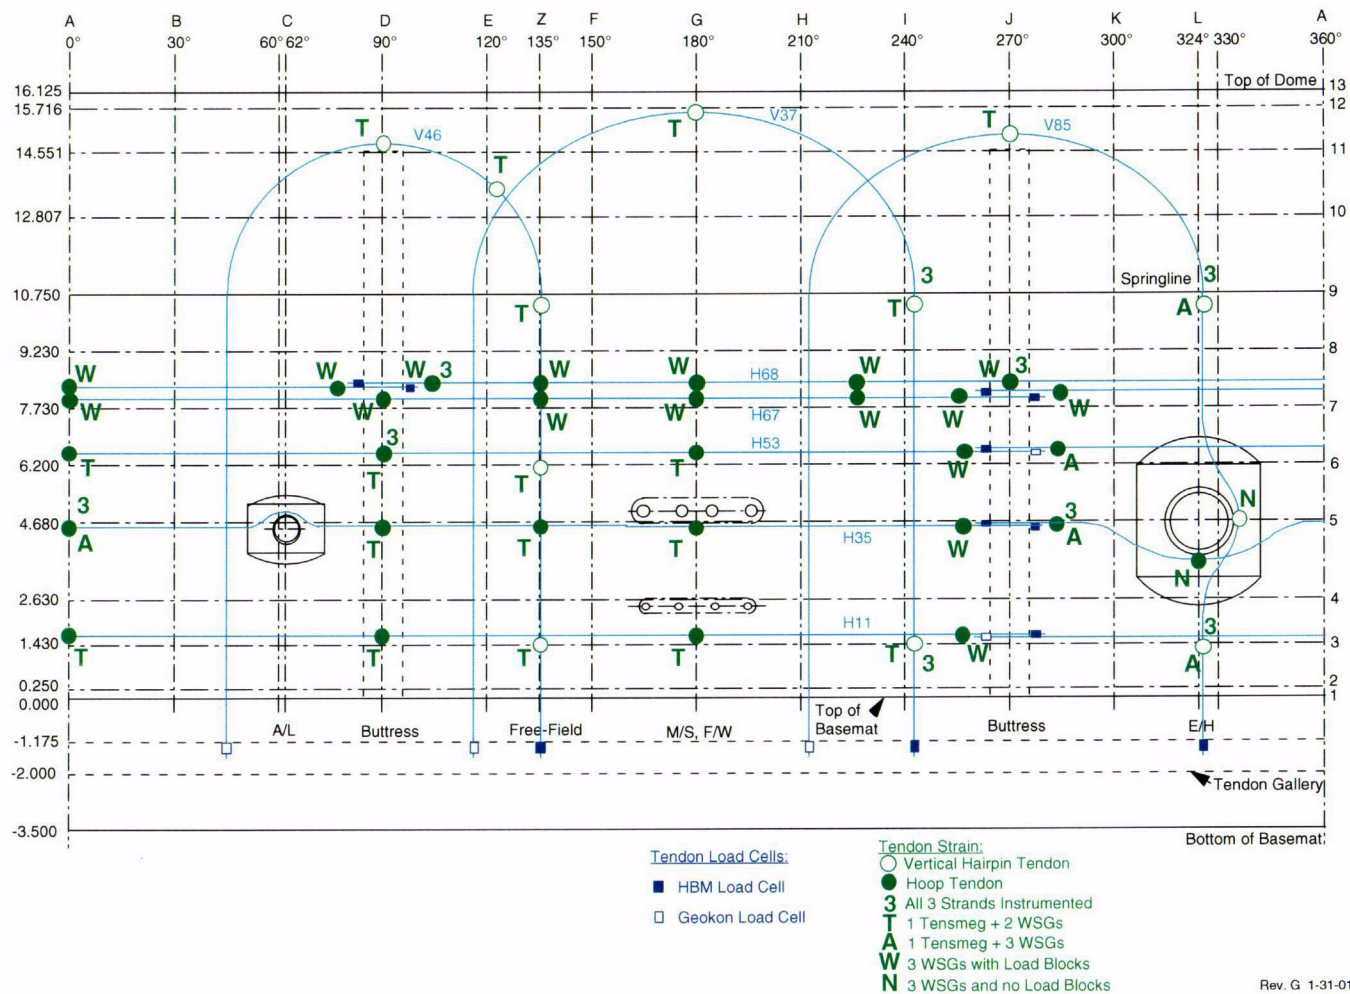
Figure 3.21. Tendon Instrumentation Locations

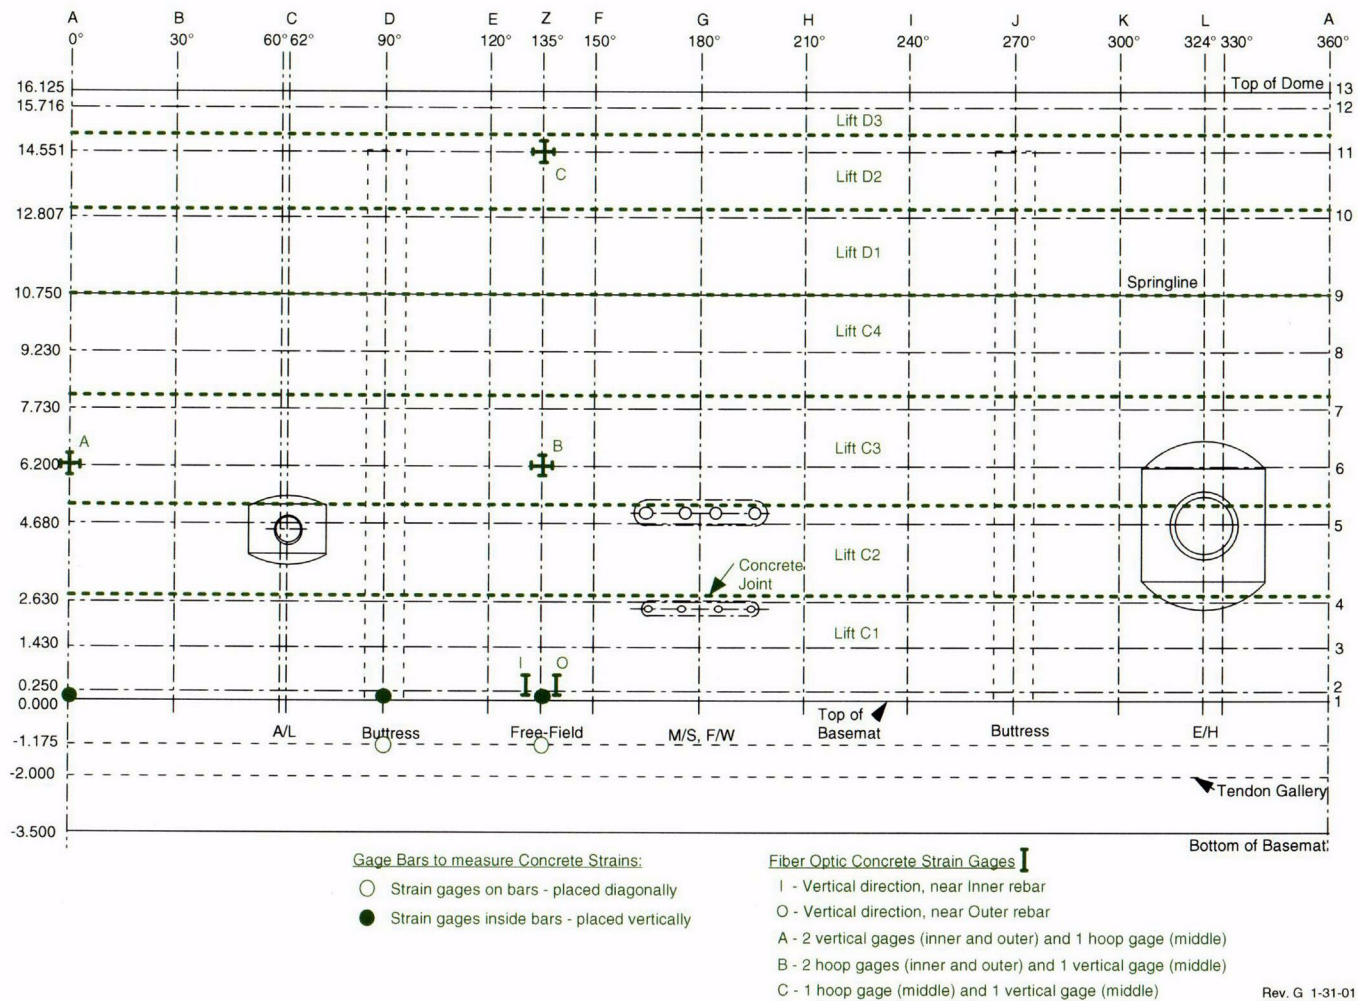
Figure 3.22. Concrete Instrumentation Locations

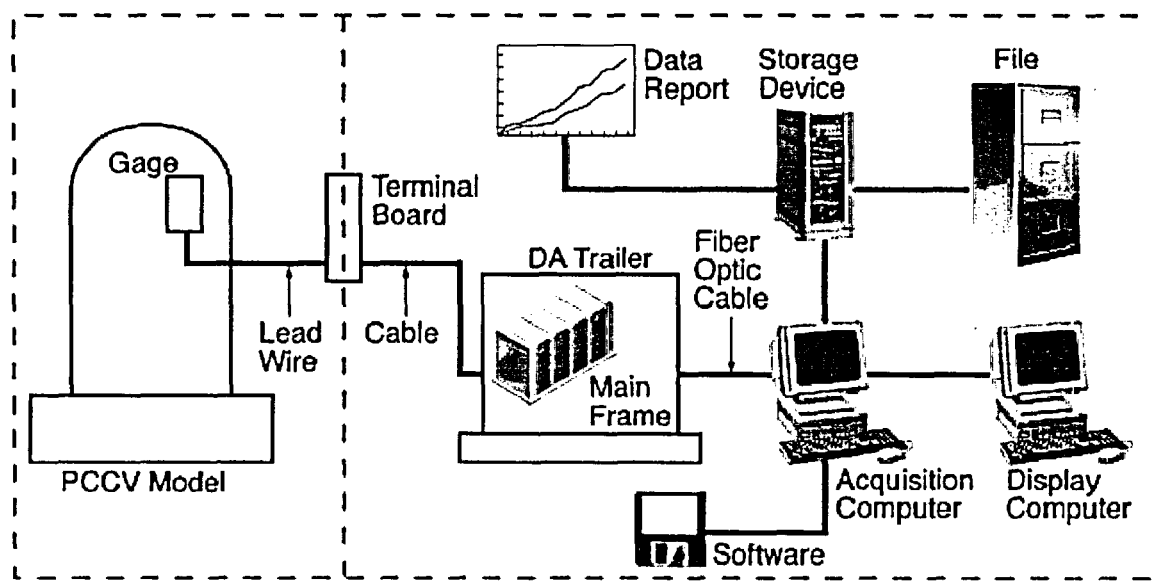
Figure 4.1 PCCV/DAS Hardware Configuration

The primary hardware component involved in the data gathering was the Hewlett Packard 75000 Series B system, which included the HP1302A VXI Mainframe and its associated 5 ½ digit multimeter (HP1326B). Analog signals from the instruments were sent to plug-in cards installed into the mainframe housing. An analog bus jumper connected the signals to the digital multimeter where the analog-to-digital (A-D) conversion occurred.

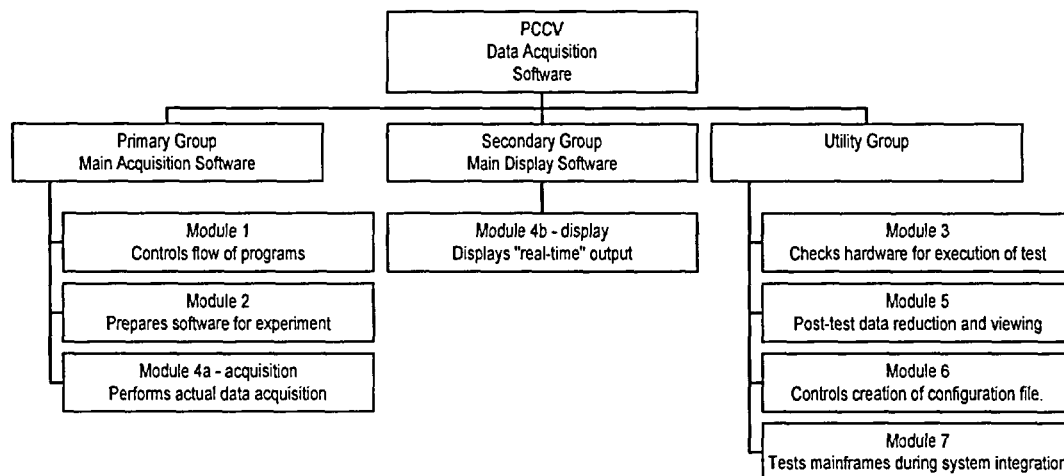
Figure 4.2. DAS Software Tree

The three PCCV DAS software groups were divided into seven main modules. Modules 1, 2, and 4a composed the main acquisition group. Module 4b was the main display software group. Modules 3, 5, 6, and 7 composed the Utility Group. Figure 4.2 shows a schematic of the modules and how they were grouped.

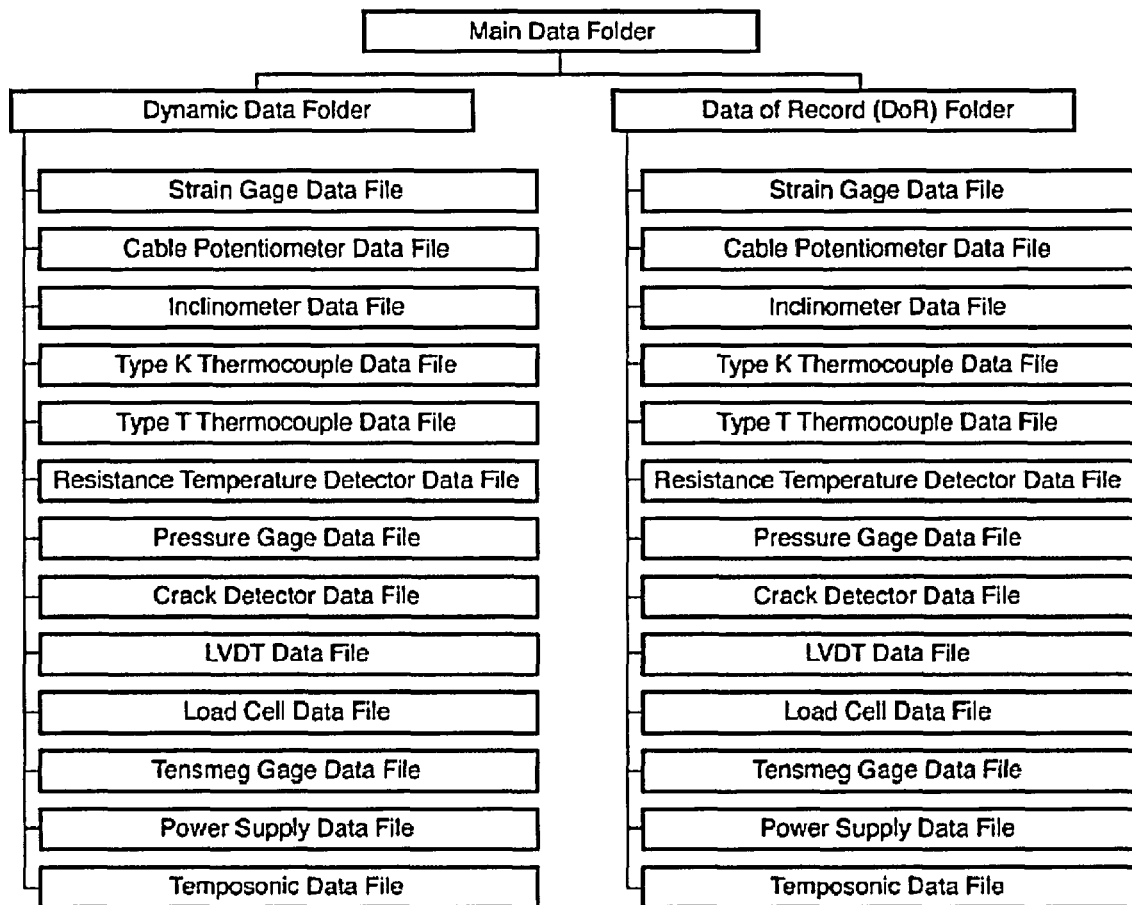
Figure 4.3 Top-Down Data File Folder Structure

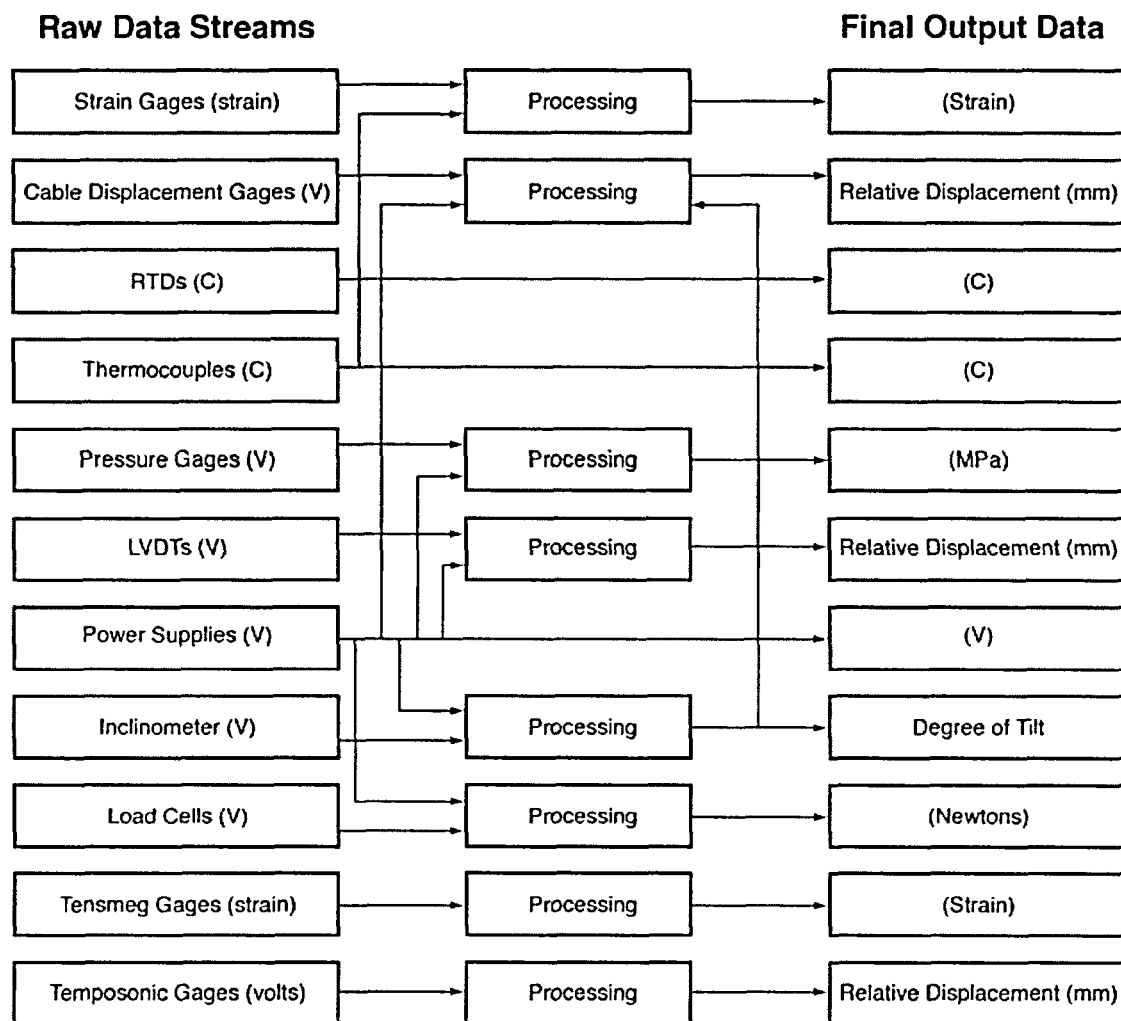
Figure 4.4 Basic PCCV Data Flow Diagram
