Thermal Creep of Dry-Cask- Stored PWR Cladding and High-Burnup PWR Cladding

***Review of
ANL Cladding Performance Program
July 17, 2003***

Argonne National Laboratory

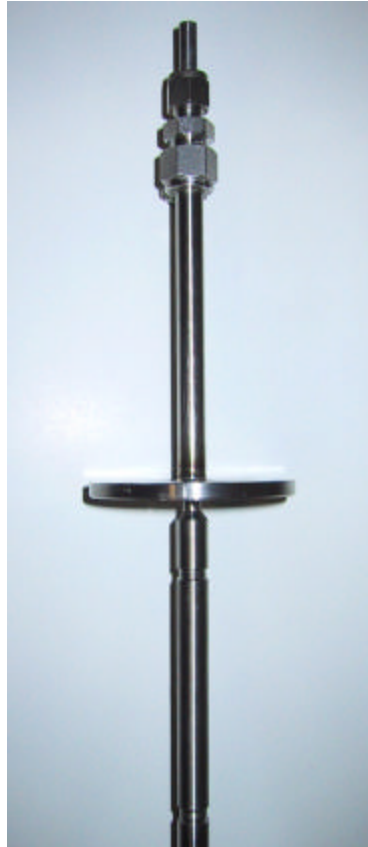
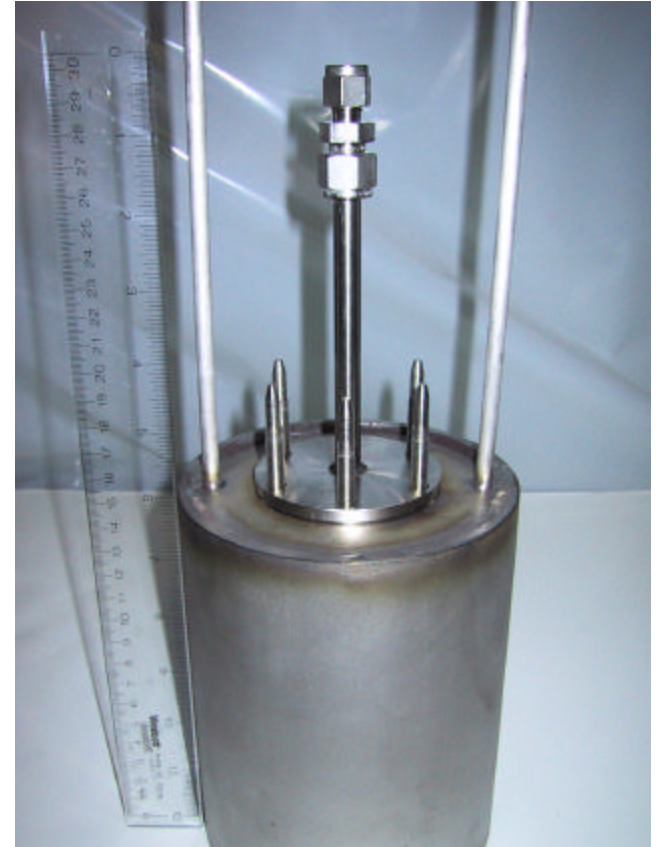
- Test Chamber
 - Inert-gas purged to preclude sample oxidation during test

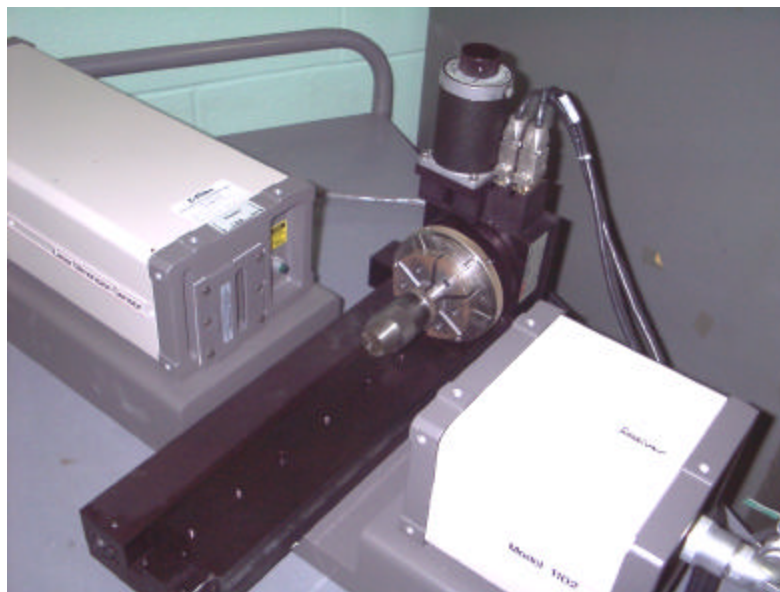
- Measurements made off-line at room temperature
- Diameters measured at multiple axial and azimuthal locations to within $\pm 2 \times 10^{-5}$ in. (0.005% strain)
- Length measured to $\pm 10^{-3}$ in. to evaluate creep anisotropy.
