Examination of Spent PWR Fuel Rods after 15 Years in Dry Storage

Argonne National Laboratory

**U.S. Nuclear Regulatory Commission
Office of Nuclear Regulatory Research
Washington, DC 20555-0001**

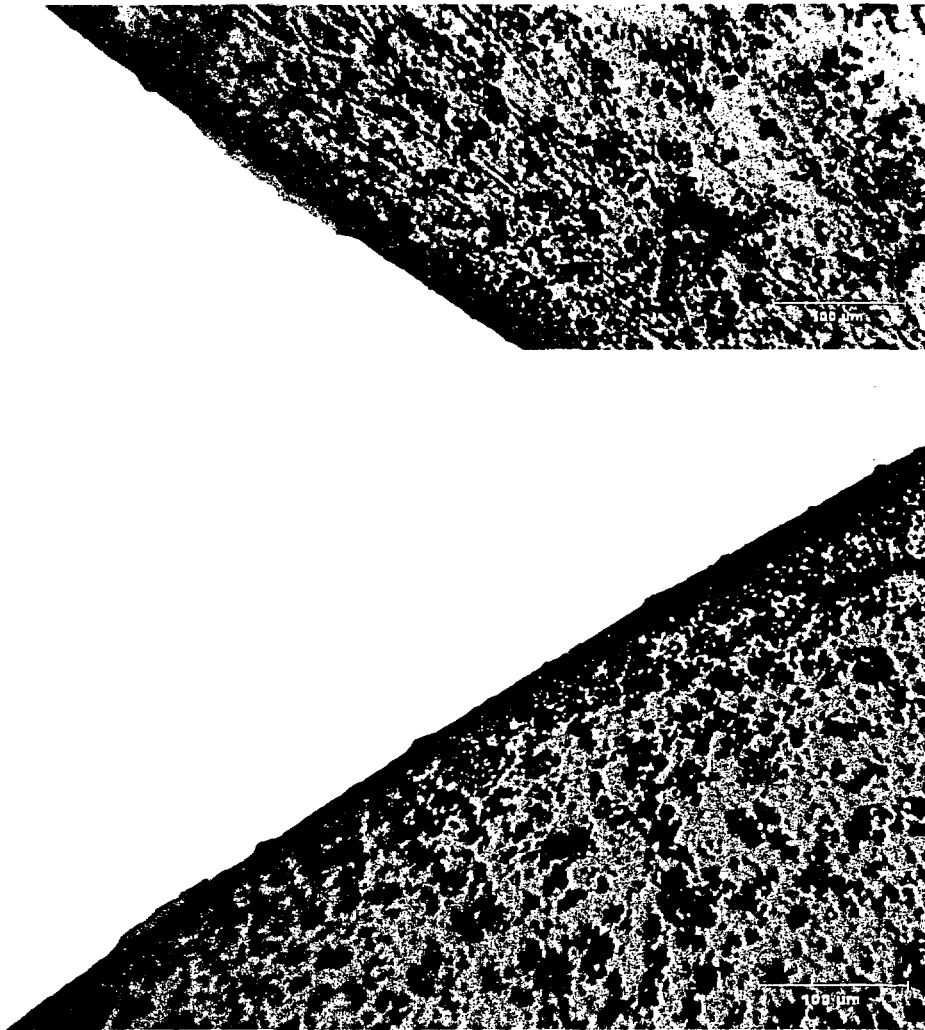
Fig. D.13 Cross-sectional view of Rod G6 fuel-cladding interface and cladding inner-surface oxide layer at two azimuthal positions located at ≈ 500 mm above the fuel midplane (areas 6-8). Scale marker = $100\ \mu\text{m}$.
JPG file = 592C12 ID Oxide Areas 6,8. ET703123, ET703129

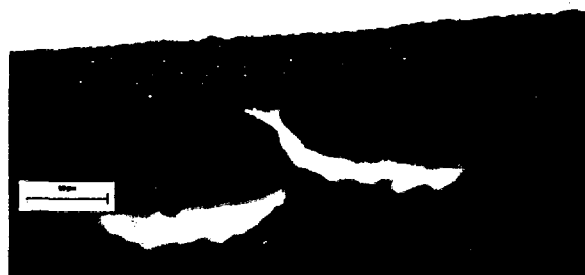
ET-701828

Fig. D.23 Cross-sectional view of Rod H9 cladding outer-surface oxide layer at ≈ 500 mm above the fuel midplane (areas 4-6). Scale marker = 50 μm .
JPG file = 591C12 OD Oxide Area 4-6.

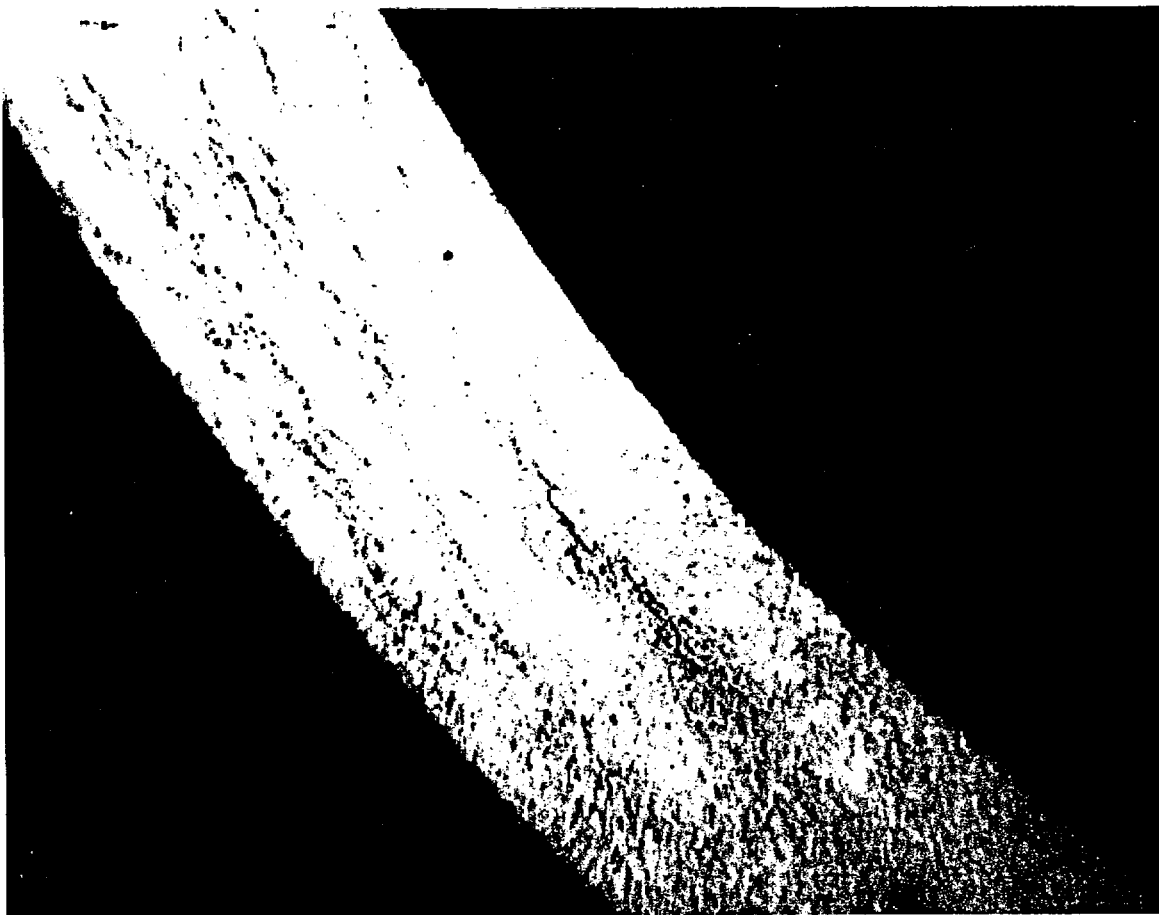
Fig. D.64 Cross-sectional view of Rod H9 cladding hydride morphology at ≈ 500 mm above fuel midplane (area 8). Scale marker = $250\ \mu\text{m}$.
JPG file = 591C12 Hydrides Area 8.

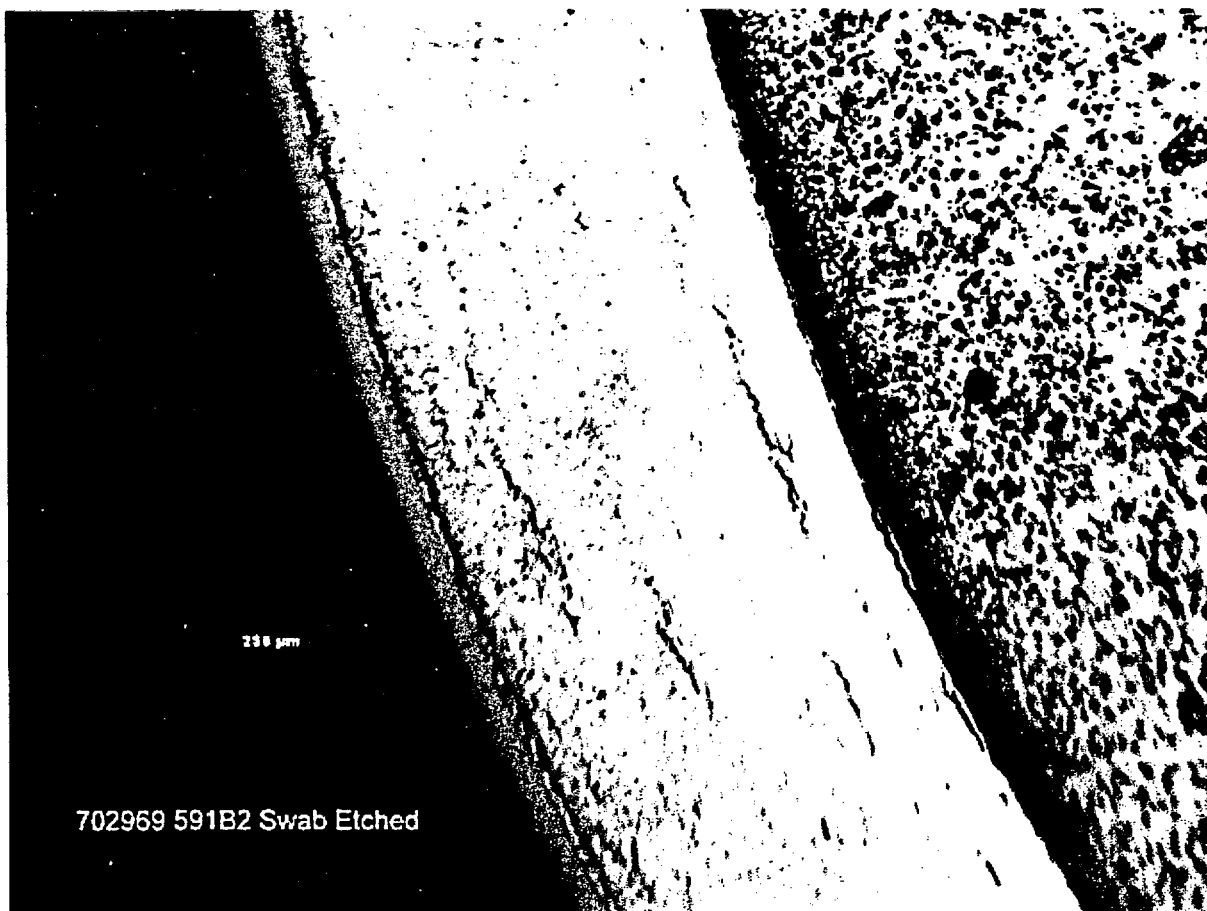
Fig. D.66 Cross-sectional view of Rod H9 cladding hydride morphology at ≈ 1000 mm above fuel midplane (area 2). Scale marker = $250\ \mu\text{m}$.
JPG file = 591B2 Hydrides Area 2.

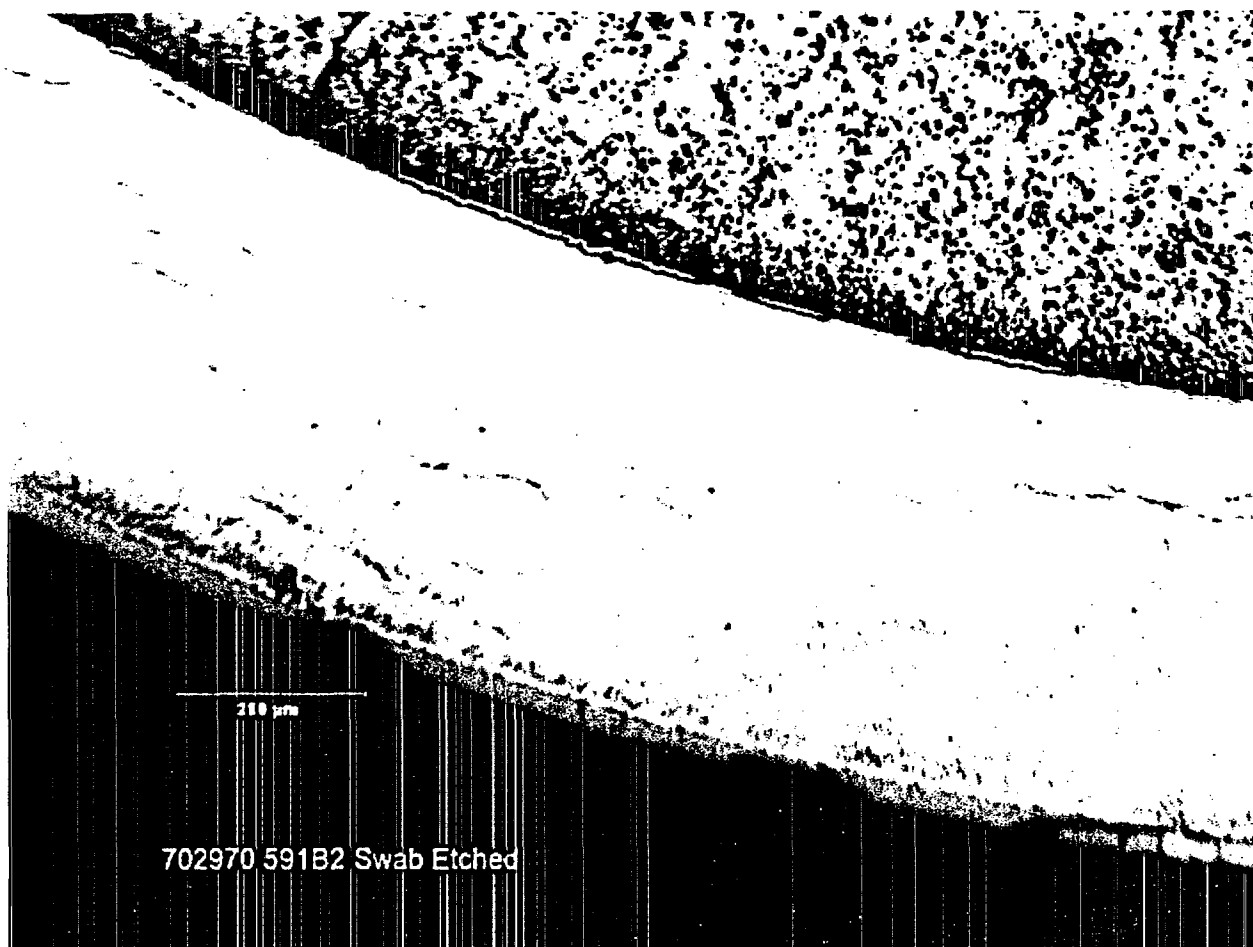
Fig. D.67 Cross-sectional view of Rod H9 cladding hydride morphology at ≈ 1000 mm above fuel midplane (area 3). Scale marker = $250\ \mu\text{m}$.
JPG file = 591B2 Hydrides Area 3.

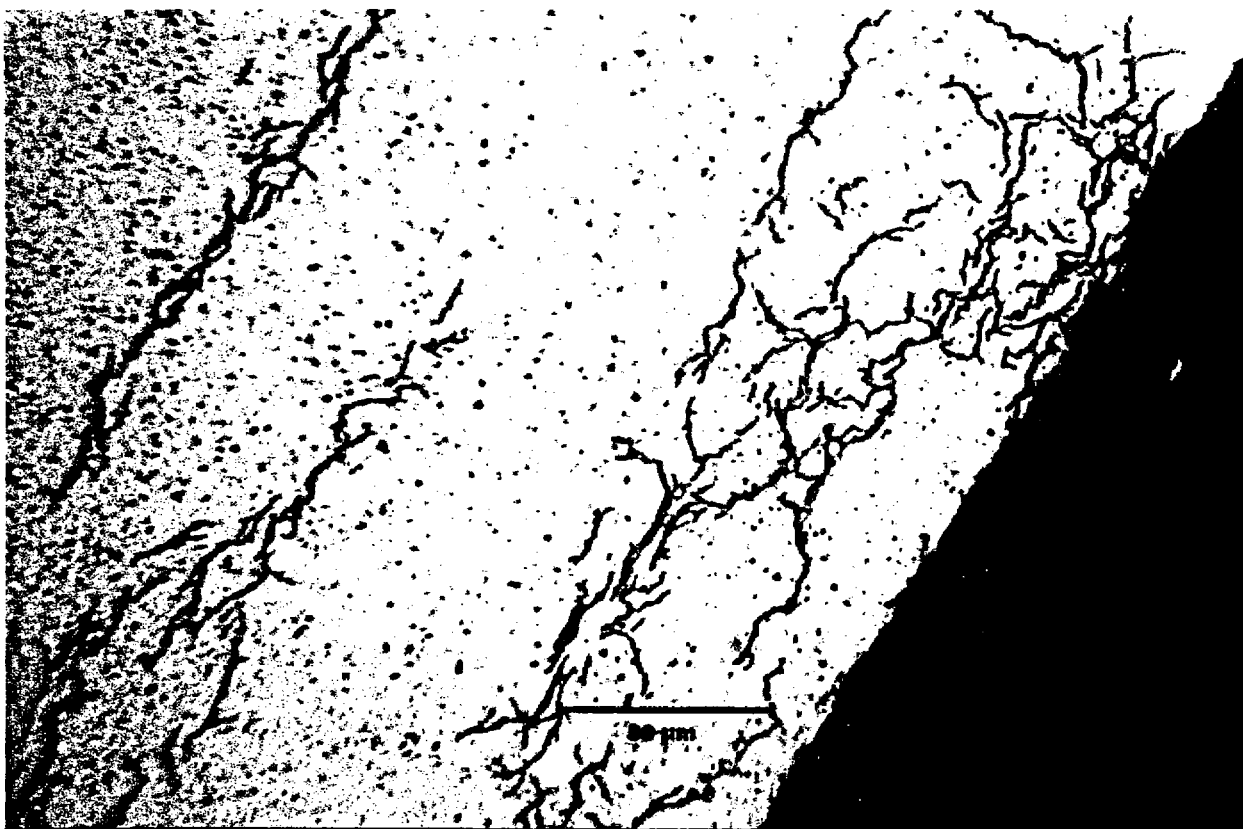
Fig. D.88a. High magnification of hydride orientation/distribution near the outer surface ≈ 500 mm above the fuel midplane (area 4) within Rod G6 cladding.
JPG file = 592C12 etched area 4 outer. ET703267.
