Smart Sign

S U P P O R T

*Structural investigation
enables engineers
from Lehigh University
and the New Jersey
Department of
Transportation
to develop design
criteria for cantilever
sign support structures.*

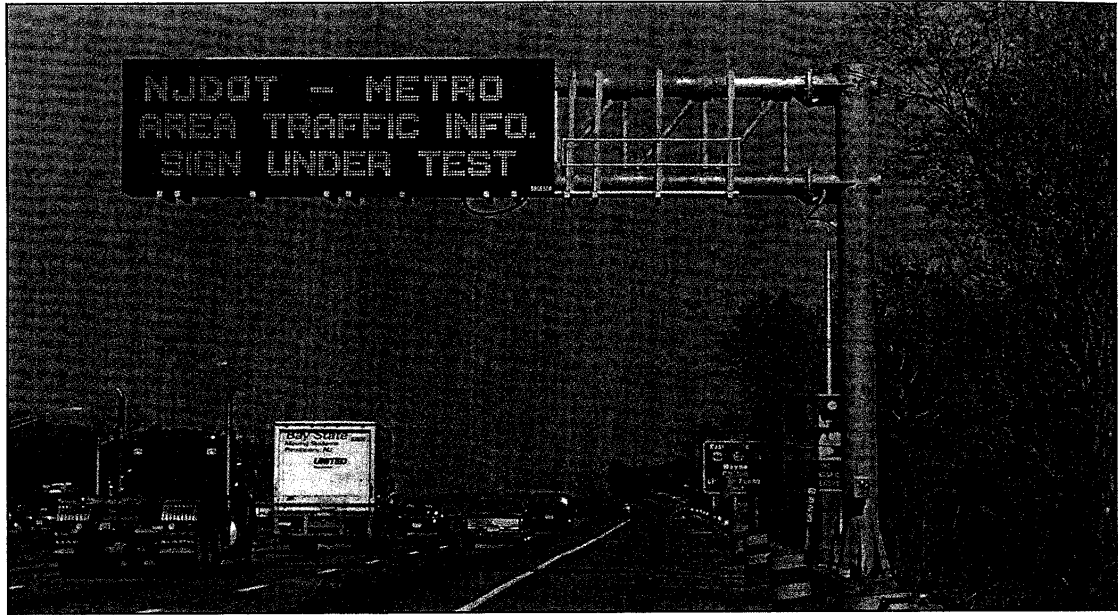
Fig. 1 Typical VMS Cantilever Sign Support Structure

Cantilever structures were selected because they are more economical than the overhead (bridge) type of sign support structure. They were to be fabricated from steel pipe, to have a maximum truss span of 44 ft (13.4 m), and to be hot-dipped galvanized. Each is supported by eight anchor bolts that attach the single-column steel post to the concrete caisson foundation. The anchor bolts for the structures are 3 in. (76.2 mm) in diameter and are produced from A-36 steel threaded rods. At most locations, the VMS has been placed at the extreme free end of the cantilever truss.

Almost immediately after the prototype was installed, the structure moved vertically as well as horizontally when trucks passed underneath. The structure oscillated for many cycles after the passage of tractor-trailer trucks, which also induced wind gust loads on the frontal area, the underside of the members, and the attachments mounted on the truss. The FHWA and the NJDOT were concerned that this uplifting movement would affect the structure's fatigue life. After about nine months of in-service performance, the anchor bolt nuts on the baseplate of the column post loosened. When that happened, the structure was immediately removed.

low natural frequency, about 1.0 Hz. Such structures also have extremely low critical damping ratios, typically less than 1 percent. These characteristics make cantilever support structures particularly susceptible to large-amplitude vibration and to fatigue cracking caused by wind loading.

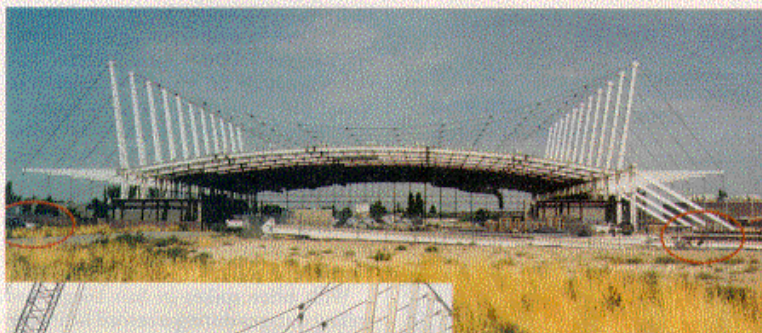
RINK Fix, after failure (left), has cables attached to steel cages over pile caps (circled).

A two-month probe by Geiger Associates Consulting Engineers, New York City, which included bolt material tests at Lehigh University in Bethlehem, Pa., confirmed the suspicion that pile-cap anchor bolts sheared to initiate the partial collapse (ENR 5/15 p. 16). The cause was "design of the cable attachment to the foundation and the serviceability of the anchor bolt materials at that attachment," says Mitt Romney, president of the Salt Lake Organizing Committee (SLOC).

Like a larger shoe box being placed over a smaller one, the 2 x 4-ft new steel cages, which vary in height, will be installed over the tops of the piles and pile caps, after some excavation. Workers will then bolt the cages to the pile caps. The suspension cables will attach to the cages. The fix is expected to take one month, according to the skating rink's contractor, Layton Construction Co., Salt Lake City.
