CABRI CIP0-1 PRELIMINARY TEST RESULTS

JC Mélis, C Marquié, M Faury, J Papin
IRSN

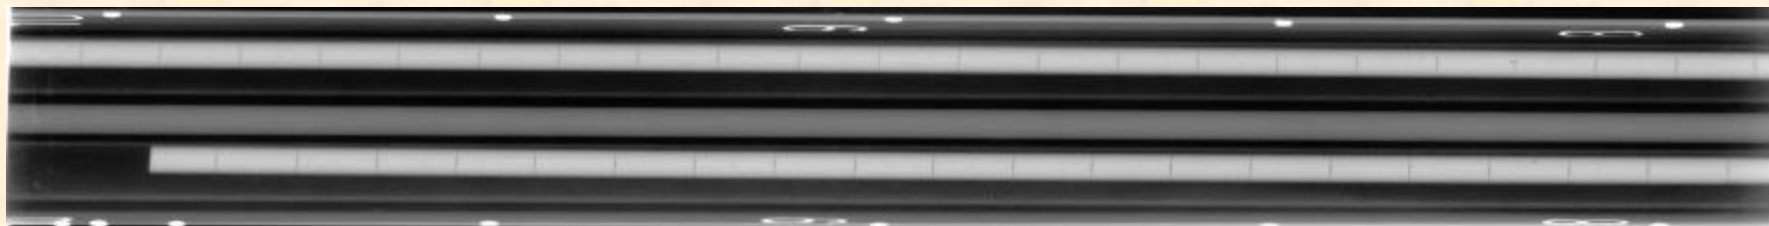
Neutronography : hydride concentrations at pellet-pellet interface

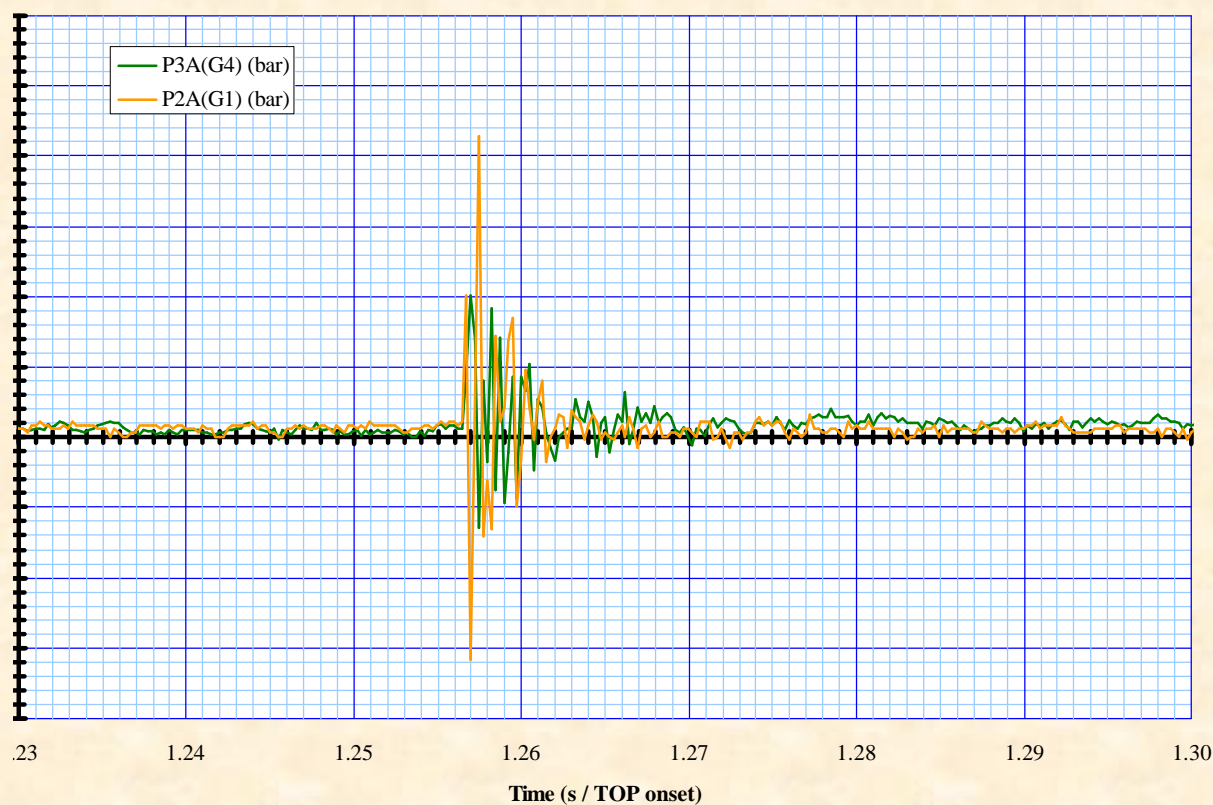
Pressure event

Time: TOP+1.26 s

Energy: 98.2 cal/g

150 μ s before microphone event !!!

- Microphone event close to saturation on M2
- Flow, pressure and VD event
- This event could be interpreted as clad failure, but:
 - No detection on DND signals
 - No detection of ^{85}Kr on the Na cover gas after test
 - Unconsistent timing: P,Q before microphones
 - No failure seen during visual examination in hot cells
- Quantitative gamma-scanning on the upper plenum was performed
