# **Drop Test Results for the Combustion Engineering Model No. ABB-2901 Fuel Pellet Shipping Package**

**Lawrence Livermore National Laboratory**

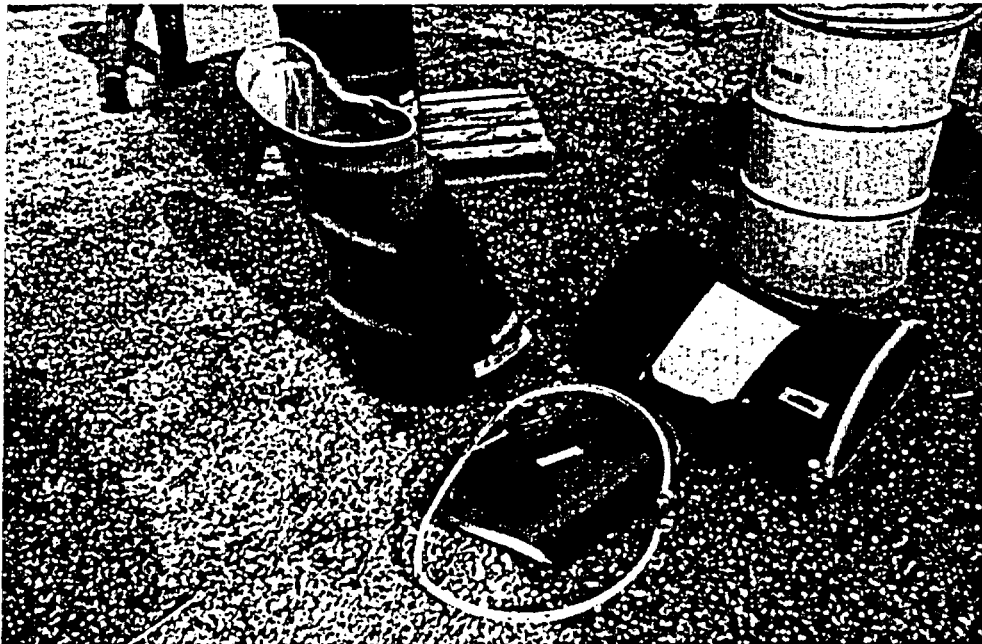
**Figure 20. Damage to Lid, Closure Ring and Drum Along Side of Damage to Previously Dropped 133-l (35-gal), Water-Filled Drum**

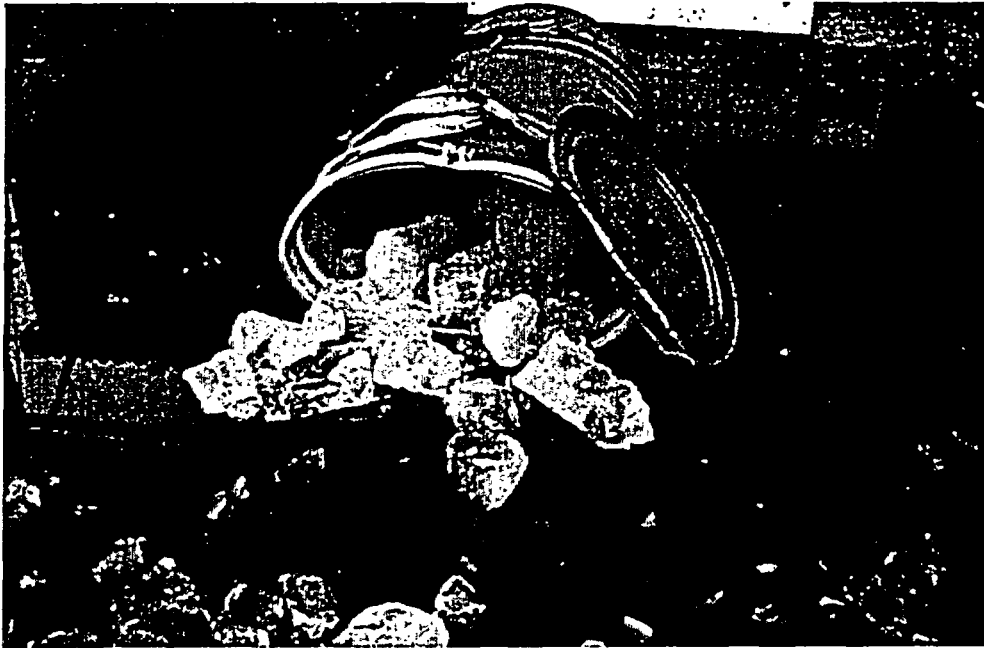
**Figure 21. Damage to Drum and Lid after Ice-Filled Drop (Close-Up)**

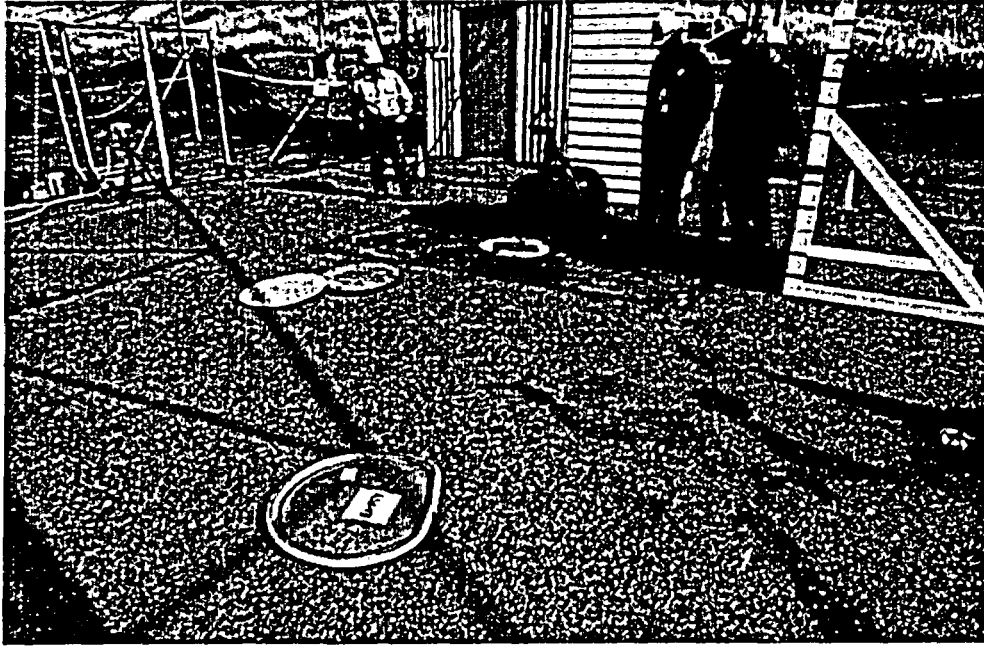
**Figure 27. Post-test Component Orientation (Wide-Angle View)**  
 From left, Jesse Rivera (LLNL), Rich Villafana (LLNL), Tom Woehrle (LLNL), and  
 Bruce Clegg (LLNL)

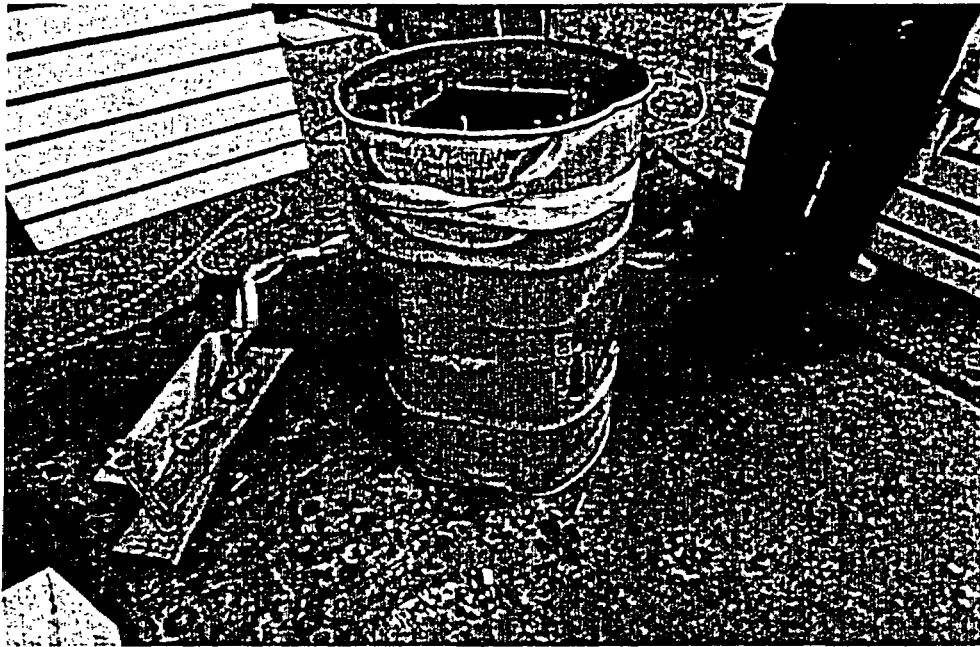
Figure 38. Damage to Open Drum, Side View
