Wind River Environmental Quality Commission
UMTRA Program - Phase II
Surface Water, Sediment, and Biota Final Draft Report

Clean Water Act Section 106 Special Project

September, 2003

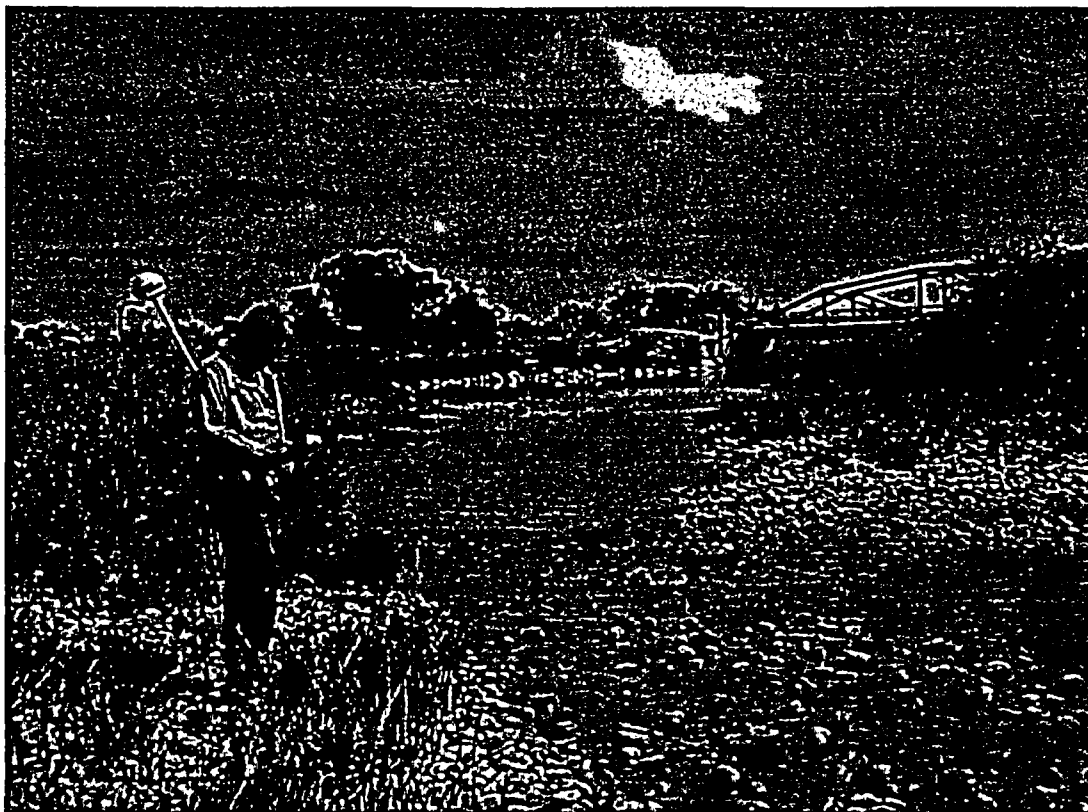
Photo #1: UMTRA Site 1 - Little Wind River

Background Site

Photo taken looking downstream (east)

Location: Just upstream of G36

Sites 1 and 2 (UMTRA#1 and UMTRA#2) are located on the Little Wind River mainstem immediately upstream and downstream of the USGS gaging station G36. This site is considered a background or unimpacted site, as it is at least 4 air miles away and upstream/upwind of the UMTRA site.

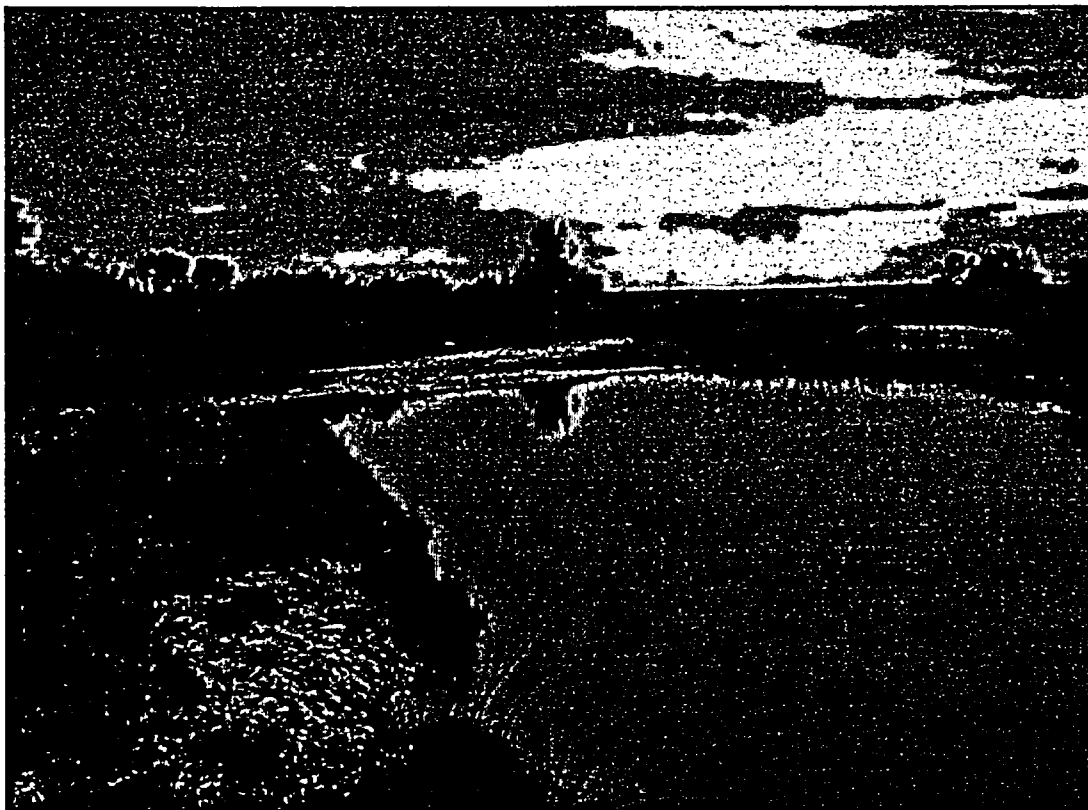
Photo #2: UMTRA Site 2 - Little Wind River

Background Site

Location: Just downstream of G36

Note: low beaver dam is visible in top center of photo

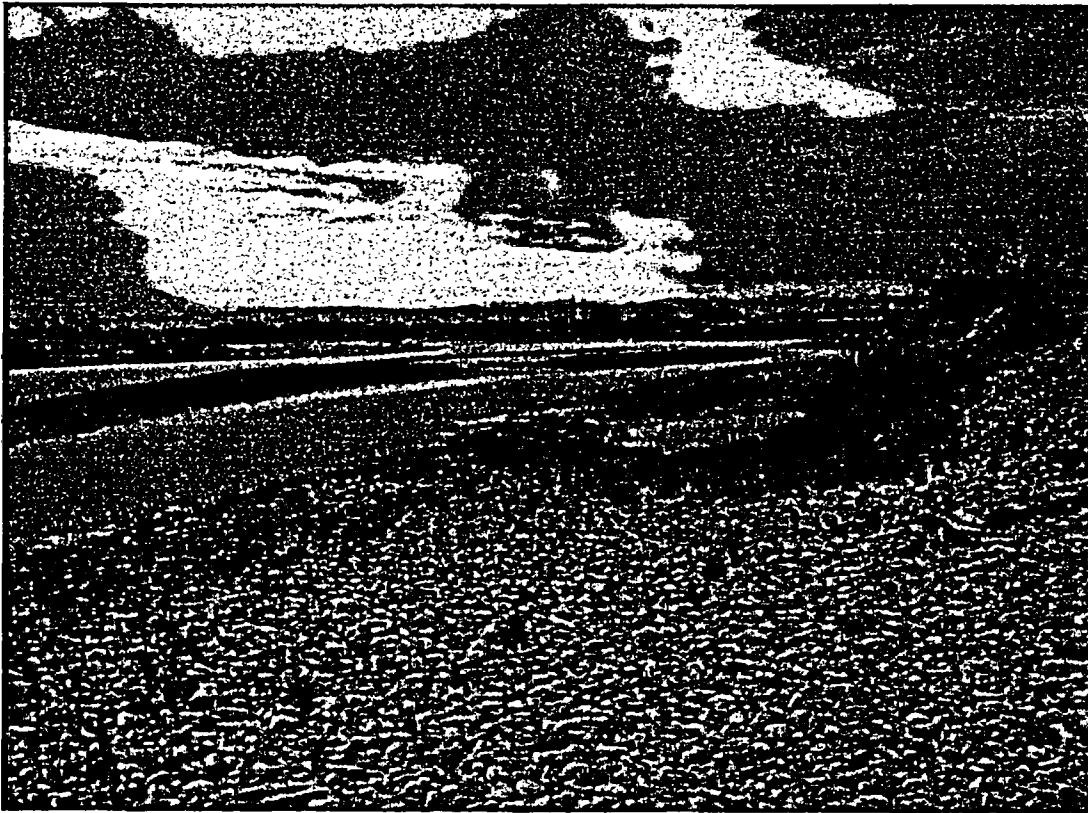
Photo #4: UMTRA Site 4 - Little Wind River
Undetermined if Background or Impacted Site
Photo taken looking upstream (west) from north bank
Location: just upstream of Oxbow Lake

Site 4 (UMTRA#4) is located on the Little Wind River immediately upstream of where the cutoff channel for the Oxbow Lake takes off from the main channel on the north bank of the river. Because of its location in the immediate vicinity of the Oxbow Lake and the discharge of the contaminated groundwater plume, this site cannot be considered a distinct background or nor a definitive potentially impacted site.

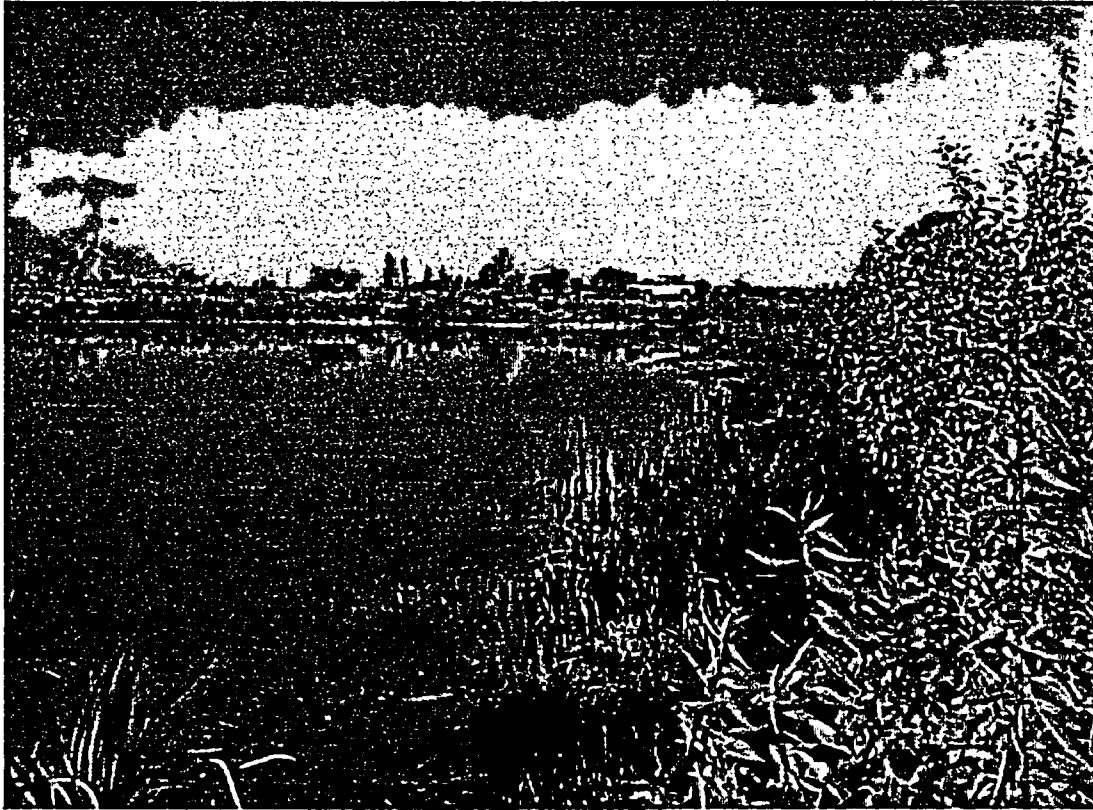
Photo #6: UMTRA Site 7/8 - Constructed Wetland

Potentially Impacted

Photo taken looking east from south bank

Location: Adjacent to Rendezvous Road

Site 7/8 (UMTRA #7-8QA1) is located at the constructed wetland along Highway 138, on the eastern edge of the UMTRA site. This site was chosen because it was one of the few areas where surface water is accessible within the Riverton UMTRA Project Area. The location of the wetland on the eastern edge of the identified contaminated groundwater plume was another reason for choosing it as a sampling site. The wetland was created in 1998 as a mitigation site for wetlands disturbed or lost during the construction of the public water supply extension into the UMTRA Project area. This site was subject to two separate ("split") samples for quality control purposes.

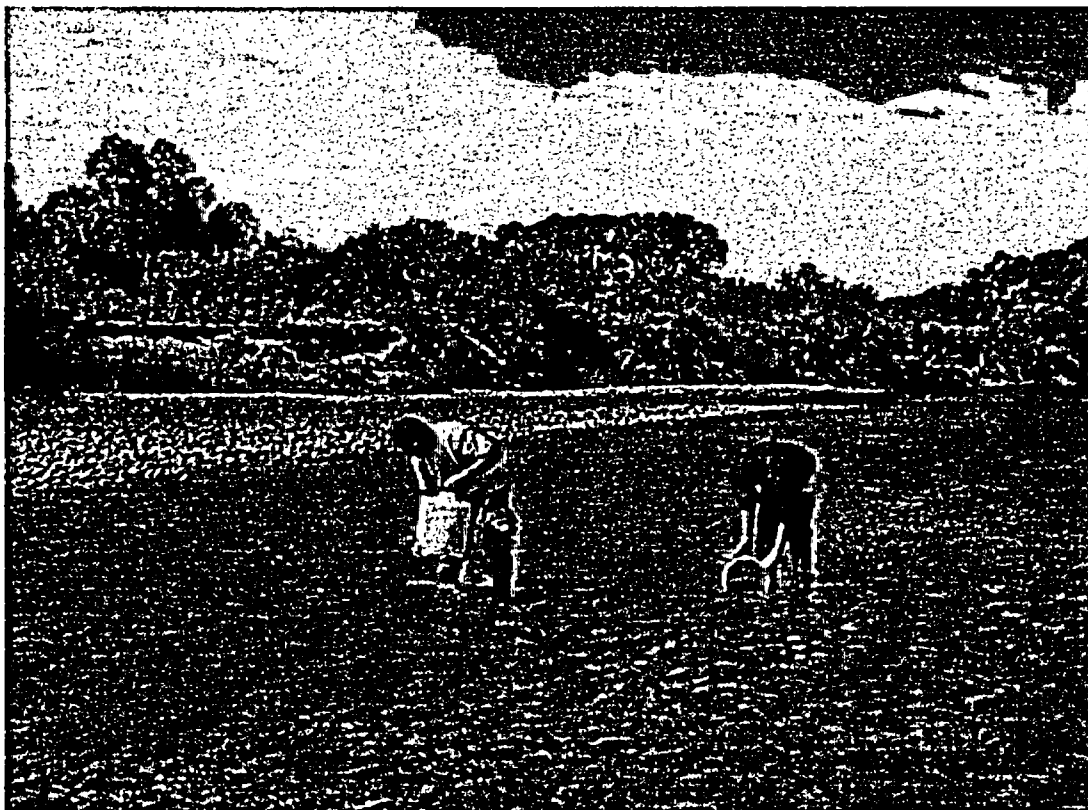
Photo # 7: UMTRA Site 9 - Little Wind River

Potentially Impacted Site

Photo taken looking downstream (north) from south bank

Location: Just upstream of Highway 789 bridge

Site 9 (UMTRA#9) is located on the Little Wind River, approximately one half mile downstream of Site 4. This site was chosen as a potentially impacted site due to its location downstream and down gradient from the Oxbow Lake and the contaminated groundwater plume. The site is located just upstream of the Highway 789 bridge over the Little Wind River, south of the city of Riverton.

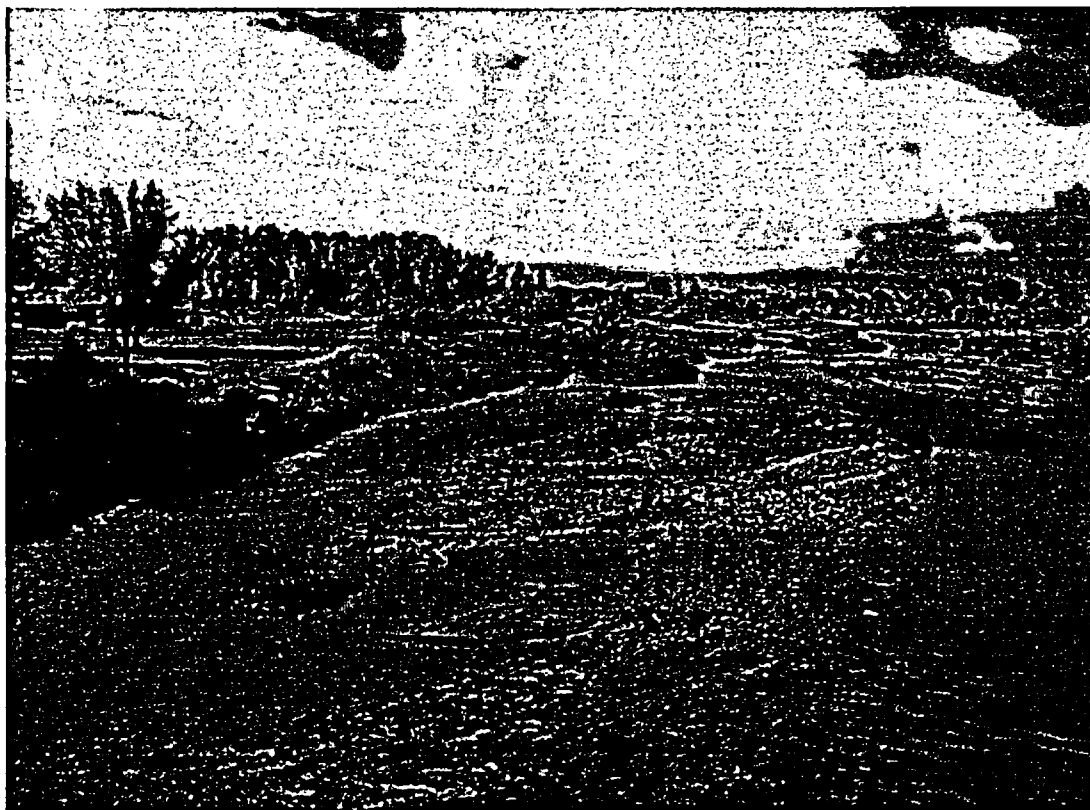
Photo #9: UMTRA Sites 11/15 - Big Wind River

Potentially Impacted Site

Photo taken looking upstream (west) from north bank

Location: Bridge on Highway 789, at south edge of
 Riverton

Sites 11 and 15 (UMTRA#11 and UMTRA#15) are located on the Big Wind River at the highway crossing just south of the city of Riverton. This site coincides with the USGS/WREQC water quality monitoring station G22.

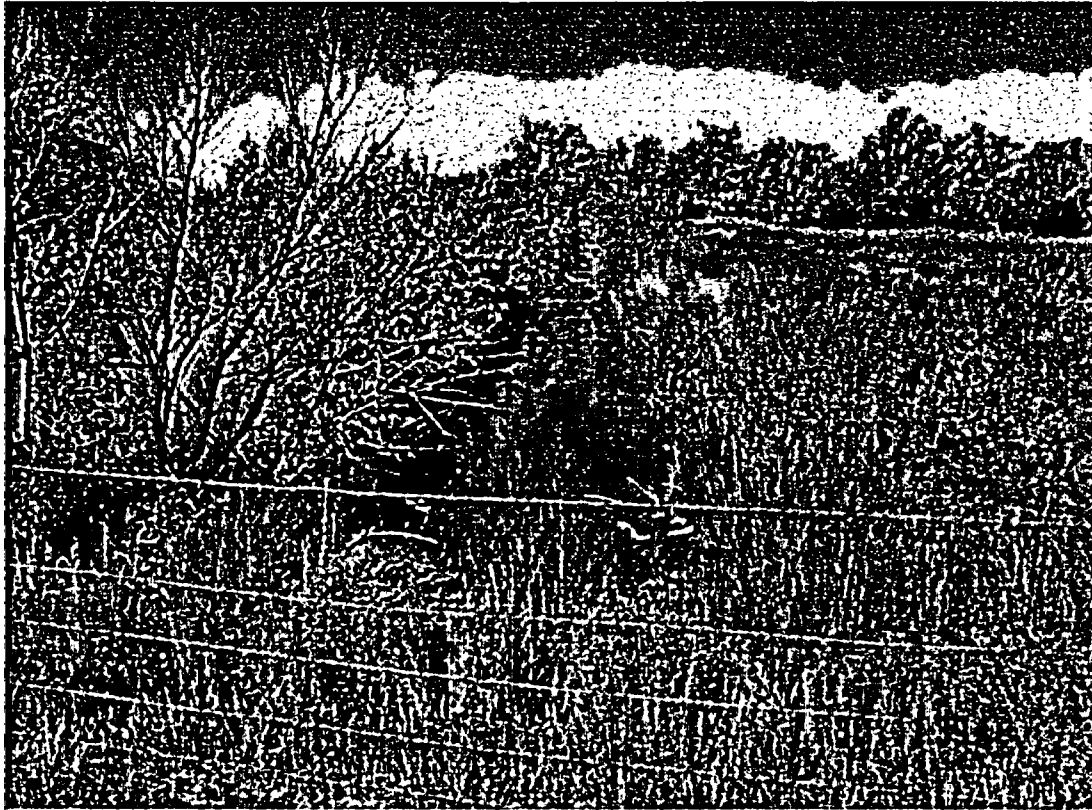
Photo #10: UMTRA Site 12 - Westside Irrigation Ditch

Expected Impacted Site

Photo taken looking upstream (north) from Rendezvous Road

Location: Adjacent to north side of Rendezvous Road

Site 12 (UMTRA#12) is located on a drainage ditch along Highway 138 (17 Mile Road) immediately across from the St. Stephens Cemetery. This ditch flows year-round as a result of both the discharge from the Peak Sulfur Company facility and because it intercepts the shallow surficial aquifer in the area. This site was chosen as a potentially

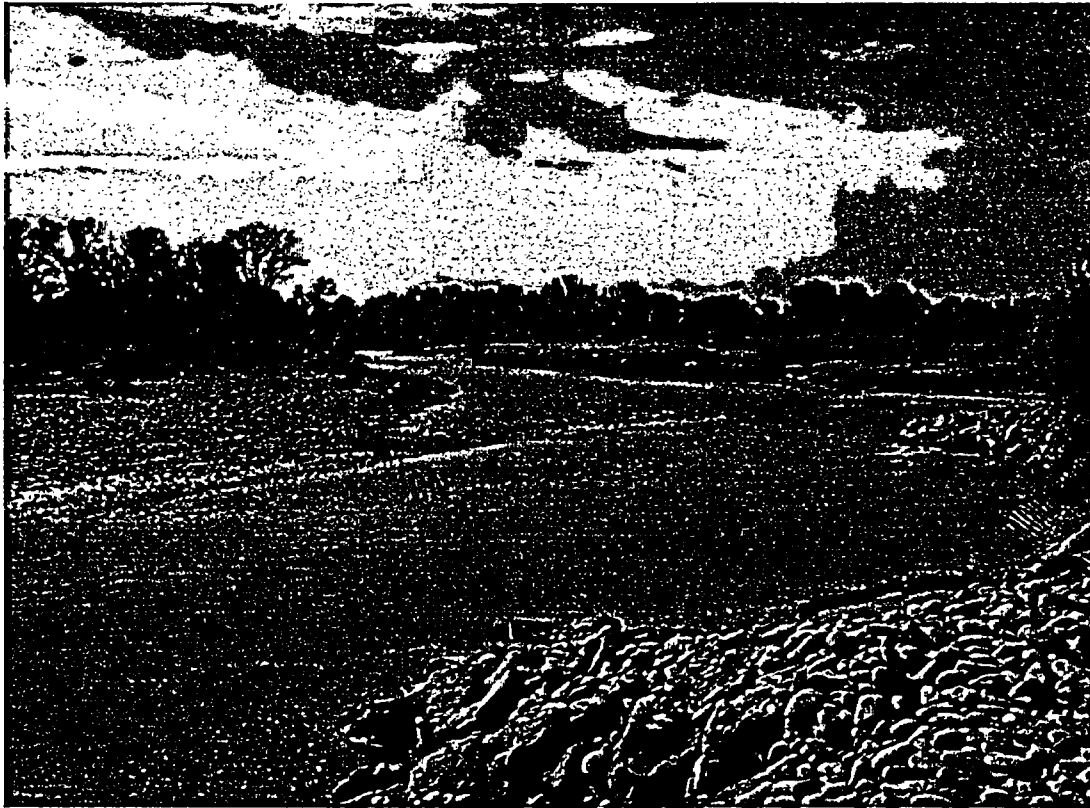
Photo # 12:

UMTRA Site 16 - Big Wind River

Location: Riverton Rendezvous Site

Site 16 (UMTRA#16) is located on the Big Wind River at the historic Wind River Rendezvous Site just south of the city of Riverton. This site was selected as a downstream, potentially impacted sampling site, as it is unknown whether the contaminated groundwater plume discharges toward the Big Wind River immediately upstream of this site.

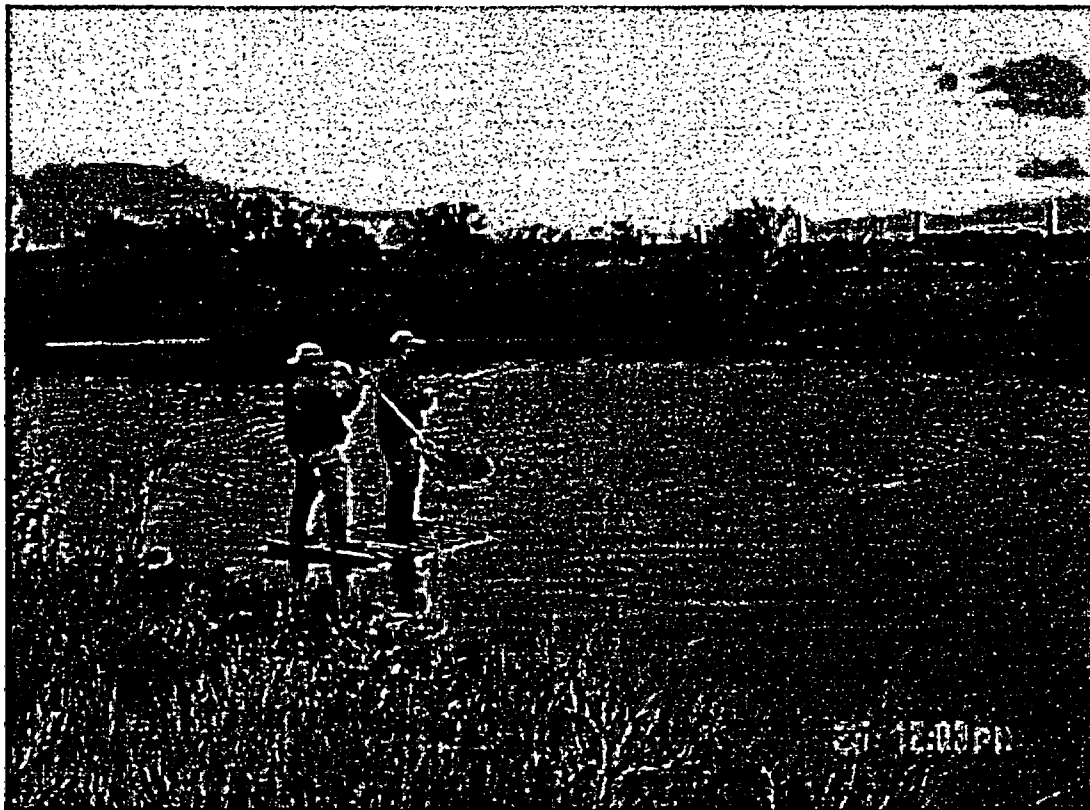
Photo #14 : Snagging and collection of carp at Oxbow Lake

- b. Biota (carp, crayfish, and vegetation) was sampled using a variety of techniques. Carp were collected by snagging, using rod and reel and a large treble-hooked spoon (Photo #14). Samples were preserved and shipped to the analytical laboratory using methods outlined in the EPA's Office of Science and Technology National Study of Chemical Residues in Lake Fish Tissue QAPP document (Photo #15).
Vegetation was collected by methods suggested by the analytical laboratory. A backhoe was used to collect entire specimens of brush or small trees (Photo #18). A sanitized set of clippers or bow saw was used to collect specific parts or sections of the vegetation for shipment to the laboratory.

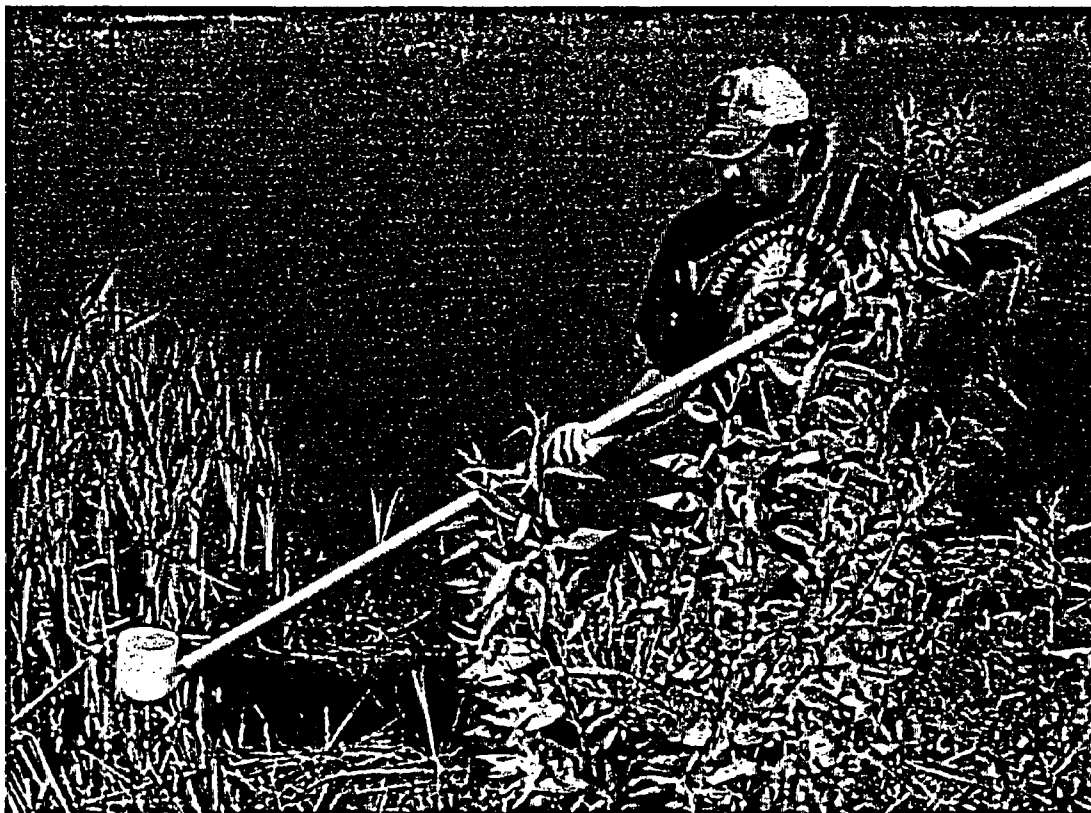
Photo #16 : Dipper on pole used for sediment and surface water composite samples from standing waterbodies

collect samples from wetlands (Oxbow Lake/Site 5) and the active gravel mining operation where flowing water (stream or river) was not present. At these three sites surface water samples were collected using a long handled dipper with a liter container attached to the end (Photo #16). A composite sample was taken (at least 10 separate liter containers of water per site) with the samples treated identically to regular surface water samples once in the 20-liter carboy.

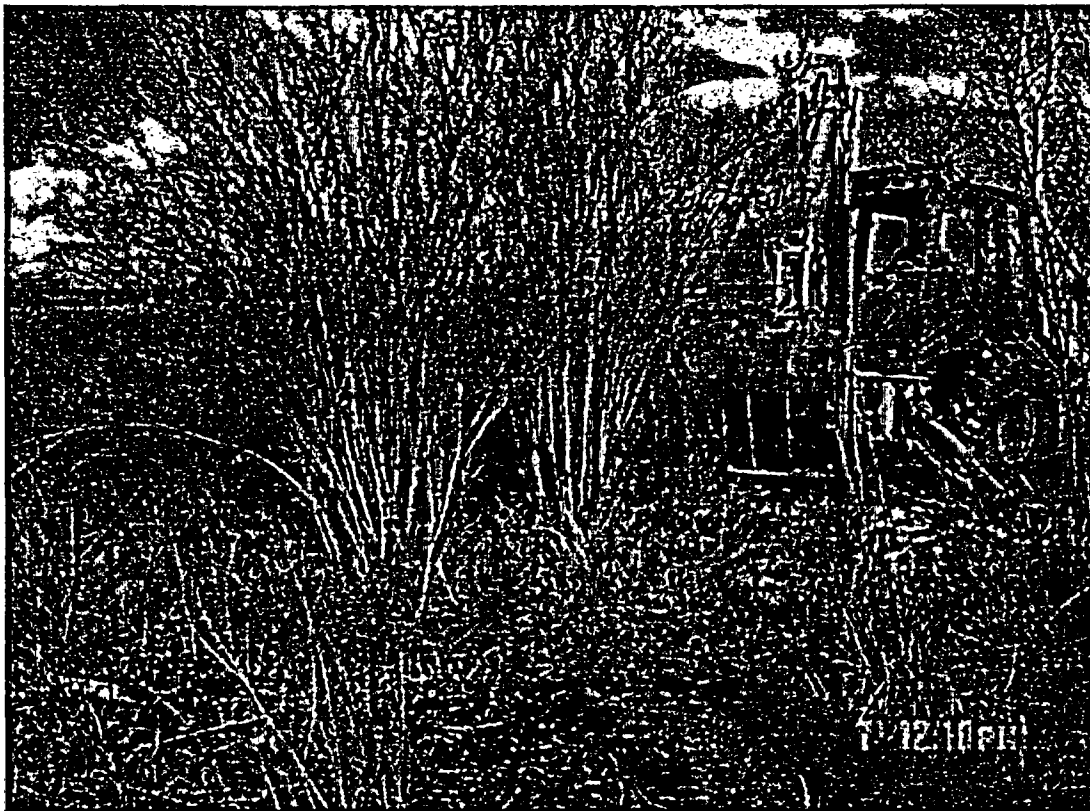
Photo #18:

Backhoe used for excavation of vegetation samples
