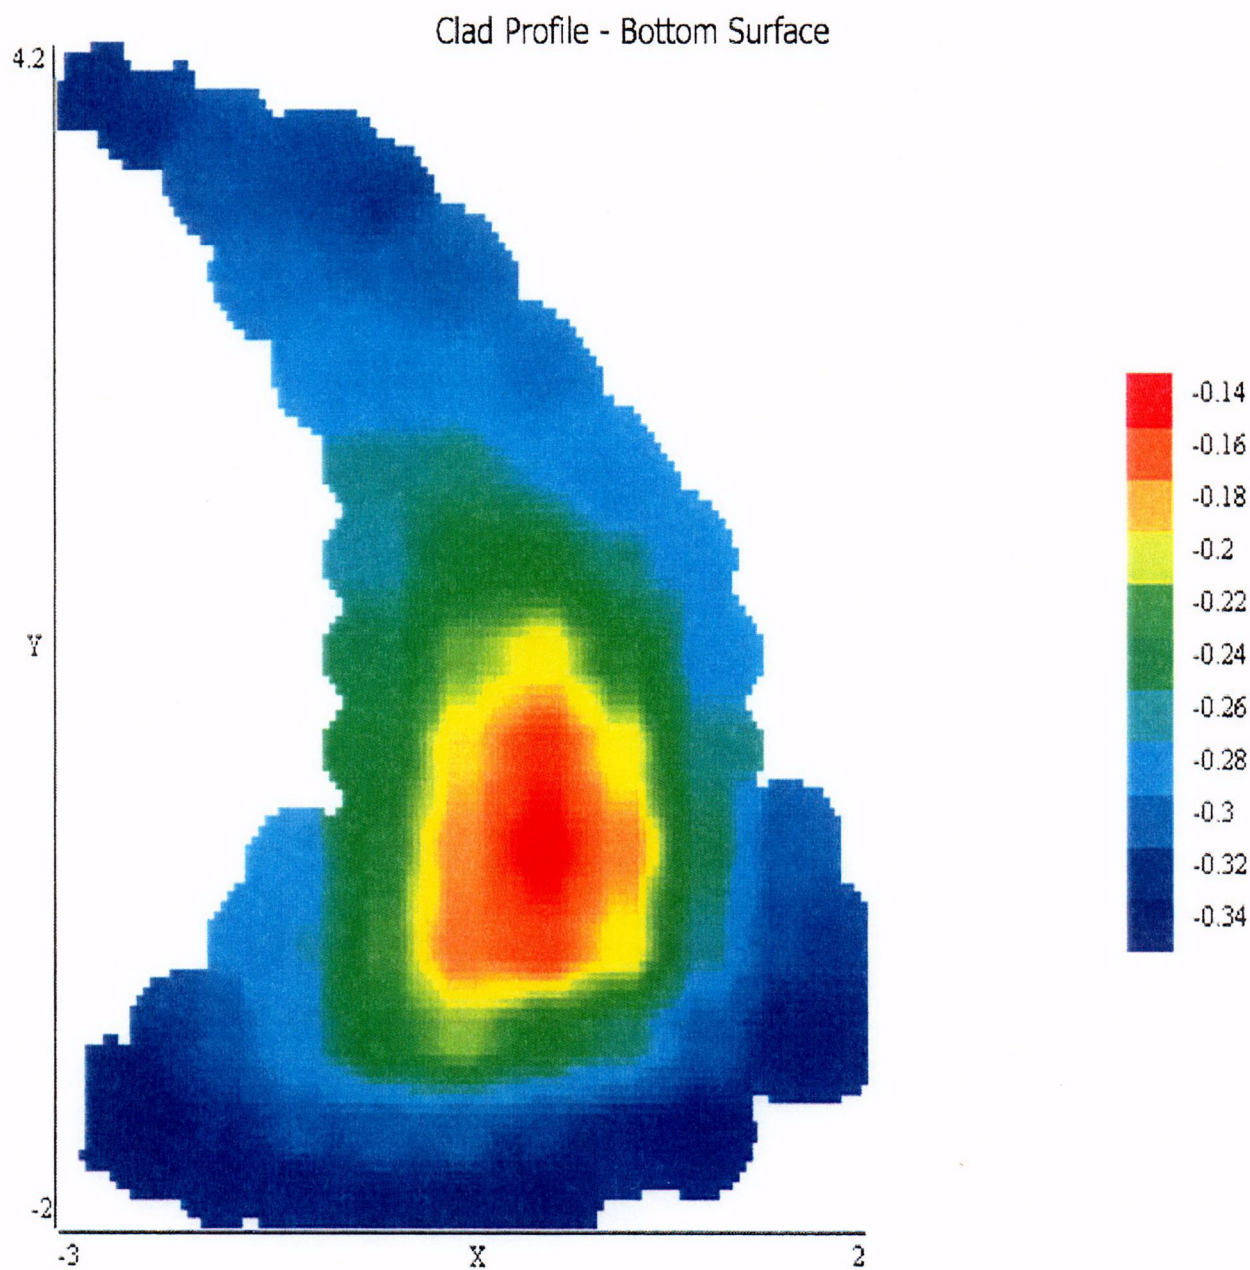
Figure 3.5.6: Colorized representation of bottom surface of cladding (RCS side). Red area denotes area of maximum deflection.

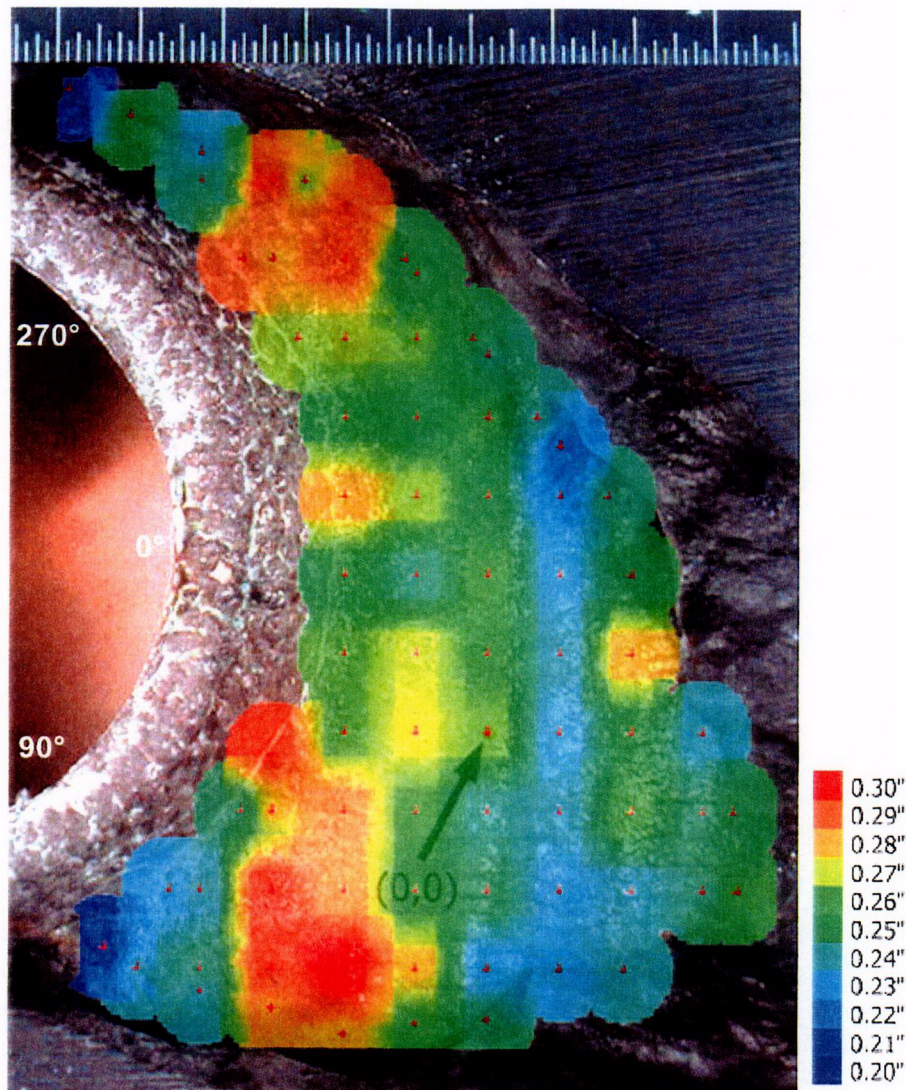
Figure 3.5.7: Exposed cladding surface with superimposed colorized thickness data. The thinnest areas of cladding occurred adjacent to the J-groove weld toward the 90° (0.202") and 270° (0.208") locations.

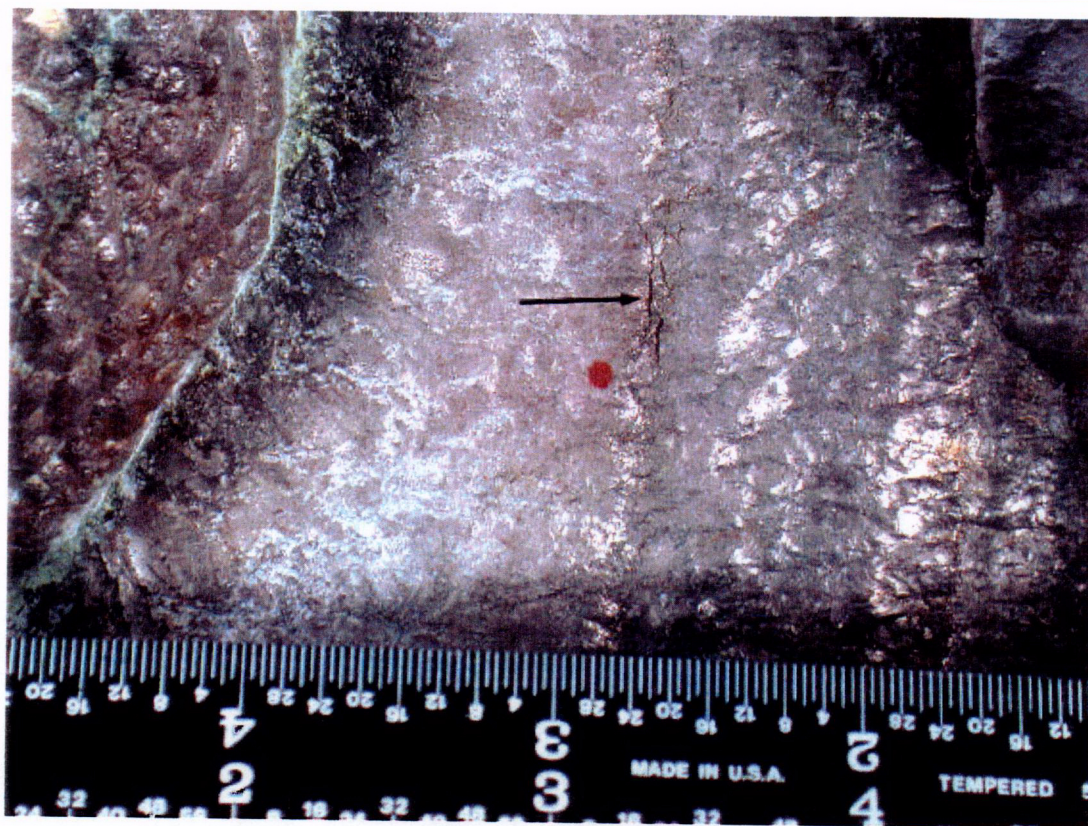
Figure 3.6.1: Photograph showing crack in exposed cladding in deflected region. Red dot indicates (0, 0) coordinates for thickness measurements.

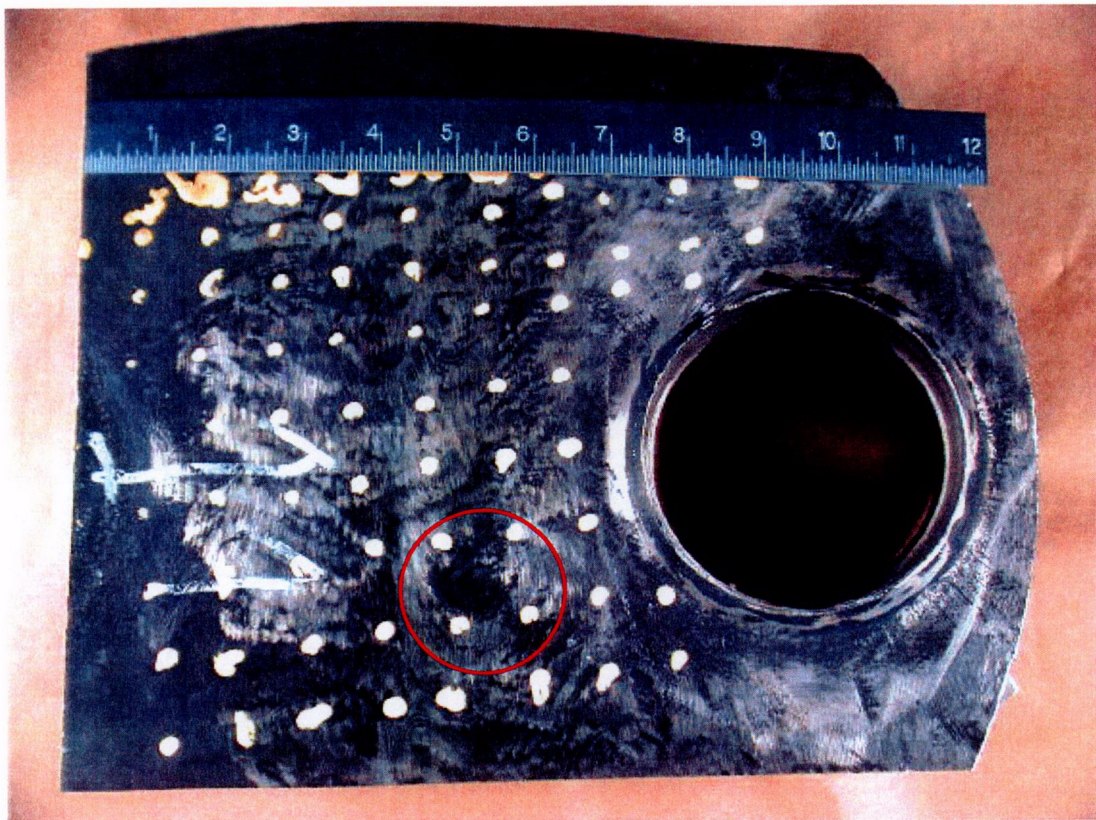
Figure 3.6.5: Low magnification photograph of the cavity underside. The red circle shows the area of maximum deflection. The white dots were applied at Davis-Besse for the UT thickness measurements. The two parallel lines toward the left indicate the Nozzle 11 position, which is outside the photo on the left. This maximum bulging area is shown at higher magnification in the next figure.

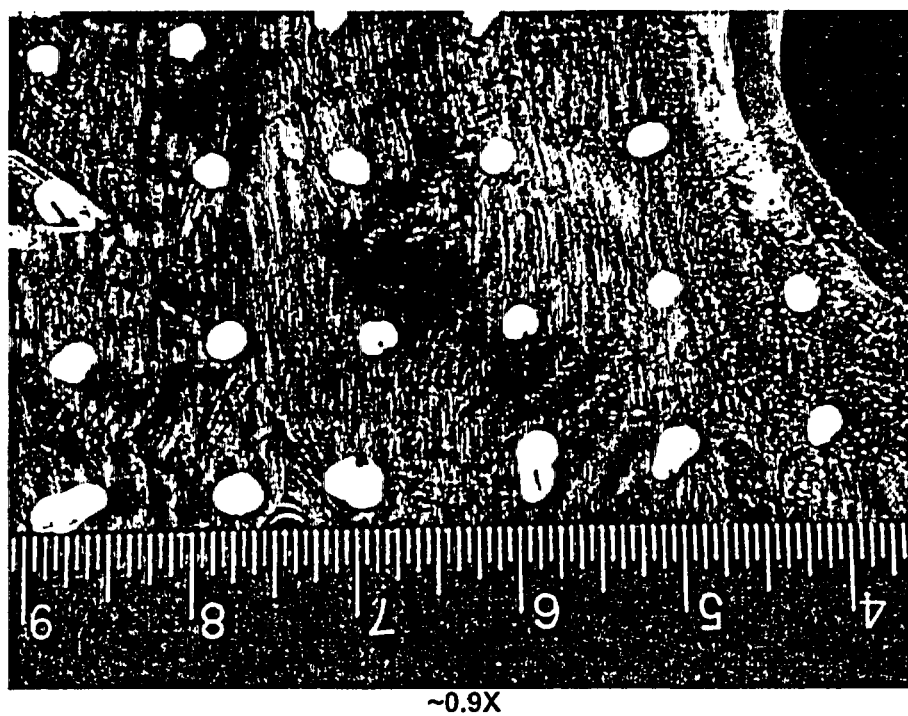
Figure 3.6.6: Higher magnification photographs of cavity underside in area of maximum deflection. No cracks were observed in this area.

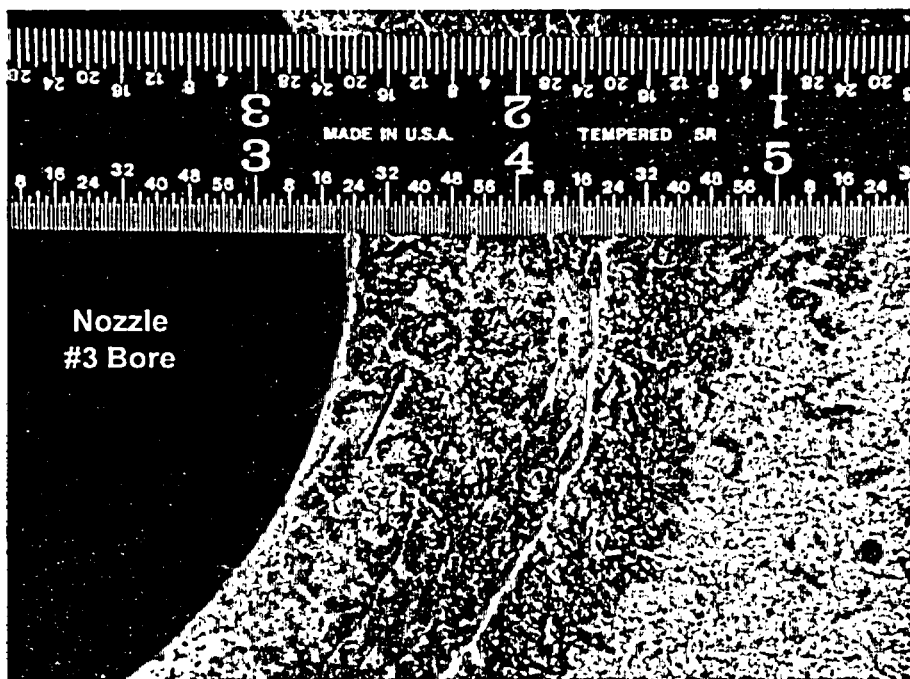
Looking at J-groove weld bore near 10°. ~1.2X

Top view of J-groove weld crack near 10°. ~1.4X

Figure 3.6.7: Photographs showing axial crack in nozzle #3 J-groove weld near 10°.

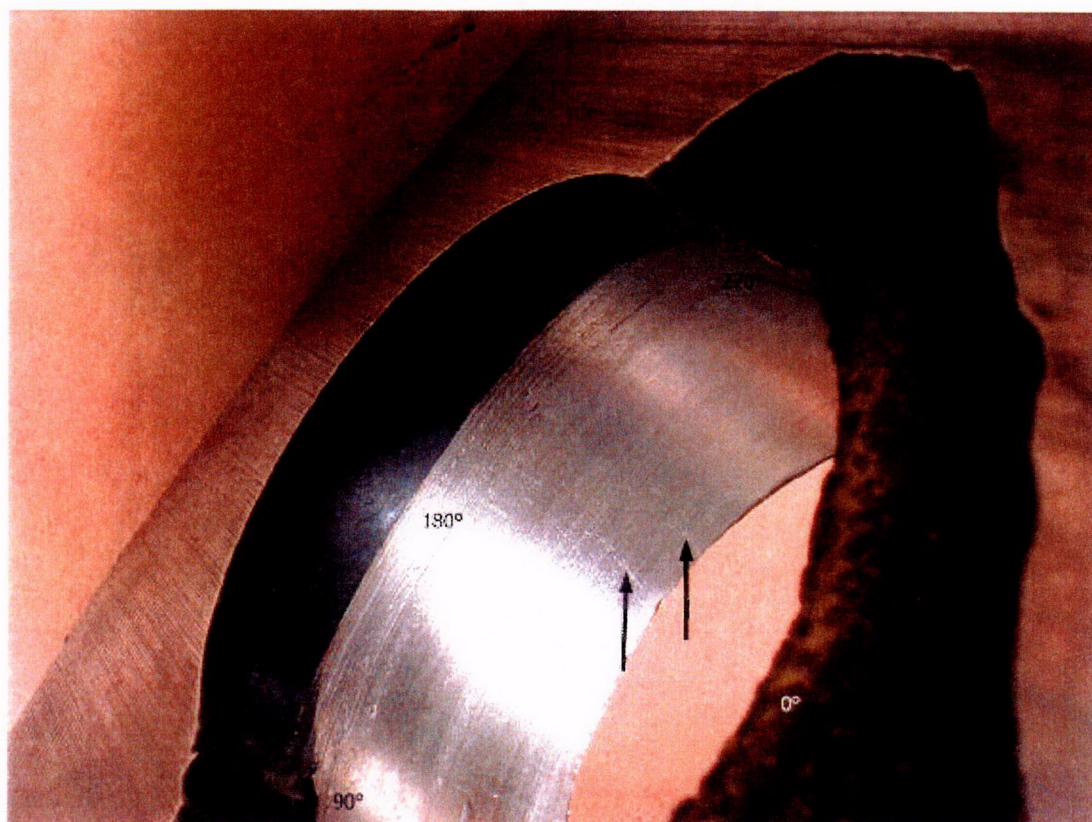
Figure 3.6.8: Axial cracks located on J-groove weld bore near 180°. ~0.75X

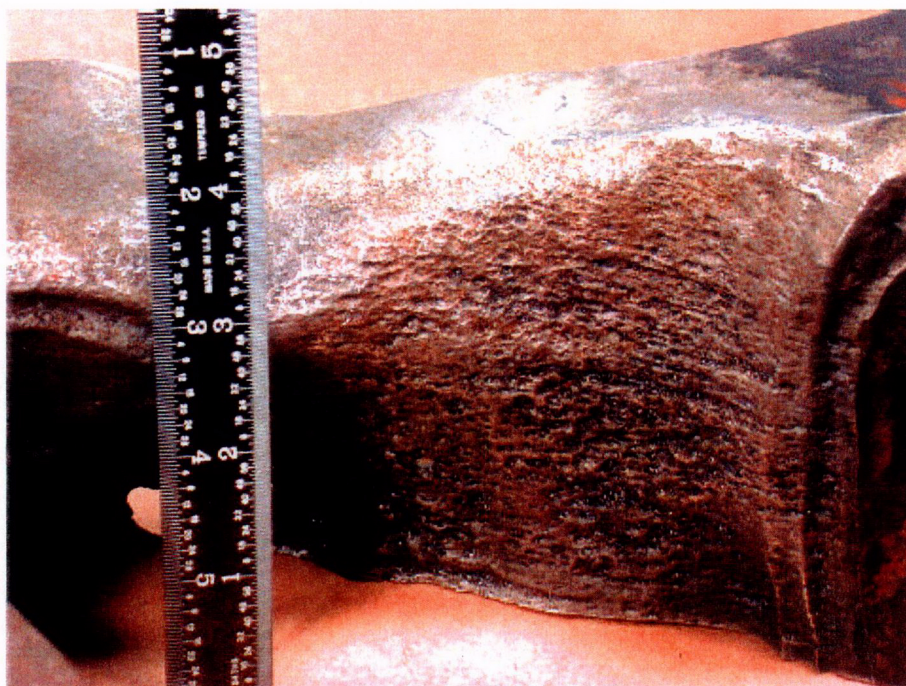
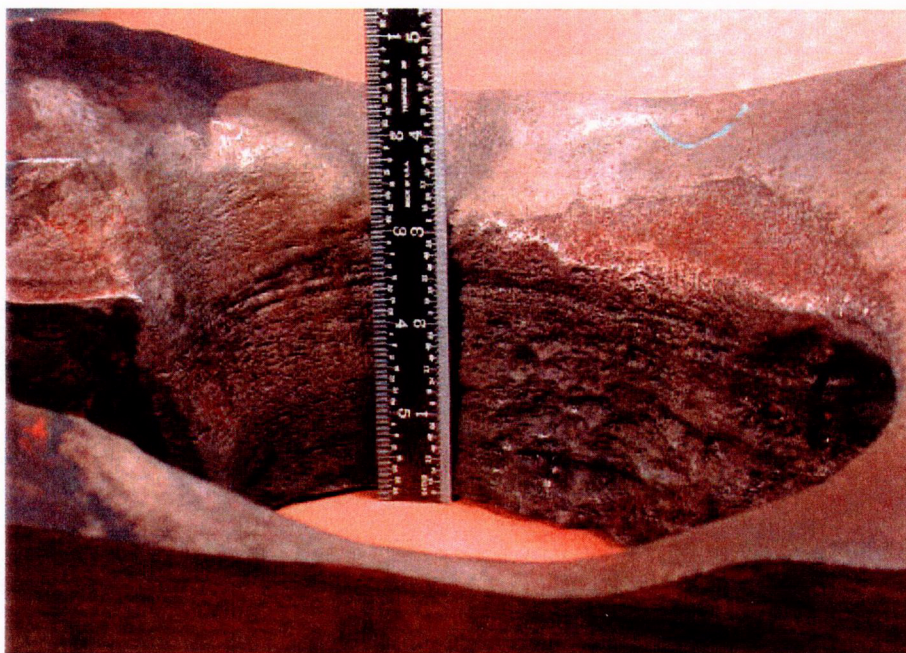
Looking toward 90° ~0.7X

Looking toward 270° ~0.5X

Figure 3.6.9: Low magnification photographs of cavity sidewall.

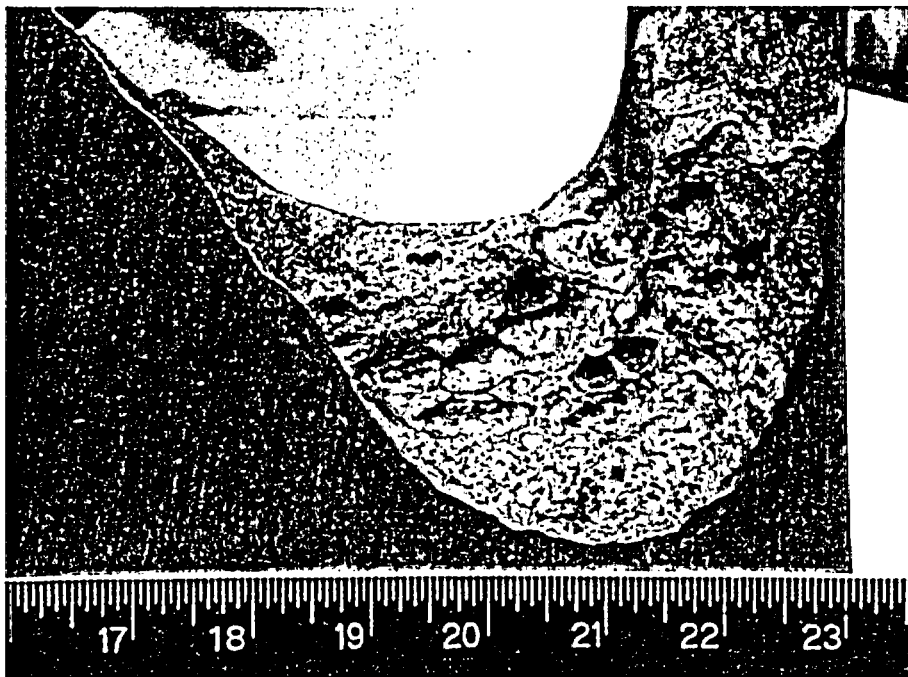
Detail of side wall near 270°. ~1.7X

Looking up at cavity nose. ~0.7X

Figure 3.6.11: Photographs showing the cavity sidewall near 270° (top) and looking up at the cavity nose (bottom).

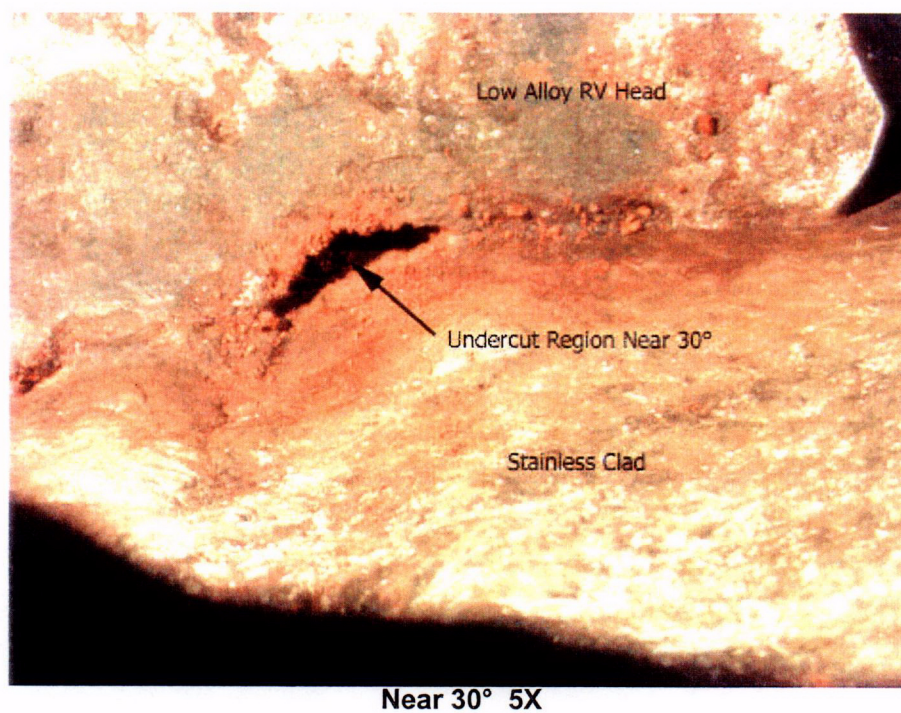
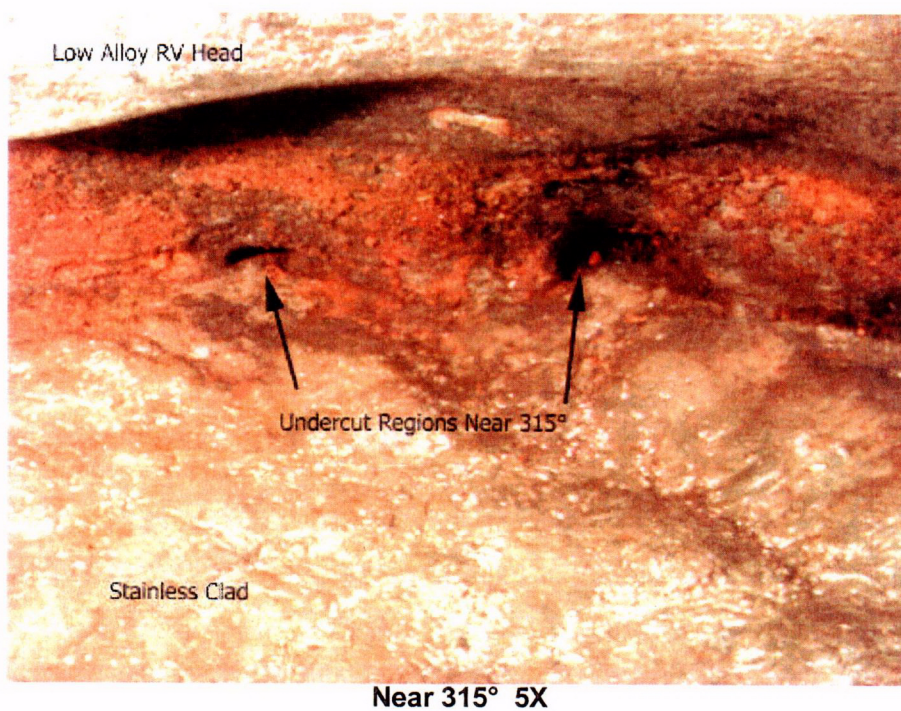
Figure 3.6.12: Photographs showing undercut regions of cavity near 30° (top) and 315° (bottom).

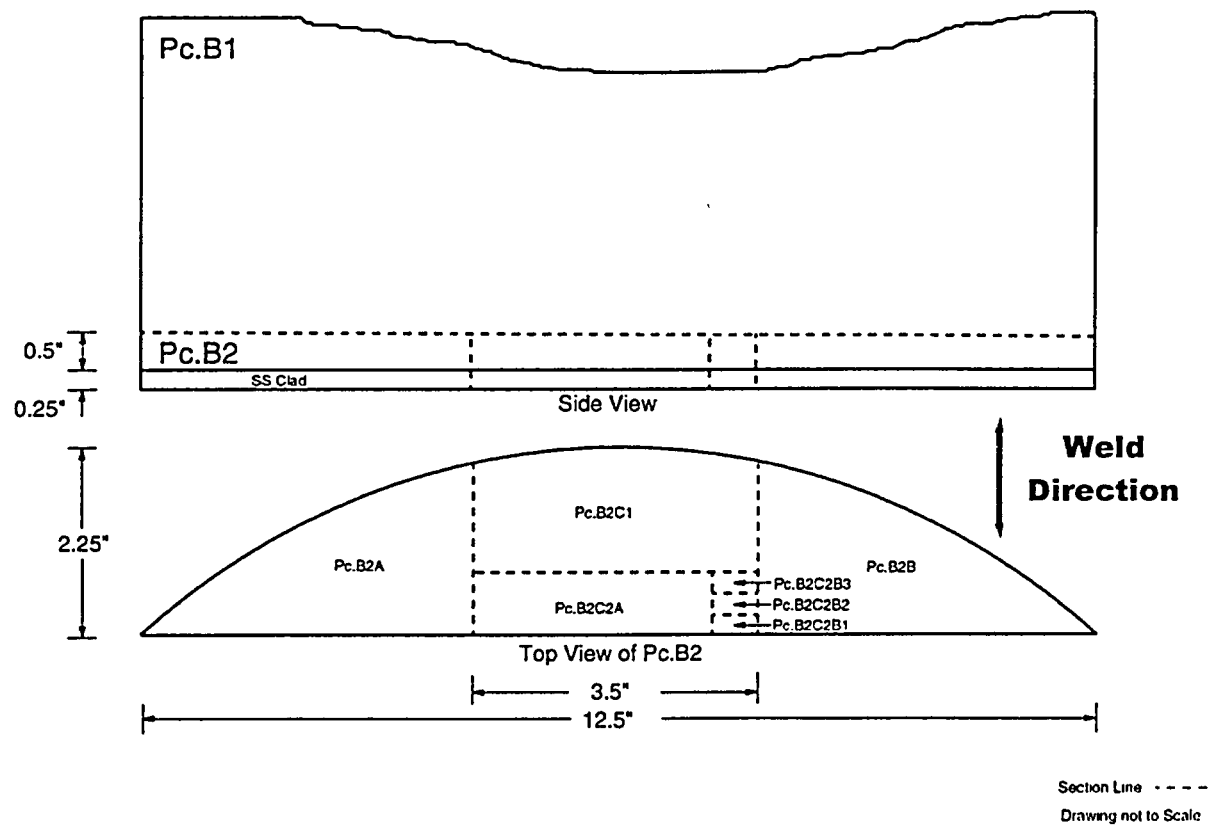
Figure 4.1.1: Schematic showing section locations and sample identifications for Block "B".

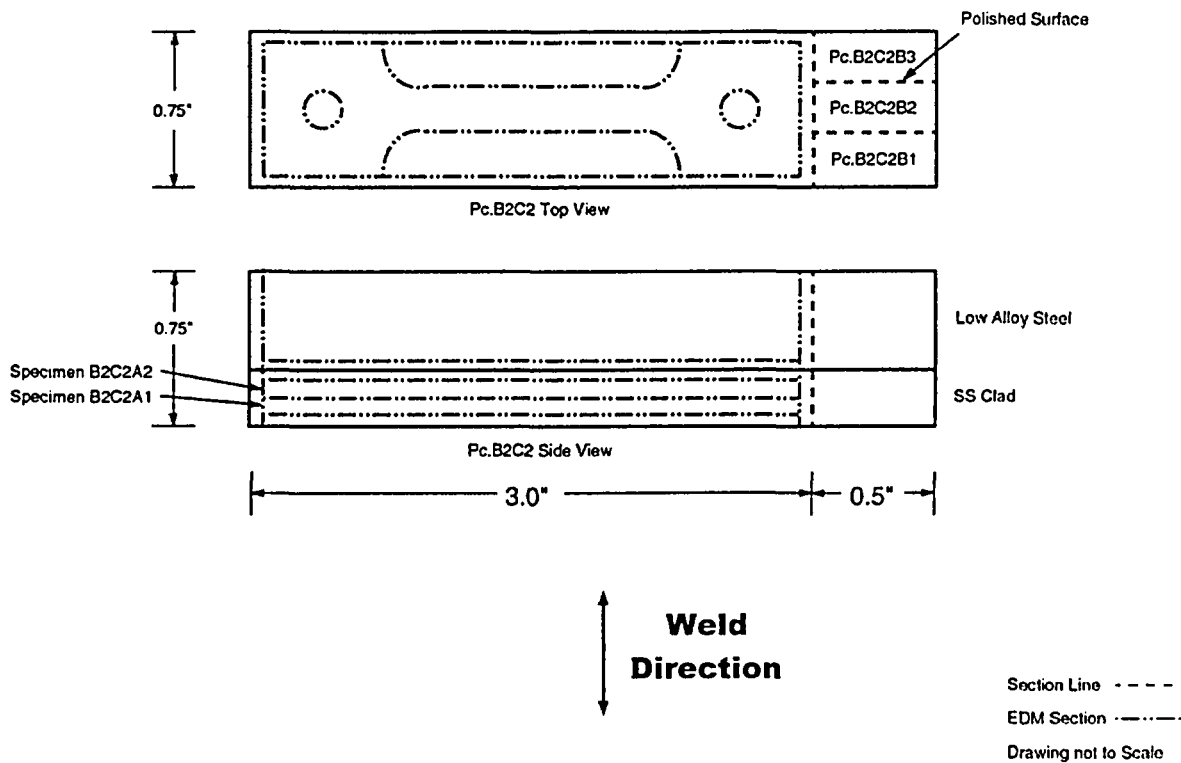
Figure 4.1.2: Schematic showing tensile specimen locations. The polished surface of piece B2C2B3 (met sample) is also indicated.

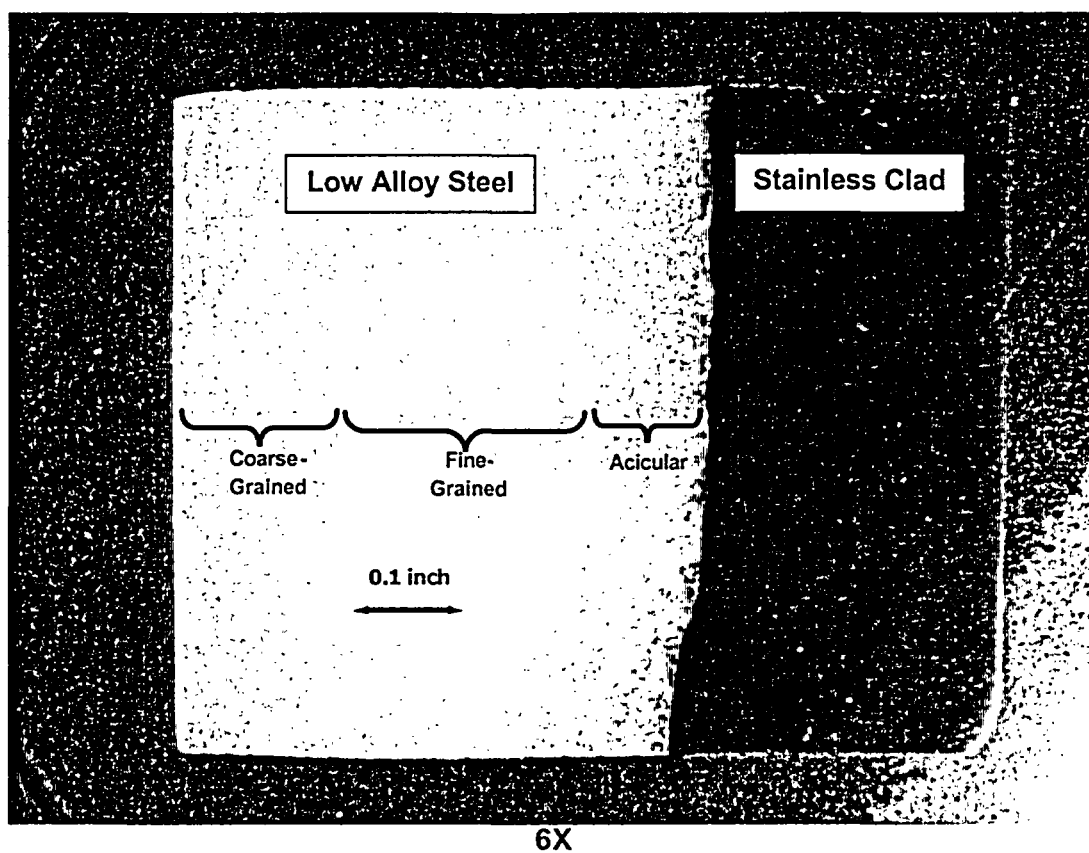
Figure 4.2.1: Macro photograph of Sample B2C2B3 showing the low alloy steel/stainless steel interface and various grain structures within the low alloy steel HAZ.

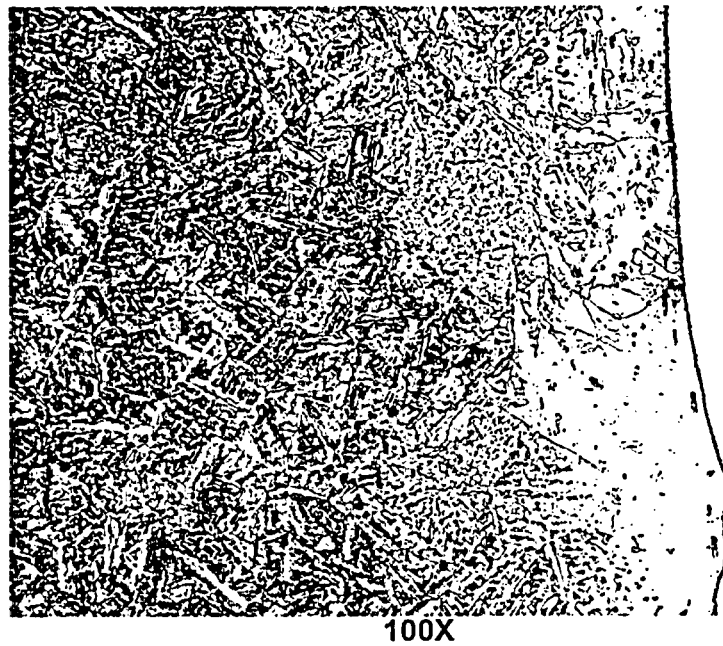
Figure 4.2.2: Typical low alloy steel microstructures near bond. 2% nital

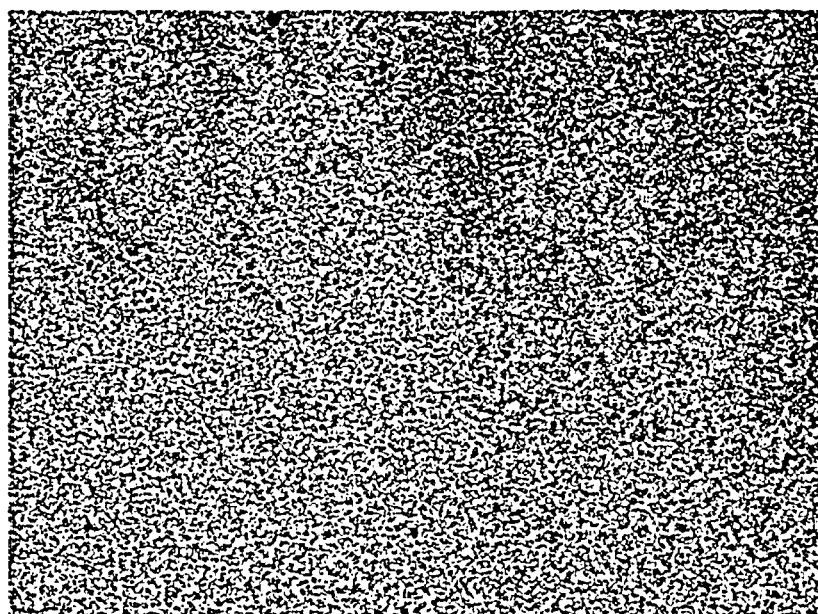
Figure 4.2.3: Typical low alloy steel microstructures 1/4" from bond. 2% nital

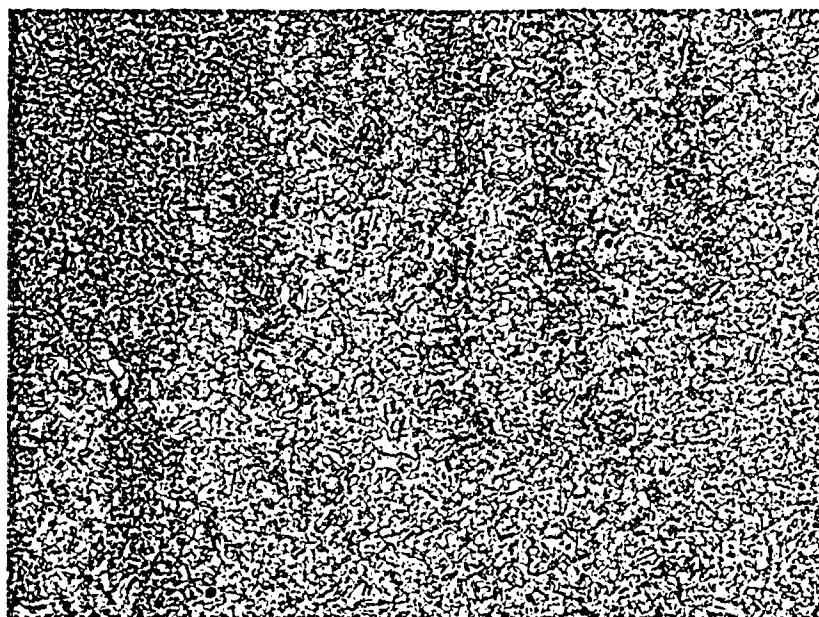
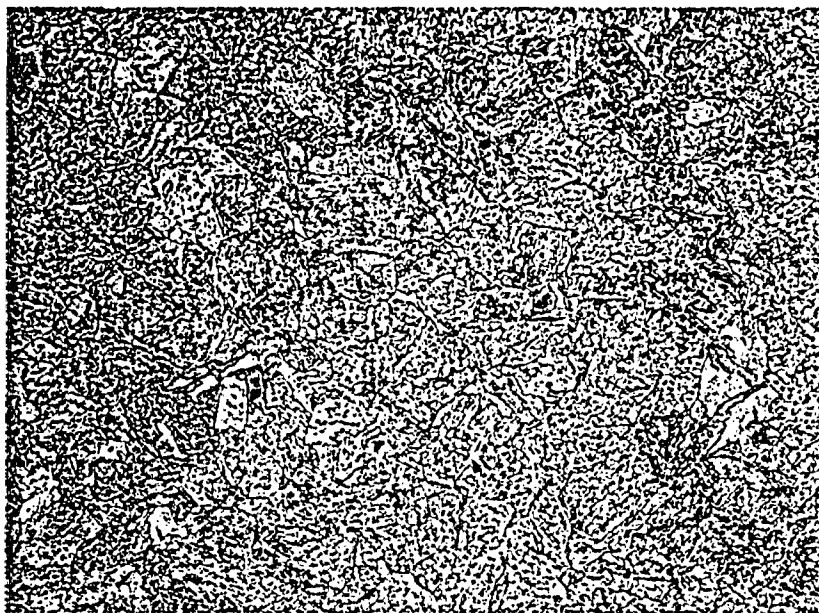
Figure 4.2.4: Typical low alloy steel microstructures ~1/2" from bond. 2% nital

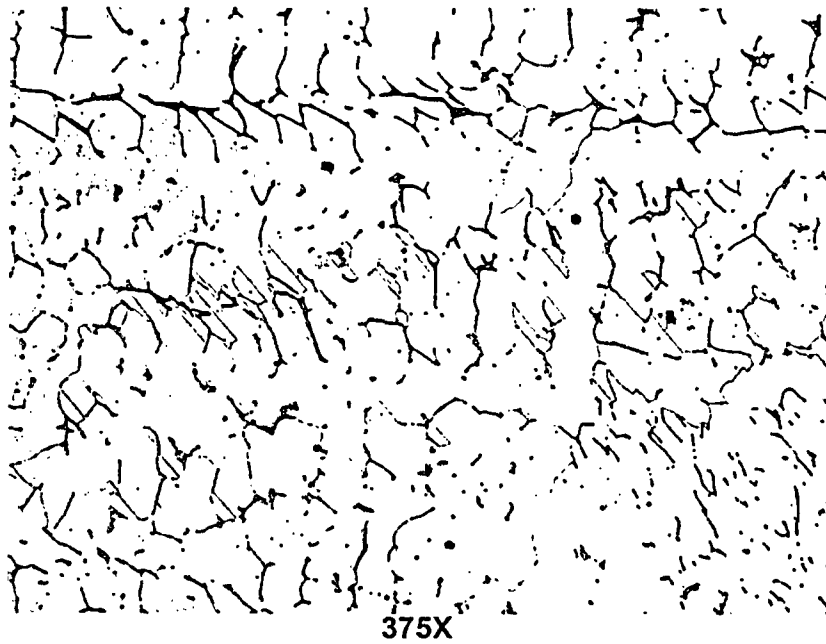
Figure 4.2.6: Typical cladding microstructures away from bond.
(Acetic-nitric-hydrochloric etch)

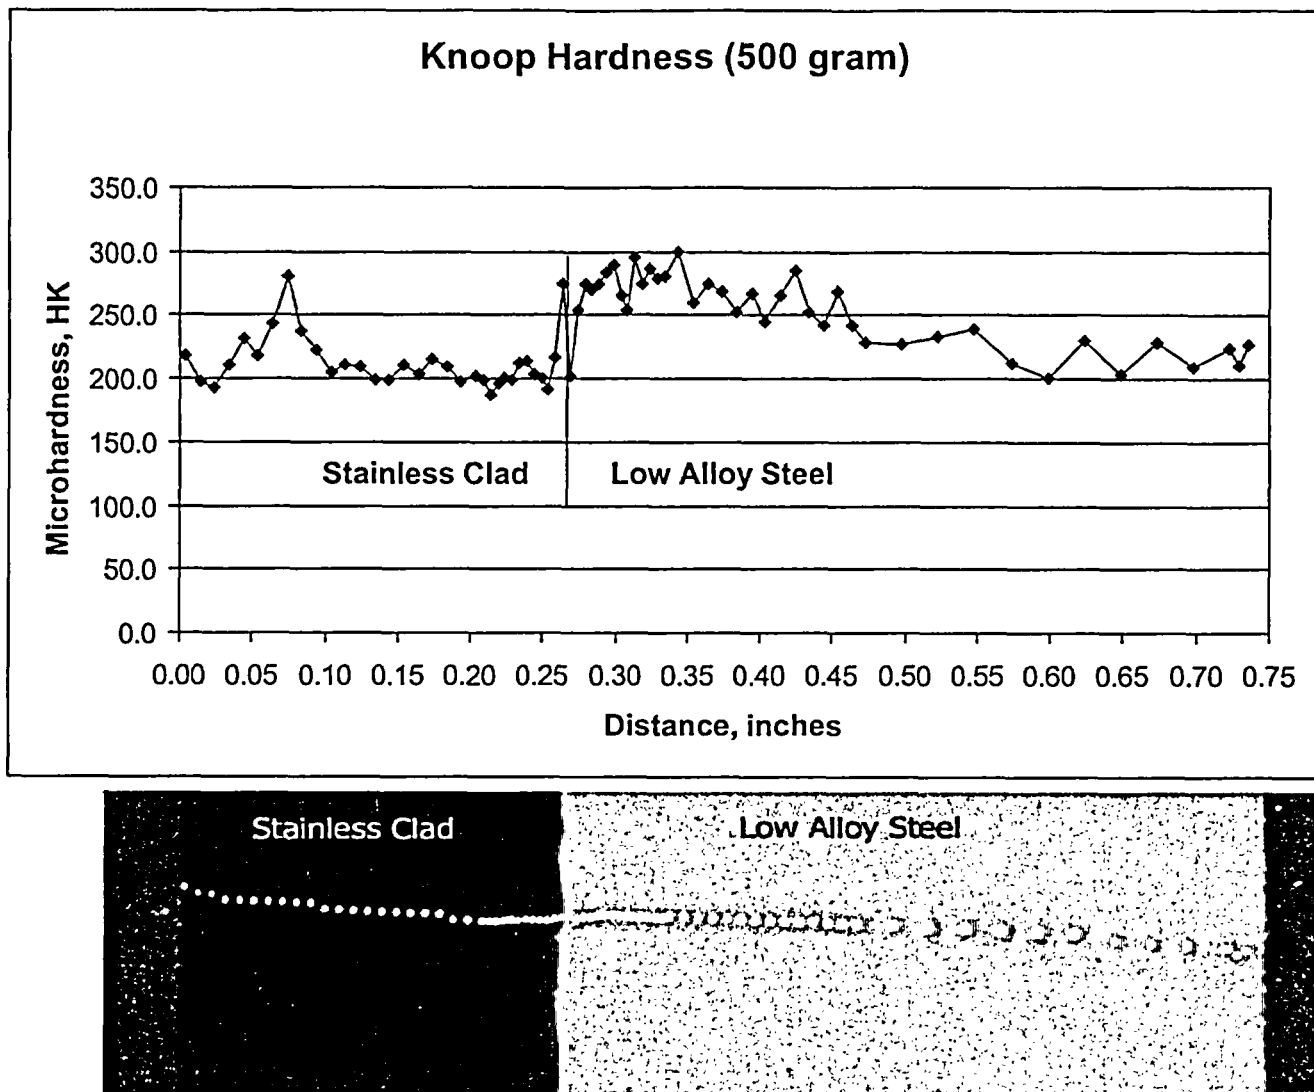
Figure 4.2.7: Microhardness data and low magnification photograph for Sample B2C2B3.

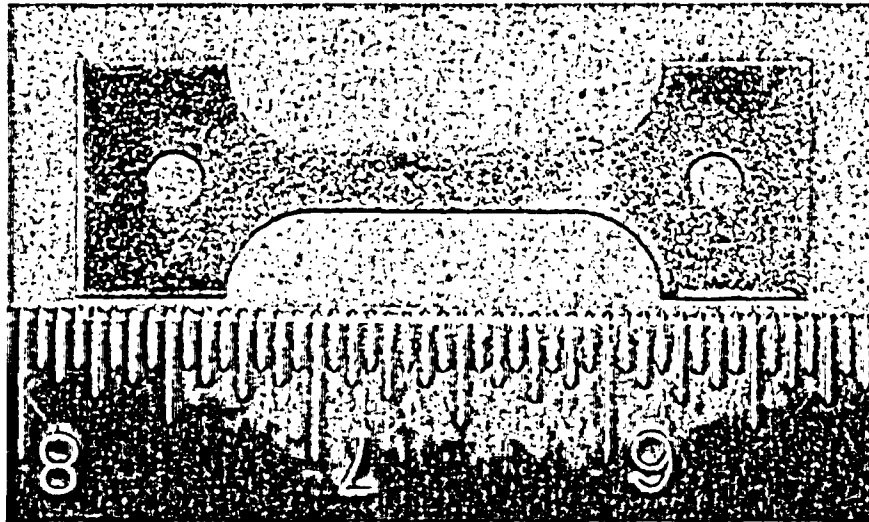
Figure 4.3.1: Tensile specimen design (dummy test specimen shown).

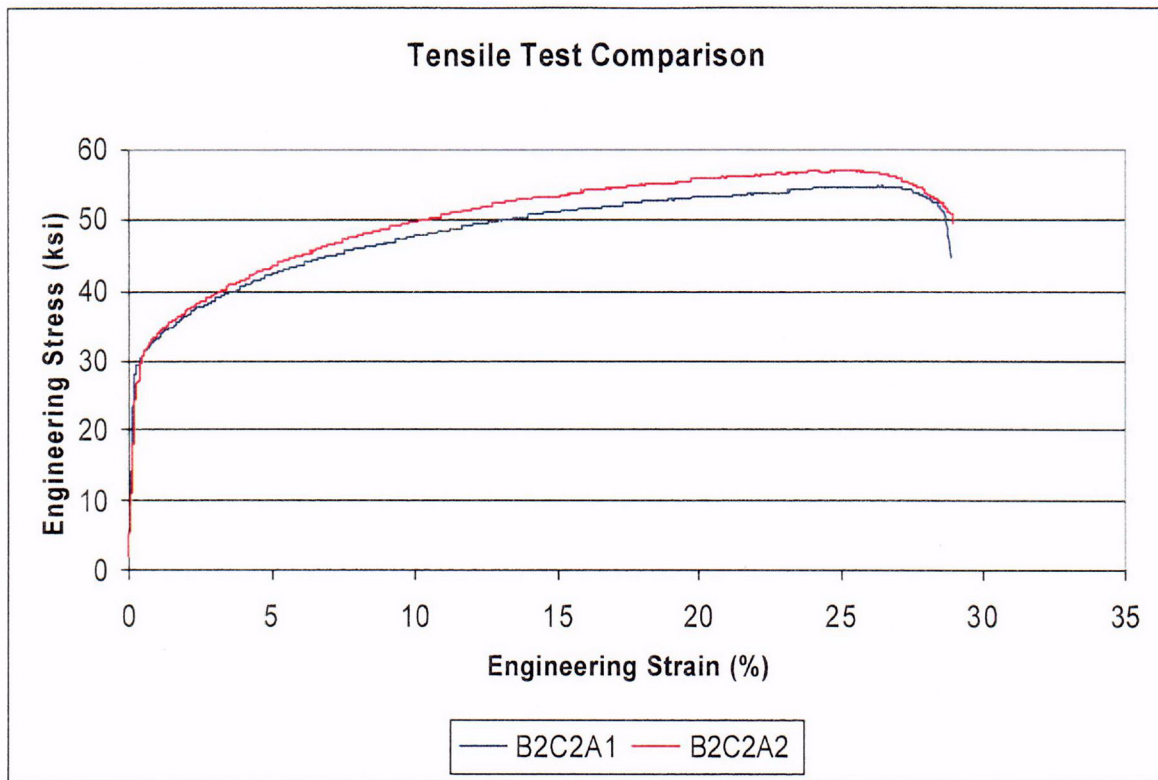
B2C2A1	B2C2A2
UTS	54,800 psi	57,100 psi
2% Offset YS	30,500 psi	31,300 psi
Elongation	28.7%	28.7%
Reduction in Area	39.3%	34.3%

Figure 4.3.2: Tensile test results for specimen B2C2A1 (near RCS) and specimen B2C2A2 (near low alloy steel).

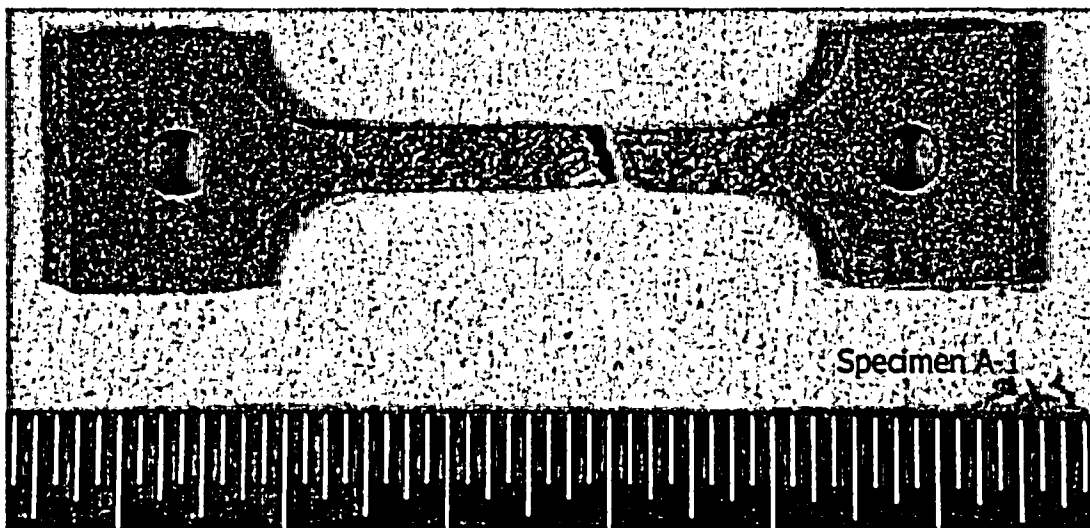
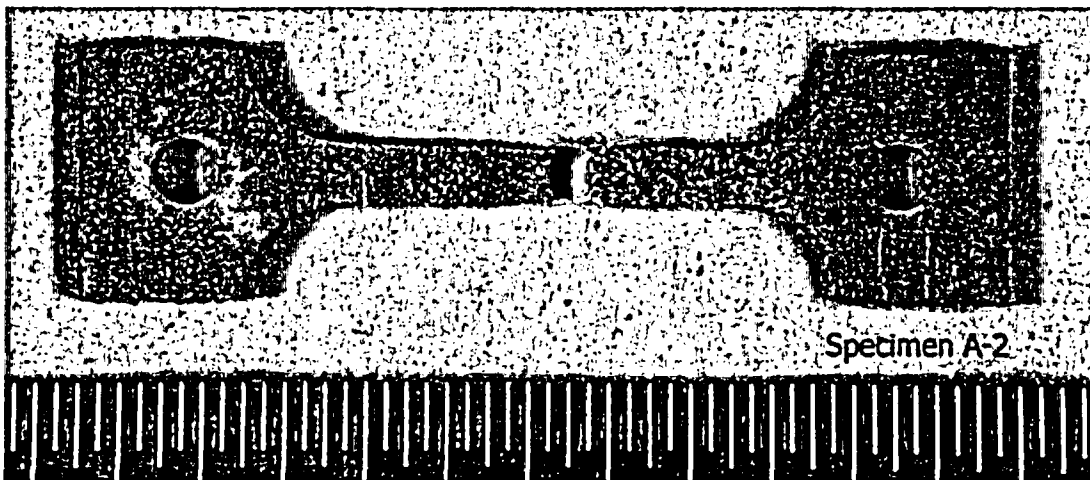
Figure 4.3.3: Low magnification photographs of tensile specimens after test.

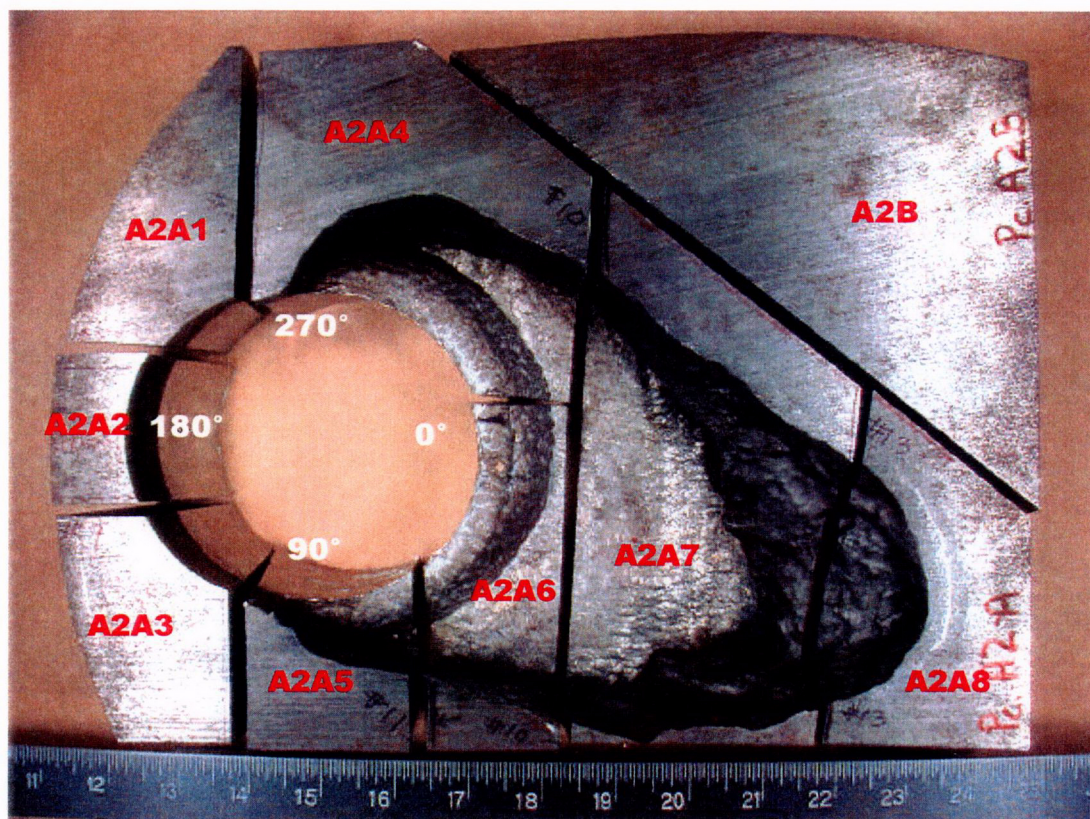
Figure 5.1: Sectioning of Piece A2A (lower portion of cavity) showing new sample identifications.

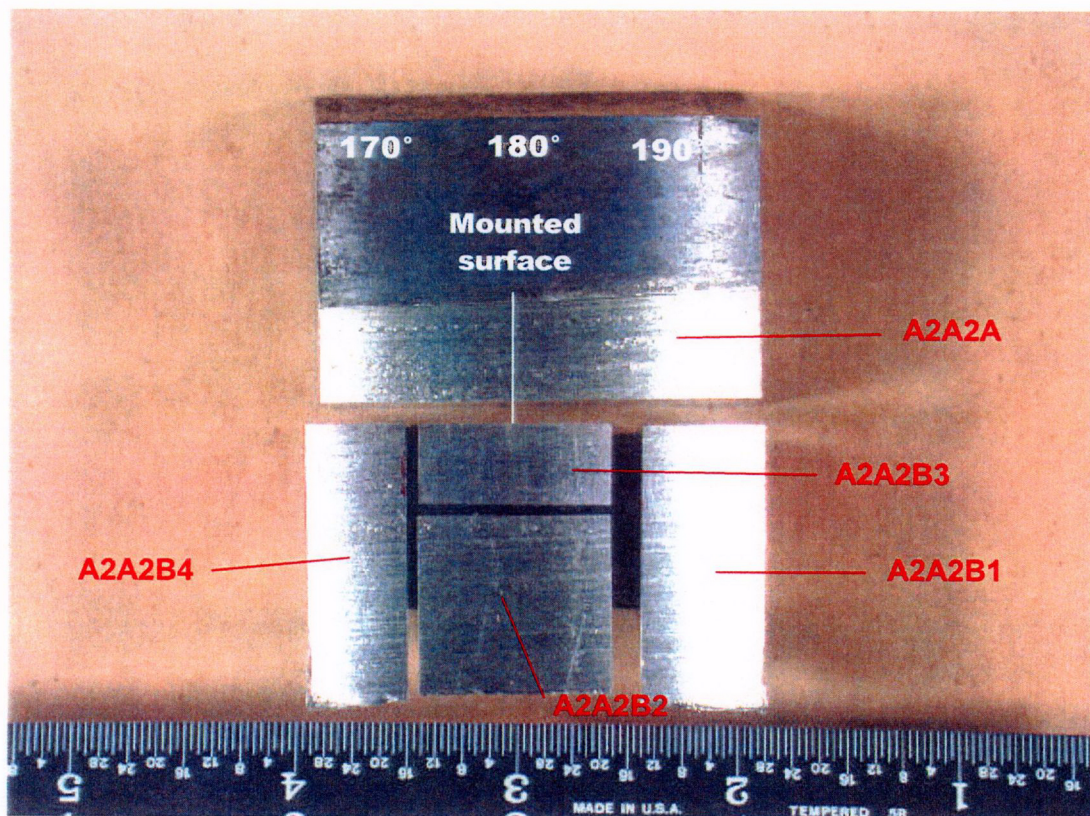
Figure 5.2: Sectioning of Piece A2A2, looking at the ID of the J-groove weld bore.

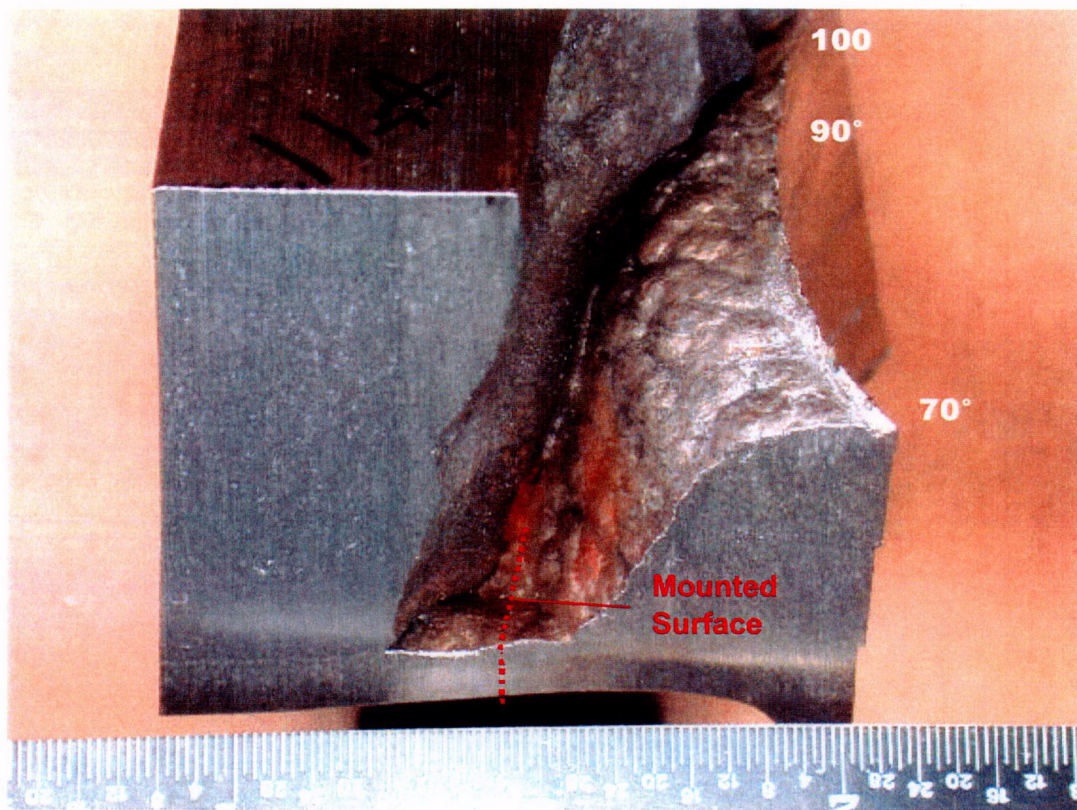
Figure 5.3: Piece A2A5 before sectioning. The mounted surface is indicated.
